MARINE SAFETY INVESTIGATION REPORT

Safety investigation into a fatality on board the
Maltese registered oil tanker

SEAPRINCESS

in TK Tuzla Shipyard, Türkiye
on 14 August 2023

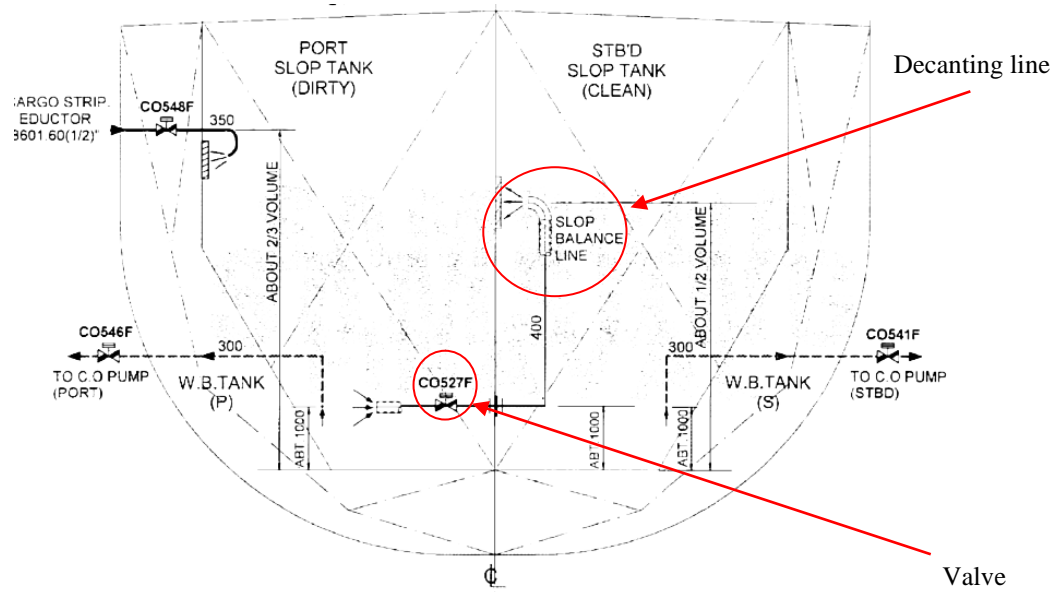
Figure 4: Cross-section through the slop tanks, showing the decanting line

On 07 August, the chief officer and a service technician tested all the valve actuators located in the cargo and slop tanks, to identify any defective valves. Valve 'CO527F' (**Figure 4**) in the port side slop tank was also tested. During the opening and closing testing sequence of the valve, a quantity of oily-water mixture that had remained

During the testing of the actuator valves inside the slop tank, a quantity of oily-water mixture, which unknowingly had remained inside the decanting line between the two slop tanks, was released inside the port side slop tank. Although the safety

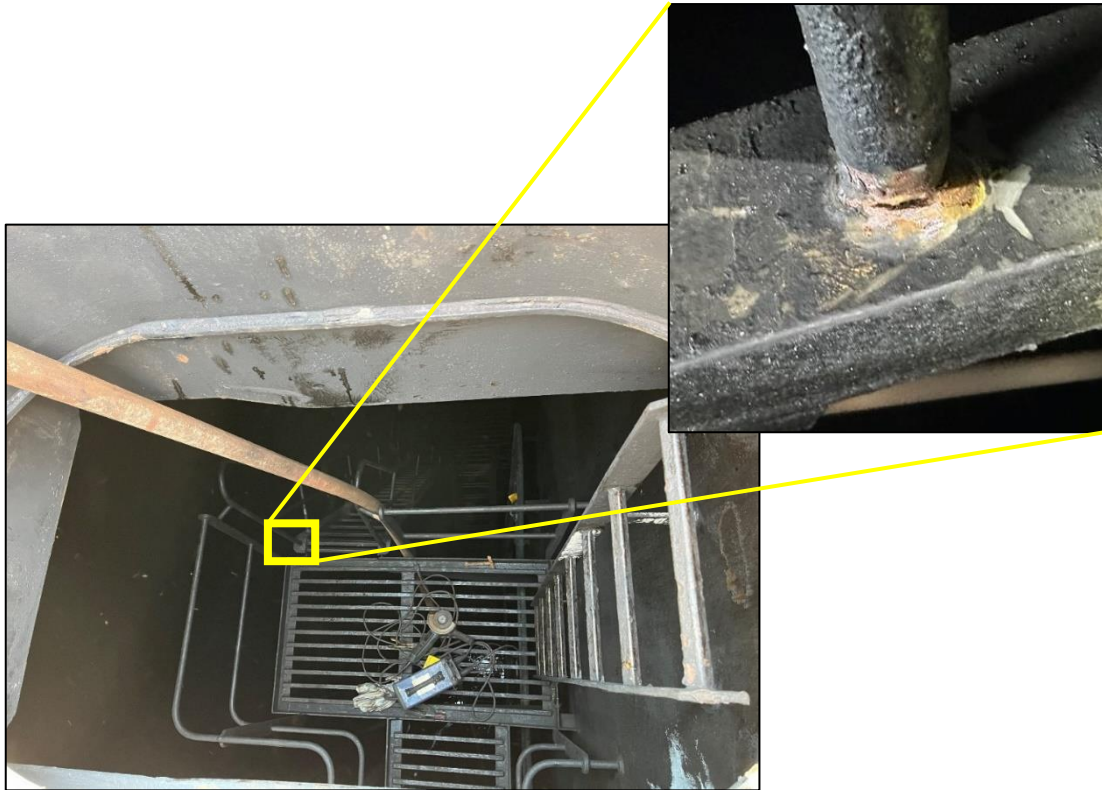
Figure 8: entrance to port side lope tank, showing the first stanchion that required repairs

The first and second stanchions on the sloping ladder were identified as the ones requiring attention (**Figure 8**). Whilst neither an entry permit nor a hot work permit was granted for the entry into the tank, the crew members were not informed that the foreman and welder 2 were entering the tank.

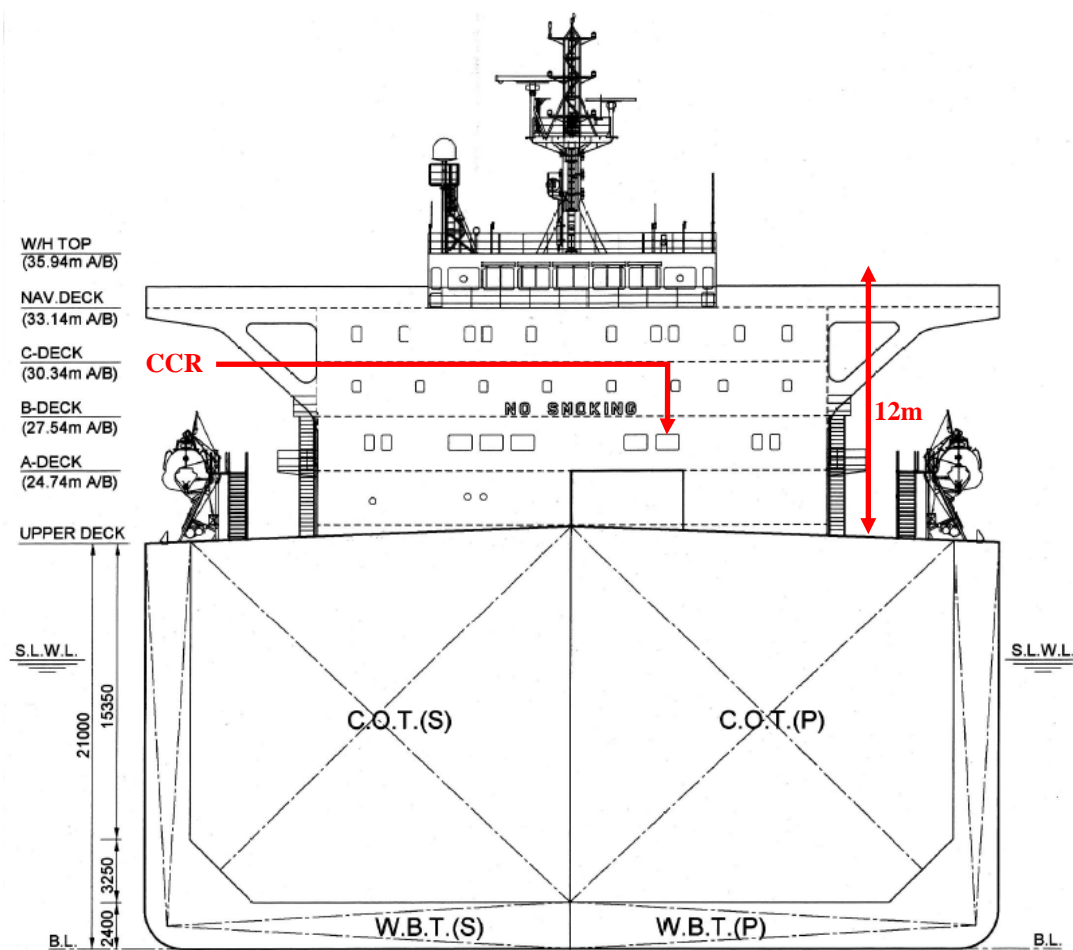
Figure 9: Approximate height from main deck

Persons on board, who witnessed the accident, stated that they saw welder 2 rise to an estimated height of about 12 m from the main deck (Figure 9); the OOW observed welder 2 from the bridge window. Falling back to the main deck, a second explosion³ appeared to cushion his fall, slowing his free fall before landing on the deck.

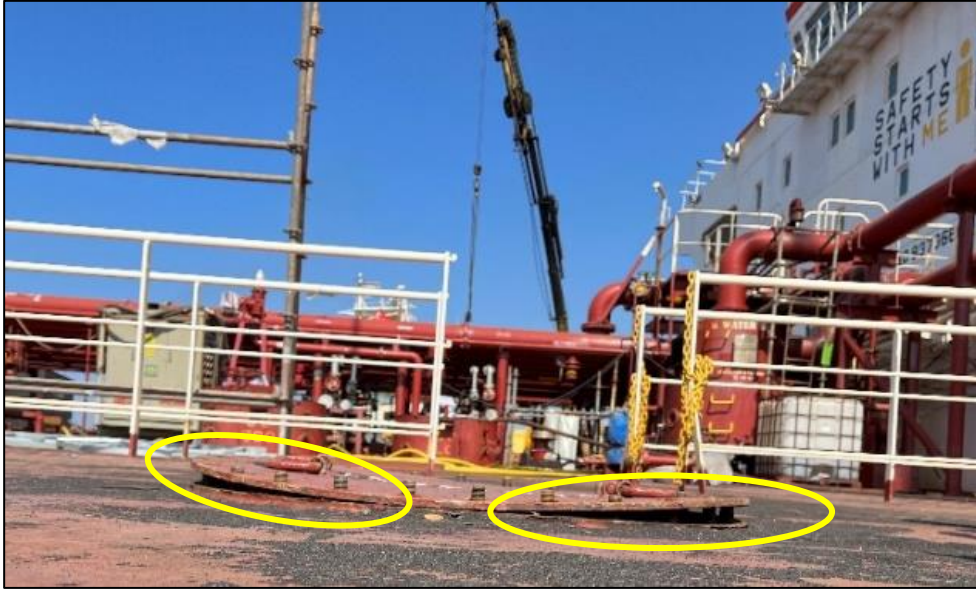
Figure 10: Buckling of the port side slop tank's manhole cover

An inspection of the area only revealed damages to the slop tank's manhole cover, which was found buckled (**Figure 10**) by the pressure wave generated by the explosion inside the tank. No structural damages were observed inside the slop tank. Soot residue from the fire was observed on the bulkheads (**Figure 11**).

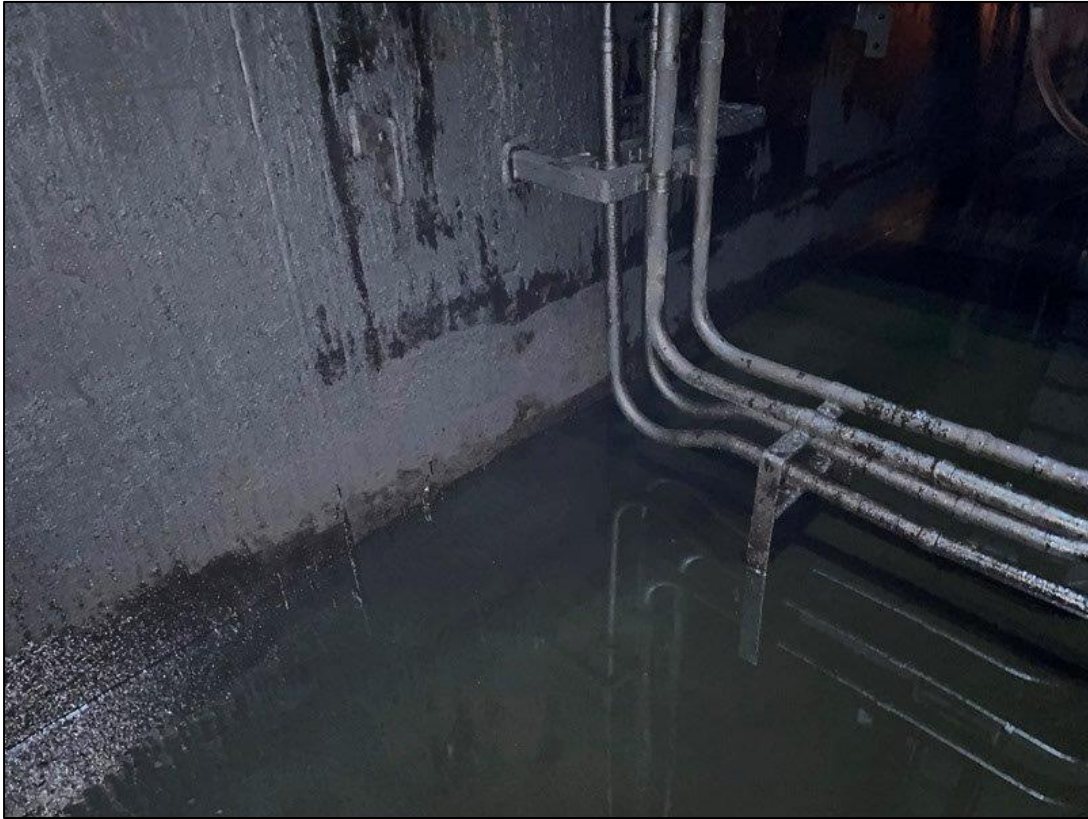
Figure 13: Firefighting water inside the slop tank

investigation could not determine the actual quantity of liquid because of the firefighting water remaining inside the slop tank after the accident (**Figure 13**), it was estimated that between 500 litres and 600 litres of the oily-water mixture may have been accidentally spilled inside the slop tank.

Over the following seven to eight days, the oily-water mixture, which accumulated inside the slop tank at ambient hot temperatures ranging between 29 °C and 33 °C, was very likely to have generated vapour. Being heavier than air, the oil vapour would have remained at the bottom of the tank, with the splatters from the arc welding causing the explosion.
