MARINE TRANSPORTATION SAFETY INVESTIGATION REPORT M21P0297

LOSS OF CONTAINERS OVERBOARD AND SUBSEQUENT FIRE

Container vessel *ZIM Kingston*
La Perouse Bank, British Columbia
21 October 2021

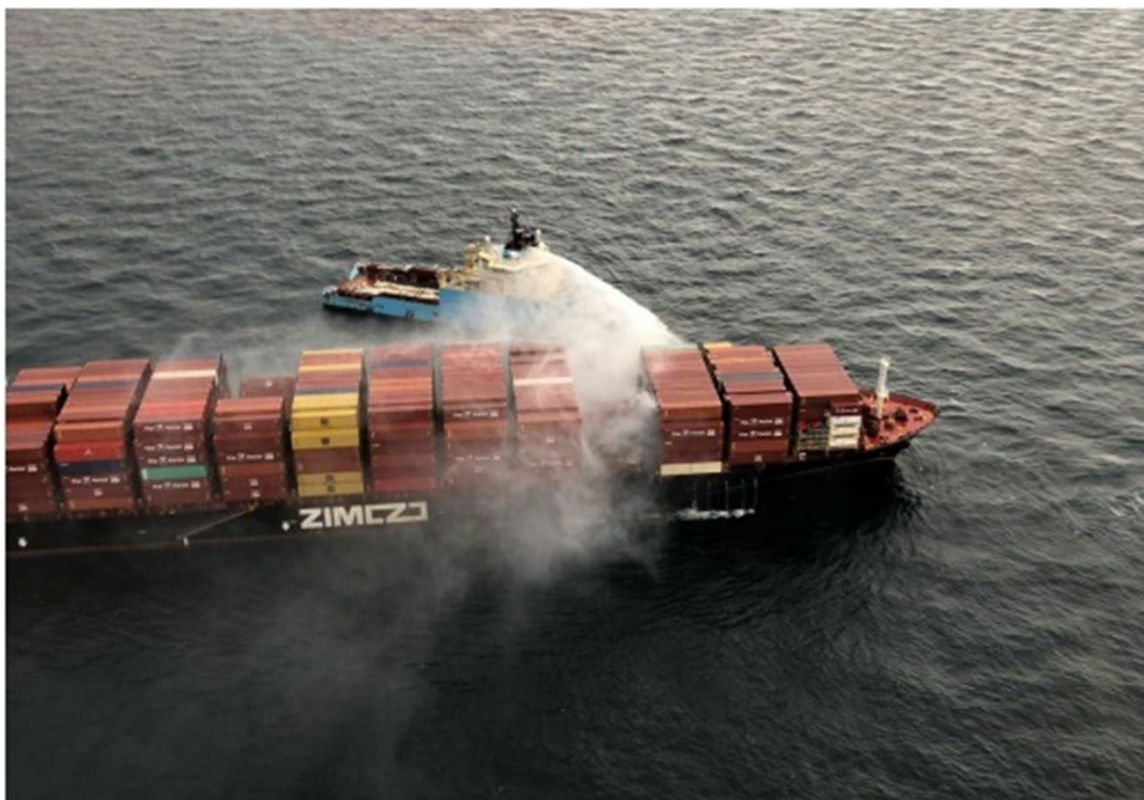
Figure 3. *Maersk Trader* performing boundary cooling (Source: Resolve Marine)

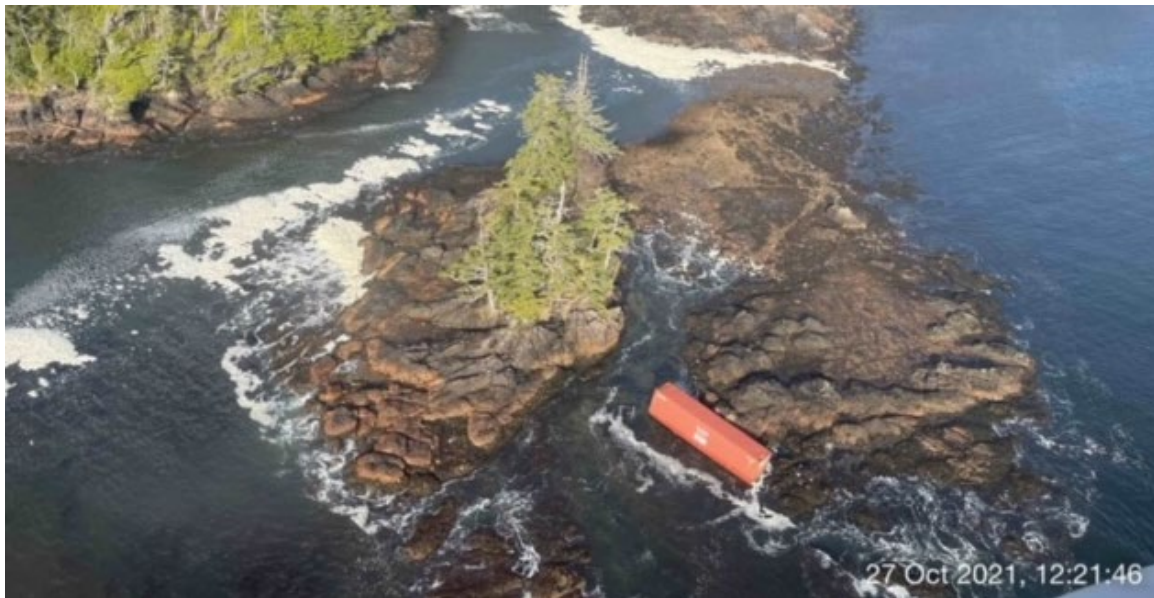
Figure 5. Aerial photo of a container from the *ZIM Kingston* washed up on land (Source: Transport Canada)

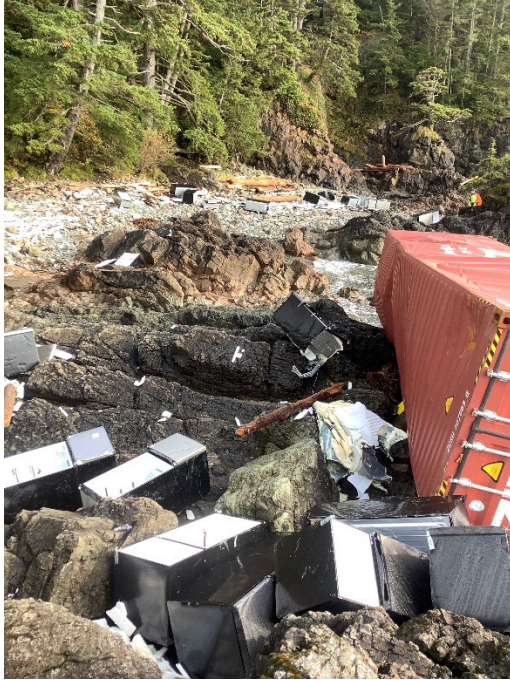
Figure 6. Photo of a container from the *ZIM Kingston* and refrigerators on the beach at Cape Palmerston, BC (Source: Pacificus Biological Services Ltd.)

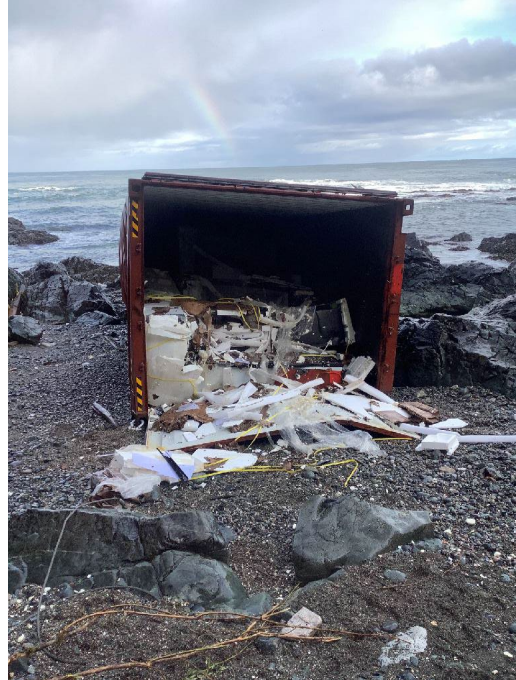
Figure 7. Photo of an open container from the *ZIM Kingston* with plastic debris inside at Shuttleworth Bight, BC (Source: Pacificus Biological Services Ltd.)

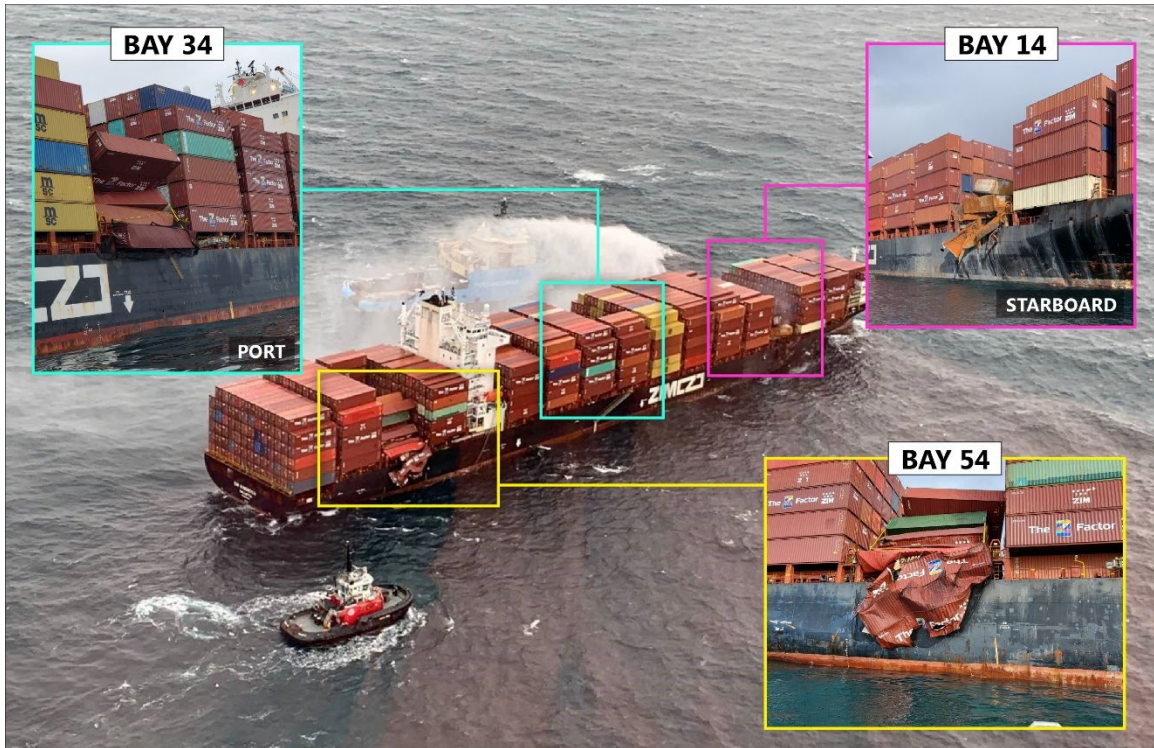
Figure 8. Bays in which containers were damaged or lost overboard (Main image source: Transport Canada; inset images source: TSB)

As a result of the occurrence, a total of 109 containers went overboard from 3 bays (bays 14, 34, and 54) and 53 containers on deck were damaged (figures 9 and 10). Post-occurrence examination of the containers showed that there had been fires inside 6 of the containers in bay 14: of these, 3 had held xanthates and 3 had held tires and general consumer goods. One of the hatch covers in bay 14 was bent, and the port-side accommodation ladder was also damaged.

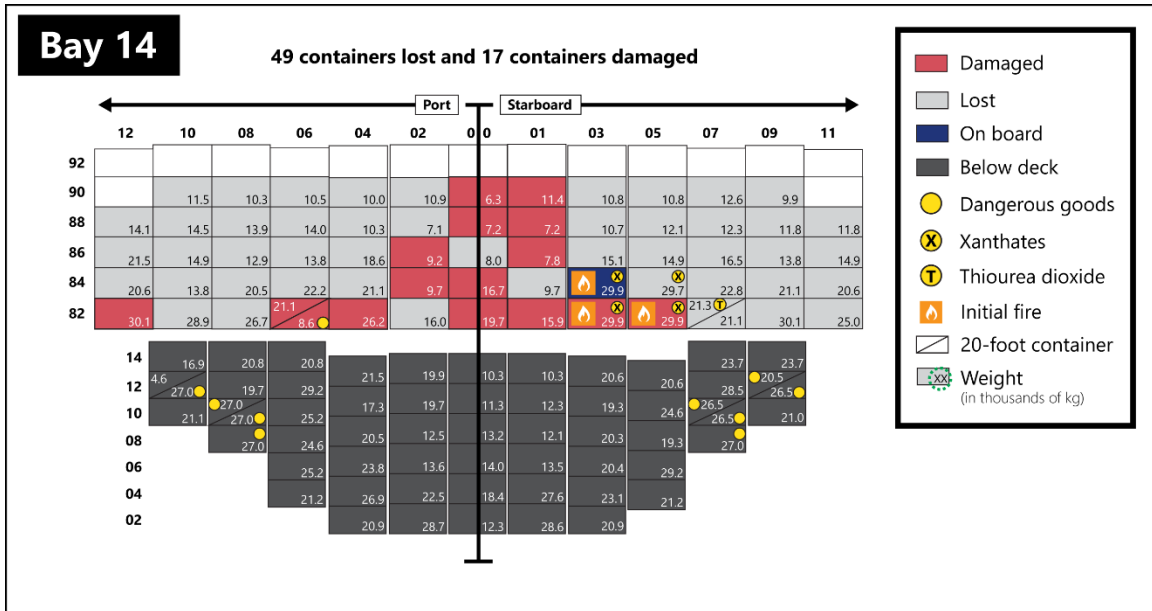
Figure 10. Cross-section of bay 14 showing lost and damaged containers (view from aft looking forward) (Source: TSB)

Bay 14 held a combination of 40-foot containers and 20-foot containers on deck. The 20-foot containers were stowed in pairs end-to-end, forming the equivalent length of the 40-foot containers. Forty-nine containers were lost overboard from bay 14, and 17 were damaged (Figure 10).

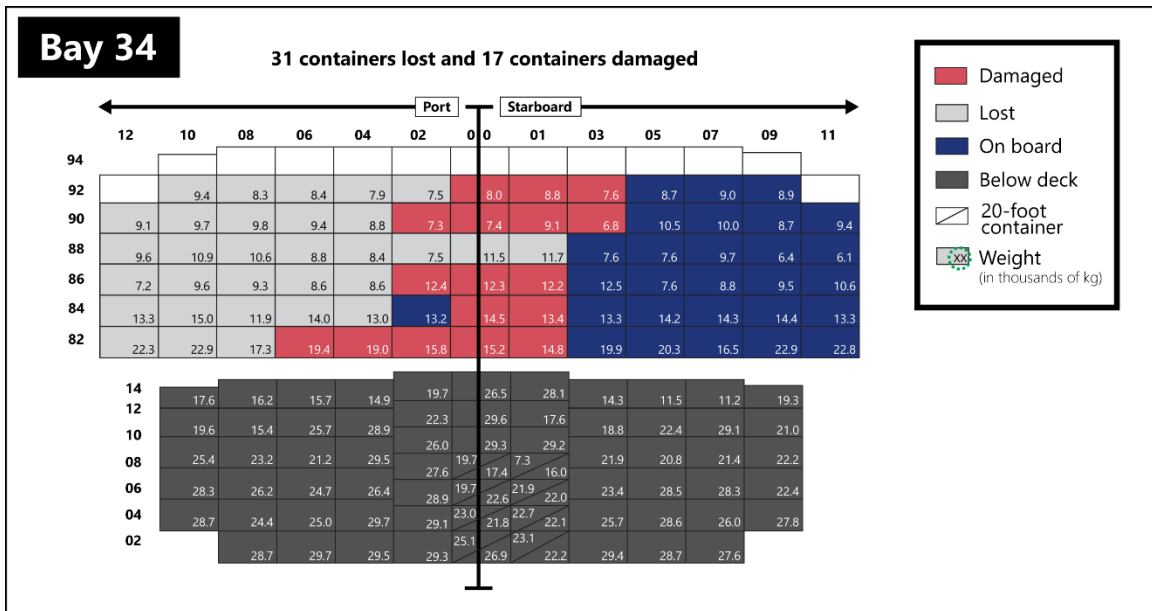
Figure 11. Cross-section of bay 34 showing lost and damaged containers (view from aft looking forward) (Source: TSB)

Bay 34 held only 40-foot containers on deck. Thirty-one containers were lost overboard from bay 34, and 17 were damaged (Figure 11).

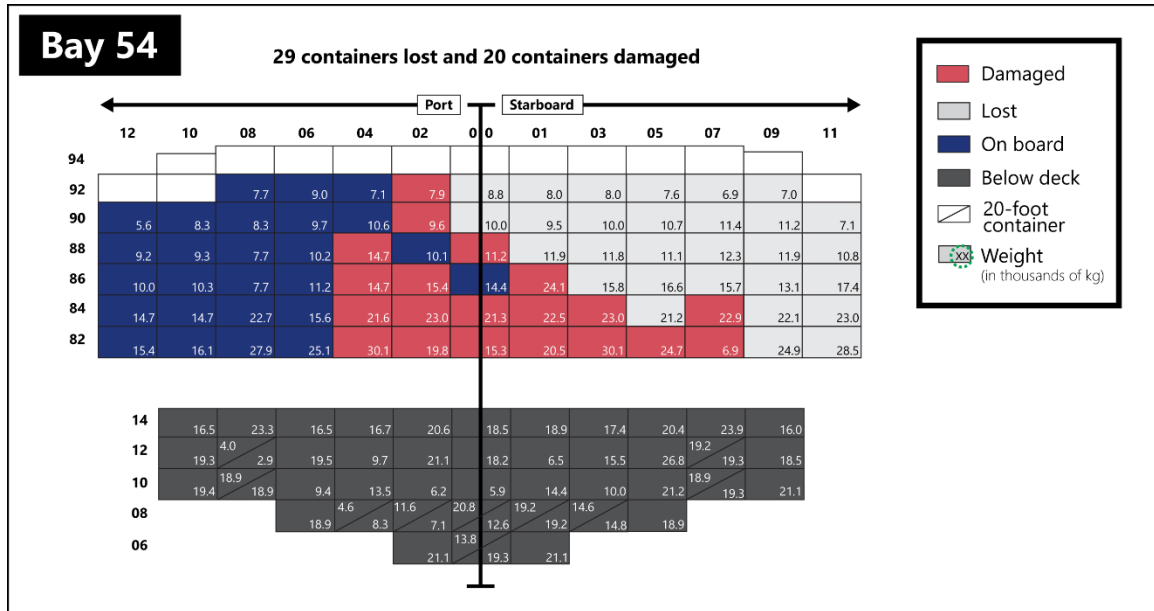
Figure 12. Cross-section of bay 54 showing lost and damaged containers (view from aft looking forward)
(Source: TSB)

Bay 54 held only 40-foot containers on deck. Twenty-nine containers were lost overboard from bay 54, and 20 were damaged (Figure 12).

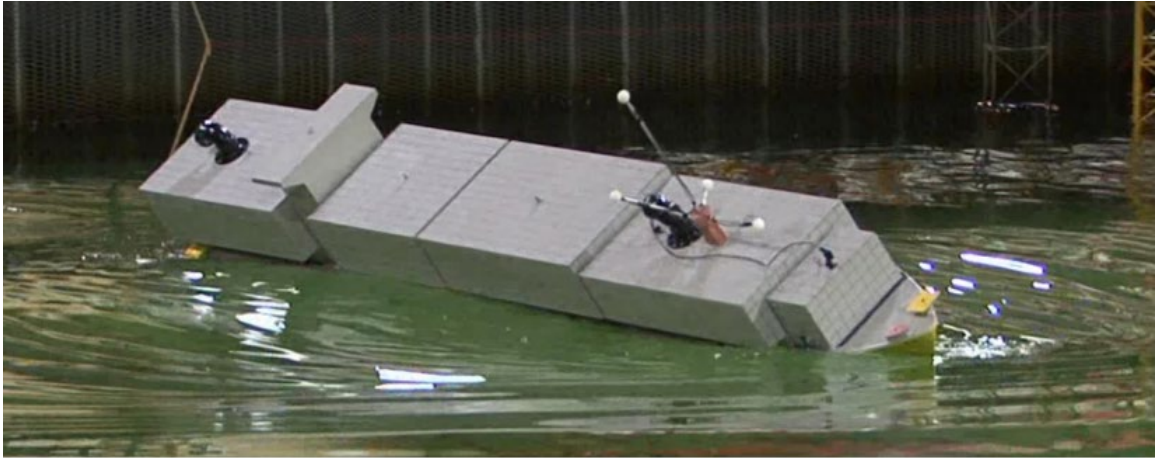
Figure 18. Still photo of the *ZIM Kingston* model rolling to large angles during tests. Note that the level of water is reaching the containers on the deck; at full scale, this would be considered a green water event (Source: National Research Council Canada)

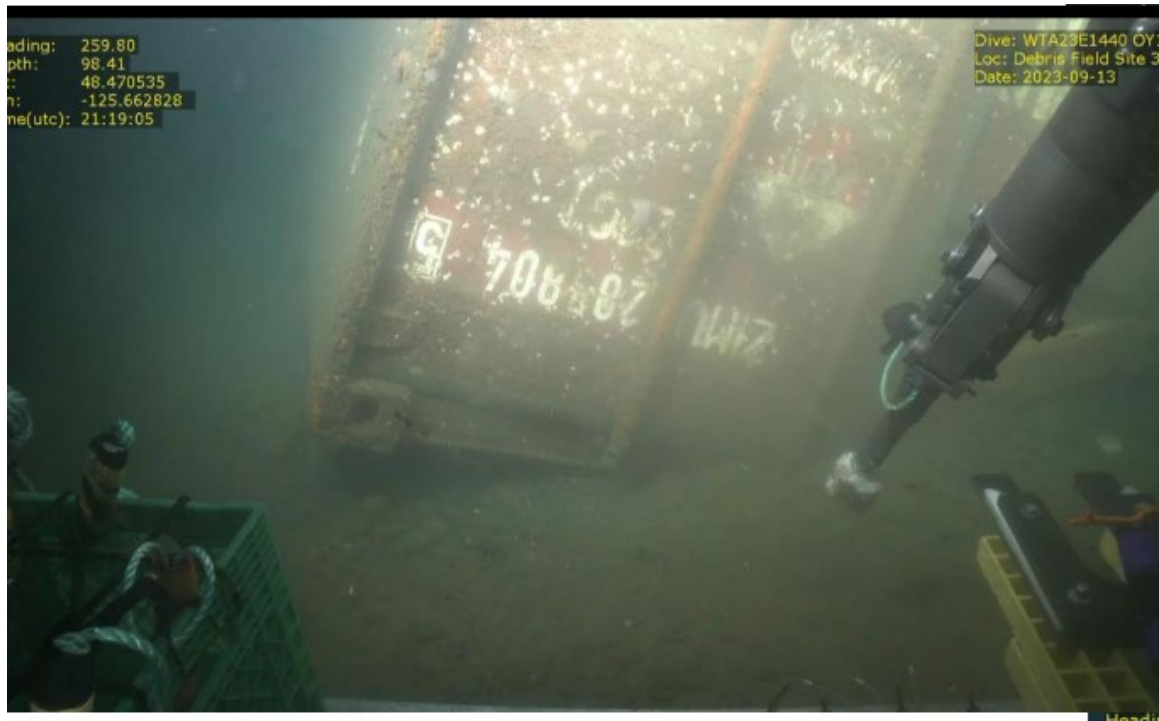
Figure 25. A ZIM container on the ocean floor (Source: DFO)

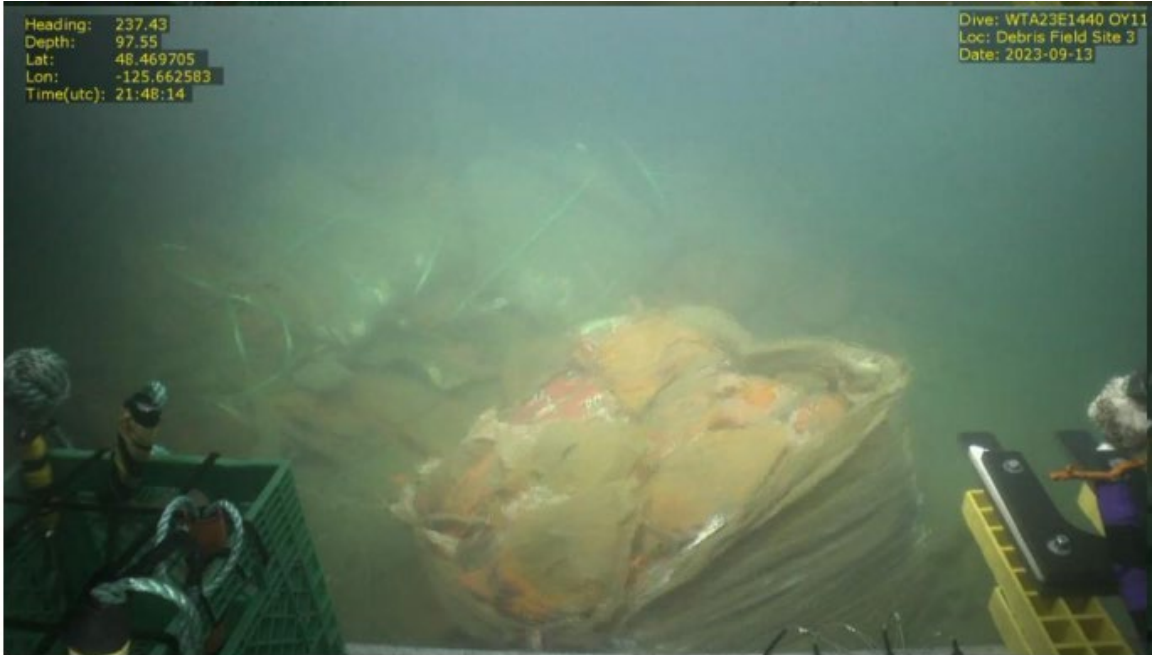
Figure 26. Plastic debris on the ocean floor (Source: DFO)

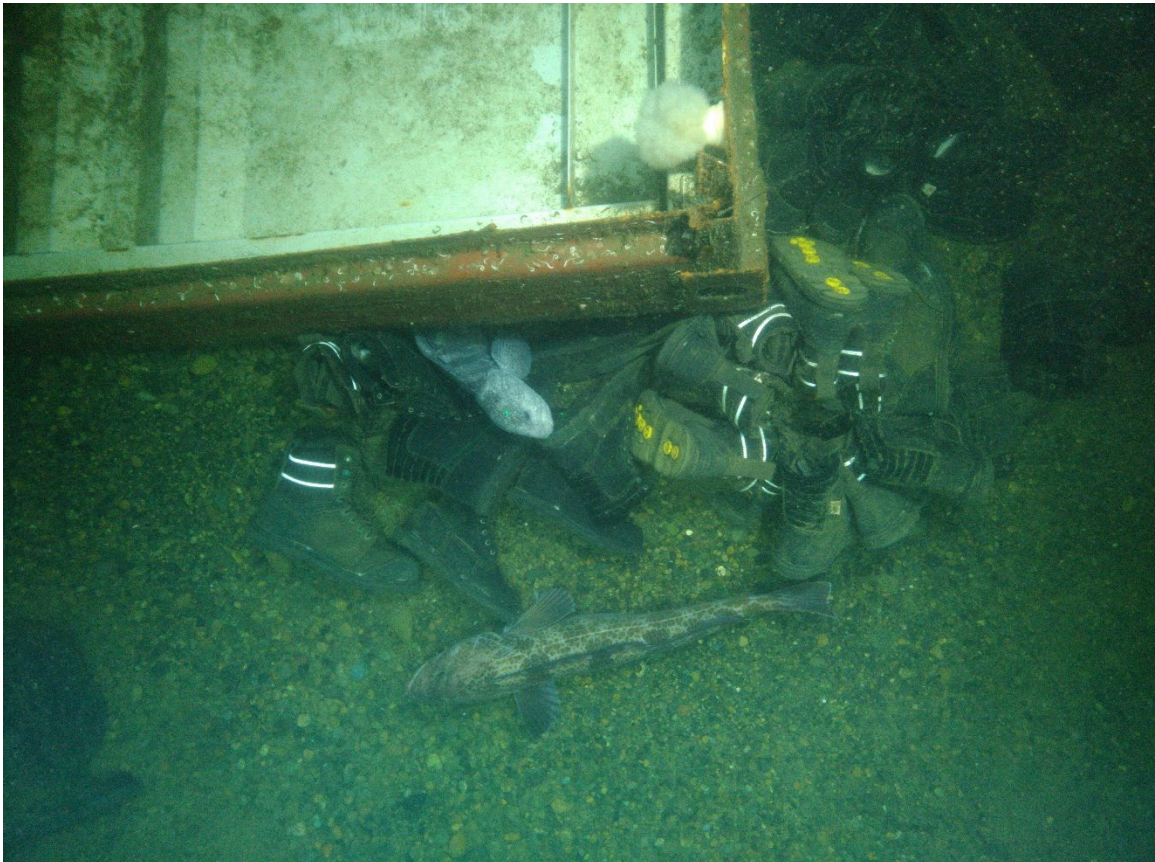
Figure 27. Boots on the ocean floor (Source: DFO)
