NTSB Engineering Group (DCA24MM031) *Dali* Shipboard Machinery Examination and Record of Electrical Testing, April 1-29, 2024

September 11, 2024

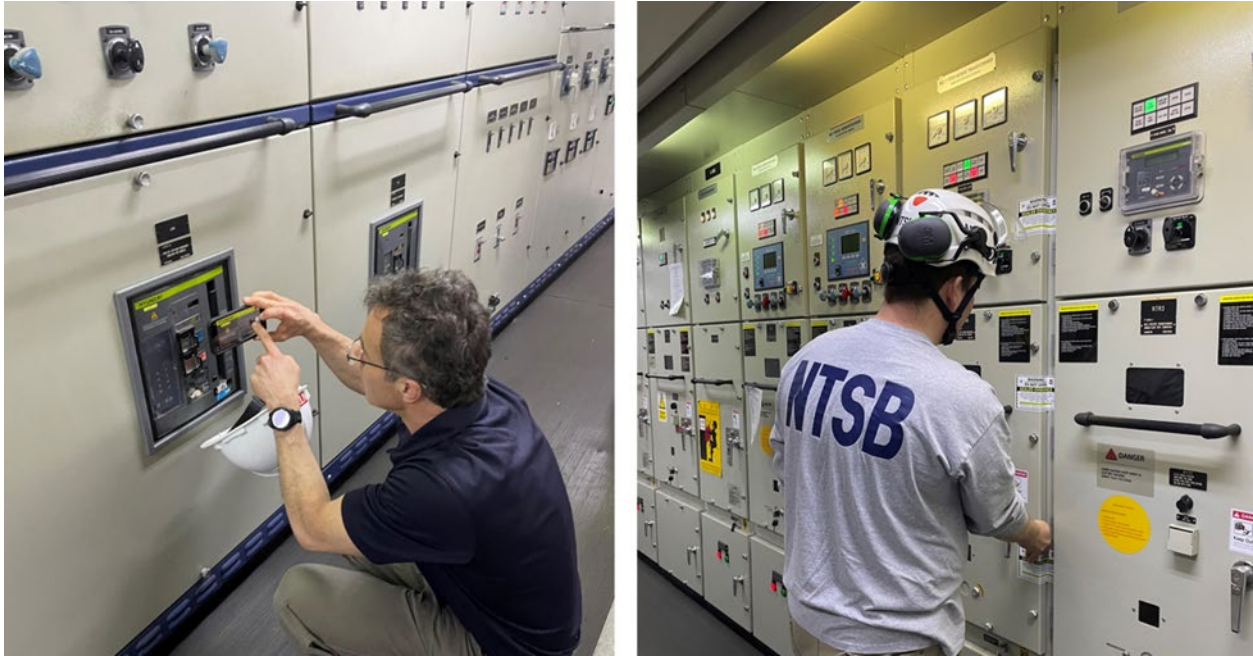
Figure 1. *Left to right:* An NTSB investigator examines a circuit breaker on *Dali*'s low-voltage (LV) switchboard, and an NTSB Investigator applies tamper-evident preservation seals to the HV switchboard.

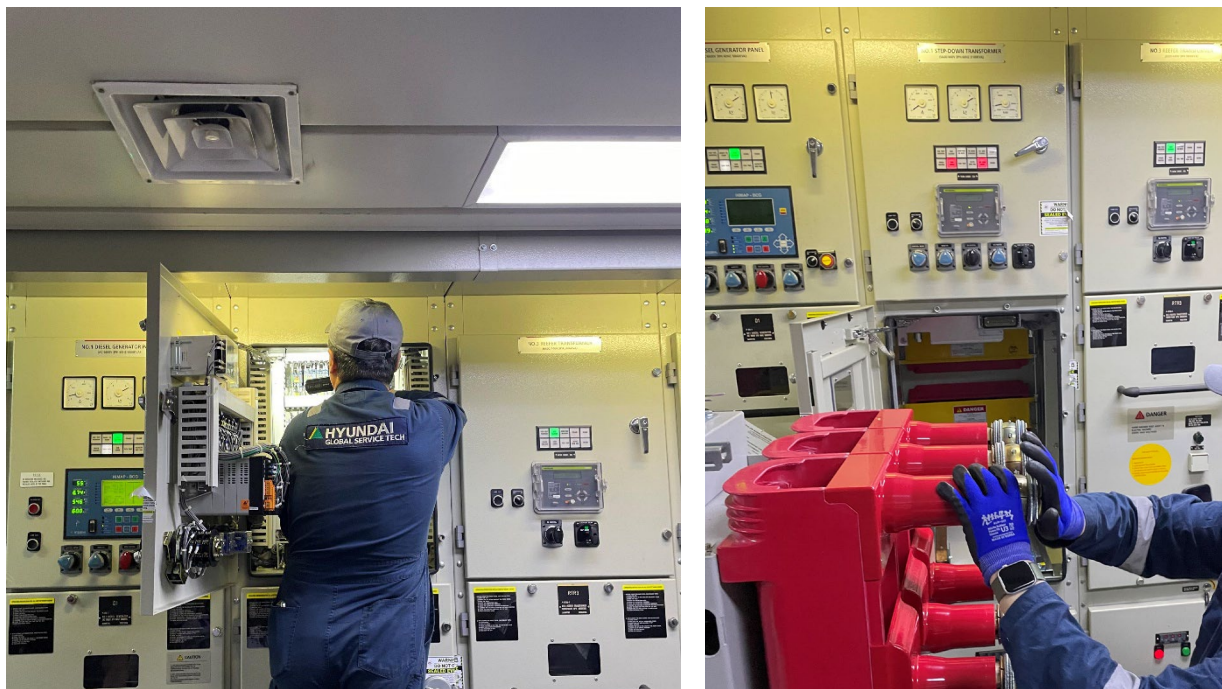
Figure 2. *Left to right:* An HHI engineer examines HV switchboard control circuitry, and an HHI engineer inspects the HR1 HV vacuum circuit breaker (VCB).

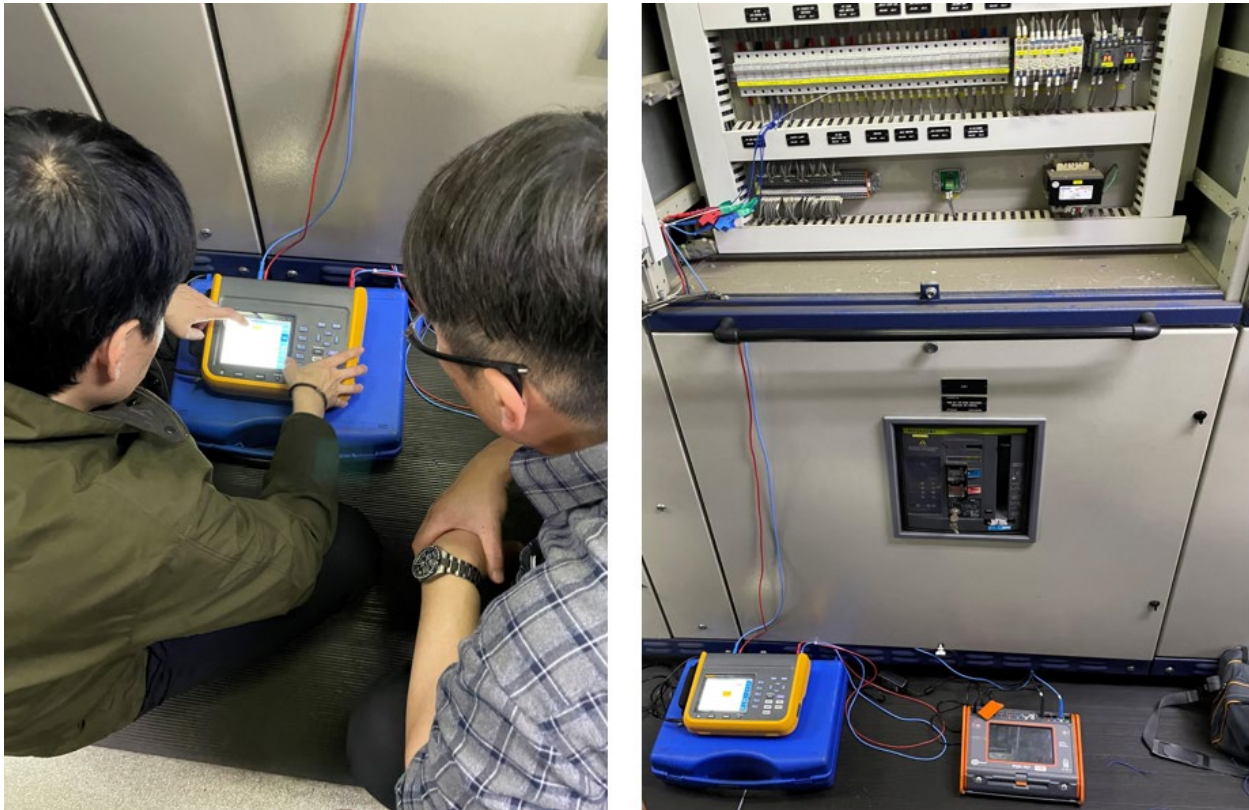
Figure 3. *Left to right:* HHI electrical engineers installing and monitoring the power analyzer connected to the LV switchboard. The power analyzer fully connected to and monitoring the LV switchboard.

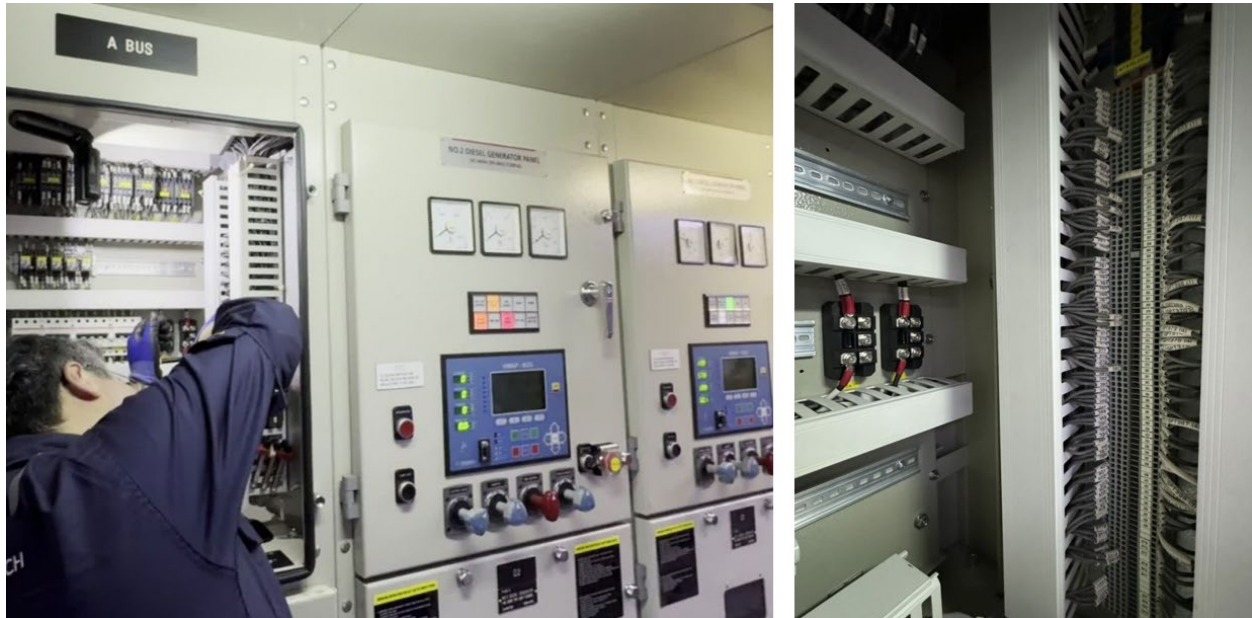
Figure 4. *Left to right:* An HHI engineer inspects wire connections within the HV switchboard. Also shown, terminal block arrangement with individual wire connections.

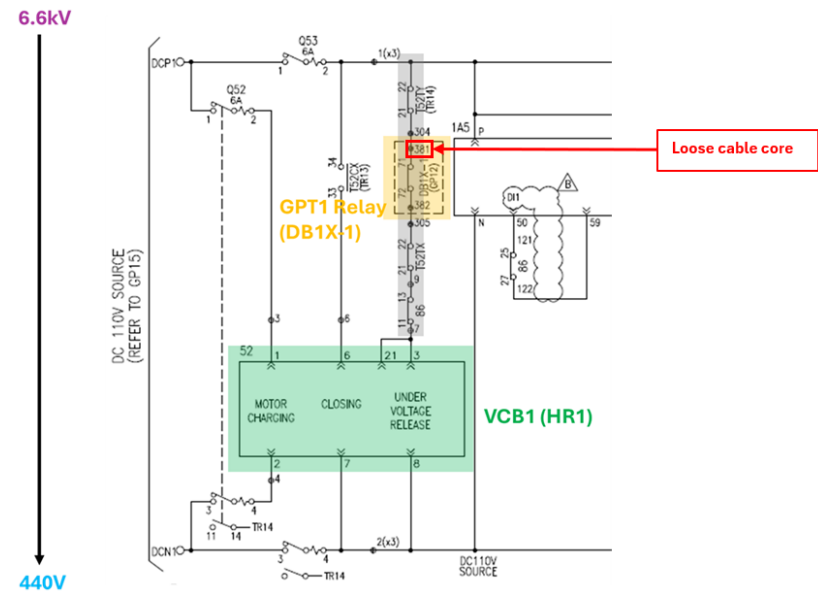
HHI engineers found that one of the cable cores that connects the DB1X-1 relay of the GPT1 panel to the control line was loose. The DB1X-1 relay is for bus blackout detection. Two ends of the DB1X-1 relay are nodes 381 and 382. Node 381 is connected to node 304 of the control line and node 382 is connected to node 305 of the control line (see Figure below).

HHI engineers found that the cable was loosely connected at node 381. That condition can create an open circuit and interrupt the 110VDC power to the HR1 UVT Coil, which would trigger an under voltage release trip of HR1. This would result in a 440V blackout without leaving any records in the HiMAP-T sensor.
