August 12, 2024

MIR-24-23

Flooding and Partial Sinking of Towing Vessel *Uncle Blue*

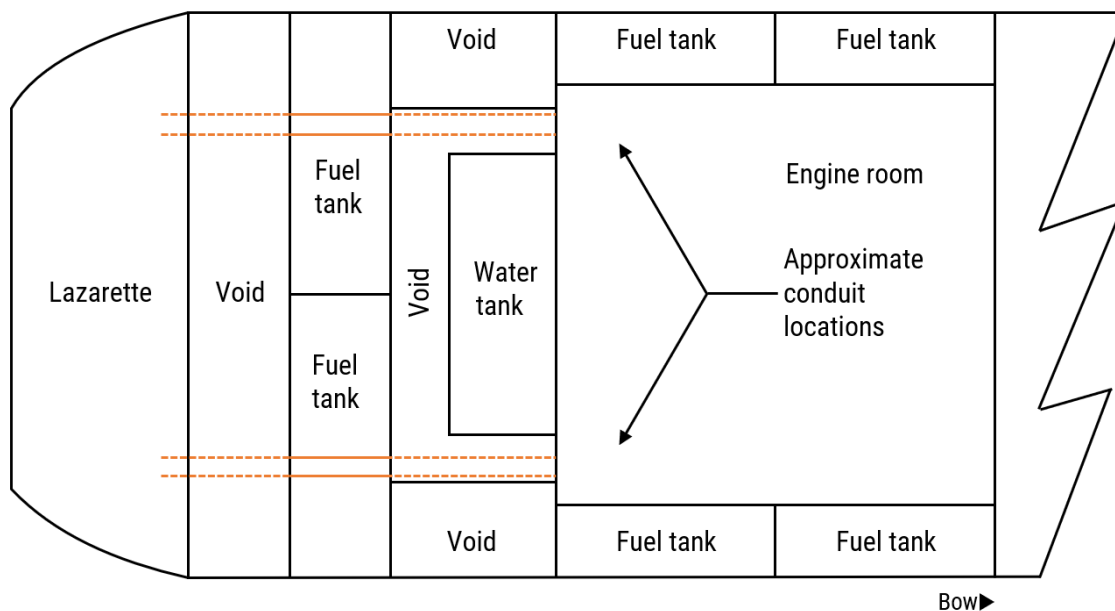
Uncle Blue was outfitted with a single bilge alarm in the forward end of the engine room. The bilge system included a small submersible pump by the two main propulsion shaft seals in the engine room. A deckhand told investigators the crew had never had to dewater the voids or the lazarette. A roughly 2-inch-diameter pipe conduit ran from the lazarette to the engine room (see figure 3).

Figure 3. Aft section of the *Uncle Blue* below deck general arrangement.

Pipe runs (conduits) inside the hull, which had previously been used to allow rods to run the length of the hull, were either corroded or missing where they passed through the voids. These openings allowed water from the lazarette to flood through two voids and, eventually, into the engine room. Thus, the conduits allowed for progressive flooding, which resulted in the partial sinking.

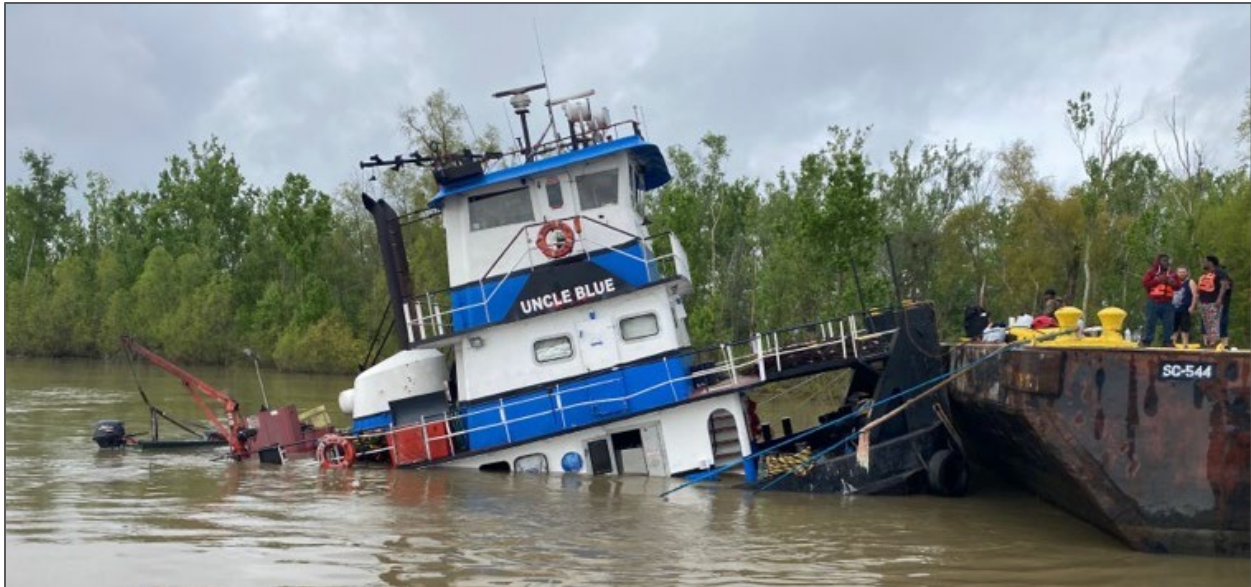
Because the suction hose for the *Uncle Blue's* portable pump was stowed on the stern (which was now under water), the *CSS Richmond* crew provided pumps. However, efforts to dewater the engine room were unsuccessful, and the crew abandoned the vessel to the barge. The *Uncle Blue* continued to sink until it was partially submerged; the barge remained afloat (see figure 4).

Figure 4. *Uncle Blue* partially sunken. (Source: US Coast Guard)

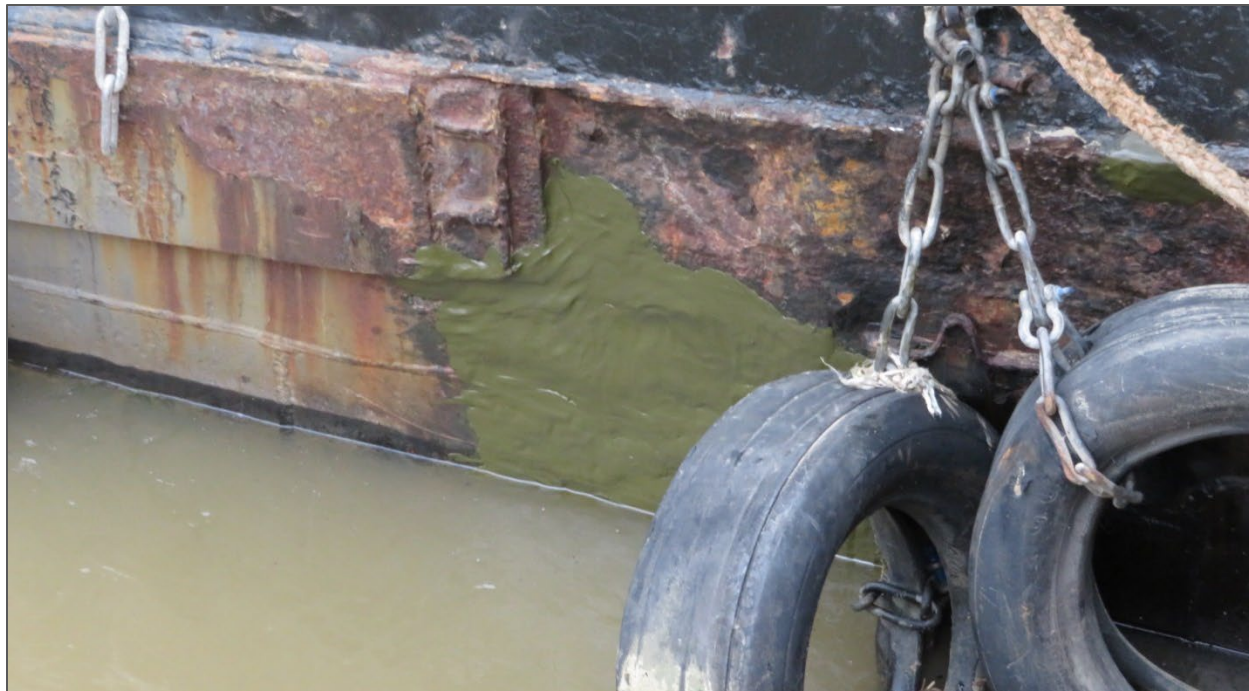
Salvors worked for 4 days to remove 1,400 gallons of fuel from the vessel and refloat the towboat. When the vessel was lifted by crane, NTSB investigators noted water pouring from holes in the portside shell plating of the flooded lazarette. They also noticed numerous doubler plates in that area of the hull.³ Salvors made temporary epoxy repairs to keep the vessel afloat (see figure 5).

Figure 5. Temporary epoxy repair, applied during the postcasualty salvage, on the port quarter, near the lazarette, with an existing doubler plate just above and to the left.

The *Uncle Blue* had been in service for almost 60 years. During salvage, investigators discovered numerous wastage holes in the hull on the port side of the lazarette. They also discovered doubler plates installed on the hull near the wastage holes. Doubler plating can be used as a temporary repair solution; however, because doubler plate repair can lead to increased stress concentrated in the area of the repair, doubler plates are not suitable as a permanent repair for sections of the hull. Given the vessel's age, the holes found in the hull, and the presence of the doubler plates, the vessel's hull had not been adequately maintained. Investigators did not identify other potential sources for the flooding; therefore, the wasted steel hull plating in the lazarette was the initial source of the flooding.

The National Transportation Safety Board determines that the probable cause of the flooding and partial sinking of the towing vessel *Uncle Blue* was a lack of watertight integrity due to the poor condition of the hull, which allowed water to ingress through wastage holes into the lazarette. Contributing to the sinking were unsealed penetrations in transverse bulkheads, which allowed for progressive flooding forward into the engine room, and the lack of a high-water bilge sensor in the lazarette, which prevented early detection of flooding into the space.

Although doubler plating can be used as a temporary repair solution, it is not generally suitable as a permanent repair for a vessel's hull. Vessel owners should crop out wasted steel on the hull and replace it by inserting new plating instead of covering it up with doubler plating.

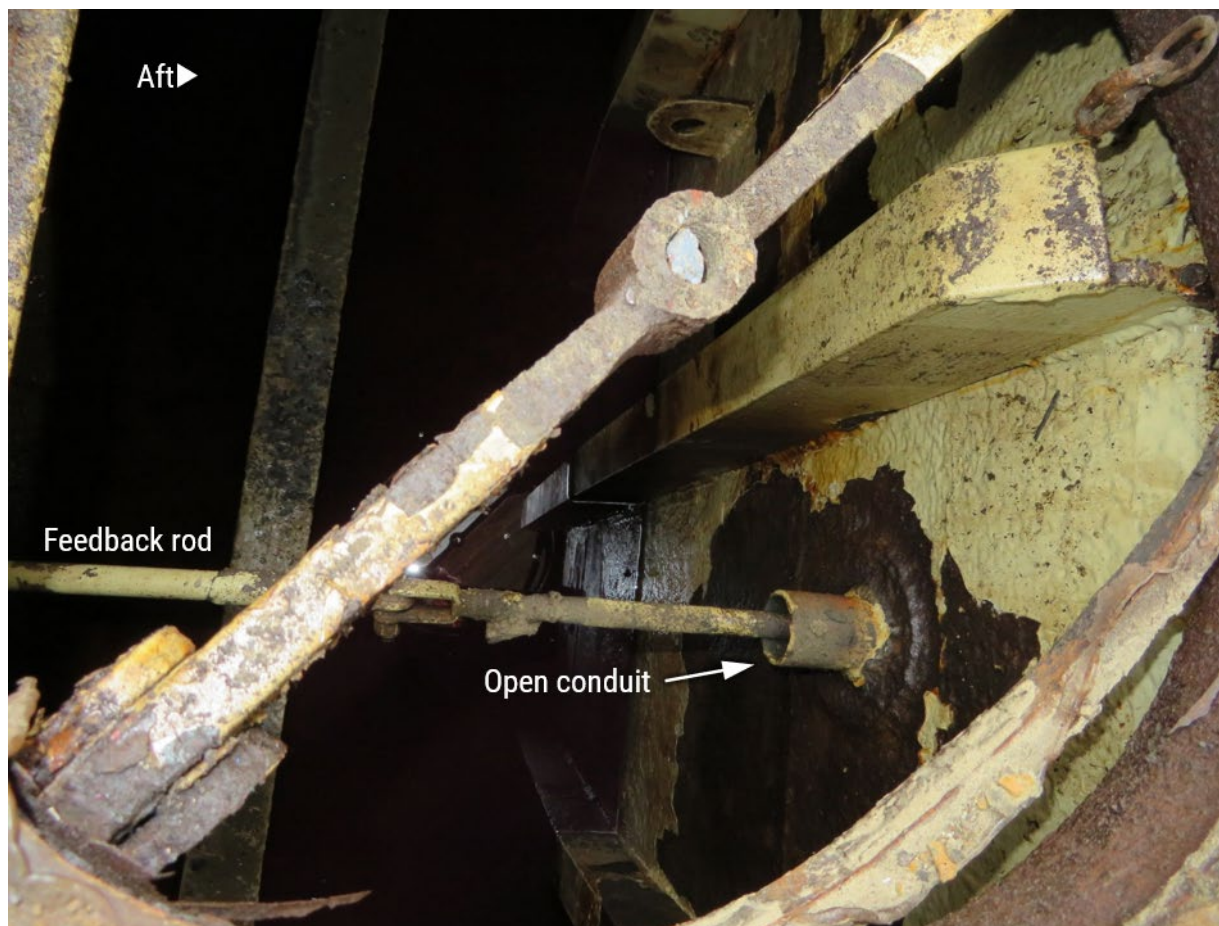
Uncle Blue was originally outfitted with rods used for rudder angle feedback (feedback rods). Although the feedback rods were no longer used, they were still in place within conduits (about 2-inch-diameter pipes) that passed from the lazarette to the engine room. Investigators noted that the conduits were either corroded or missing where they passed through the voids (see figure 6). The conduits were intact where they passed through the fuel tanks. These conduits were unsealed on their ends, and if there was flooding of the lazarette, they would have allowed progressive flooding of water from the lazarette to the voids and the engine room.

Figure 6. Feedback rod and conduit in the flooded void, between the lazarette and aftmost fuel tanks, taken during salvage operations.
