MIR-24-26

Contact of Tugboat *Olympic Scout* with Hylebos Bridge Fender

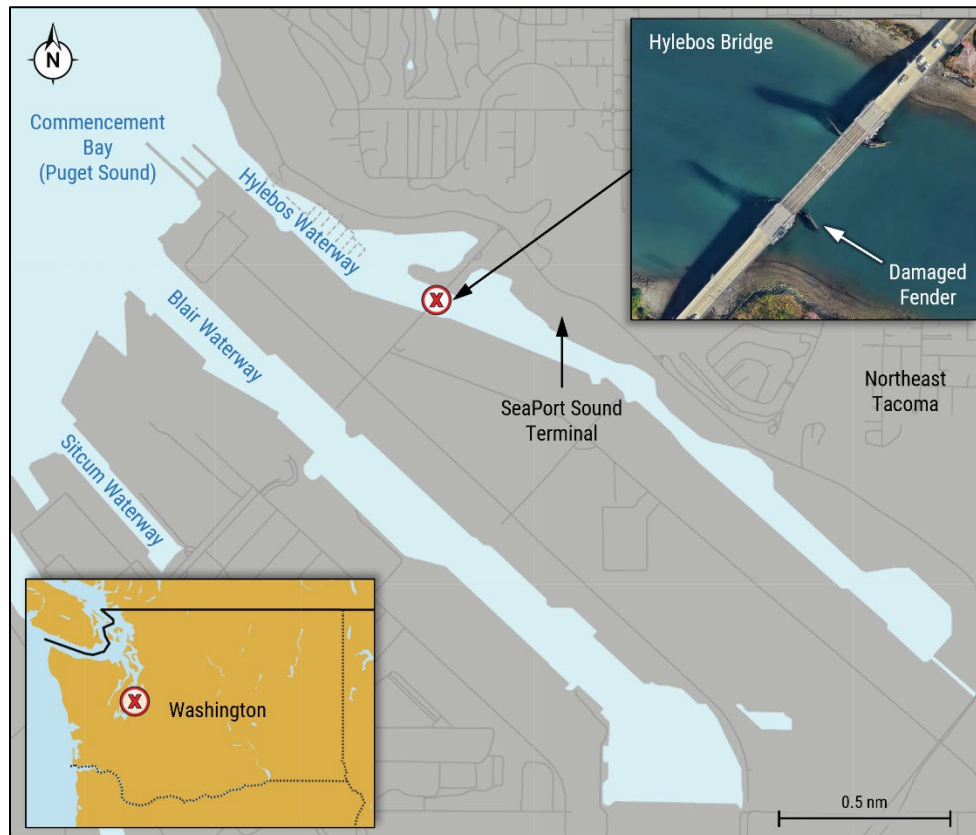
Figure 2. Area where the *Olympic Scout* contacted the Hylebos Bridge fender, as indicated by a circled X. (Background sources: Google Maps [maps], Google Earth [bridge image])

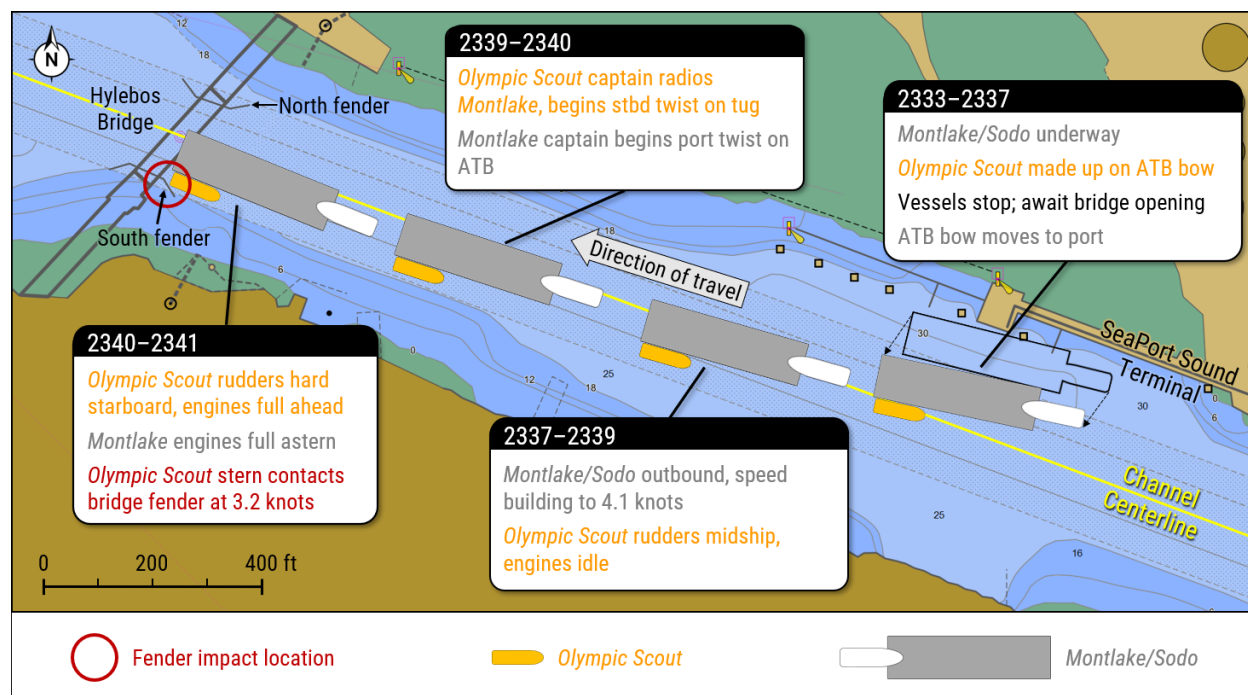
Figure 5. Casualty sequence of events. Times of engine speeds and rudder movements are approximate based on crew interviews. (Background Source: National Oceanic and Atmospheric Administration electronic navigation chart US5W22M - Tacoma Harbor, as displayed on Rose Point Electronic Charting System)

At 2341, the *Olympic Scout*'s starboard quarter contacted the fender protecting the south pier of the Hylebos Bridge. The ATB's speed over ground at the time was 3.2 knots. When the *Olympic Scout* made contact, one of its three lines to the ATB parted.

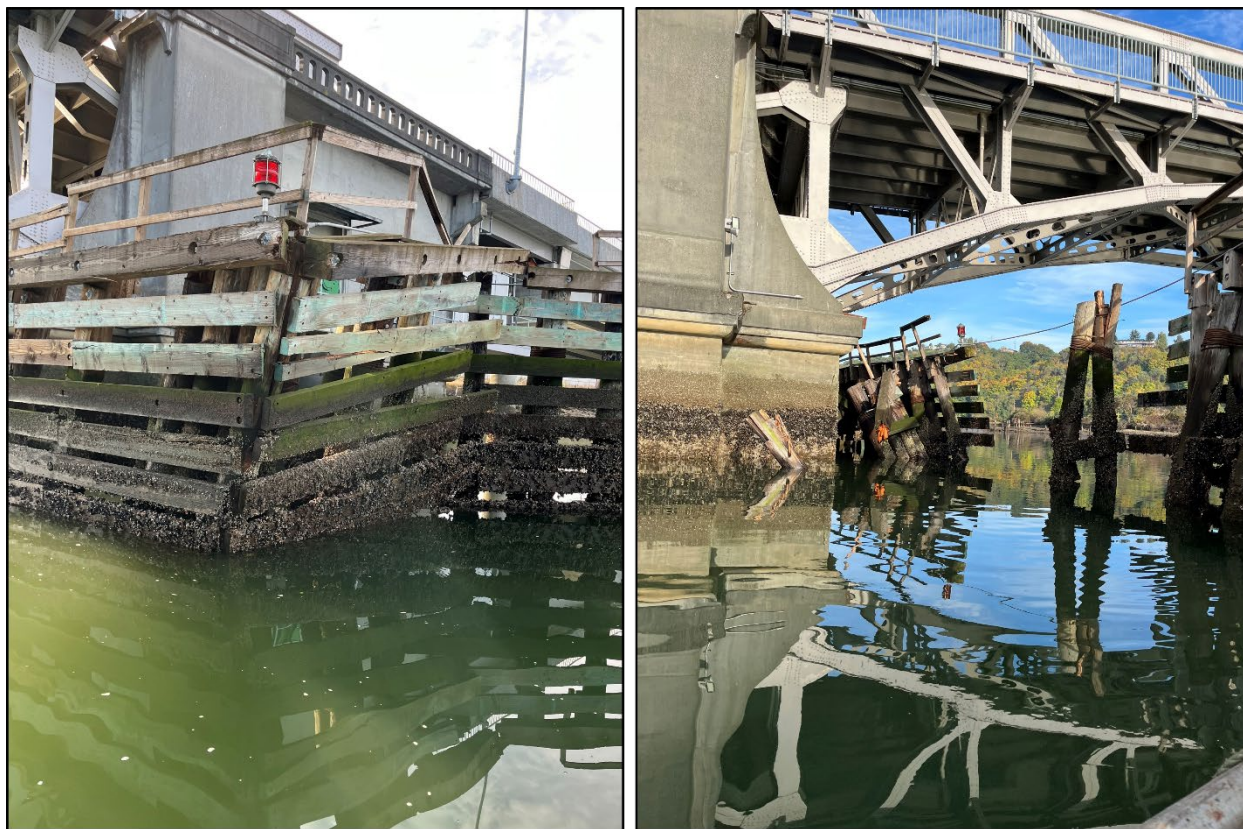
There was no damage to the Hylebos Bridge piers, mechanical structure, or roadway. However, the center section of the south fender was displaced about 50 feet to the west, with the supporting piles pushed over at angles up to 40°. Timber facing boards were broken or missing along the full length of the fender. Dolphins, which were constructed of timber piles and located at the east end and the junctions of the center and west end section of the fender, were also pushed over (see figure 6). Navigation lights mounted on the fender were damaged or destroyed. The damaged south fender was replaced with a steel fender at an estimated cost of \$2.43 million.

Figure 6. Damage to Hylebos Bridge fender system. *Left to right:* displaced center section and damaged dolphin; broken and missing timber facing boards on eastern and center sections. (Source: Coast Guard)

Although the fendering above the waterline can be considered as being in a generally fair condition, where sighted, the supporting structure below the waterline displays significant areas of wastage, rot, and marine worm and borer tracks....As such it is our considered opinion, based on our above comments and observations, that the timber fendering structures...are subject to an inherent loss of structural strength, and that the damage caused by the allision [*Olympic Scout* contact] resulted in significantly more damage being sustained as would have been, had the fendering structure been of sufficient structural strength.

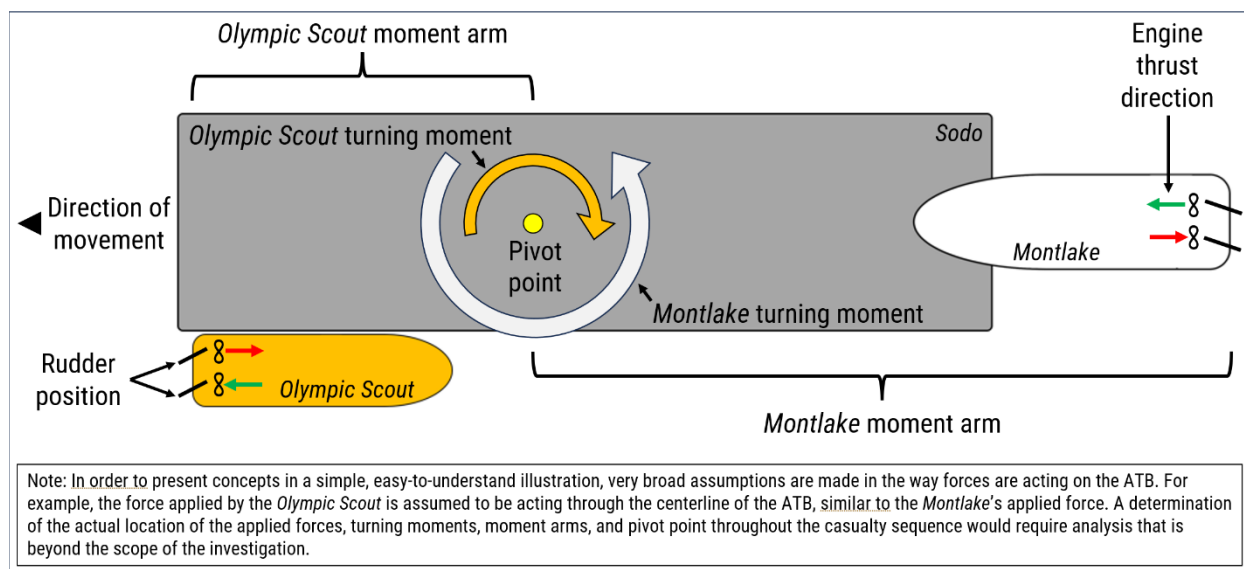
Figure 7 (below) shows the *Montlake/Sodo* with the *Olympic Scout* made up as it was during the Hylebos Bridge casualty. In this simplified illustration, the pivot point is assumed to be one-third of the total length of the *Montlake/Sodo* aft of the bow of the barge, and both the *Montlake* and *Olympic Scout* are applying a turning moment through the centerline of the ATB via their respective rudder and engine orders. Note that the moment arm for the *Montlake* is longer than the moment arm for the *Olympic Scout*, and thus the *Montlake* would require less effort to impart a turning moment on the ATB.⁵ In addition to requiring less effort to turn the ATB, the *Montlake* had almost twice the engine power of the *Olympic Scout* (4,200 hp compared to 2,250 hp). Given the advantages in moment arm and power (turning moment), the *Montlake's* port counter twist effectively negated the efforts of the *Olympic Scout* to move the ATB's bow back toward the center of the channel. The *Olympic Scout* captain applied progressively more rudder angle and engine speed, and the *Montlake* captain began backing down on his vessel's engines, but, by the time these actions were taken, the fender was too close for the *Olympic Scout* to avoid contact.

Figure 7. Simplified illustration of turning moments applied by *Olympic Scout* and *Montlake* as the ATB moved toward the Hylebos Bridge. The magnitudes of turning moments and moment arms are representative of relative strengths but are not to scale.
