Marine Safety Investigation Report

VERY SERIOUS MARINE CASUALTY | October 2024

Seapeak Napa

Fire on deck on 27 October 2023

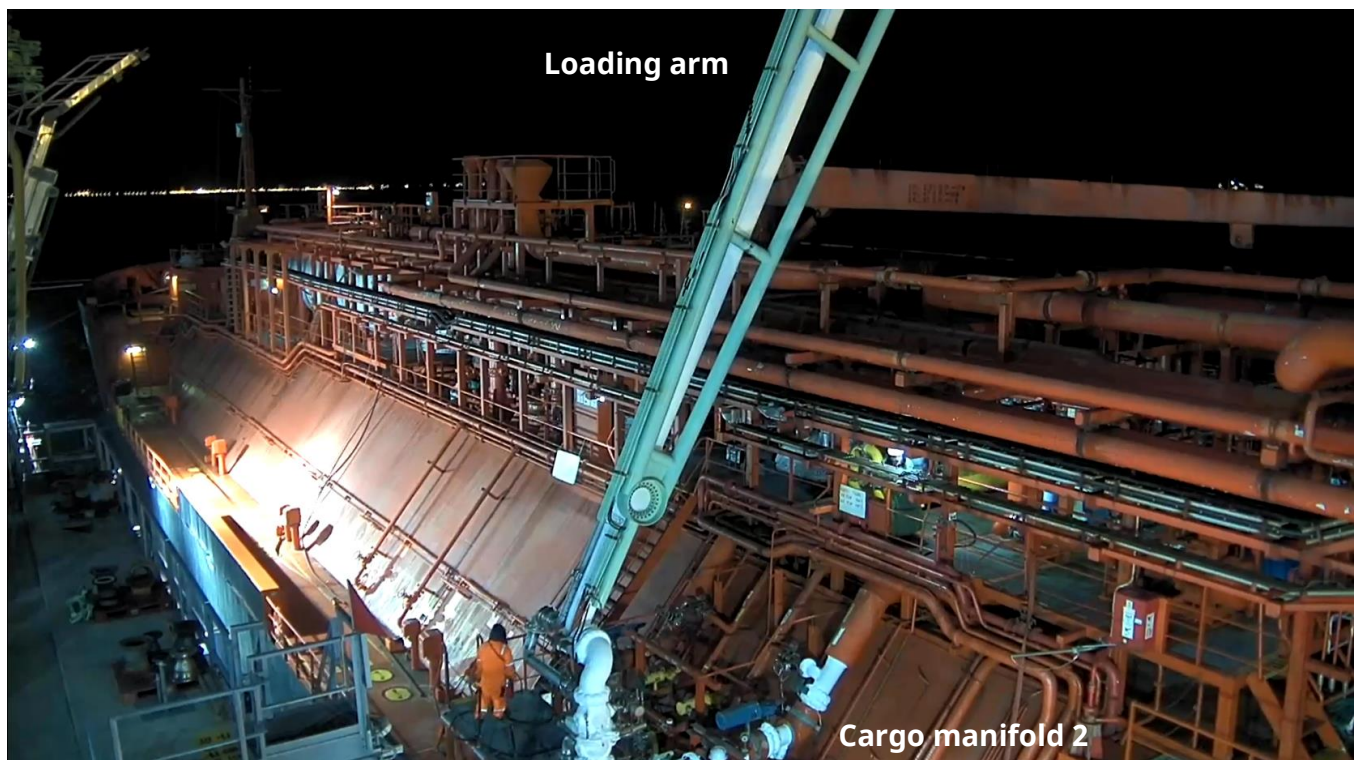
03:00 Completion of hot gas blowing – loading arm connected to manifold 2 (icing on exposed pipework and valves due to cargo temperature)

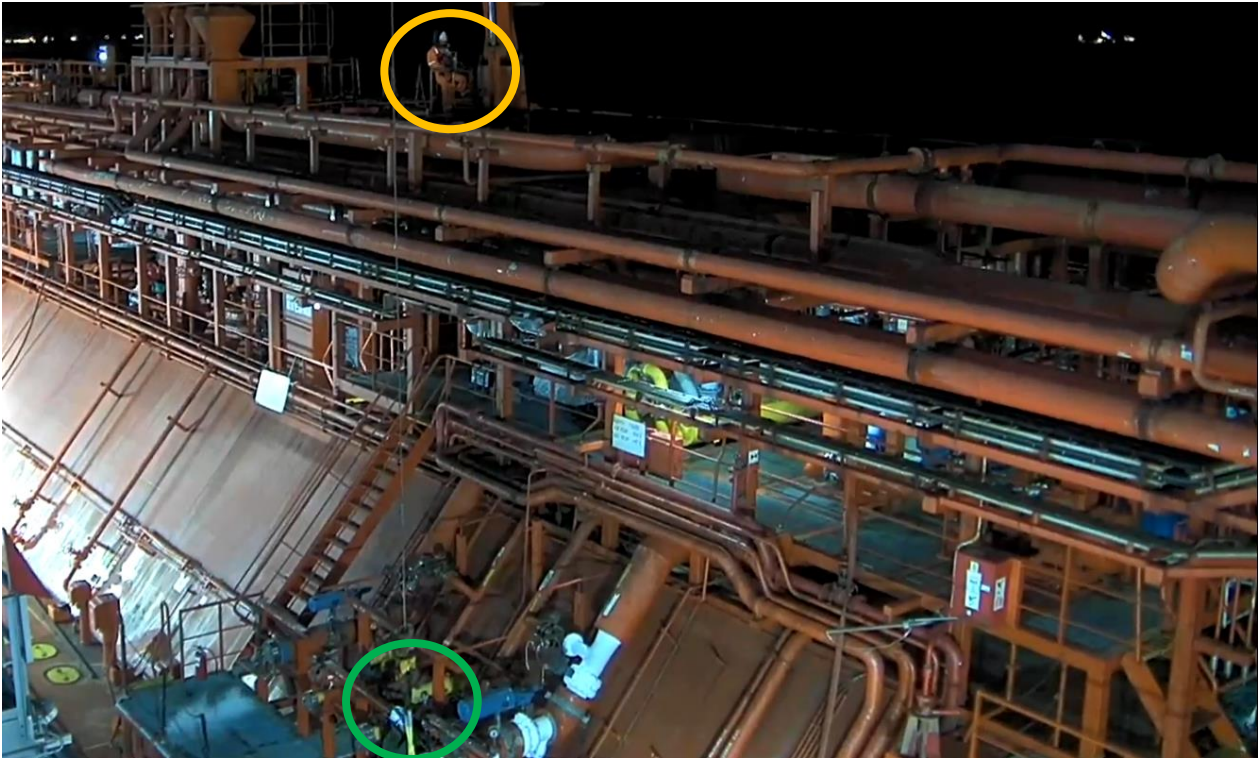
03:15 Gas engineer (in green overcoat, green ring) working to unbolt the reducer at the manifold, AB1 operating crane (orange ring)

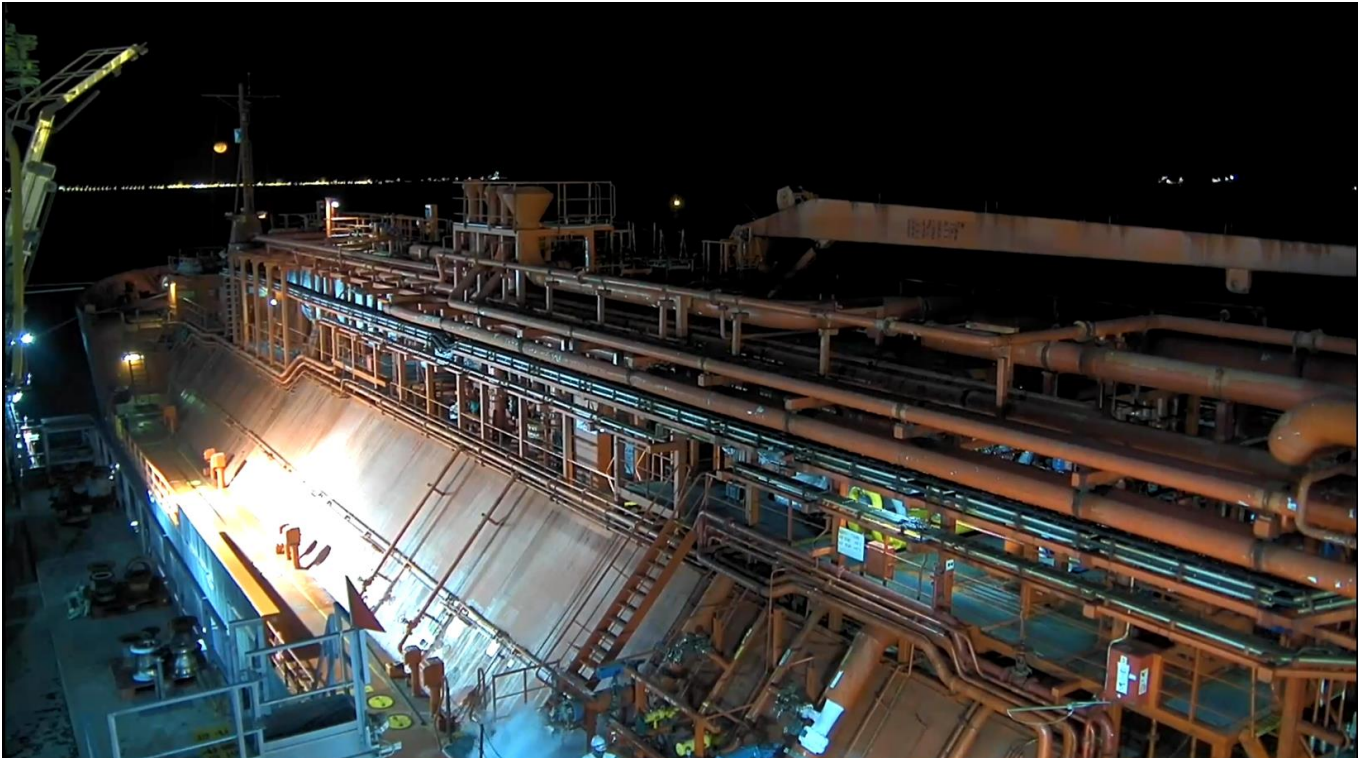
04:26 Gas engineer opens drain valve, cargo vapour rising from drip tray, AB3 retreating

Ethylene is highly flammable, draining the cargo at the manifold to the drip tray was a significant violation of the protocol for handling of such cargoes and (evidently) carried a significant risk.

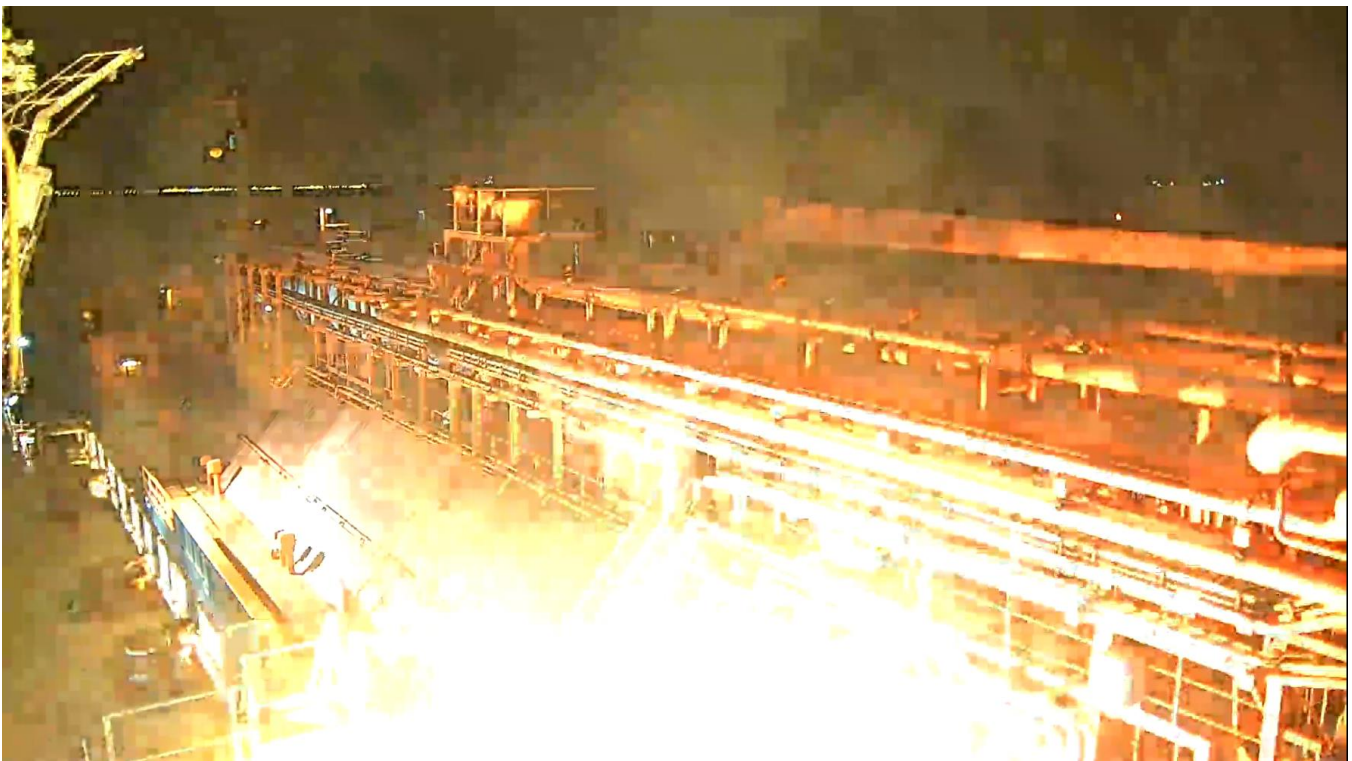
With the gas engineer behind the manifold, at 04:27 AB3 backed away from the growing vapour cloud to get fresh air when the cargo vapour ignited, creating a fire ball that engulfed the manifold platform, including AB3 and the gas engineer, and extending in excess of 10 meters in diameter.

04:27 Cargo vapour ignites

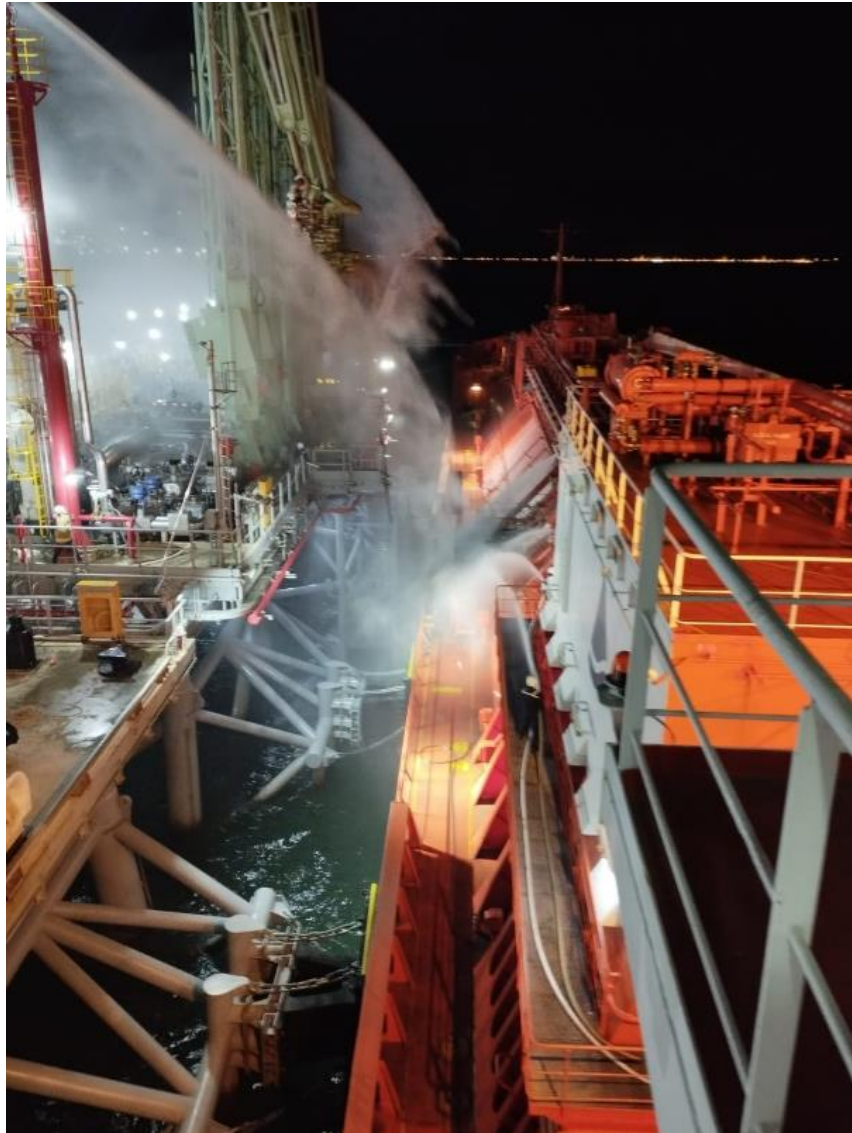
The vessel's automatic water-spray system was activated when its fusible plug melted but the system failed to provide any spray at the manifold. Shipboard firefighting efforts started at 04:30 and the terminal began to assist at 04:43. The fire was extinguished at 04:44.

04:44 Shipboard and terminal firefighting efforts

During the casualty, the fire melted the fusible plug at the manifold and the pump and alarm were activated but the system did not provide any spray at the manifold. Post-casualty inspection identified that the spray head was clogged by debris. Work by the US Coastguard⁶ has identified scale accumulation at spray heads as an ongoing issue with water-spray systems on gas carriers due to the fundamental design and operating environment: scale that has formed anywhere in the pipework is ultimately carried to the point of discharge, blocking the spray head when activated.

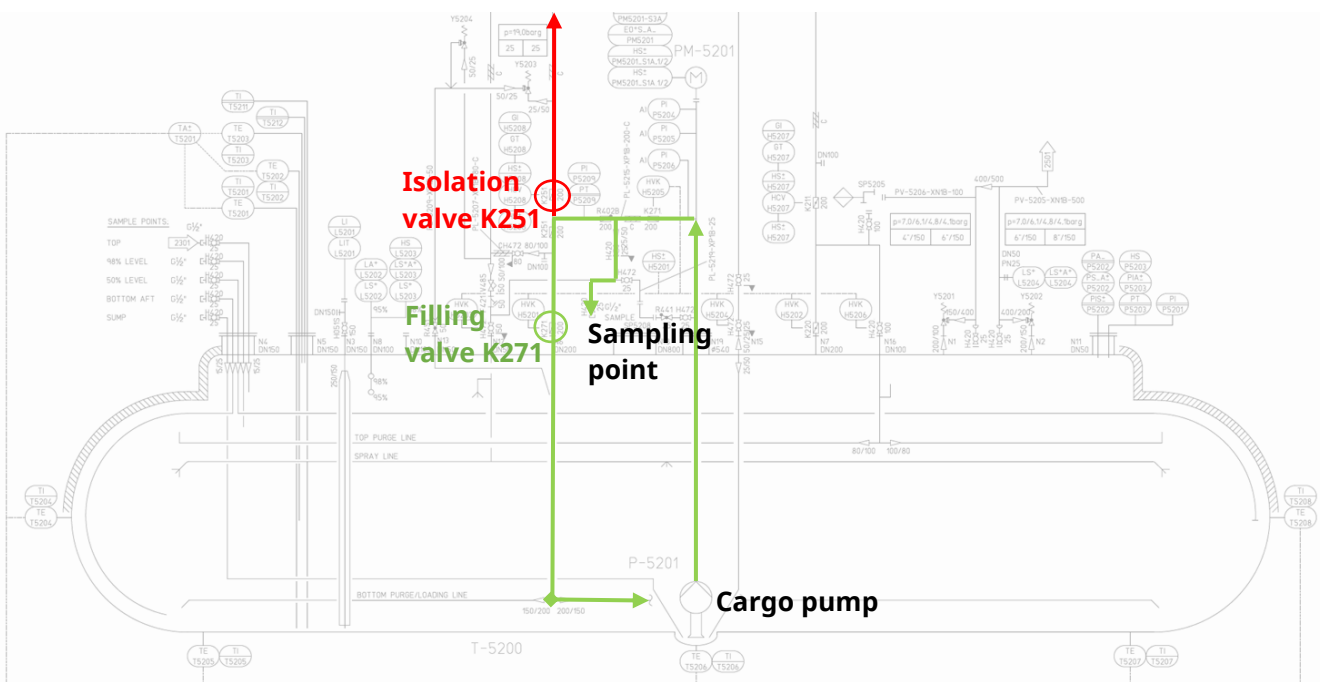
Inspection of the valves after the fire identified that the isolation valve (K251) was not closed, allowing unintentional cargo migration.

**Cargo tank 2: Planned cargo pumping loop and sampling point in green.
Open isolating valve and resultant cargo migration in red.**

Beyond the open isolation valve, cargo passed through manual valve K451 and hydraulic valve K451F (which were not closed after line clearing) to reach the manifold. The presence of the cargo at the manifold may have gone undetected if the manifold blank did not leak. Inspection after the fire confirmed that the manifold blank had been fitted without a gasket.

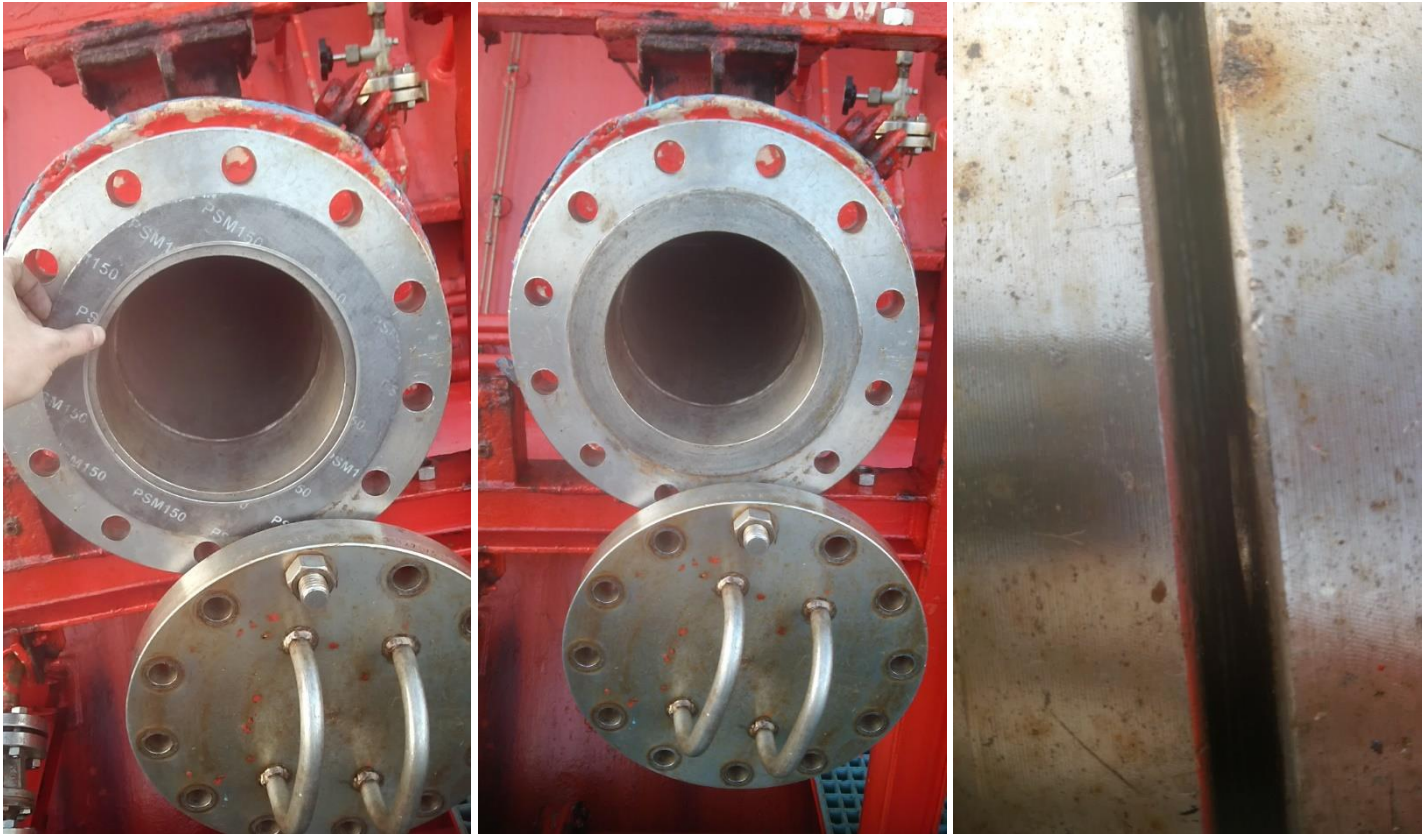
The manifold gaskets onboard Seapeak Napa were of a reusable type but, due to their design (no tab), once the blank was fitted, it was not possible to visually identify whether a gasket was present. In any event, the blank was not fully secured when cargo sampling started.

Undamaged manifold with and without gasket. View between with blank mounted

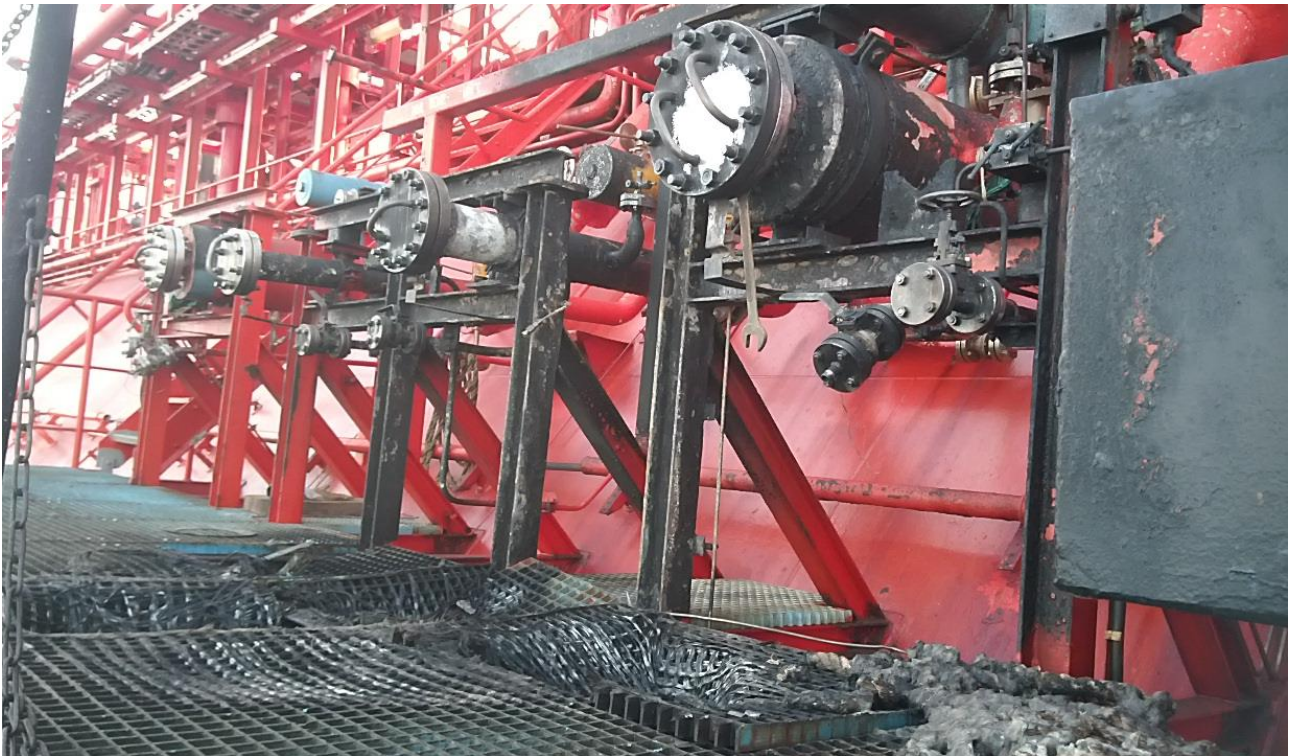
There were three spanners found at the manifold post-casualty – two standard (steel) 36mm spanners and a 36mm (steel) spanner with an extended handle. Due to the risk of creating a spark, steel tools were not to be used on deck or in proximity to highly flammable cargoes. There was a selection of non-sparking tools stored in the compressor room (including 36mm spanners) but the tools available did not include spanners that the deck crew considered to be suitable for the task – they were of insufficient length to generate enough torque to tighten the bolts fully and the use of steel tools was not considered to be dangerous by the crew that noticed their use prior to the fire – the use of steel tools to get the job done was normal.

Manifold with steel spanner attached post-fire

- Undertaken a full review of its safety management system.
- Introduced "life-saving rules" across the fleet.
- Updated requirements for personal protective equipment onboard its tankers.
- Overhauled the control of tools (including the supply and location of non-sparking tools) in hazardous areas.
- Adapted its generic risk assessment to include human factors.
- Adapted its cargo plans to include critical stages of operations from arrival until departure.
- Provided mimic plans in compressor rooms and cargo control rooms.
- Increased test frequency for of fixed water spray system and enhanced schedule for replacement of pipework.
- Shared lessons learned from the casualty across its fleet.
- Conducted (onboard) workshops on stop work authority, leadership, risk assessment and toolbox meetings.

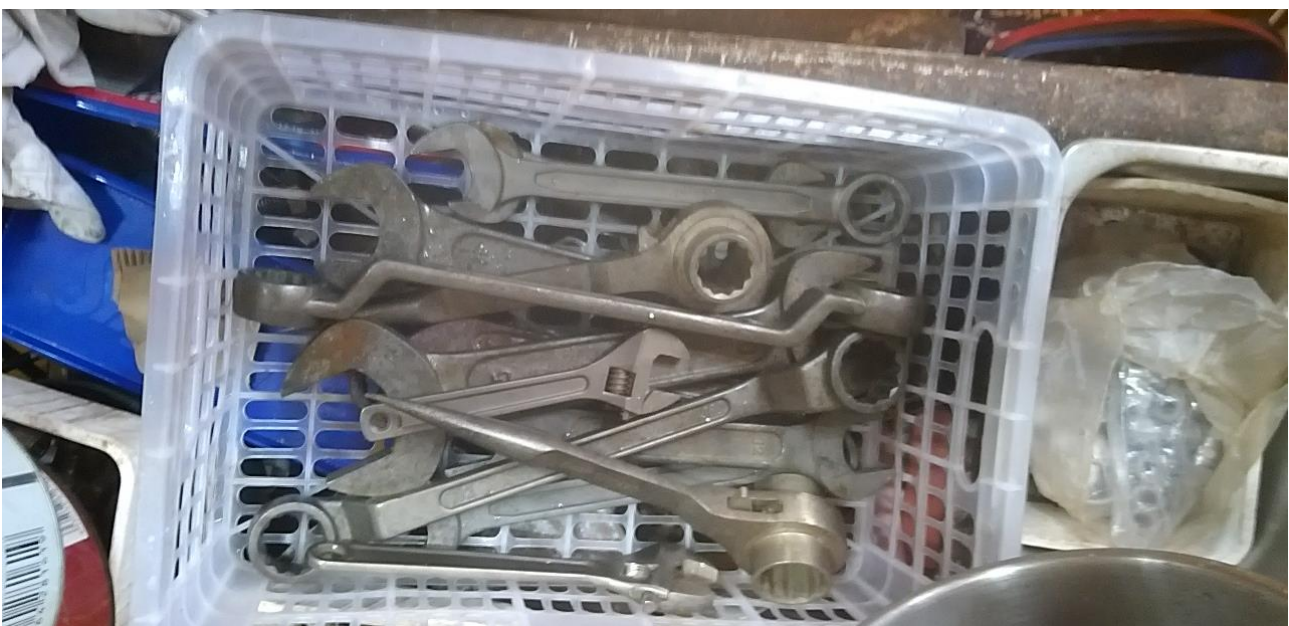
Non-sparking tools stored in the compressor room

There was a crate of non-sparking tools onboard but the tools available did not include spanners that the deck crew considered to be suitable for the task.
