September 23, 2024

MIR-24-30

Contact of *Cindy B* Tow with Dock

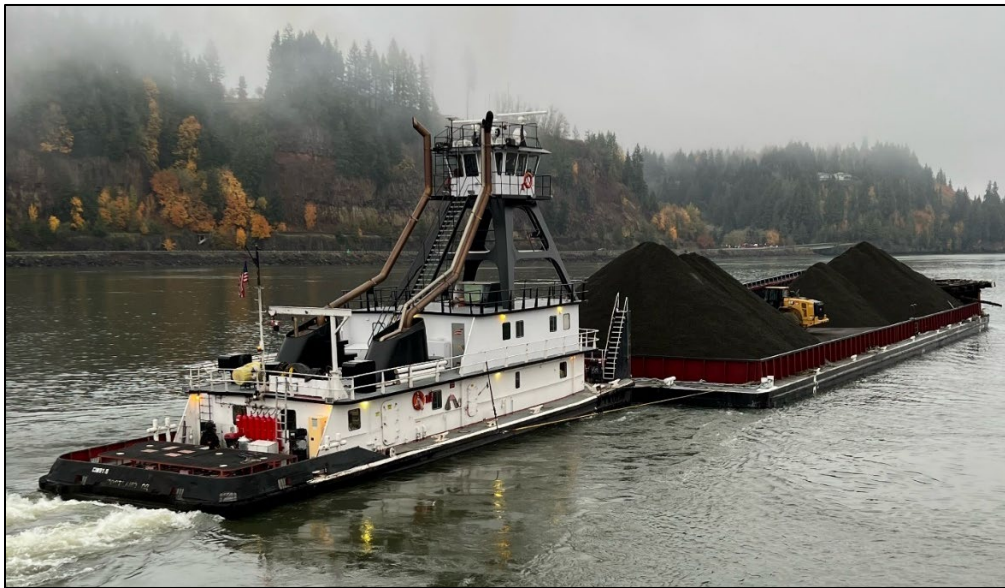
On November 12, 2023, about 0552 local time, the towing vessel *Cindy B* was pushing the loaded deck barge *St. John* upbound on the Columbia River at mile 53 near Clatskanie, Oregon, when the tow gradually moved to starboard out of the navigation channel and struck the Port Westward Beaver Dock (see figure 1 and figure 2).¹ None of the three crewmembers aboard the *Cindy B* were injured. During the cleanup, about 2 gallons of renewable diesel fuel leaked onto the dock from a damaged pipe on the dock, with about 1 gallon going into the river; a portion of the spilled fuel was recovered. Damage to the *St. John* and the Beaver Dock was estimated to be about \$6 million.

Figure 1. *Cindy B* and *St. John* underway after the contact with the Beaver Dock. (Source: Columbia Pacific Bio-Refinery)

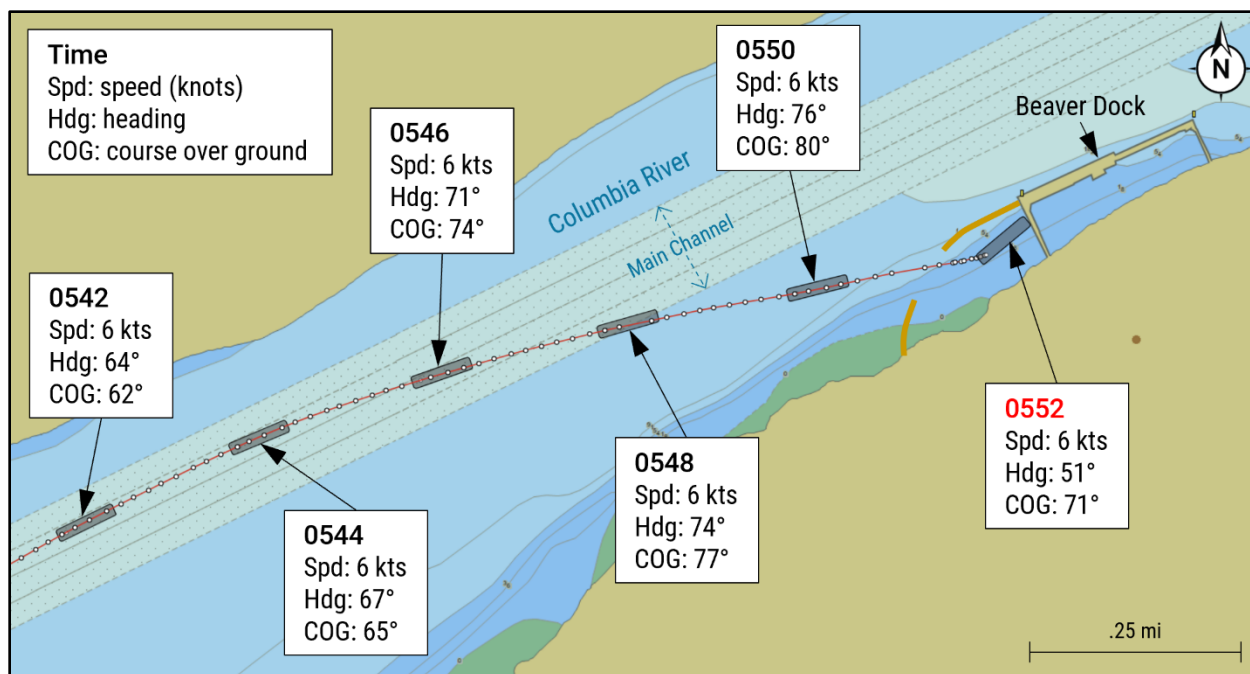
Automatic identification system (AIS) data showed that, at 0544, the *Cindy B* tow began to move to starboard (see figure 4). The *Cindy B* and *St. John* subsequently exited the main channel at 0548. The tow's speed remained constant. The *Cindy B* and *St. John* passed between two sections of the Beaver Dock's abandoned railway structure and then struck the dock's western causeway at 0552.

Figure 4. AIS trackline of the *Cindy B* tow as it transited east. (Background source: National Oceanic and Atmospheric Administration Electronic Navigation Chart US5OR12M as viewed on Made Smart AIS)

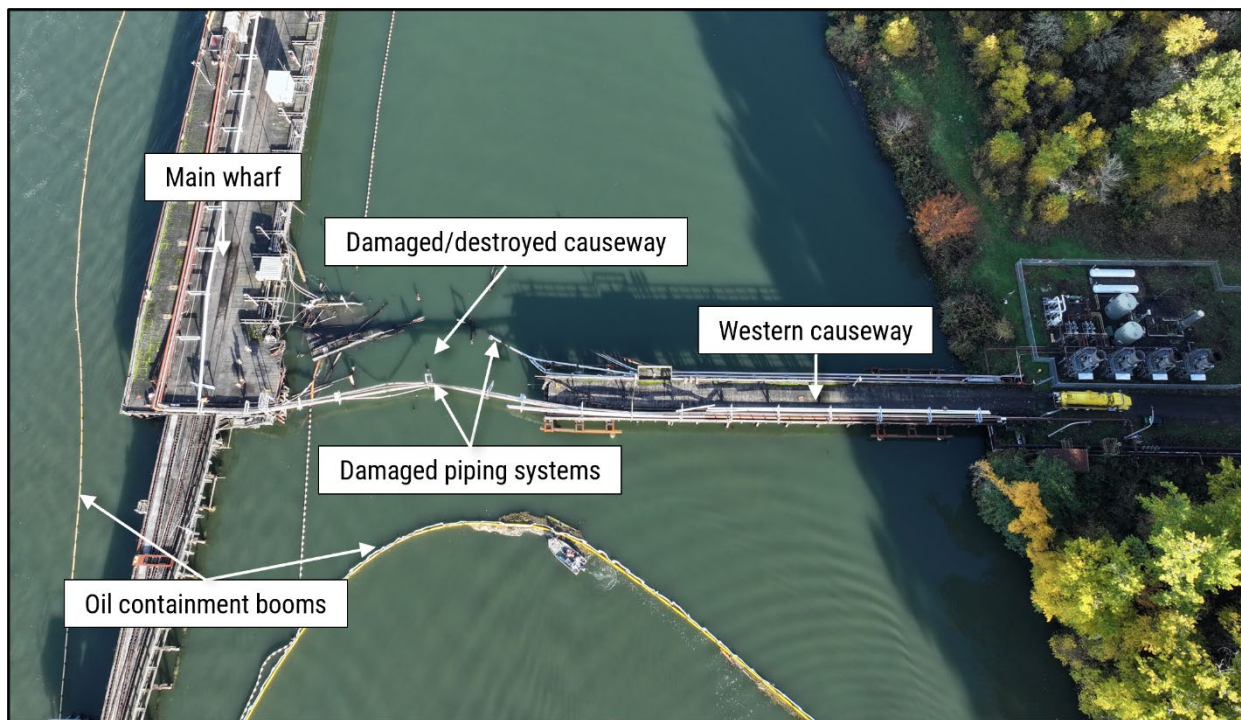
About 100 feet of the western causeway connecting the Beaver Dock’s main wharf to the shore were destroyed (see figure 5). Piping, electrical lines, and navigation lights on the causeway and main wharf were also damaged. A pipe on the causeway used for transporting renewable diesel fuel to the main wharf was severely bent but did not rupture. An estimated 525 barrels of diesel were in the pipe at the time of the casualty. Most of the diesel was recovered from the pipe during cleanup and recovery operations; however, about 2 gallons spilled onto the dock, and 1 gallon of the spilled fuel eventually entered the river. The fuel was contained within

booms that had been deployed after the casualty, and a portion of the spilled fuel was recovered using absorbent pads. The estimated cost of cleanup, recovery, and repairs to the Beaver Dock was \$5,429,274.

Figure 5. Beaver Dock after contact by the *Cindy B* tow. (Background source: US Coast Guard)

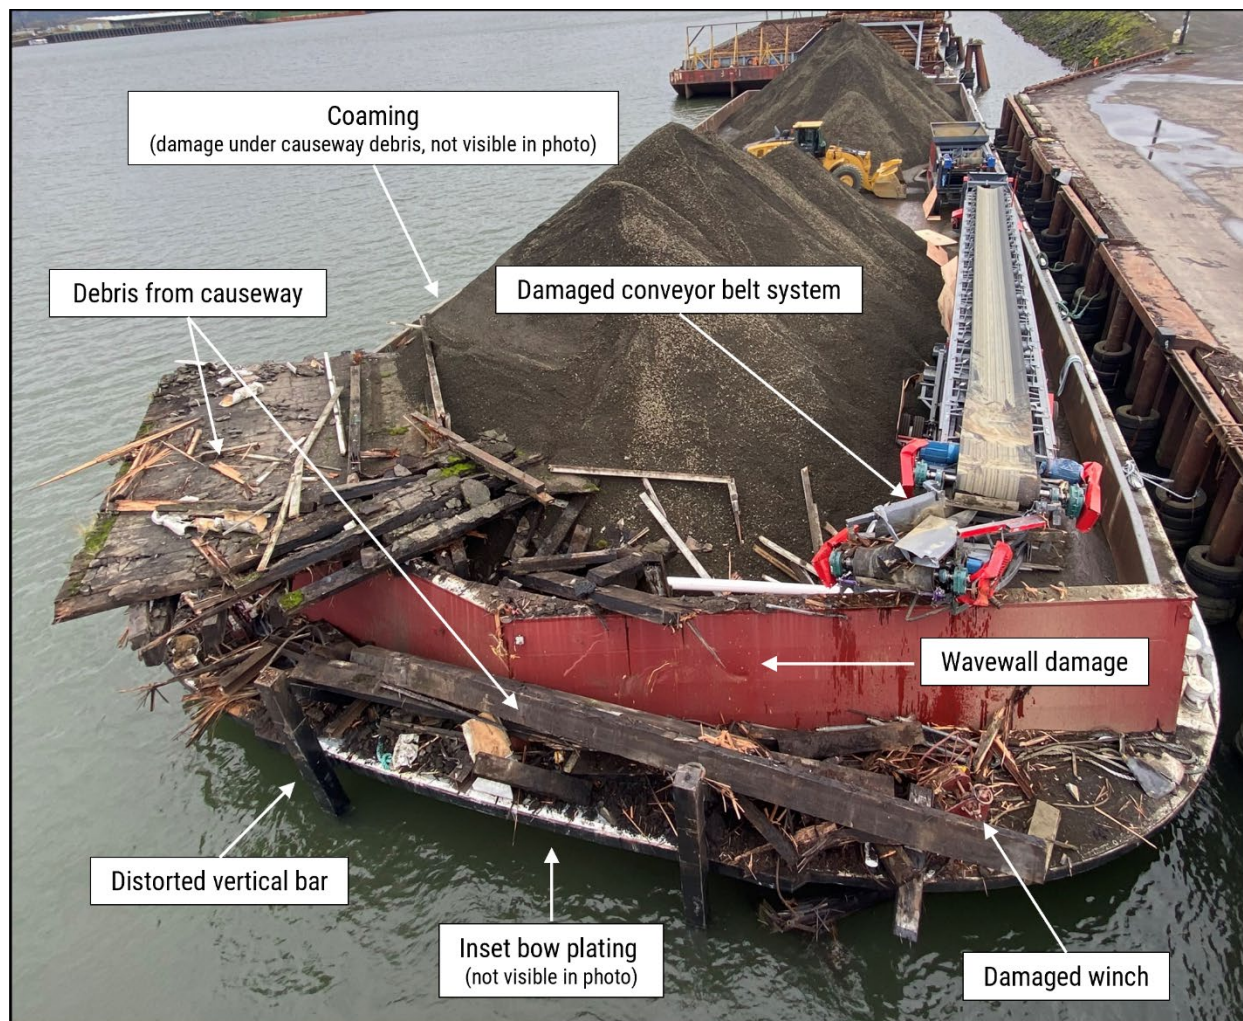
On the bow of the *St. John*, hull plating was inset to a maximum of 3 inches over a 2-foot-by-3-foot area, and one of two vertical bars that allowed the barge to be pushed by its raked bow was slightly distorted (see figure 6). Additionally, plating on the wavewall at the forward end of the barge deck and on the starboard coaming that surrounded the deck was distorted. On the deck at the bow, a manual winch was pushed aft and its handwheel was damaged. A conveyor belt system on the barge, used for unloading cargo, was also damaged. The cost of repairs to the *St. John* and equipment totaled \$647,224.

Figure 6. *St. John* after contact with the Beaver Dock. (Background source: Coast Guard)

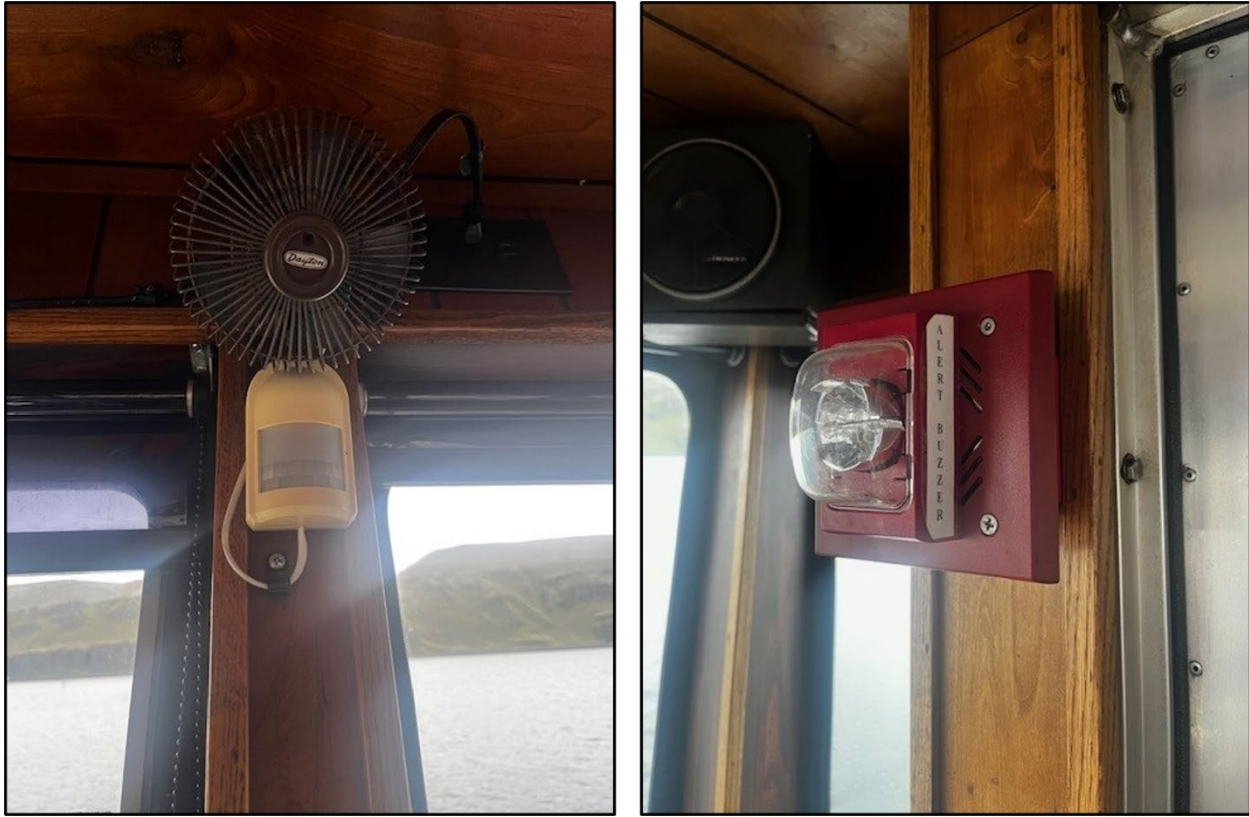
The *Cindy B* was required by Title 46 *Code of Federal Regulations* Subchapter M (Towing Vessels) to be fitted with a pilothouse alerter system (sometimes referred to as a watch alarm) to detect when an operator became incapacitated while underway. The pilothouse alerter on the *Cindy B* consisted of two motion sensors, buzzer and horn alarms, indicator and strobe lights, and control circuitry (see figure 7). According to the crew, the system was on whenever the steering system was online.

Figure 7. Left to right: *Cindy B* pilothouse alerter system motion detector (one of two on board) and strobe light with audible alarm. (Source: WCP Inc.)

According to the captain, during the casualty transit, the *Cindy B* pilothouse alerter system did not activate. Following the casualty, the system was tested and found to be operational. However, during testing, the captain determined that a VHF radio microphone that had been rigged to hang by its cord from the overhead could swing back and forth, tripping the motion sensors and thereby resetting the alarm timers.

Although postcasualty testing verified that the system operated as designed, the vessel captain determined that a VHF microphone hanging by its cord from the wheelhouse overhead could swing and trip the system's motion detectors and reset the system timers, thus defeating the system and interrupting the activation of any indicators and alarms. Therefore, the pilothouse alerter system was rendered ineffective because a swinging VHF radio microphone in the motion sensors' field of view defeated the system.

After the contact, the pilothouse alerter system on the *Cindy B* was replaced with an updated system.
