SAFETY INVESTIGATION REPORT

REPORT NO.: 14/2024

October 2024

MV CMA CGM SAN ANTONIO **Serious injury to a crew member,** **during maintenance work on the main engine** **in the port of Jebel Ali, UAE** **21 October 2023**

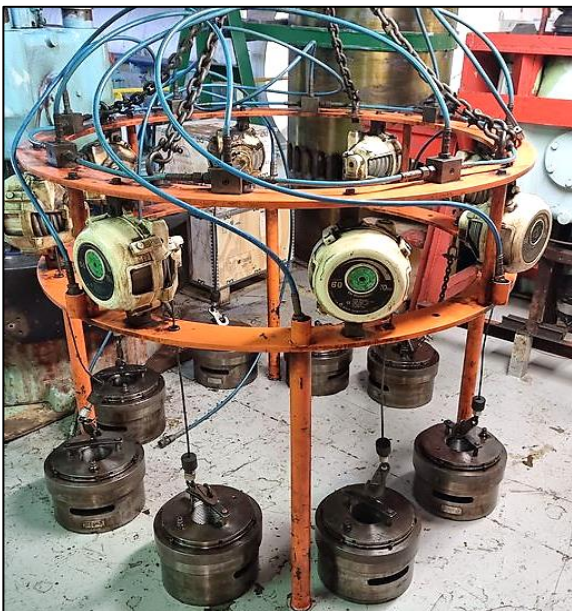
Figure 2: Hydraulic jack assembly used to untighten the cylinder head

Several seconds later, when the pressure had reportedly reached about 450 bar, one of the hydraulic jacks failed. Hydraulic oil and some other pieces were ejected from the hydraulic jack at a tremendous pressure, hitting the third engineer in the face. It was immediately evident that the crew member had sustained facial injuries, which required medical attention.

The hydraulic jack used on board *CMA CGM San Antonio* was of the conventional type and relatively very common on board, for the tightening and untightening of nuts, which are specifically designed and manufactured for use with a hydraulic jack. The hydraulic tool assembly (**Figure 2**) consisted of a spacer ring, an air driven hydraulic pump, flexible hoses, distribution blocks and a pin / tommy bar.⁵ Two sets of sealing and back-up rings⁵ served as the sealing components of the hydraulic jack.

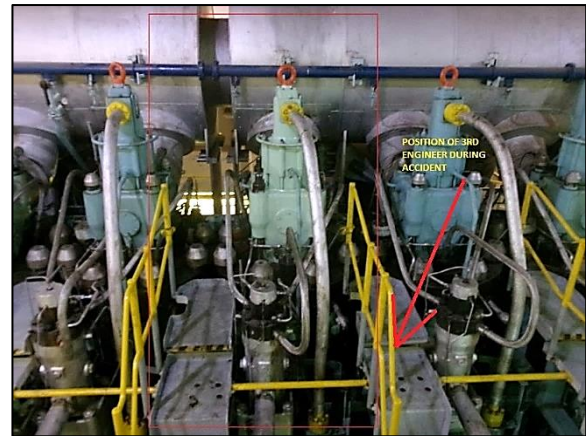
Figure 3: Picture showing the location of the third engineer, just before the accident

At 1244, the engine-room crew members⁴ rigged the hydraulic jack on all the studs of cylinder head no. 5. The third engineer was closest to the cylinder head, observing the work which was in progress (Figure 3). Using a hand pump, the chief engineer applied hydraulic pressure in the jack to commence the untightening procedure.

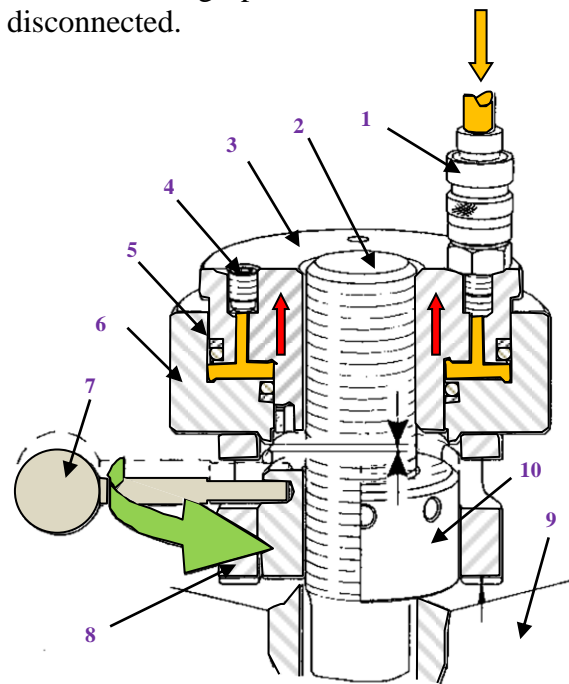
Figure 4: Cross-section through the hydraulic jack, nut, and stud

The stretching of the stud is relative to the pressure acting on the underside of the tool's piston (**Figure 4**). As described in the previous section, it is the stretching of the stud which will eventually allow the loosening (and tightening) of the nut, by means of the tommy bar.

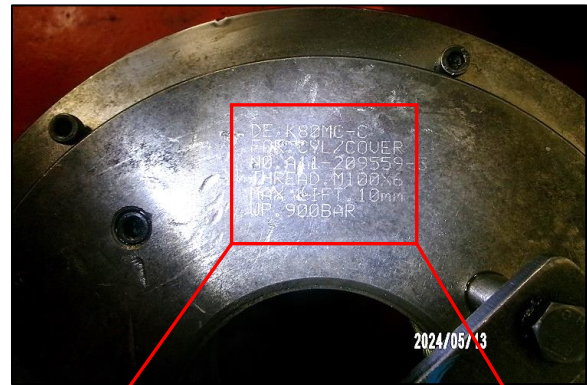
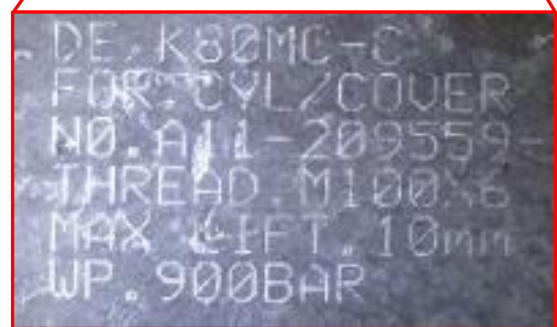
Figure 5: Maximum working pressure and lift, stamped on the hydraulic jack assembly

As for any hydraulic jack, the one used on *CMA CGM San Antonio* had a maximum lift⁶ value stamped on it. The maximum lift on this hydraulic jack was 10 mm (**Figure 5**). The operations manual cautioned that beyond this maximum travel, the lower sealing and back-up rings may be damaged and would have to be replaced.

Exceeding the maximum working pressure was not considered to be the most plausible option. The hydraulic jack assembly was designed not to exceed this pressure. Pressure relief orifices would align with the oil chamber below the moving piston, relieving the pressure below the hydraulic jack. Moreover, crew members who were on site recalled that the working pressure at the time had only reached 50 % of the maximum.

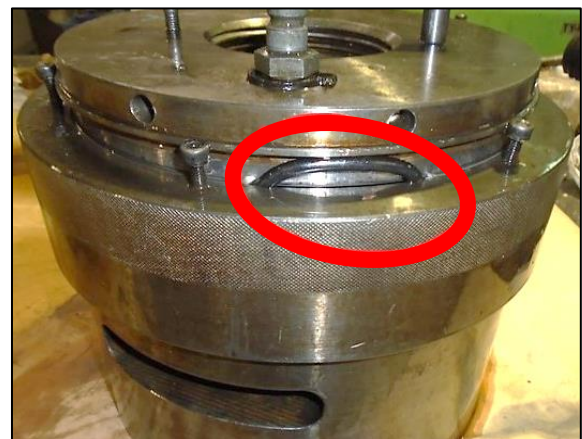
Figure 6: Displaced upper sealing ring

A photo taken soon after the accident showed the upper sealing ring displaced from its recess on the moving piston (**Figure 6**).

Equally important to consider, was the cause of the displaced sealing ring. The upper sealing ring could not be displaced out of its recess because of the stationary cylinder walls unless:

- the working pressure exceeded 900 bar, the safety drain passages were blocked, and the maximum lift of 10 mm was exceeded;
- the back-up ring was damaged and could not support the upper O-ring when subjected to the hydraulic oil;
- the clearance between the piston and the cylinder exceeded the 3.0 mm stipulated in the operations manual; or
- a combination of these factors.

The other possibilities appeared more plausible, although no accident data was available to confirm the precise dynamics. The importance of the back-up ring is critical to support the O-ring, when the assembly was subjected to the working pressure. To this effect, the safety investigation did not exclude the possibility that the back-up ring had been damaged before the accident (and went unnoticed by the crew members), and consequently failed during the application of the working pressure, resulting in the O-ring

being pushed out of its recess and popping out of the moving piston.

14/2024_R1 distribute this safety investigation report to ensure that crew members serving on board Company managed ships are aware of the findings and discuss the outcome of the safety investigation during on board safety management meetings.

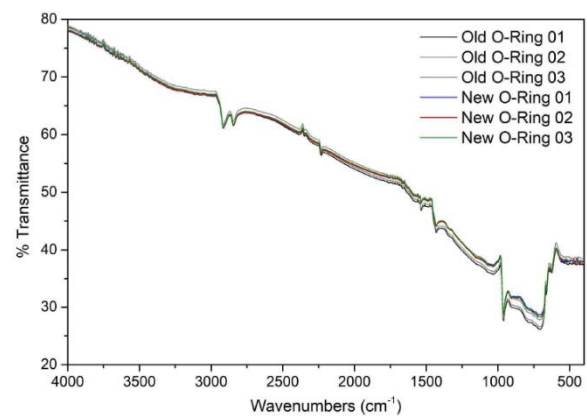
Figure 7: FTIR spectra of both samples, superimposed

Moreover, a Fourier-transform Infrared (FTIR) spectroscopy was carried out to obtain a unique IR spectrum, reflecting the materials' chemical makeup. Attenuated total reflectance Fourier-transform infrared spectroscopy was carried out. The hardness data (Table 1) and the infrared spectra of both O-ring samples (Figure 7) confirmed that the O-rings were virtually identical with no indicator of change or degradation being detected.
