Bundesstelle für Seeunfalluntersuchung
Federal Bureau of Maritime Casualty Investigation

**Allision with an offshore wind turbine in the
Gode Wind 1 wind farm by the PETRA L on
24 April 2023**

Investigation Report 192/23

30/01/2025

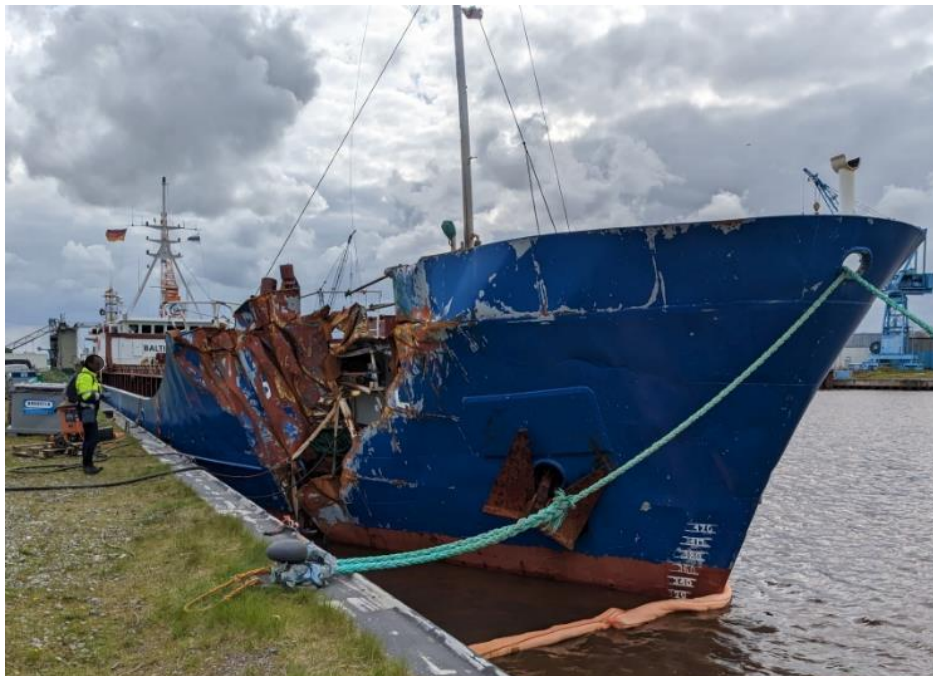
The below photographs clearly show the damage to the bow of the PETRA L. The deck at the forecastle is damaged over an area of some 5 m. The V-shaped breach extends below the ship's waterline.

Figure 3: Damage to the bow⁴

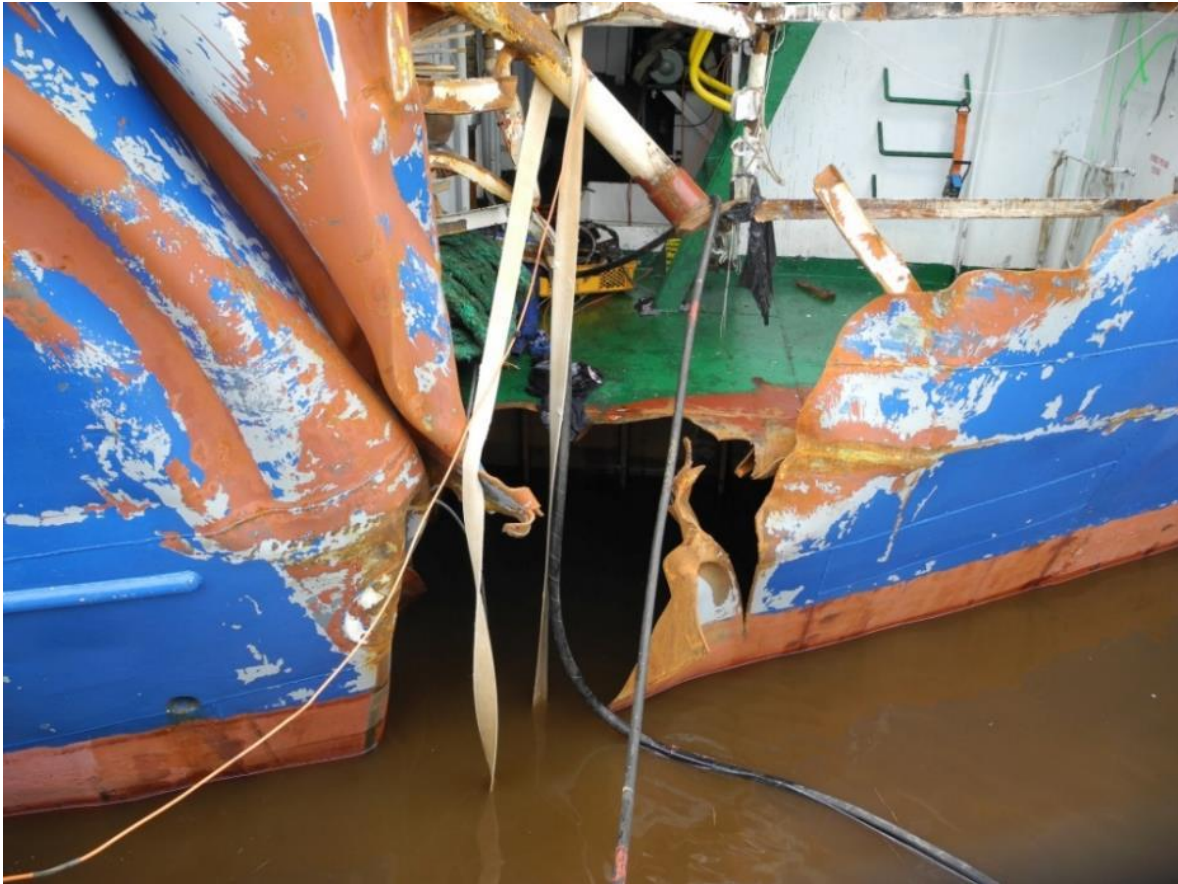
The breach is almost 1 m wide at the waterline. Water had flooded the spaces within the forecastle. However, the collision bulkhead toward the cargo hold had remained intact, preventing further water ingress there, which was crucial for the ship's buoyancy.

Figure 4: Breach at the waterline⁵

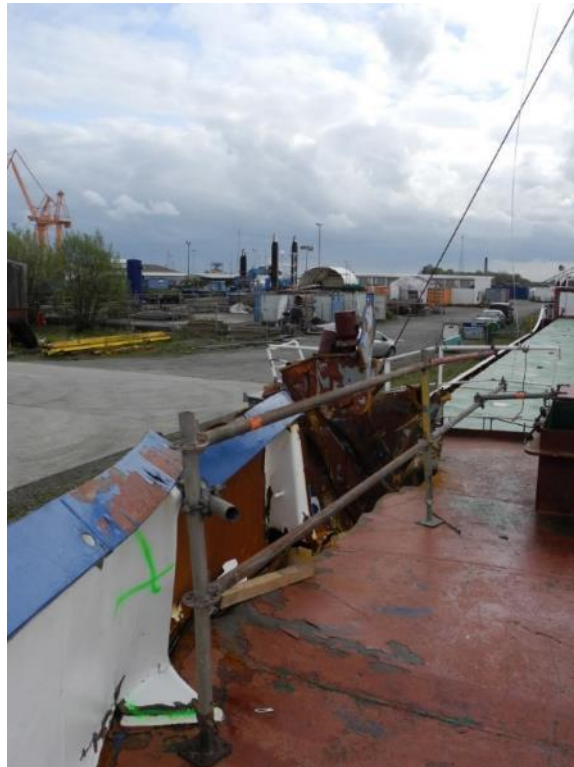
Figure 5: Forecastle with view of the damage⁶

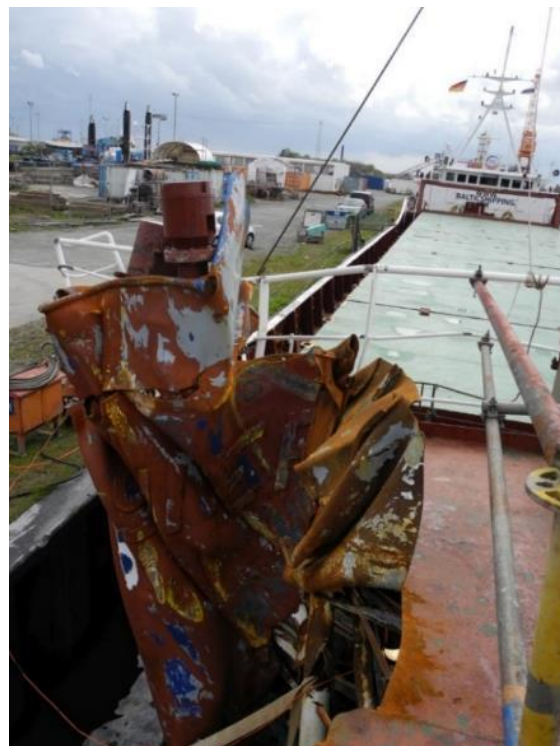
Figure 6: Rippled hull plating at the breach⁷

Figure 6 shows how the impact pushed the ship's hull metal backward, creating ripples in the process. This illustrates the immense forces that were at work. Finally, Figure 7 shows the breach directly from above.

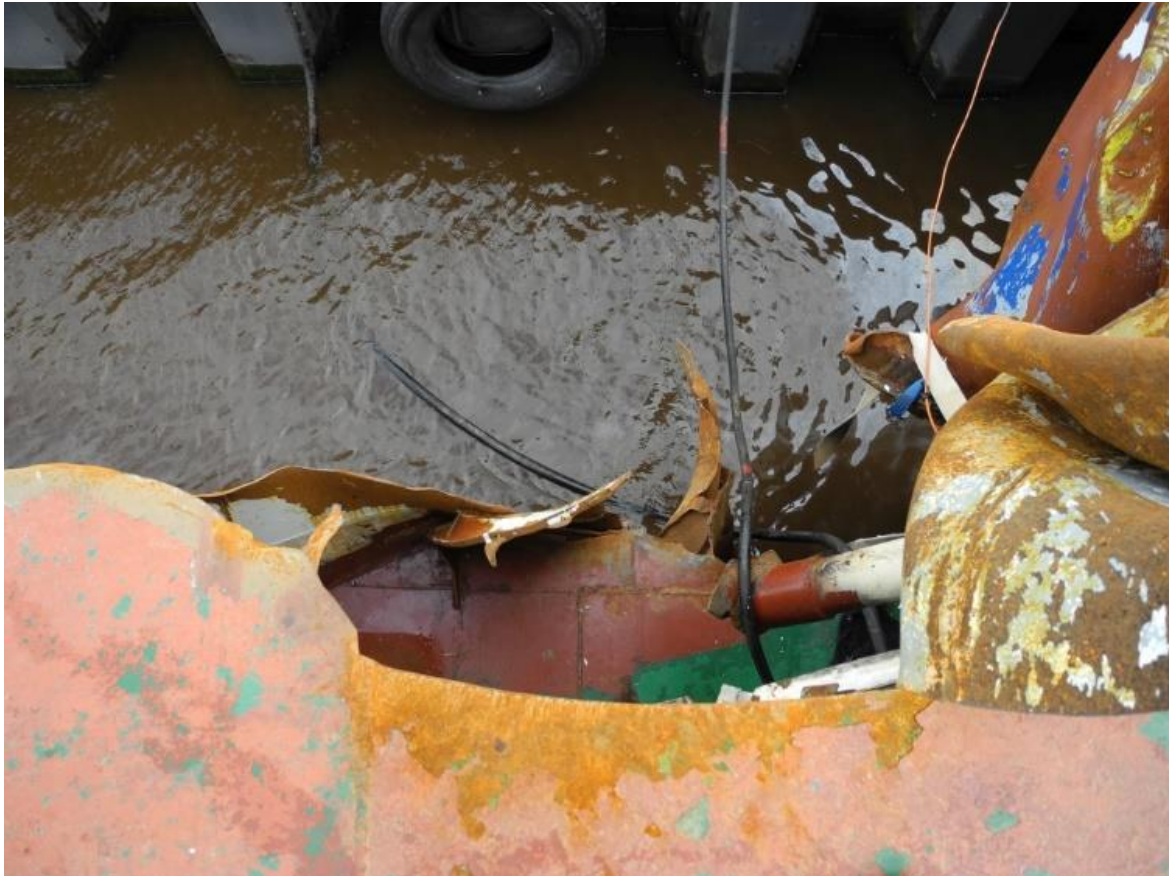
Figure 7: The breach from above⁸

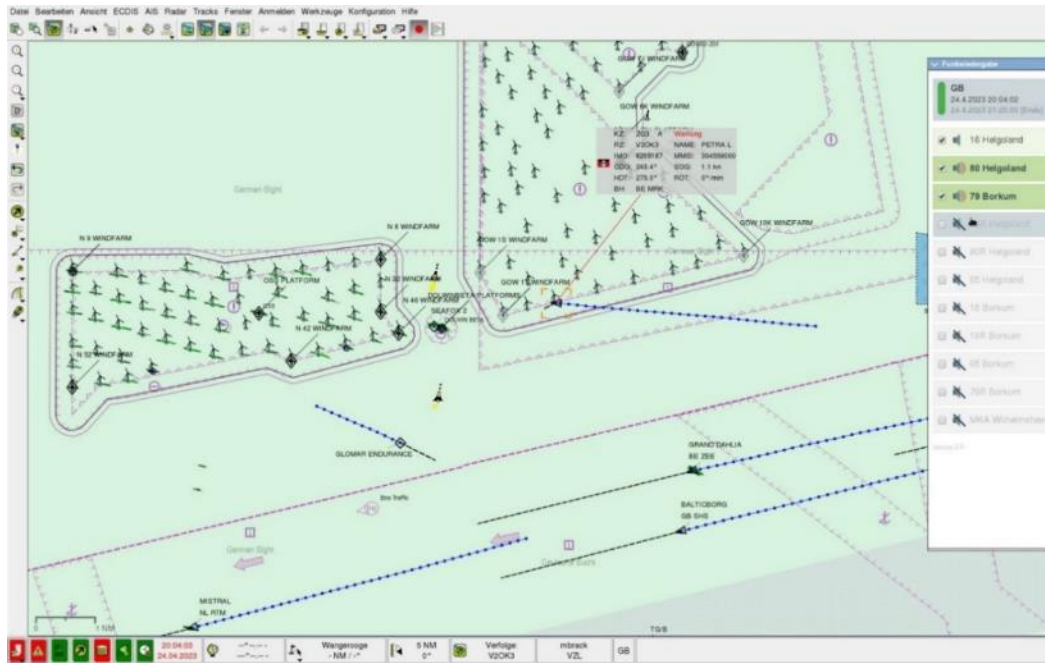
Figure 15: 2004 – time of the allision¹⁷

Figure 15 shows the time of the accident. At 2004, the PETRA L sails into the wind turbine OWT GOW R04. This is clearly evident from the sudden drop in speed. The ship picks up speed again shortly afterwards and leaves in a westerly direction.
