December 16, 2024

MIR-24-38

# Breakaway of Bulk Carrier *Chang Hang Hui Hai* and Subsequent Collision with Tugboat *Signet Defender*

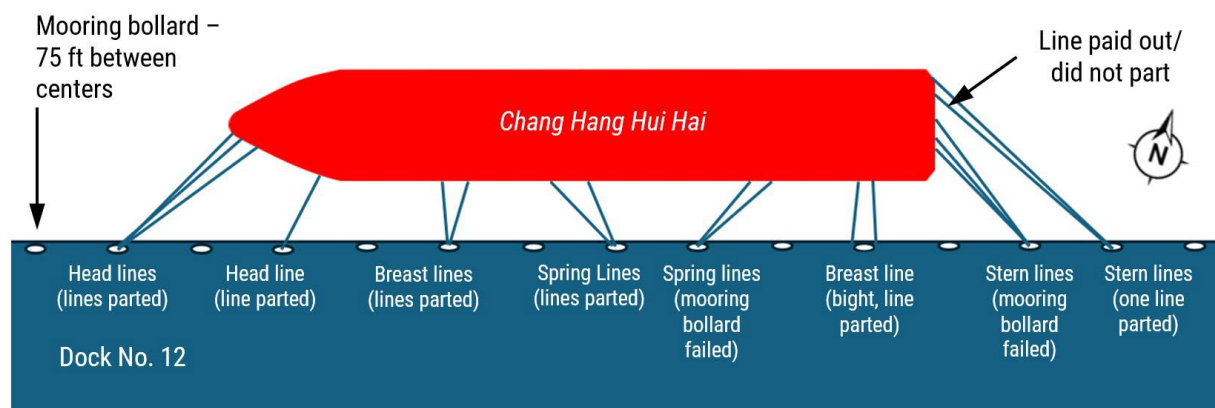
As the morning progressed, the winds increased. Two US Coast Guard Port State Control officers boarded the vessel at 1034 for a routine inspection, and one noted that the winds were "starting to pick up." The chief mate evaluated the increasing wind conditions and ordered additional mooring lines to be deployed, bringing the total to 16 (see figure 3). The crew added a headline, two breast lines forward, one breast line aft (a bight) and two stern lines. The ship carried three (additional) spare mooring lines.

**Figure 3.** *Chang Hang Hui Hai* mooring line arrangement (scale approximate).

During the casualty event, 10 mooring lines parted, one line (starboard stern line) paid out all the way, and two mooring bollards, holding five lines, failed. A review of the mooring lines' original manufactured certificates showed that the lines met the standards of the ship's classification society. Inspection records showed that the crew had examined the mooring lines every 3 months, looking for anything that would make them unsuitable for use. When examining the mooring lines, crewmembers rated the lines as either very good, good, fair, or poor on the mooring rope inspection record. The last visual inspection of the mooring lines before the collision, on December 21, 2023, recorded each line in "good" condition. Neither postcasualty testing of the mooring lines nor an assessment of the failed mooring bollards was conducted.

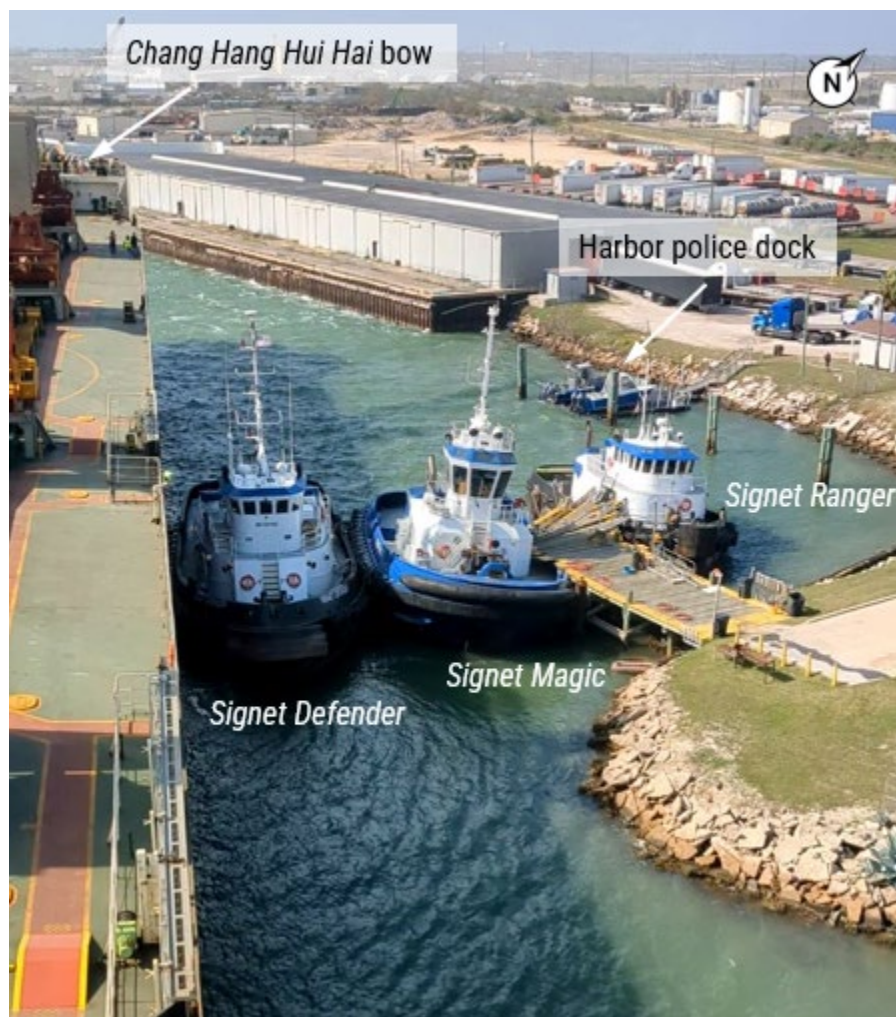
At 1243, the vessel's continued drift pulled two bollards off the dock along with the five lines (two aft spring and three stern lines) that had been secured to them. At 1249, the *Chang Hang Hui Hai* collided with the tugboat *Signet Defender*, which was moored on the opposite side of the channel (see figure 4). Fourteen minutes had passed from the time the vessel started to drift until the collision.

This first collision led to cascading collisions. The *Signet Defender* was pushed into the side of the tugboat *Signet Magic*, which was moored alongside the *Signet Defender*. The *Signet Maritime* pier was destroyed as the *Signet Magic* was pushed into it. The pier was pushed into the tugboat *Signet Ranger*, tied up on the other side of the pier.

**Figure 4.** *Chang Hang Hui Hai* colliding with the tugboat *Signet Defender*. (Source: Coast Guard)

The National Transportation Safety Board determines that the probable cause of the breakaway of the dry bulk carrier *Chang Hang Hui Hai* from a dock and subsequent collision with the tugboat *Signet Defender* was the force of the wind acting on the exposed freeboard of the *Chang Hang Hui Hai*, which overcame the breaking strength of several mooring lines.
