### CREW FATIGUE CAUSED GROUNDING OF SHIP ON THE BULGARIAN COAST

ON 20 SEPTEMBER 2021, A GENERAL CARGO SHIP RAN AGROUND ON THE ROCKY COAST OF THE YAILATA PROTECTED AREA IN BULGARIA. THE INCIDENT OCCURRED WHEN THE SHIP, TRAVELING FROM YUZHNIY, UKRAINE, TO VARNA, BULGARIA, DEVIATED FROM ITS PLANNED COURSE BECAUSE THE SECOND OFFICER (2/O) ON WATCH FELL ASLEEP. THE BRIDGE NAVIGATIONAL WATCH ALARM SYSTEM (BNWAS) WAS FOUND DEACTIVATED, REMOVING A CRITICAL SAFETY NET. THE INVESTIGATION BY THE BULGARIAN NATIONAL AIR, MARITIME, AND RAIL ACCIDENT INVESTIGATION BOARD (NAMRAIB) CONCLUDED THAT FATIGUE, INSUFFICIENT LOOKOUT ARRANGEMENTS, AND LAPSES IN THE SHIPS SAFETY MANAGEMENT SYSTEM (SMS) CONTRIBUTED SIGNIFICANTLY TO THE INCIDENT. THIS CASE STUDY EXAMINES THE EVENT, THE DAMAGE INCURRED, AND THE LESSONS LEARNED TO IMPROVE SAFETY PROTOCOLS AND PREVENT SIMILAR ACCIDENTS IN THE FUTURE.

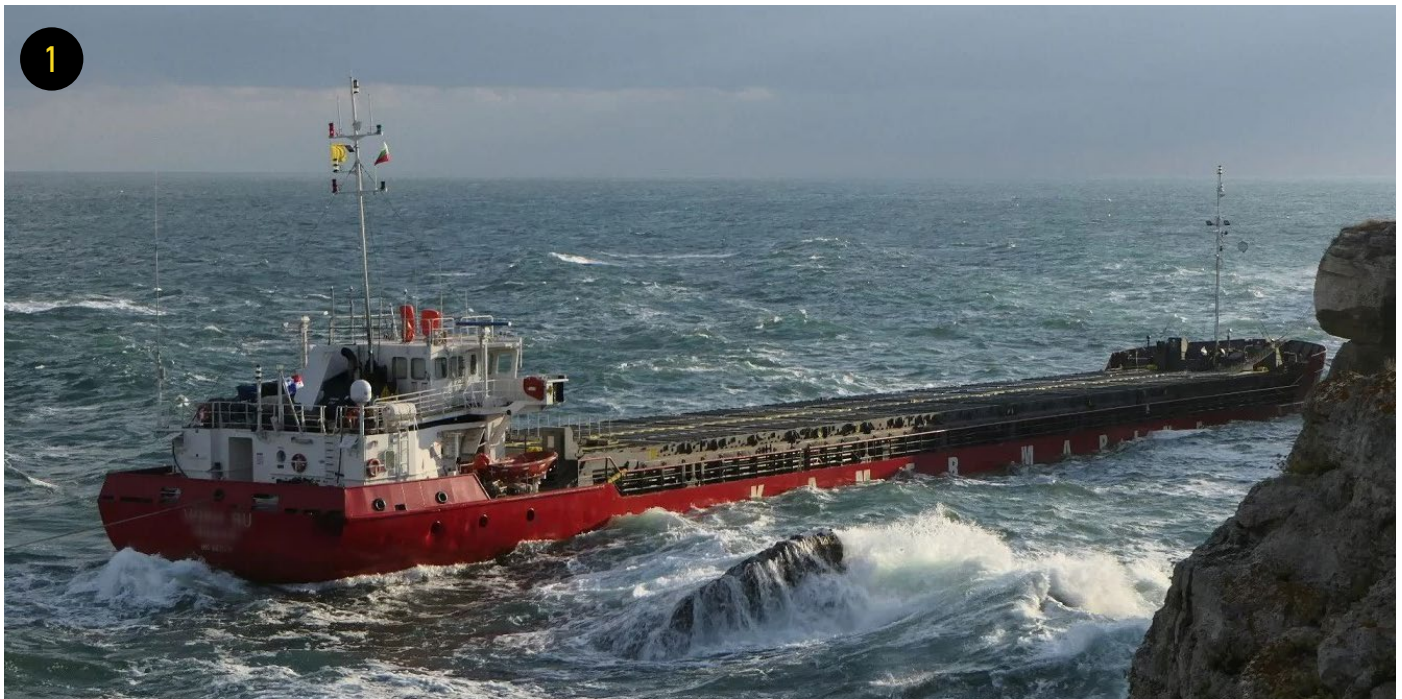
**FIGURE 1** GROUNDED SHIP  
**SOURCE** REPUBLIC OF BULGARIA NAMRAIB

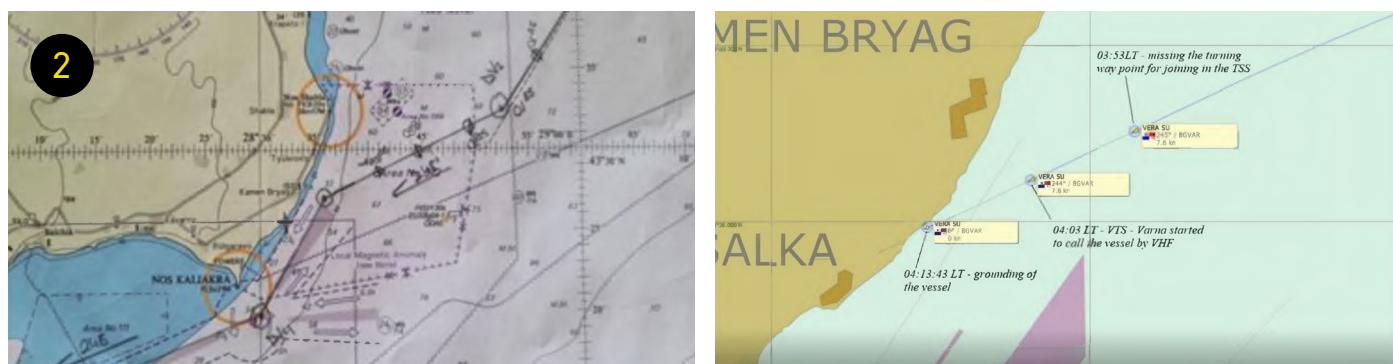
During the night, the ship proceeded on autopilot. The 2/O conducted his watch normally. However, between 0345 and 0355, he briefly sat on the bridge's couch and fell asleep. This lapse proved critical. At 0353, the ship failed to execute a planned turn to join the TSS and continued a straight course towards the shoreline. Coastal authorities monitoring the ship attempted to call on Very High Frequency (VHF) radio when it did not alter course, but the 2/O failed to respond.

**FIGURE 2** PART OF THE PASSAGE PLAN AROUND THE STRANDING DRAWN BY 2ND OFFICER ON A NAVIGATIONAL CHART AND AIS PLOTS SHOWING FINAL STAGES OF THE SHIP'S PASSAGE

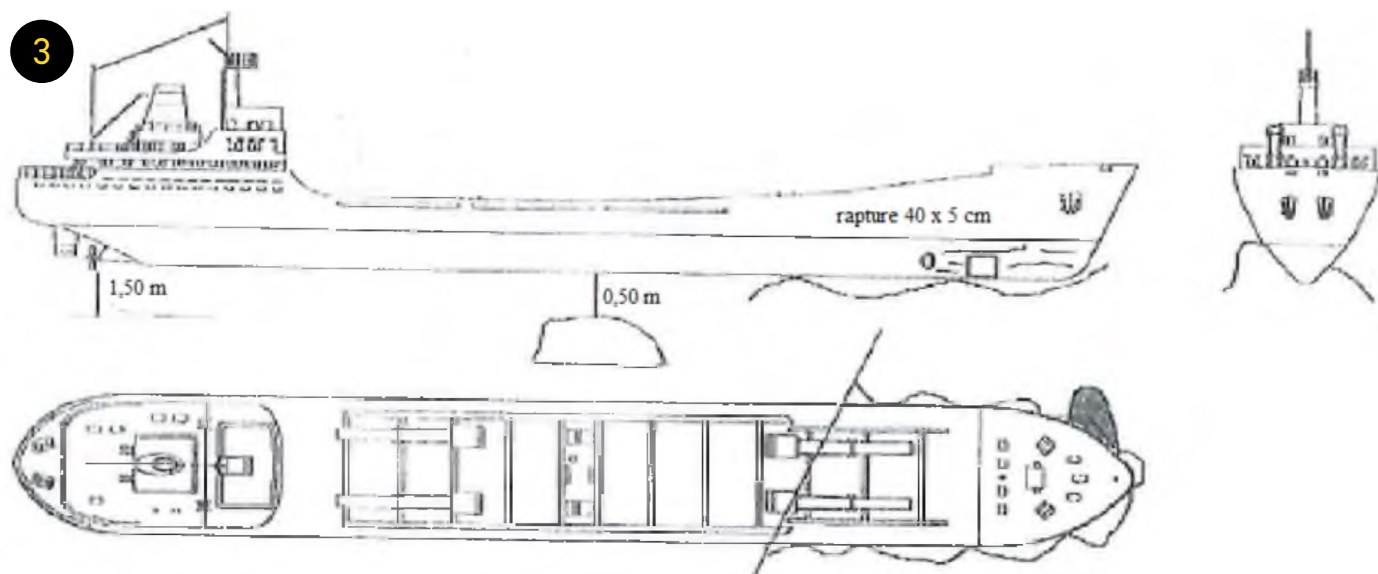
At around 0413, the ship ran aground at a speed of 7.8 knots in the Yailata Protected Area, causing extensive hull damage. Water entered several ballast tanks through breaches in the hull, but there was no immediate fuel leakage. The impact rendered the ship immobile, and the rocky bottom complicated subsequent refloating efforts.

**FIGURE 3** PLACES OF CONTACT OF THE HULL WITH THE BOTTOM, AT THE TIME THE SHIP'S GROUNDING

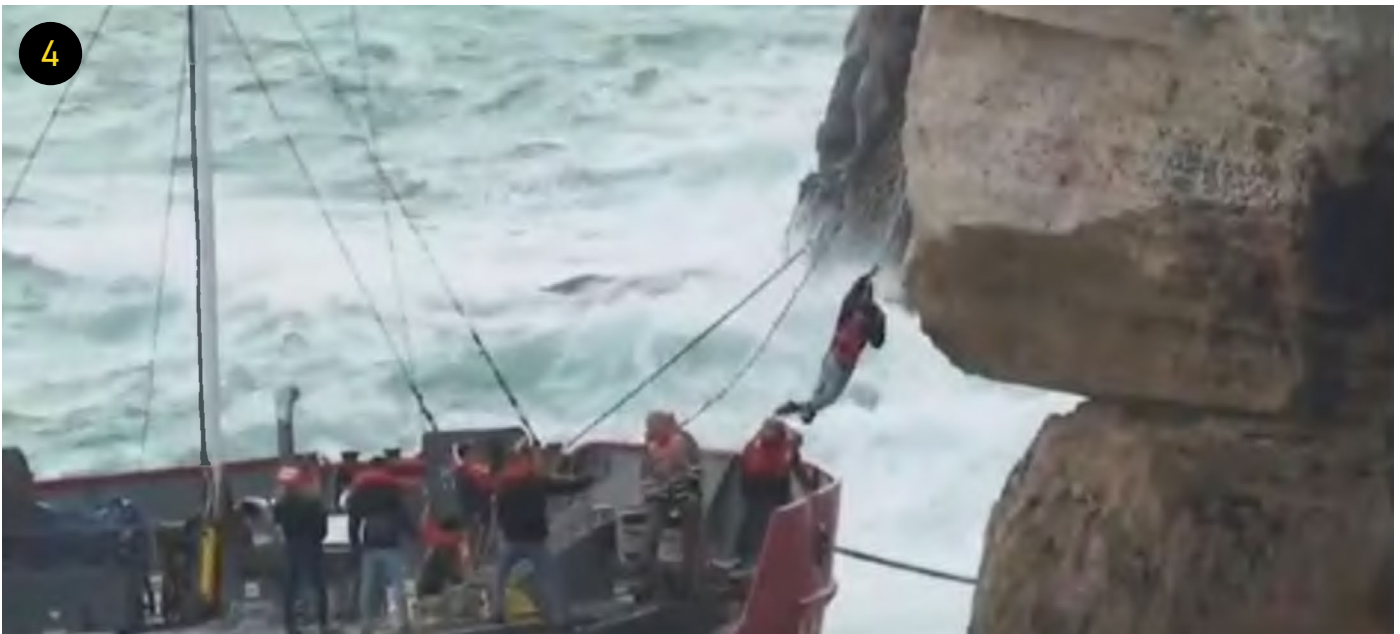
**FIGURE 4 CREW EVACUATION**  
SOURCE REPUBLIC OF BULGARIA NAMRAIB

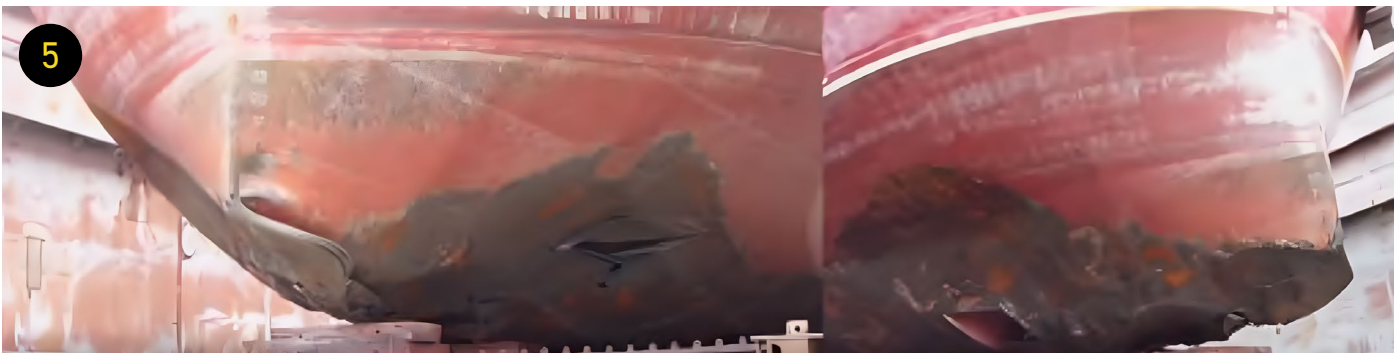
The ship sustained substantial structural damage, primarily to the hull, due to its impact with the rocky seabed. Initial inspections revealed breaches in several ballast tanks, resulting in water ingress, which further complicated refloating efforts. Over time, as the ship remained grounded, the pressure on the hull increased, exacerbating the structural damage. Subsequent refloating attempts required specialised equipment, including a floating crane and tugs, as well as partial cargo unloading to lighten the ship. The ship was eventually refloated and towed to Varna, where a detailed inspection revealed the full extent of damage to the hull, cargo hold and other mechanical systems.

**FIGURE 5** DAMAGES OF THE SHIP IN THE BOW (PORT AND STARBOARD)  
**SOURCE** REPUBLIC OF BULGARIA NAMRAIB

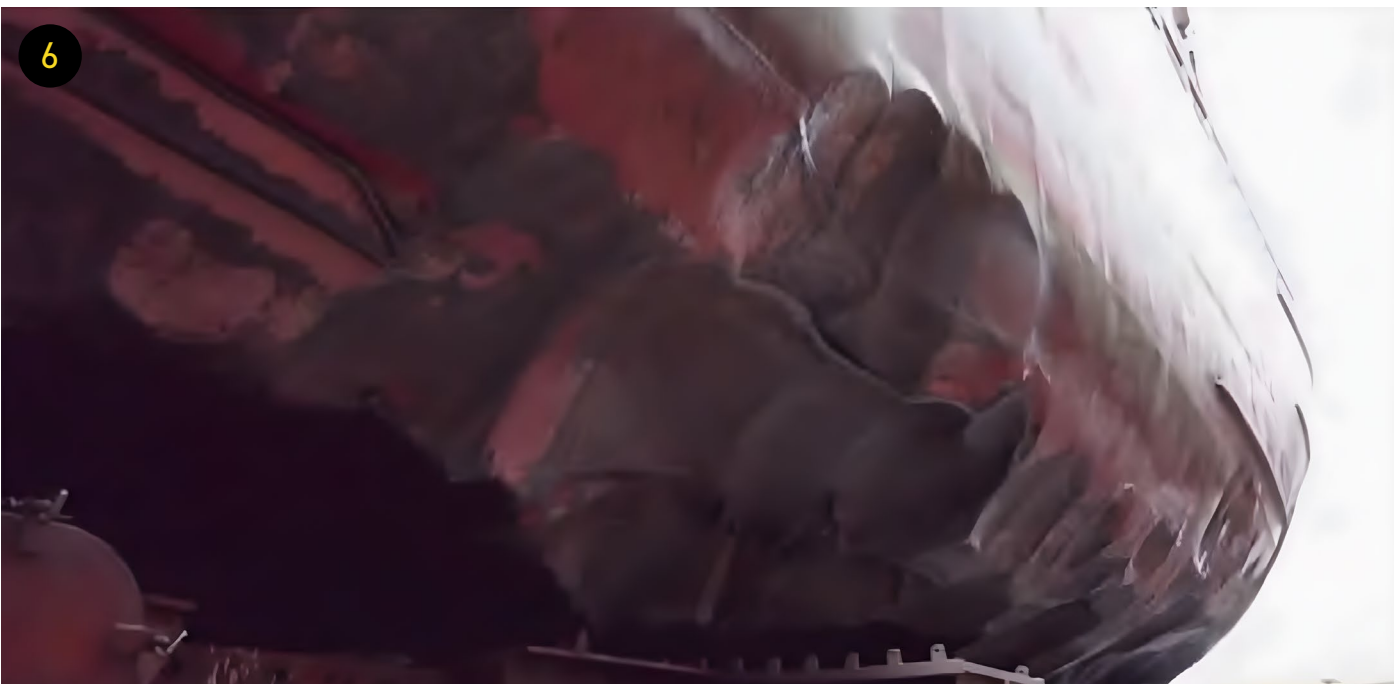
**FIGURE 6** SIGNIFICANT DAMAGE AROUND THE MIDSHIP STARBOARD SIDE  
**SOURCE** REPUBLIC OF BULGARIA NAMRAIB
