January 16, 2025

MIR-25-02

Contact of Crane on Deck Barge *BMI 209* Towed by *Nickelena* with Mackinac Bridge

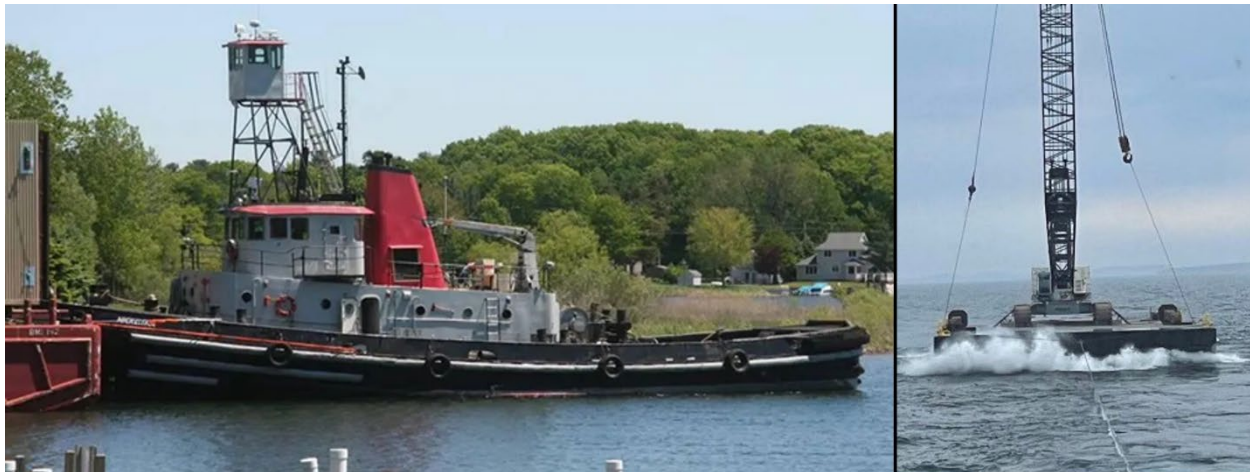
On May 7, 2023, about 0213 local time, the towing vessel *Nickelena* was transiting the Straits of Mackinac while towing deck barge *BMI 209*, transporting a crawler crane, when the crane boom struck the main span of the Mackinac Bridge (see figure 1 and figure 2).¹ The contact bent the crane boom backwards, causing the boom to eventually collapse onto the aft end of the barge. There were no injuries, and no pollution was reported. Damage to the Mackinac Bridge was estimated at \$145,000; damage to the crane was estimated at \$665,000.²

Figure 1. Left to right: The *Nickelena* on an unknown date before the contact, and the crane aboard the *BMI 209*, as seen from the *Nickelena* during the voyage and before the contact. (Sources: US Coast Guard and Basic Towing Inc.)

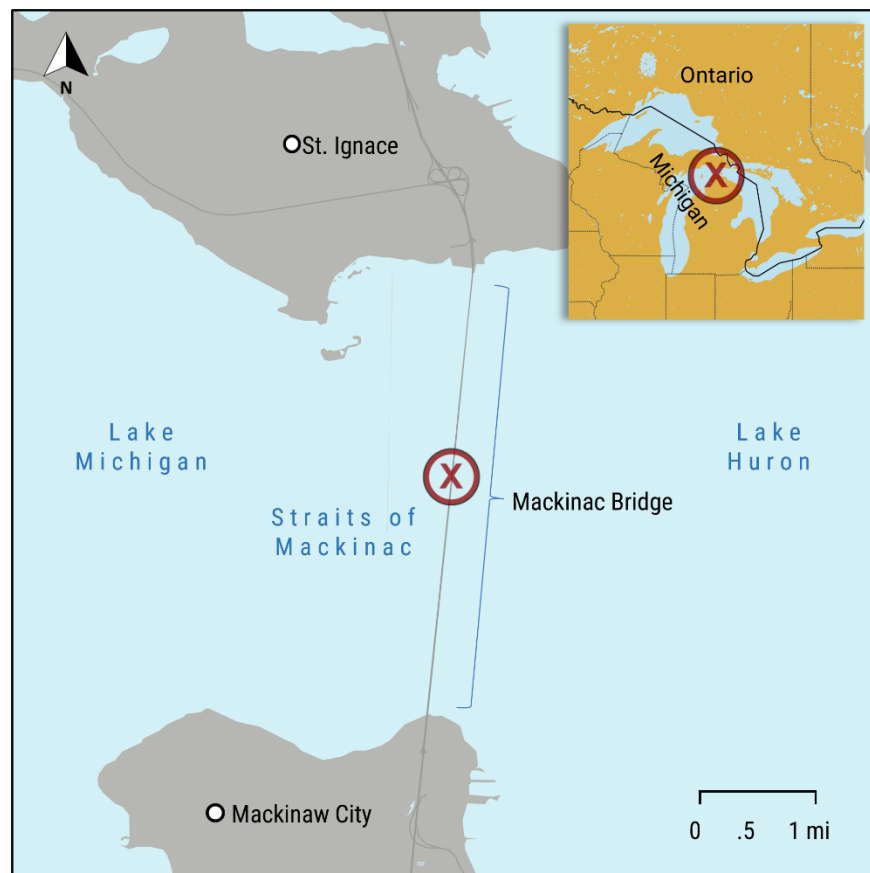
Figure 2. Location on the Mackinac Bridge that was struck by the crane aboard the *BMI 209*, as indicated by a circled X. (Background source: Google Maps)

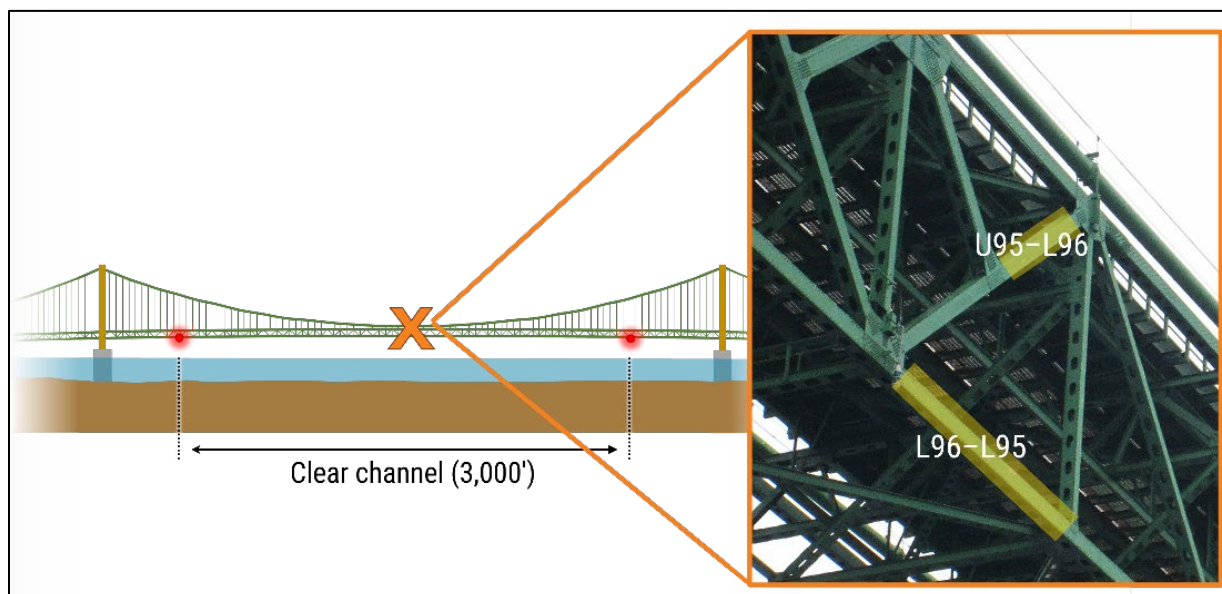
The Mackinac Bridge Authority hired a consultant to survey the damage from the impact. The survey report, dated December 14, 2023, determined that the damaged area was on the west side of the span, 25 feet south of the center of the charted navigation channel. The survey identified damage on the stiffening truss bottom chord L96-L95 and upper diagonal U95-L96 truss members of the west truss (see figure 5).

Figure 5. Area of west elevation of the Mackinac Bridge damaged by the contact with the crane boom aboard *BMI 209*, indicated by an X. Inset image at right indicates the location of the stiffening truss bottom chord (L96-L95) and upper diagonal truss (U95-L96). (Inset source: Mackinac Bridge Authority).

On the bottom chord L96-L95, the survey identified seven gouges and indentations within an impact area 6 feet and 2 inches in length along the west side of the structure. The gouges ranged from 1/8 of an inch to about 1/2 of an inch deep and were concentrated on the top edge of the bottom chord. The survey also found scratch marks consistent with the crane cables striking the westside surface of the bottom chord. In addition, 14 rivet heads on the chord were damaged, with either minor section loss to their tops or large gouges present.

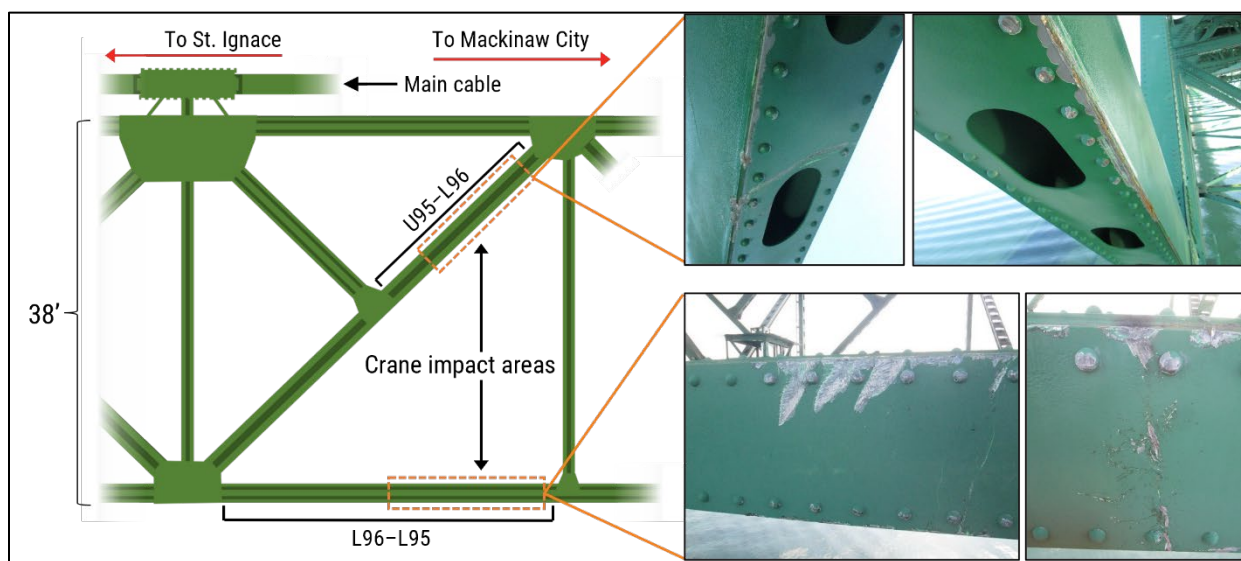
On the upper diagonal member U95-L96, the survey identified several locations of impact, including three gouges to the bottom of the member. In addition, 11 rivet heads were damaged, with either minor section loss to their tops or large gouges present (see figure 6). The height of the highest damage was 183 feet above the water.

Figure 6. Areas damaged by the crane boom's contact with the bridge. (Inset source: Mackinac Bridge Authority)

The damage to the Mackinac Bridge structure indicates that the first contact was to the stiffening truss below the roadway, at the top of the truss’s bottom chord (about 155 feet above the water). Given the configuration of the crane, the wires securing the crane boom would have hit first, and then when they parted, the boom would have contacted the top of the chord. As the barge continued forward, the boom would have been pushed backwards and its angle and height above the water would have increased, leading to damage higher up on the bridge. At some point, the boom contacted the upper diagonal truss (U95-L96), about 183 feet above the water, before folding back and collapsing on the barge.

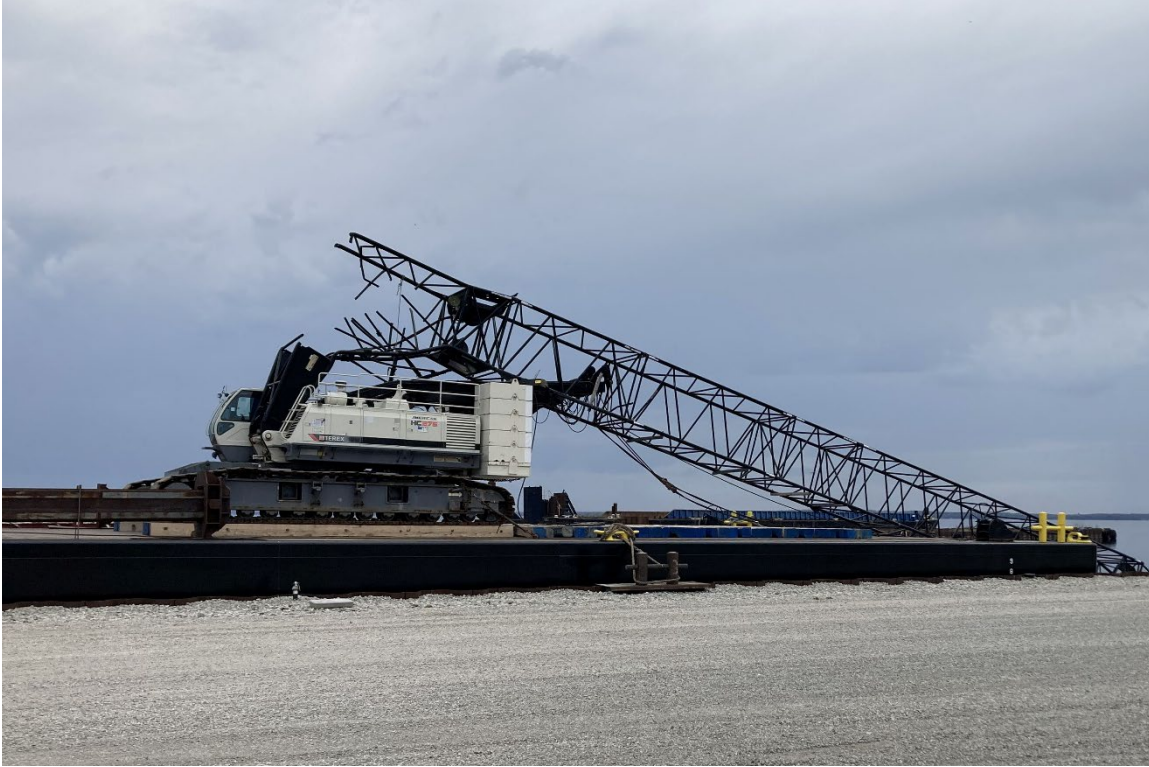
Investigators examined the crane to determine the extent of its damage and found the crane boom (which was confirmed to be 160 feet in length with a 5-foot "rooster" sheave) to be completely folded back over the crane machinery body and resting on the crane body and the barge (see figure 7). The outer assembly of the boom was completely separated, while the inner assembly was still attached to the base of the crane. The top of the boom had impact-related damage and indications of boom-structure deformations below the rooster. The two cables that had been used to secure the boom to the barge parted, and the pulley was damaged. In addition, scrape marks were found along the underside of the boom, below the pulley.

Figure 7. The boom bent backwards over the cabin after striking the bridge. (Source: Coast Guard)

The crane's mechanical boom angle indicator was extensively damaged by the contact, so investigators could not determine whether it was operational before the bridge strike. Investigators evaluated the LMI and determined that the LMI display was showing a fail mode for the boom angle, the boom pitch and roll, and the wind indicator. The system had the capability to record data, but data downloaded and evaluated later only showed the dates and times of system startups and shutdowns.

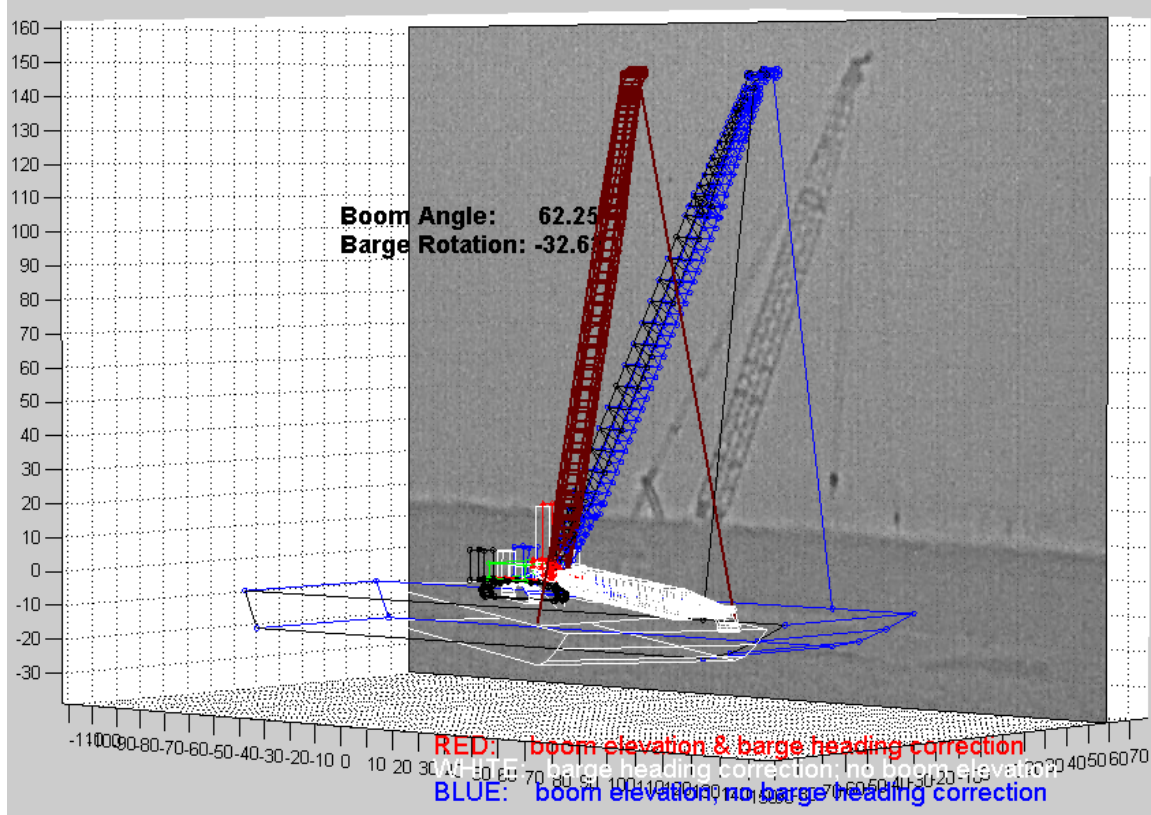
The NTSB conducted a study of the crane boom angle based on an infrared surveillance image of the crane from before the casualty (see figure 4) to estimate the height of boom at the time it contacted the Mackinac Bridge.³ The study determined, based on a 3-D Terex American HC 275 crawler crane/deck barge simulation model, that the boom angle during the voyage and before contact with the bridge was $62 \pm 1^\circ$, which equated to a height of 162.3 feet (see figure 8 and figure 9).

Figure 8. Infrared footage of the crane on board the deck barge *BMI 209* at 1226, with the NTSB simulation overlay of the boom angle at 62.2°. (Background source: Enbridge Straits Maritime Operations Center)

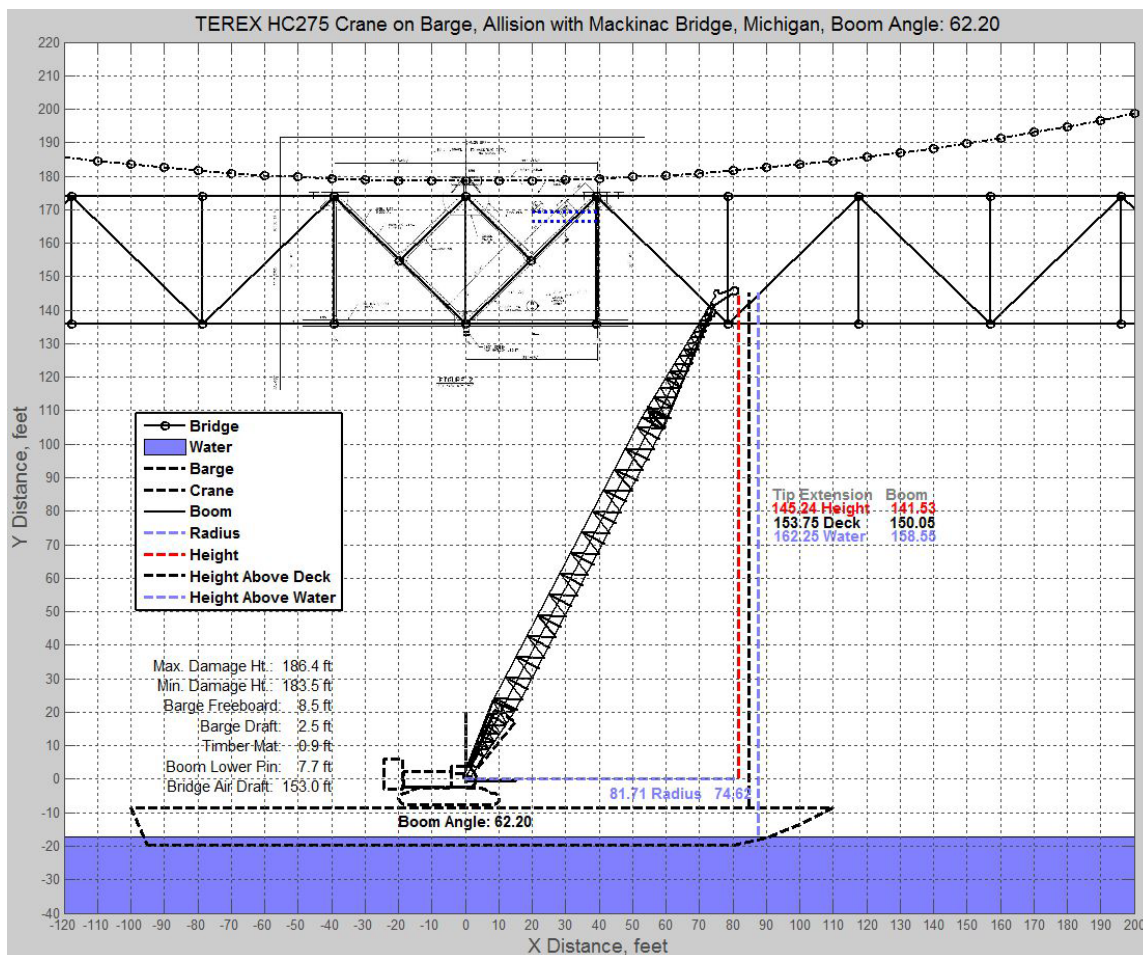
The NTSB study also determined that the maximum boom elevation angle for the Terex American HC 275 crawler crane (on deck barge *BMI 209*) to pass under the Mackinac Bridge near the center of the channel was about 55°.

Figure 9. NTSB calculations showing that a 62.2° crane boom elevation angle yields upper boom contact with the bridge truss bottom chord for the reported *BMI 209* deck barge draft (2.5 feet) and bridge vertical clearance (153 feet). The calculated height of the tip extension from the water at this angle is 162.3 feet (blue text).

An NTSB study used video of the crane barge on the day of contact to determine that a boom elevation angle for the crawler crane over about 55° would contact the truss bottom cord of the bridge with the barge near the center of the channel. The study determined that the boom angle during the voyage and before contact with the bridge was about 62°, corresponding to a boom height of 162.3 feet above the water (see figure 9). Similarly, a postcasualty Coast Guard analysis determined that if the boom angle was 60 degrees (the high end of the towing company managers’ estimate), the end of the 160-foot-long boom with an attached 5-foot rooster sheave would have been about 165 feet above the water level. Given the vertical clearance of 153 feet for the Mackinac Bridge at the time of the contact, the crane was about 10 feet too high to transit under the bridge (not including an additional safety margin).

For vessels and tows with high air drafts, such as crane barges, bridges pose a risk of overhead contact. Operators should ensure they have the most accurate and objective data about the crane and bridge heights before getting underway. Appropriate navigational resources such as the *US Coast Pilot* or navigational charts should be consulted by owners and operators when developing voyage plans to assess navigation risks and hazards, including the air draft relative to bridge vertical clearances along the intended route.
