**Bundesstelle für Seeunfalluntersuchung**  
Federal Bureau of Maritime Casualty Investigation

# Grounding of the MUMBAI MAERSK while entering the Neue Weser fairway on 2 February 2022

Investigation Report 37/22

26.03.2025

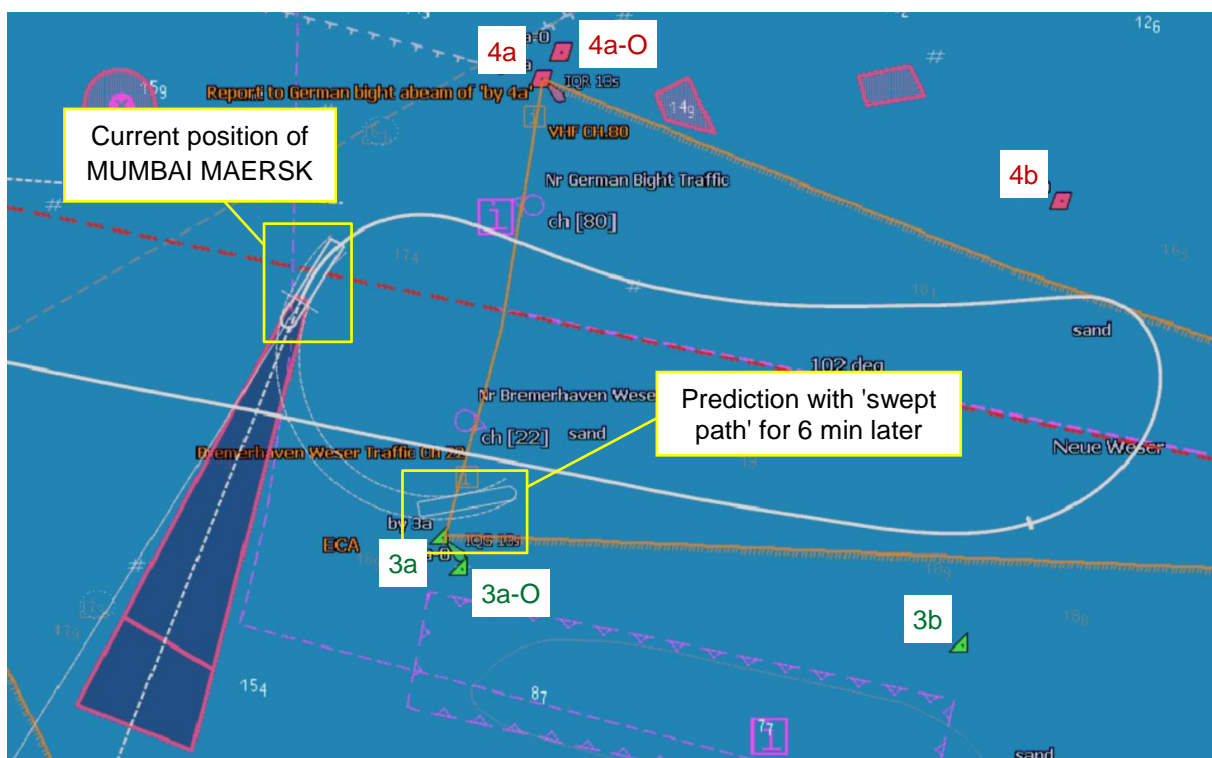
Figure 15: Track with prediction in the second turn, 2258<sup>32</sup>

The MUMBAI MAERSK's third officer reports that the ECDIS prediction indicates a dangerous close-quarters situation with buoy 3a. The pilot points out that it is important to remember that this is merely a prediction. The captain expresses concerns about the tight passage, as well. The pilot reassures him that he has no doubts about the manoeuvre's success, but acknowledges that the passage will indeed be a close one.

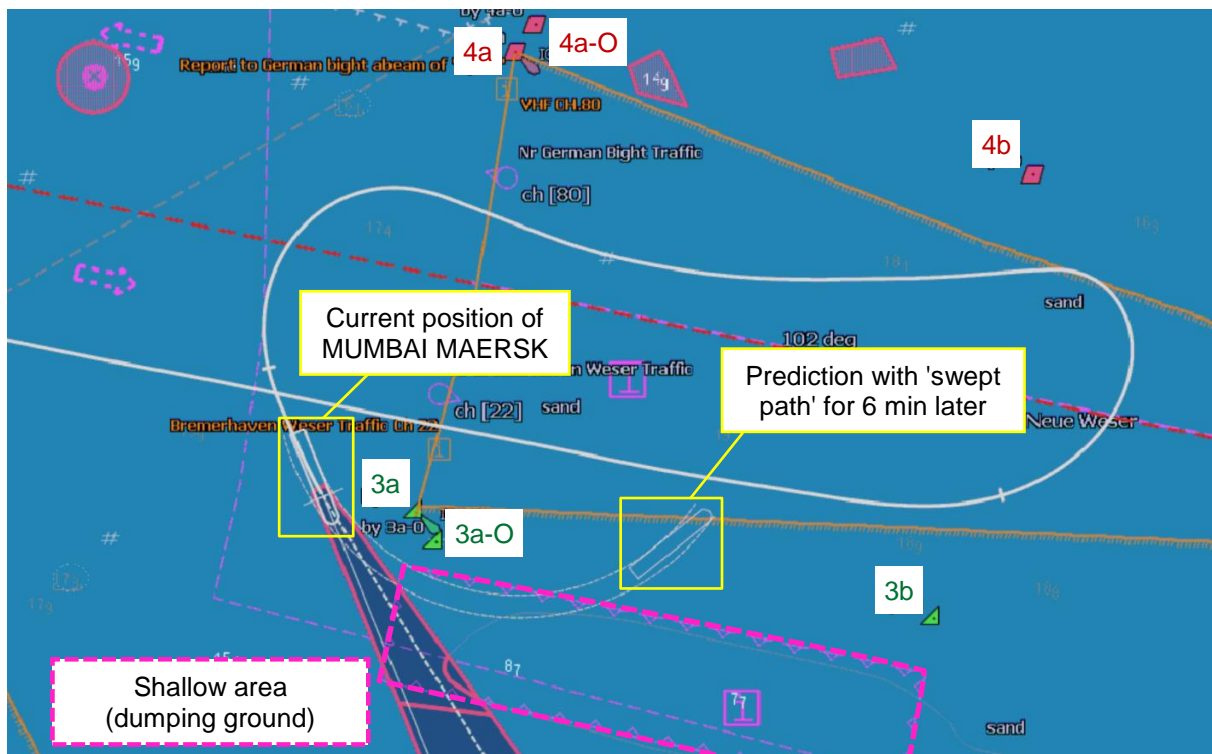
Figure 16: Increased turning radius<sup>33</sup>

Alte Weser Radar also reports that the passage of the buoys appears tight. The master then says that he believes it would be better if the buoys were kept on the port side, which the pilot then confirms. The MUMBAI MAERSK's turning radius is increased with a few short amidships and starboard rudder angles (first hard starboard, then smaller angles).

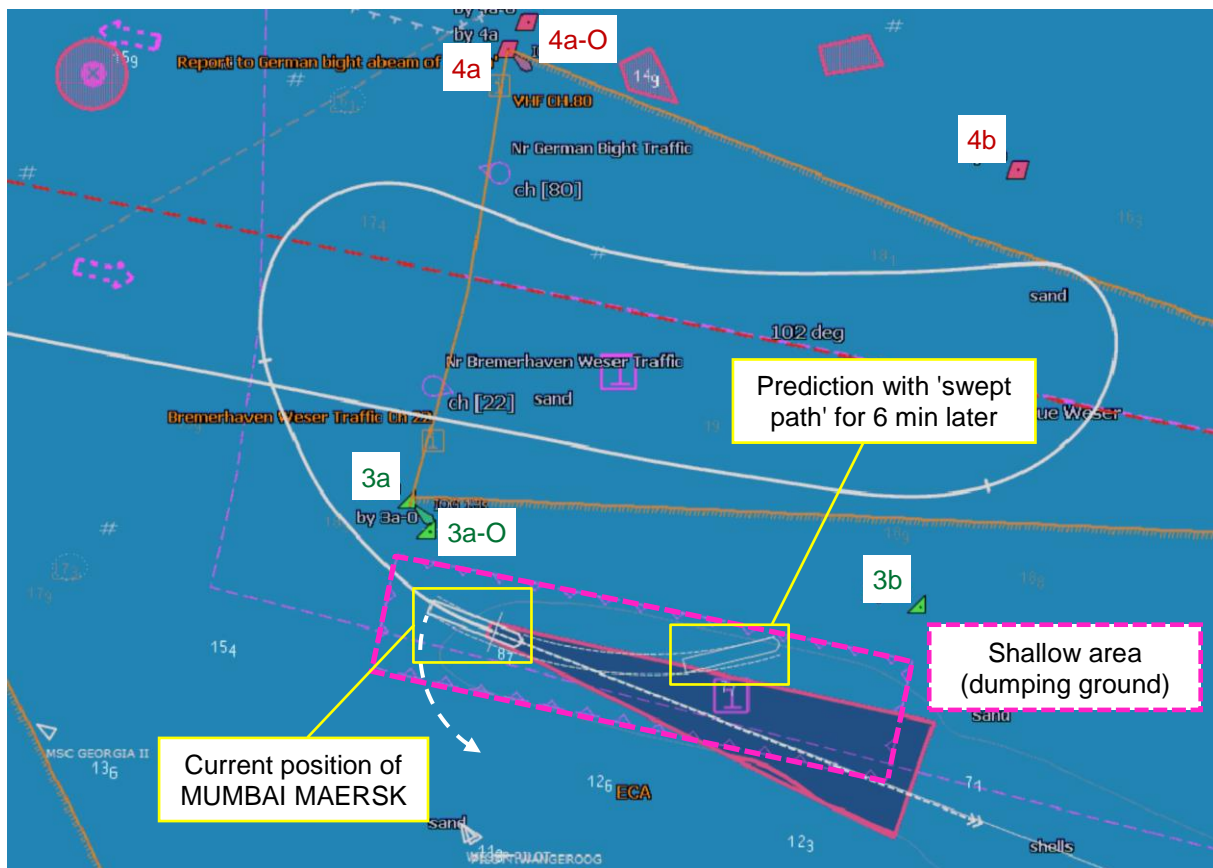
Figure 17: Time of grounding<sup>34</sup>

The pilot enquires about the under-keel clearance, which, according to the master, is 1.2 m. Shortly afterwards, the master declares that the ship has evidently run aground.

Due to the bow's contact with the seabed, the fore section is abruptly decelerated. This takes place at a speed of almost 10 kts, and in the course of a turn to port. The aft section, which is still afloat and moving, therefore begins to slew anticlockwise around a pivot point at the grounded bow (see dashed arrow in Figure 17). Because this causes a continuing speed of 0.5 kts to be indicated on the log, and because the rising tide still has another 90 minutes before it turns, there is initially hope among the bridge crew.

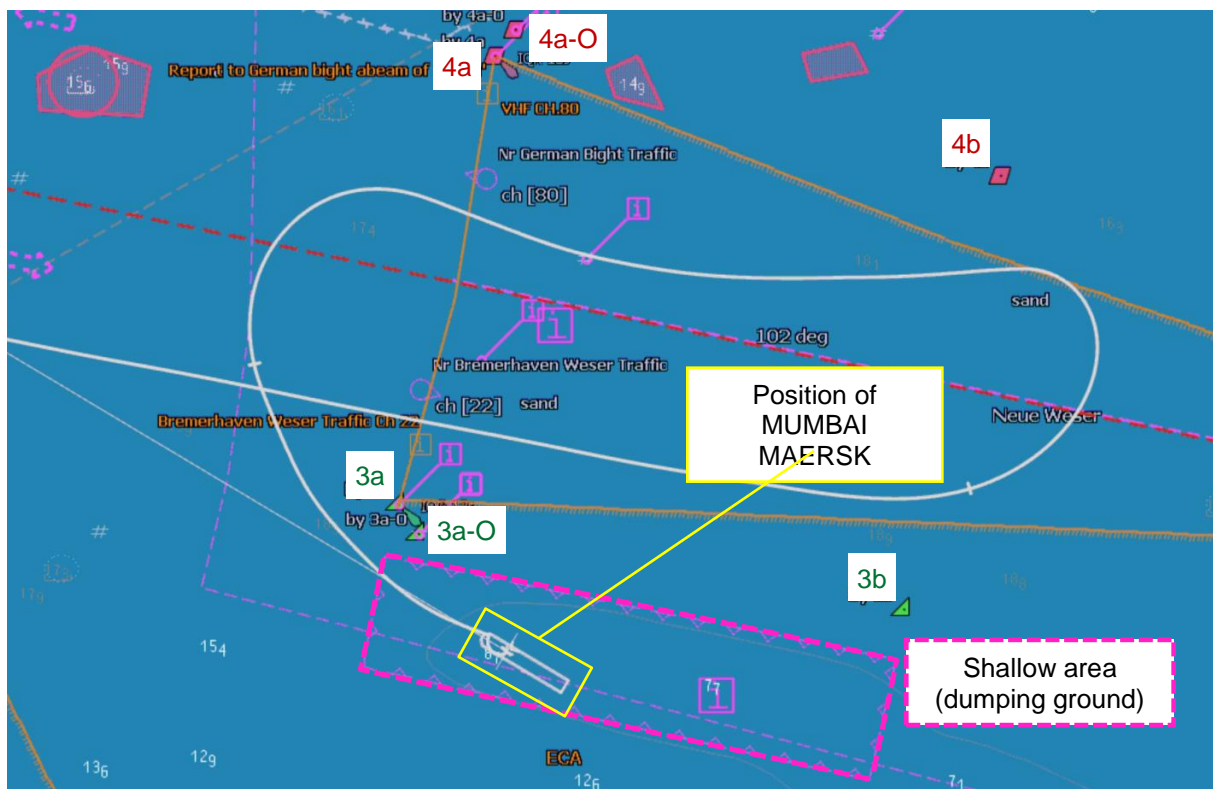
Figure 18: Final position after running aground<sup>36</sup>

It is established that there has neither been recognisable damage to the MUMBAI MAERSK's hull, nor has water pollution occurred.

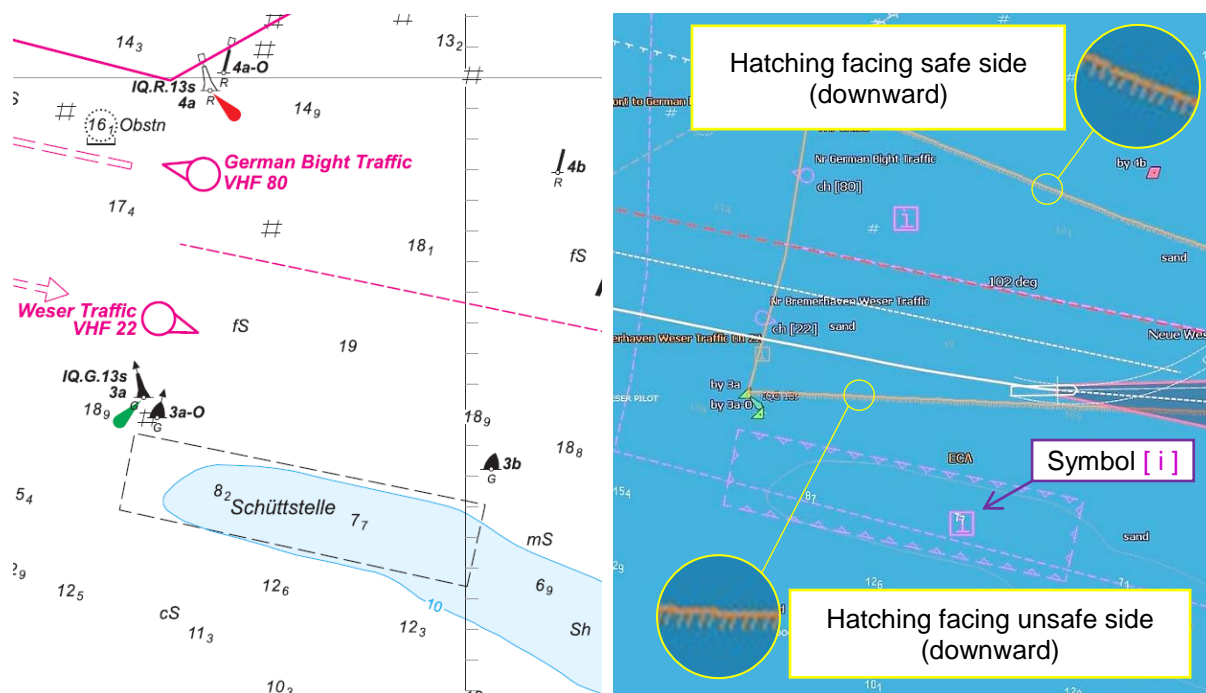
Figure 27: Image showing the dumping ground on the navigational chart (paper versus ECDIS on the MUMBAI MAERSK)<sup>56, 57</sup>

The right side of Figure 27 shows that the own safety lines delimiting the safe fairway are both oriented in the same direction – the hatching of both lines points downward, meaning the look-ahead sector (see Annexes, p. 118) would not generate an alarm if the own safety line were touched, even if the corresponding alarm was enabled. Moreover, the own safety lines do not encompass all unsafe depths, but are restricted to the Neue Weser fairway from buoy pair 3a/4a and parts of the Wangerooge fairway. Additional own safety lines were plotted around various buoys within both TSS – also with the hatched side of the line on the safe side, rather than the unsafe side.

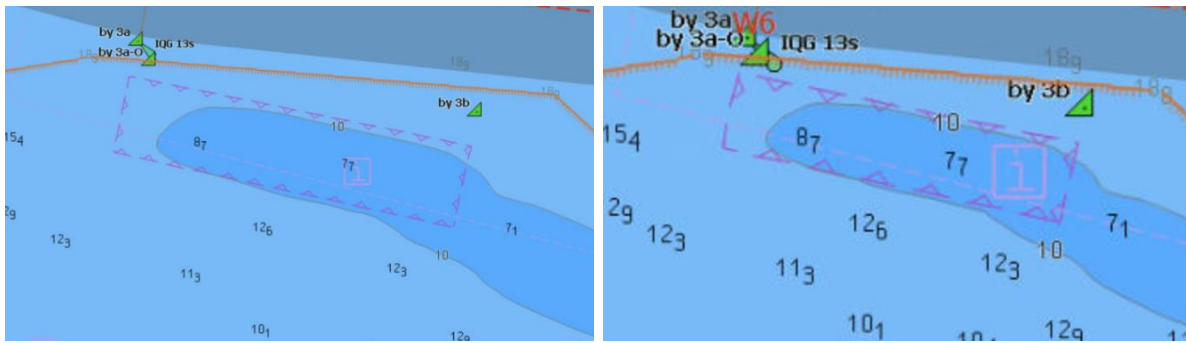
Figure 28: Dumping ground in the ECDIS (BSH system lab) with Shallow Contour set at 10 m<sup>59</sup>

Figure 28 below shows the dumping ground – on the left at a zoom level of 1.5 nm and on the right at 3 nm – but with the Shallow Contour set to the 10-meter depth contour, as recommended in SMS Document A021a. The shallower areas of the sandbank, at the tip of which the dumping ground is located near buoys 3a and 3a-O, are more clearly visible.

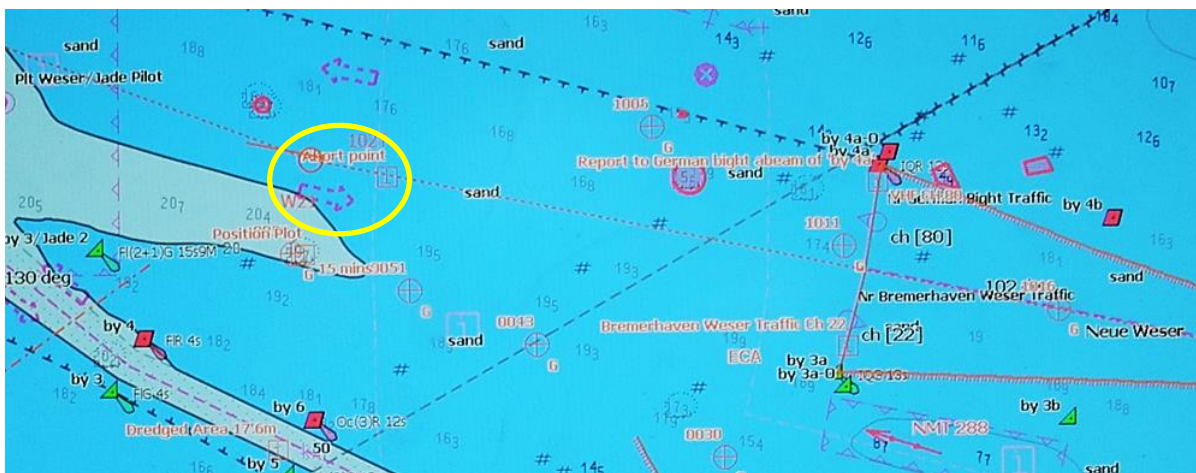
Figure 29: ECDIS screenshot of 05/02/2022 – 'Abort point' visible<sup>60</sup>

All items in SMS Document 203 – Passage Plan Checklist – were ticked 'Yes' for the voyage from Rotterdam to Bremerhaven and provided with explanations, including 'Abort positions (no way of return positions) marked' with the note 'MARKED ON ECDIS'. During the BSU's on-board visit on 05/02/2022, a corresponding user symbol (text annotation) was visible on the ECDIS shortly after waypoint 20 (see Figure 28). However, the recordings on the VDR do not show this user symbol, which indicates that the corresponding list of user symbols, if already created at the time of the accident, was not being displayed.

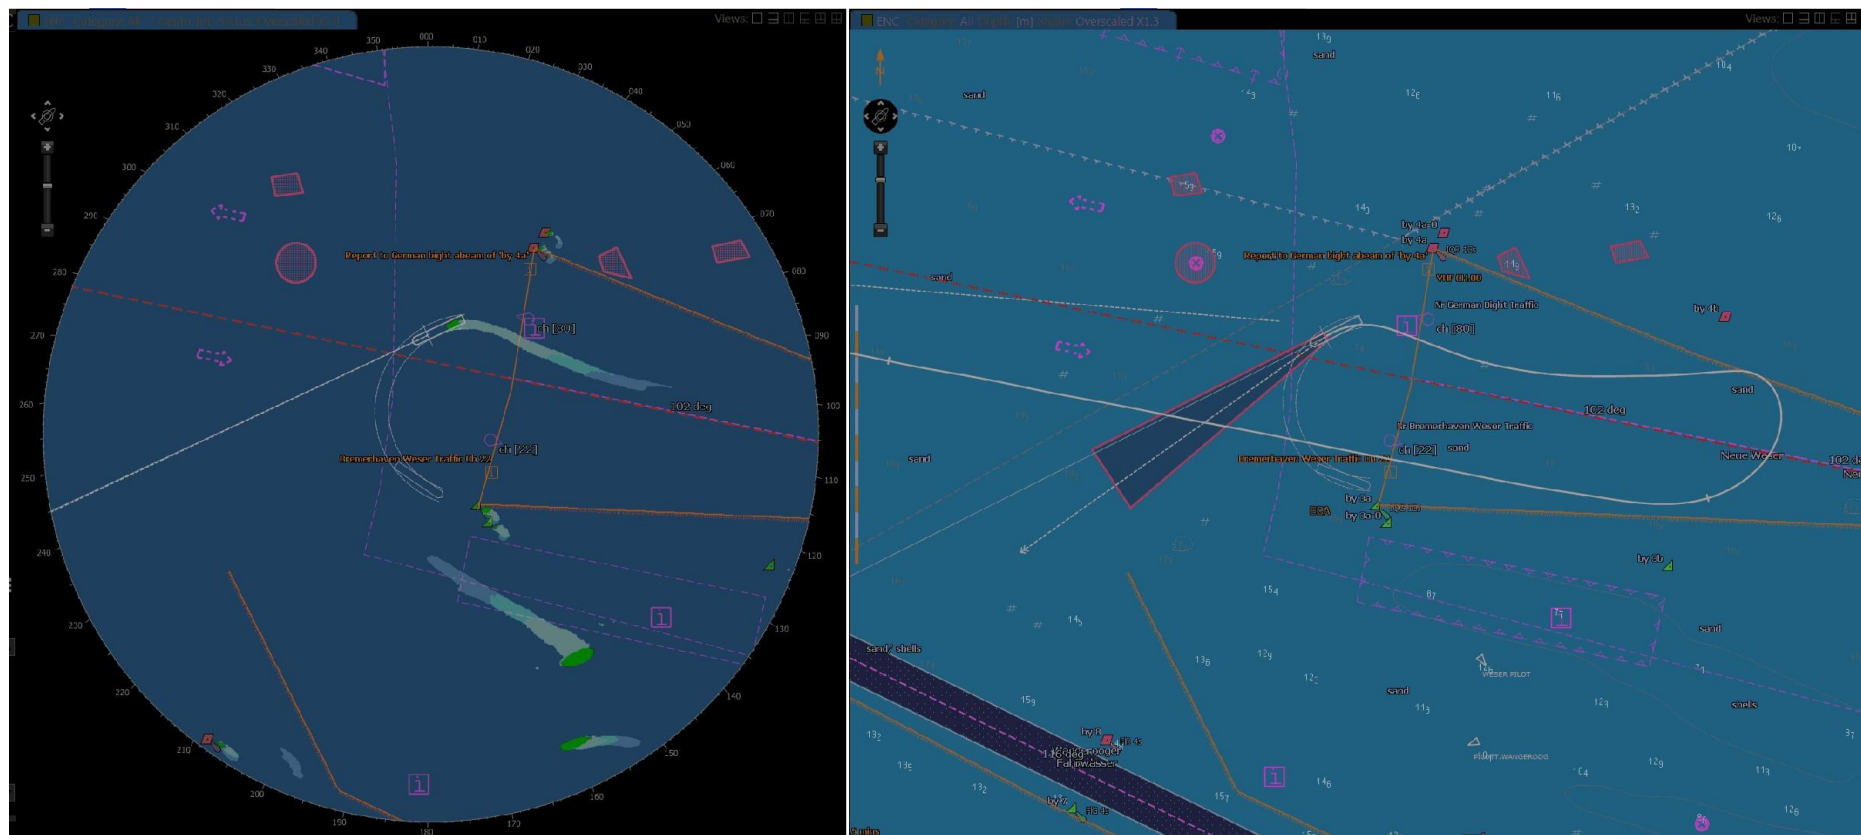
Figure 30: The master's radar and ECDIS display (MFDs 02 and 04) at 2256<sup>66</sup>

From 2155 (71 minutes before she ran aground), the MUMBAI MAERSK remained continuously within the safety contour, which was set at the 20 m depth contour. VDR data show that the 'Crossing safety contour alarm' ECDIS alert was not enabled, meaning there was no audible alarm. However, the 'Show crossing safety contour on chart' ECDIS hazard was enabled only on the master's ECDIS display (MFD 04), meaning that the look-ahead sector was continuously highlighted in red on the ECDIS display after crossing the safety contour. The ECDIS hazard and alert settings were not changed after crossing the safety contour (see Table 1).
