Collision between Fishing Vessel *Papa Rod* and Anchored Bulk Carrier *Appaloosa*

On May 2, 2024, about 0930 local time, the fishing vessel *Papa Rod* was underway in the Gulf of America, 25 miles south of Venice, Louisiana, when it collided with the bulk carrier *Appaloosa*, which was anchored east of the entrance to Southwest Pass (see figure 1 and figure 2).¹ There were no injuries, and no pollution was reported. Damage to the *Papa Rod* and the *Appaloosa* was estimated to be about \$223,000.²

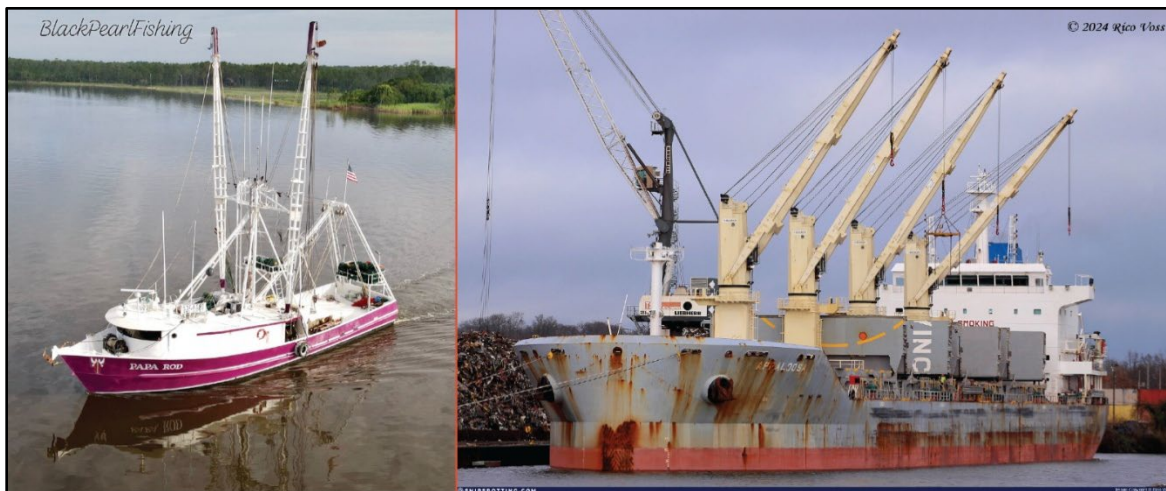
Figure 1. Left to right: The fishing vessel *Papa Rod* and bulk carrier *Appaloosa* before the collision. (Sources: Black Pearl Fishing Facebook page and Rico Voss, shipspotting.com)

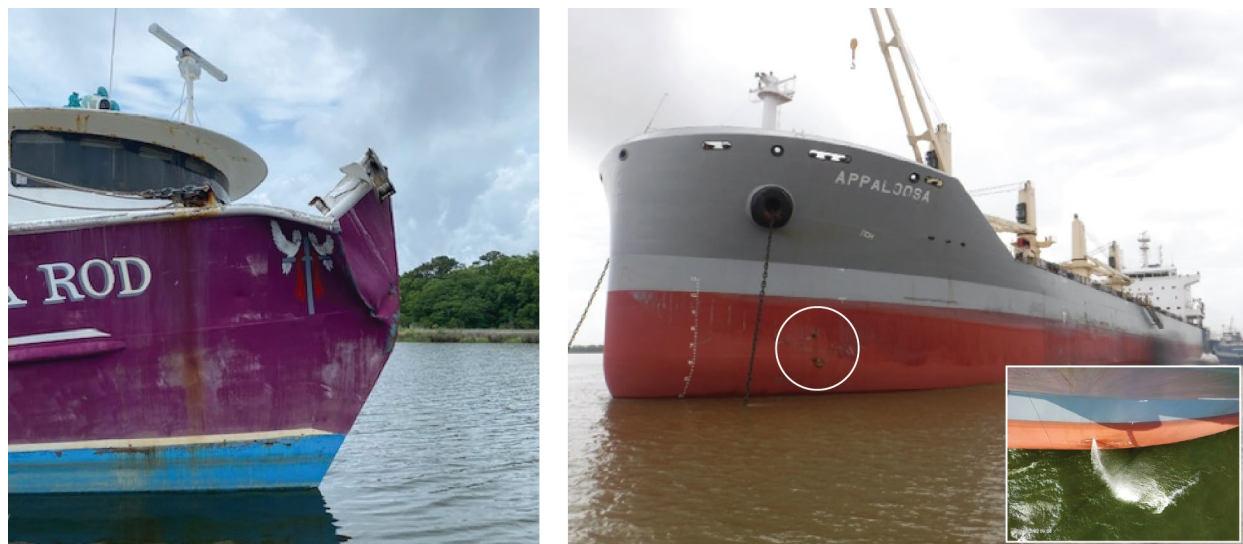
About 0928, the *Papa Rod*'s bow collided with the port bow of the *Appaloosa*, breaching the hull of the *Appaloosa*—about 4.5 feet above the waterline—on the bulkhead of a ballast water tank, which was full of treated ballast water at the time (see figure 3). The force of the collision woke deckhand 2 at the helm and the captain and deckhand 1 below.

Figure 3. Left to right: Bow damage to the *Papa Rod*, and *Appaloosa* hull breach (circled). Right inset shows ballast water leaking from the breached hull. (Source: US Coast Guard)

The *Papa Rod* returned to its home port in Bayou La Batre under its own power, arriving about 0455 on May 3. The *Appaloosa* received temporary repairs, estimated to cost \$48,000, to patch the hull breach on May 4. The estimated cost to repair the *Papa Rod*'s damaged bow was \$175,000.
