Report on the investigation into
the loss of 137 containers from the container ship

CMA CGM G. Washington

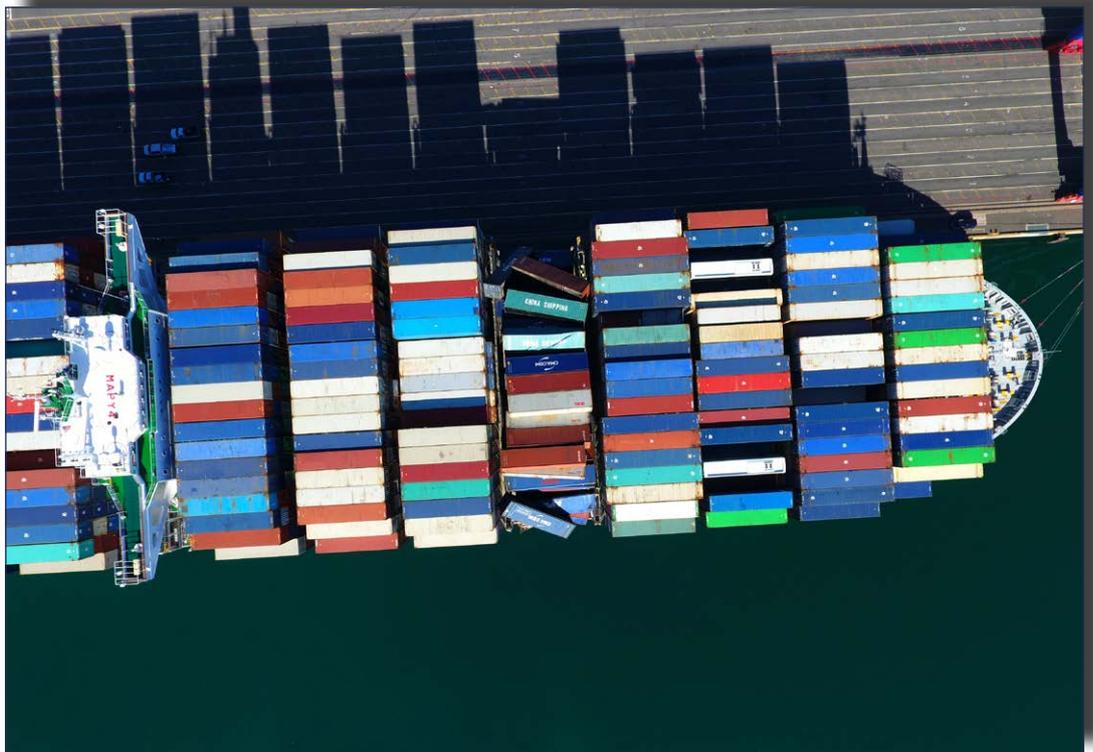
Extract from
The United Kingdom Merchant Shipping
(Accident Reporting and Investigation)
Regulations 2012 – Regulation 5:

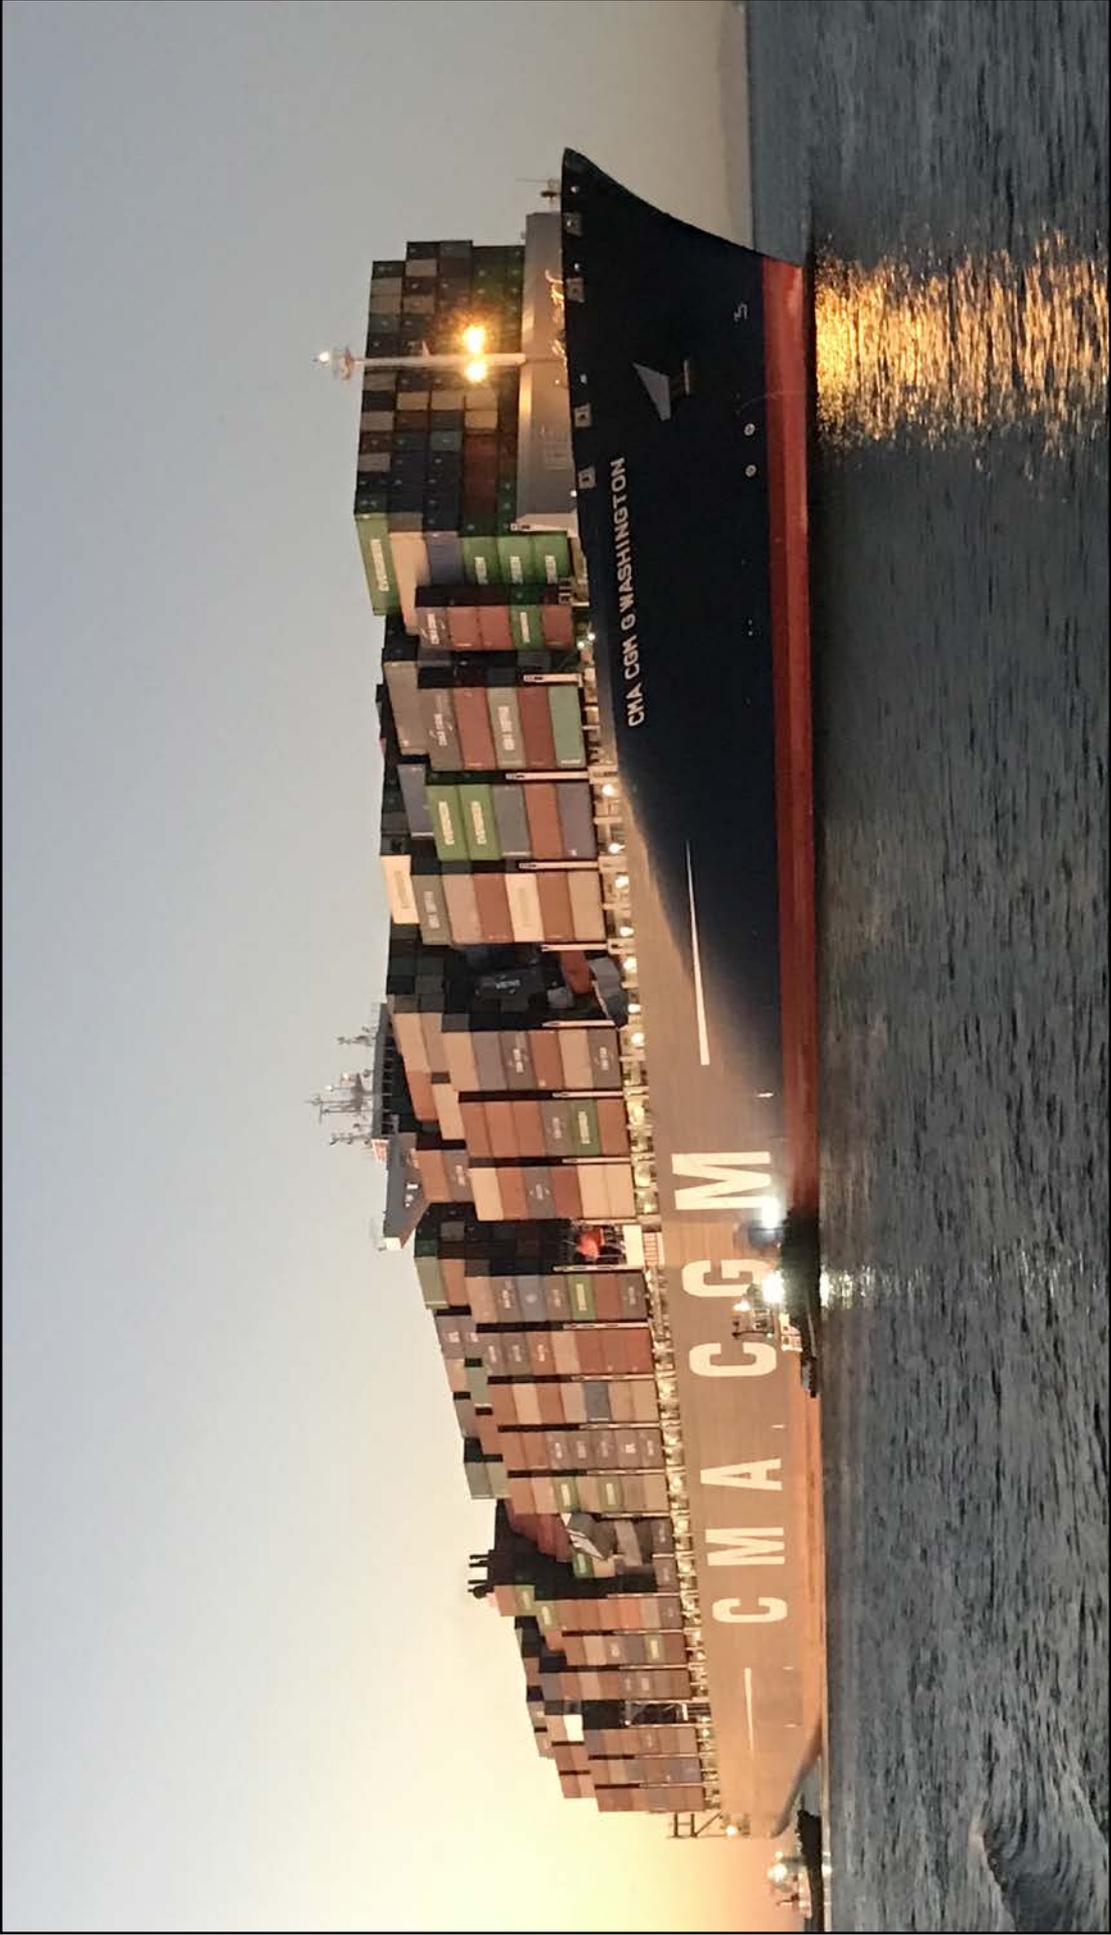
CMA CGM G. Washington

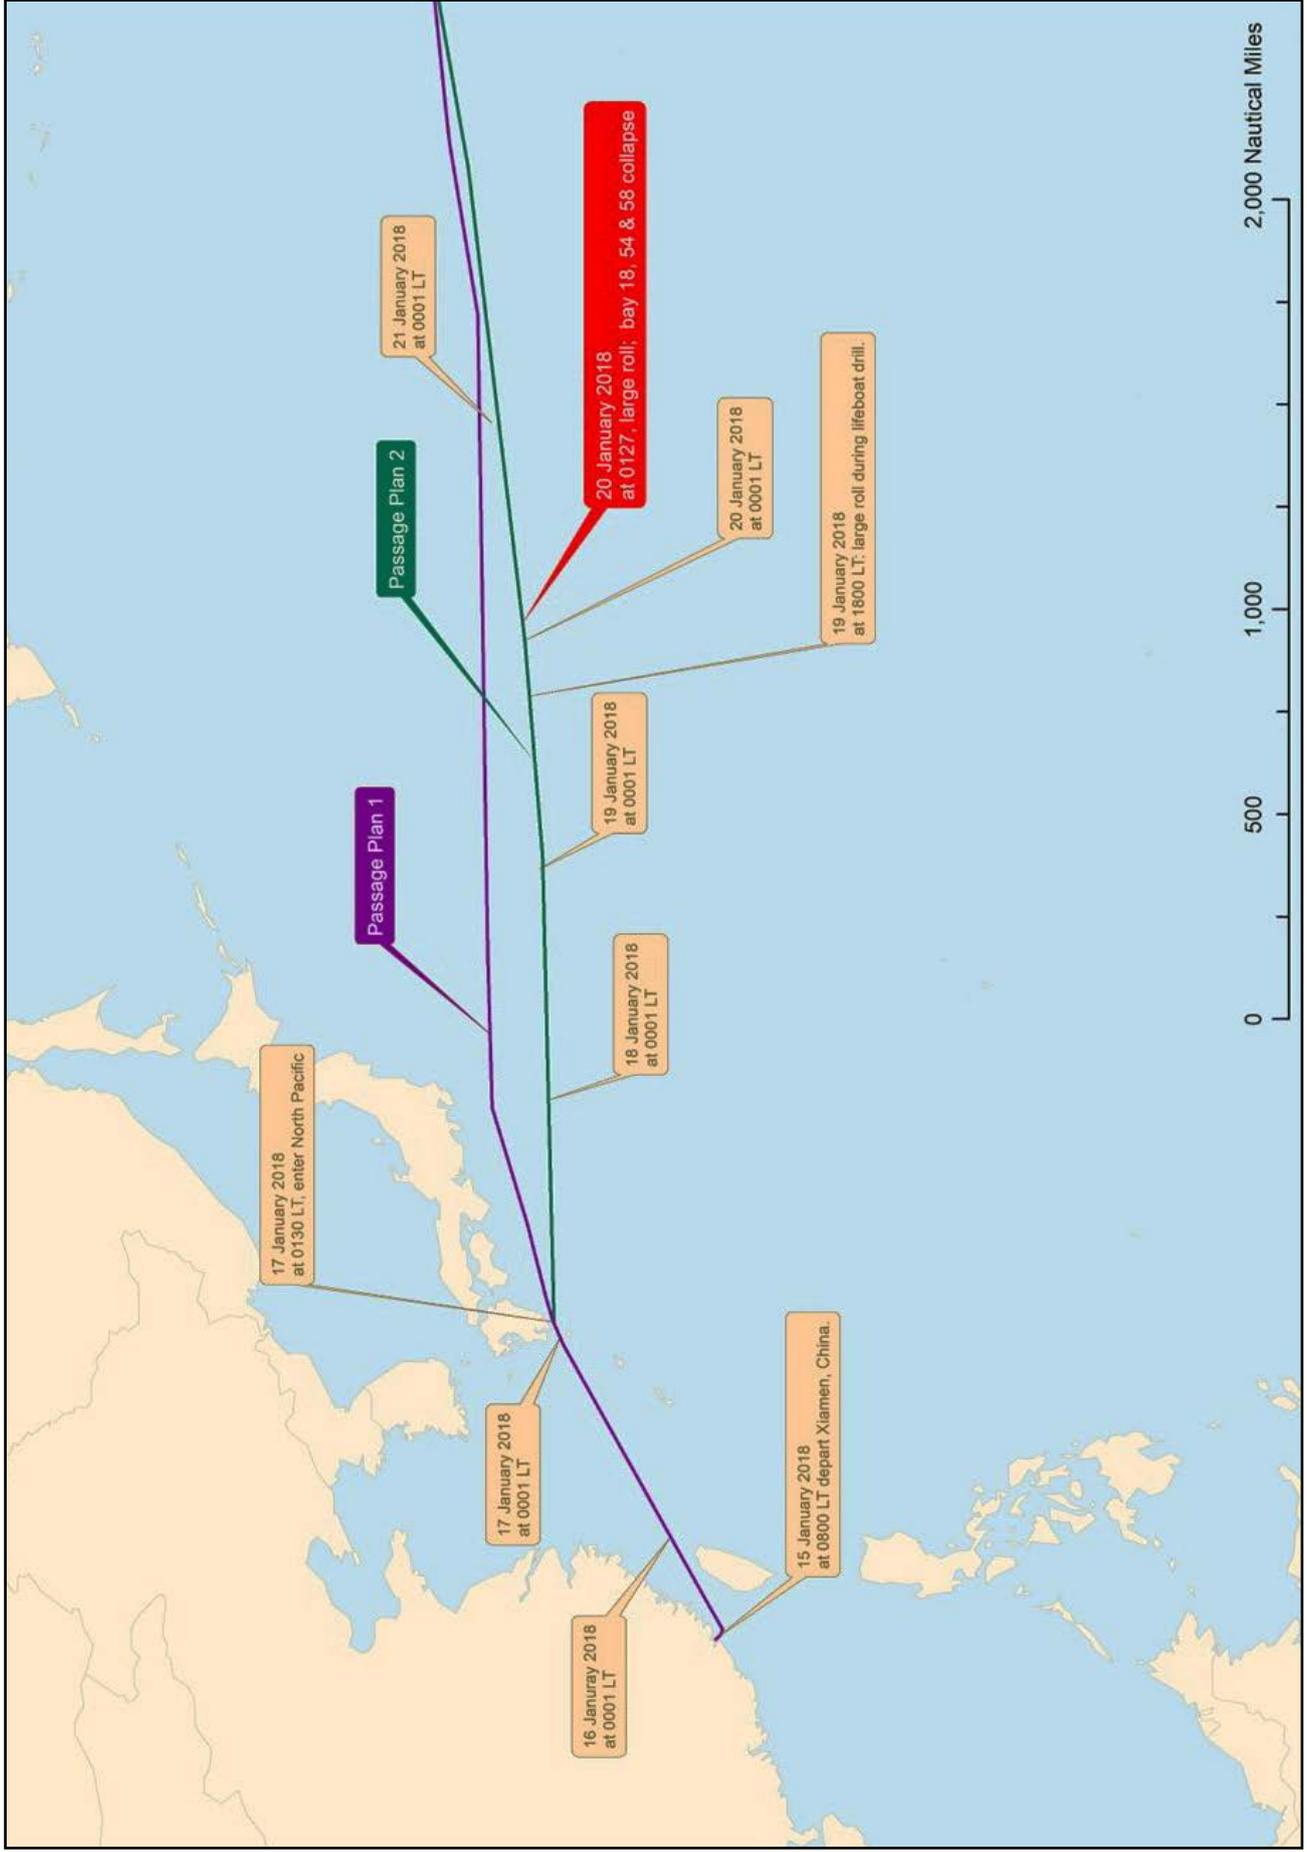
Figure 2: CMA CGM G. Washington's passage plan

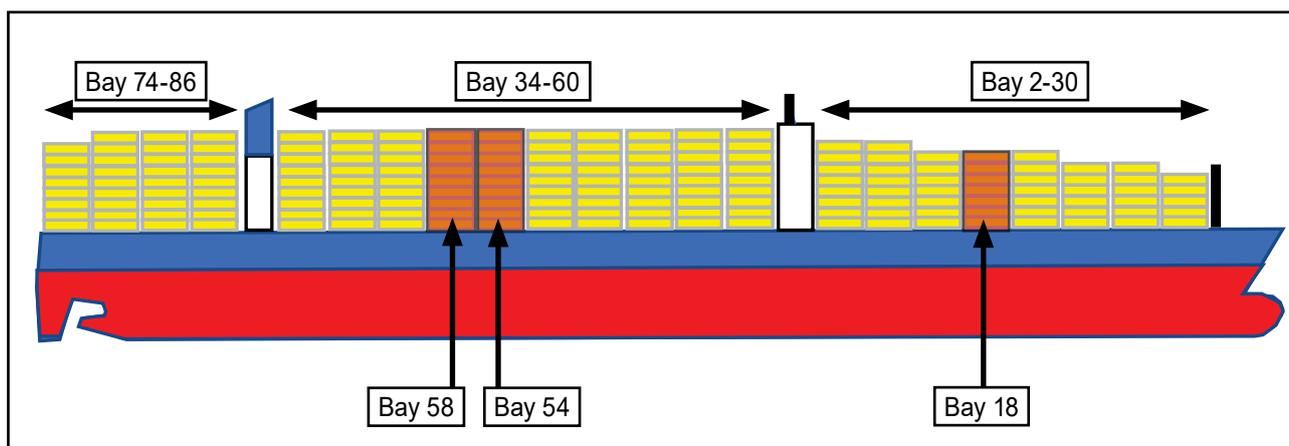
Figure 3: Location of damaged bays

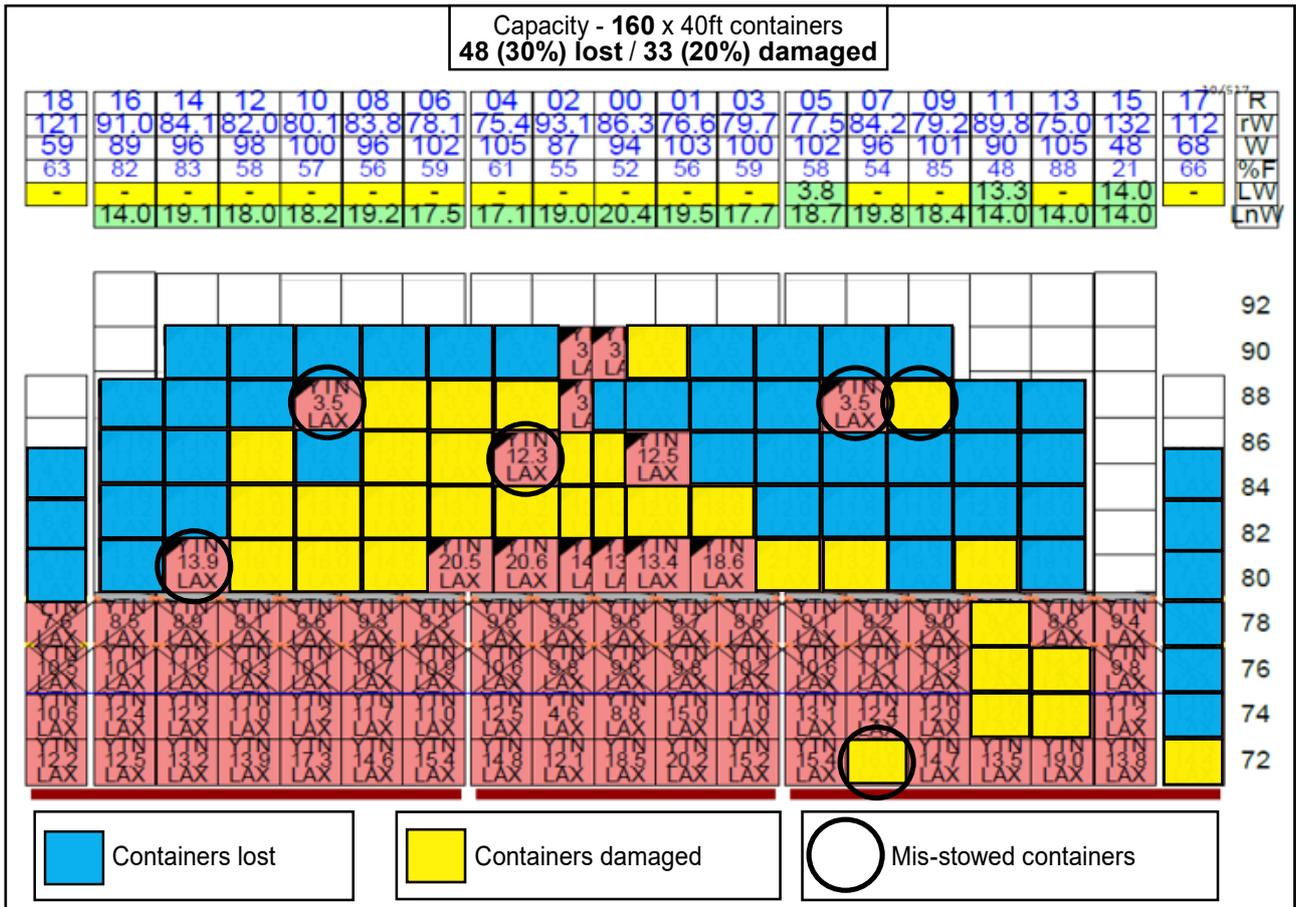
Figure 5: Bay 54 cargo stowage plan showing lost, damaged and mis-stowed containers

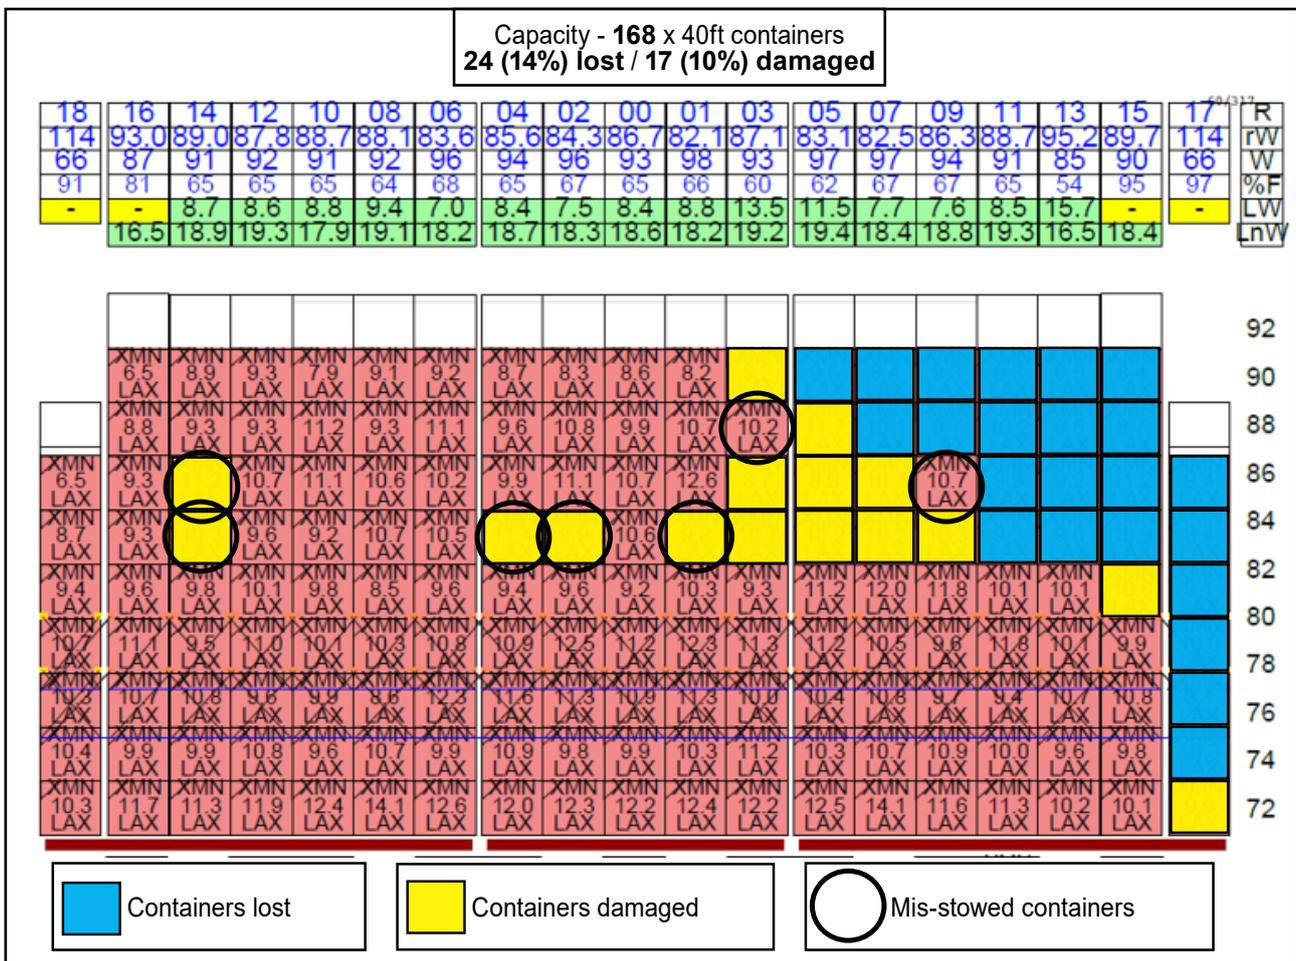
Figure 6: Bay 58 cargo stowage plan showing lost, damaged and mis-stowed containers

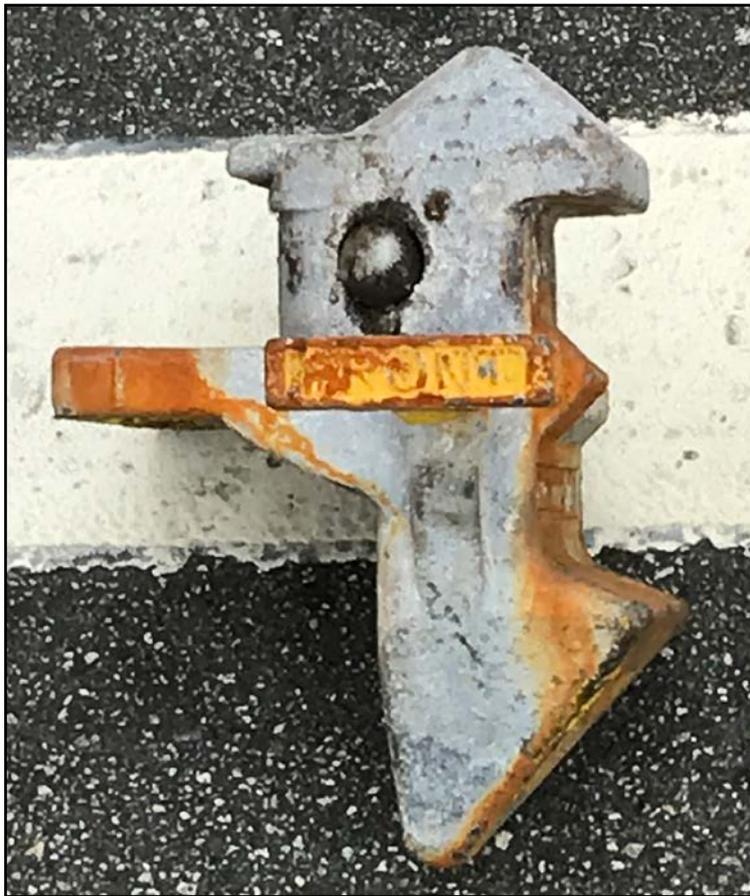
Figure 10: German Lashing fully automatic twistlocks

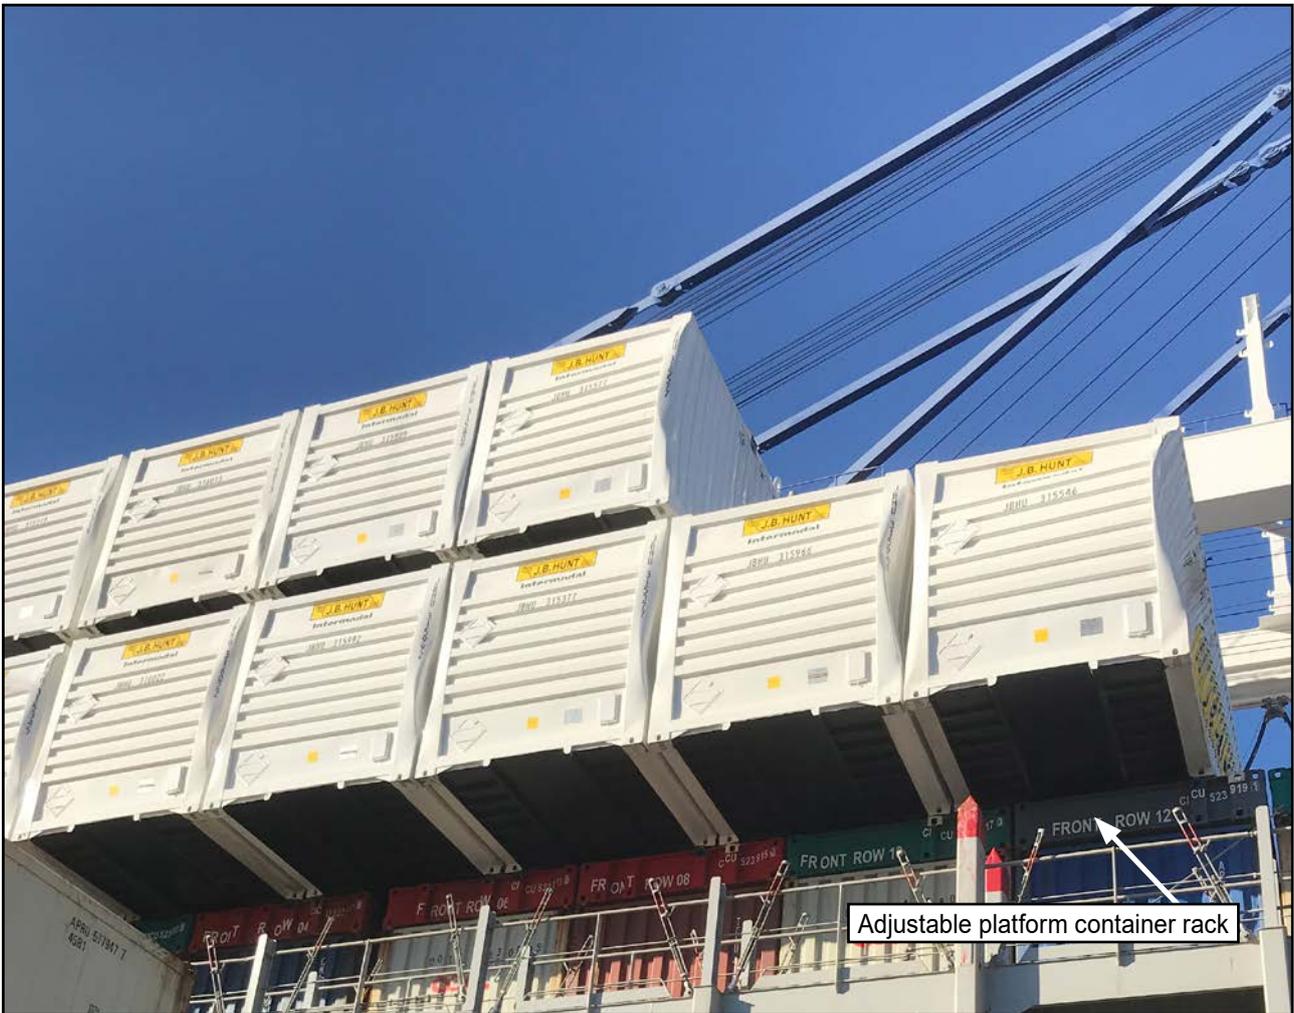
Figure 12: Adjustable platform container rack

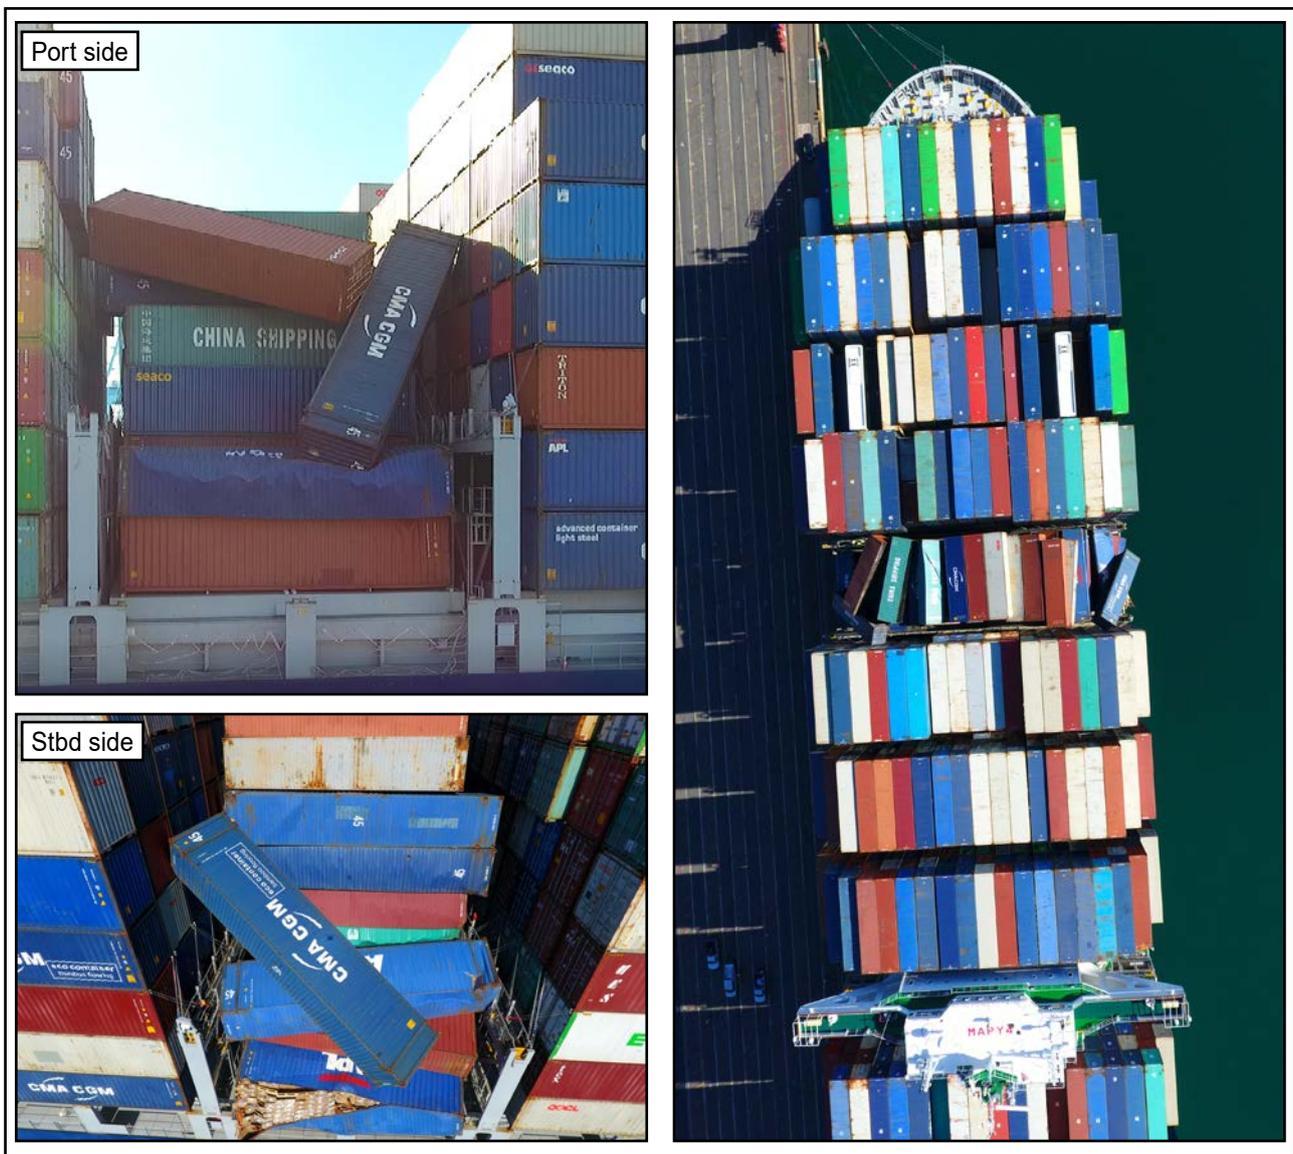
Figure 13: Bay 18 container collapse

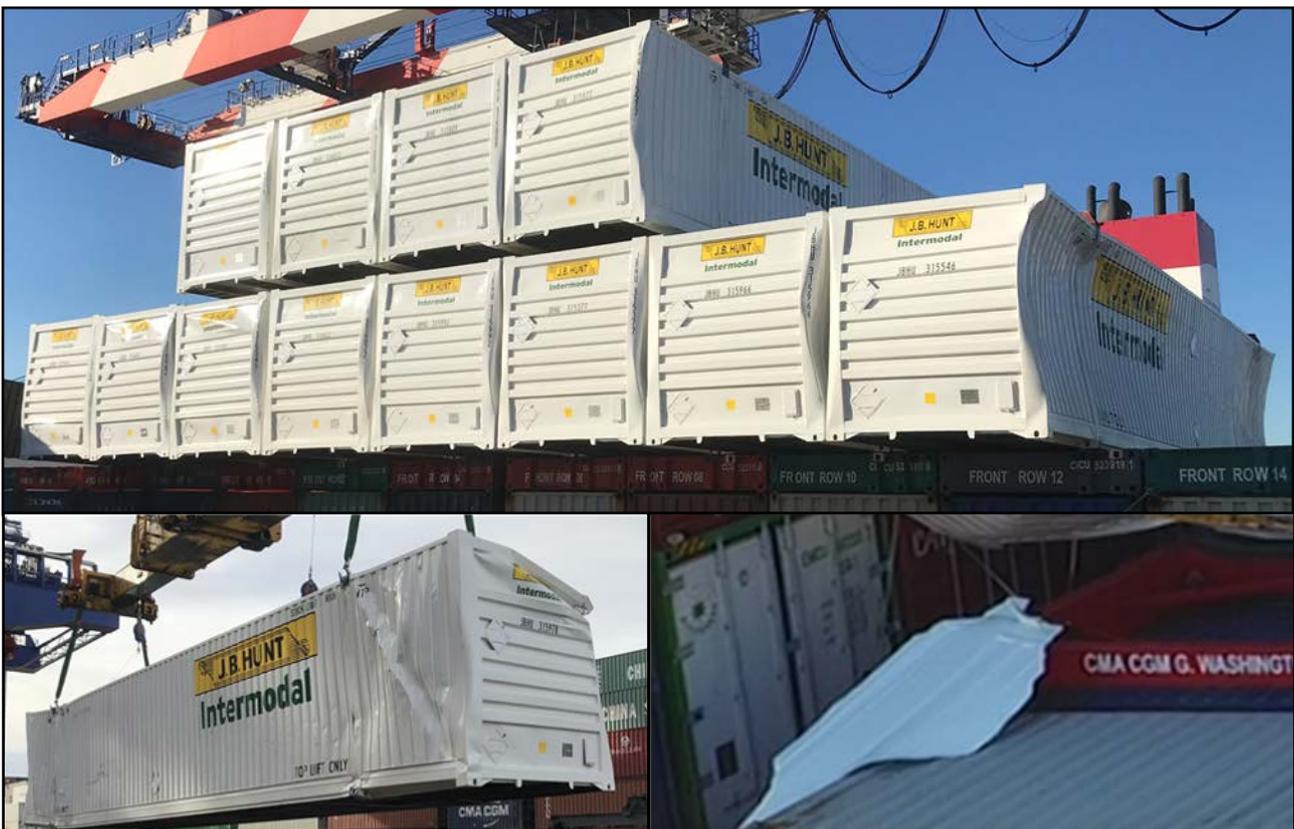
Figure 15: Damage to the 53ft containers

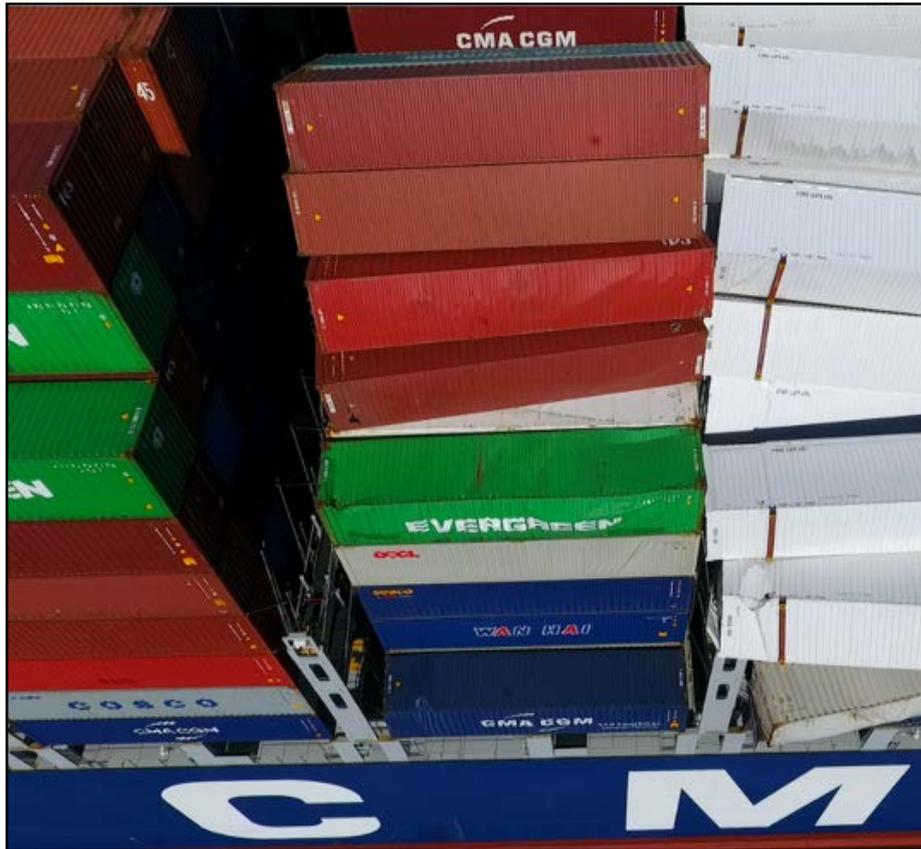
Figure 16: Bay 58 container collapse

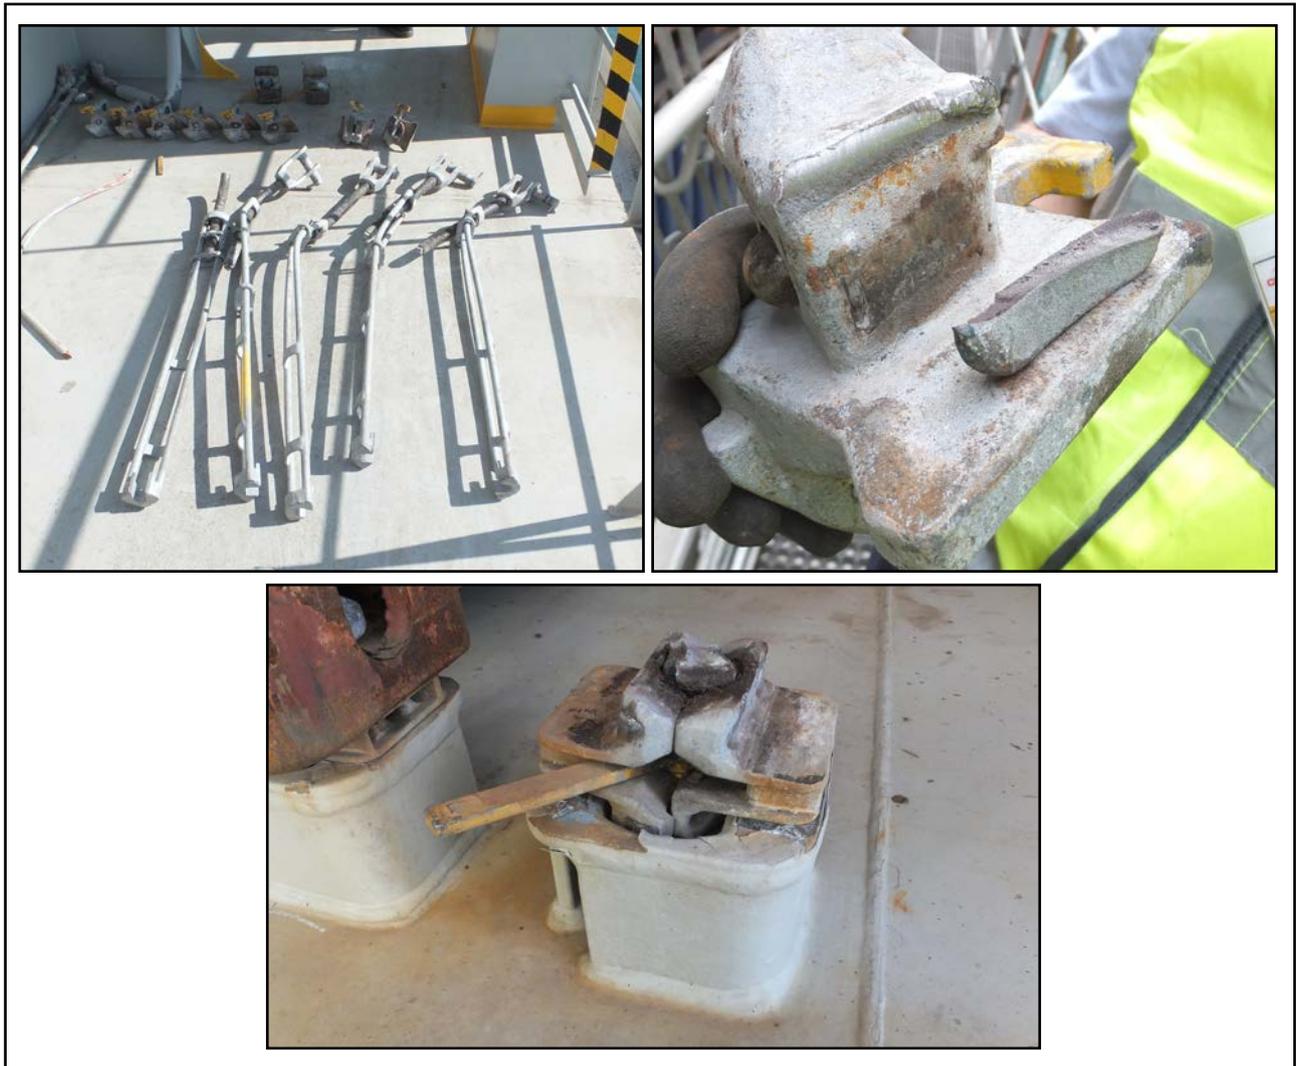
Figure 17: Damaged lashing equipment from bays 18, 54 and 58

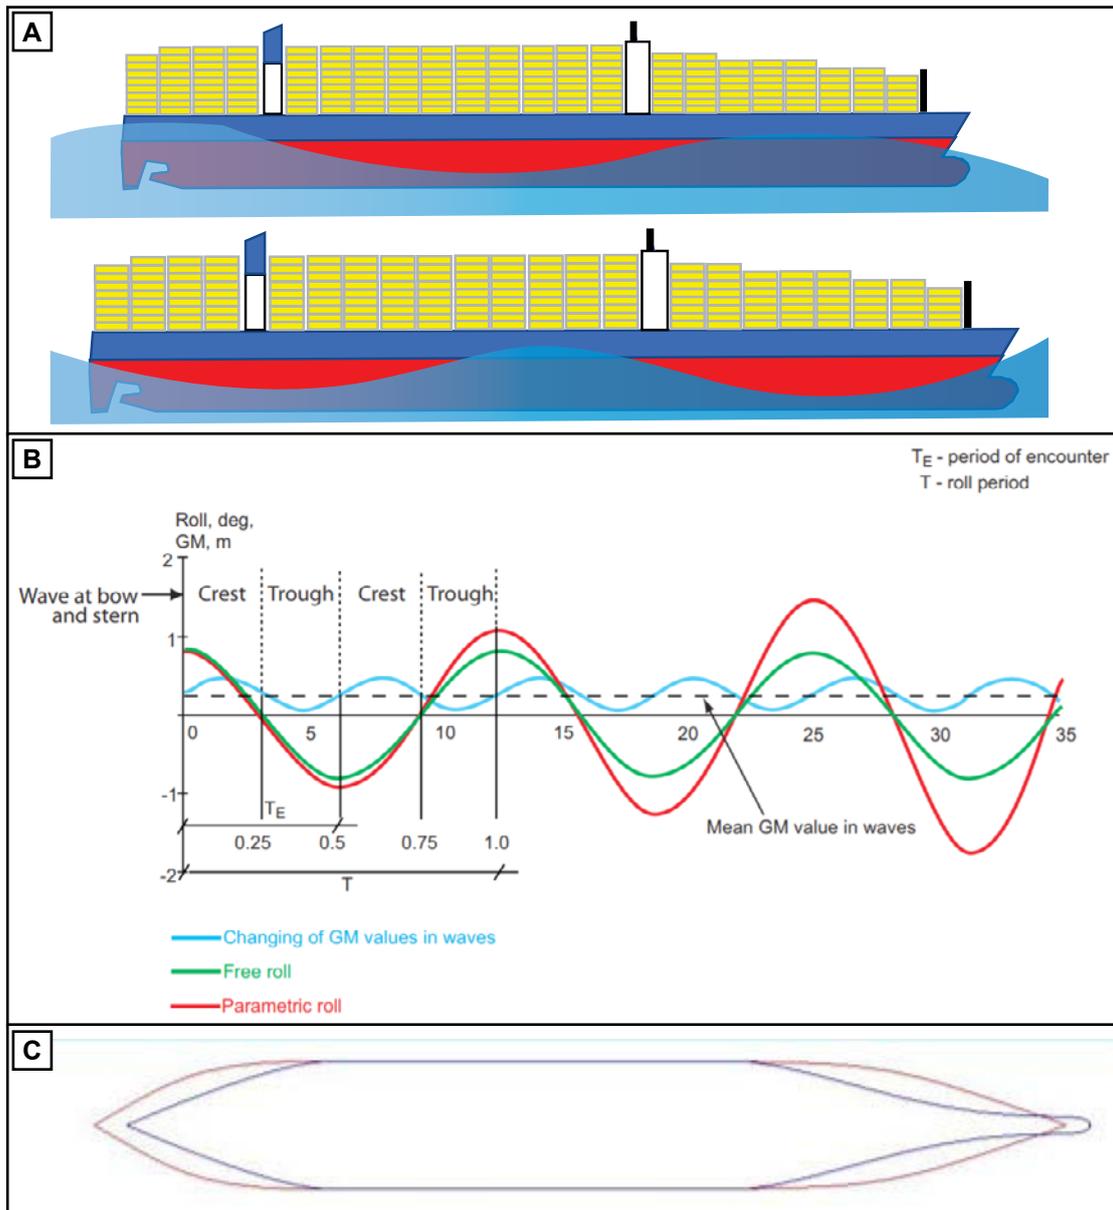
Figure 25: Illustration of a parametric roll

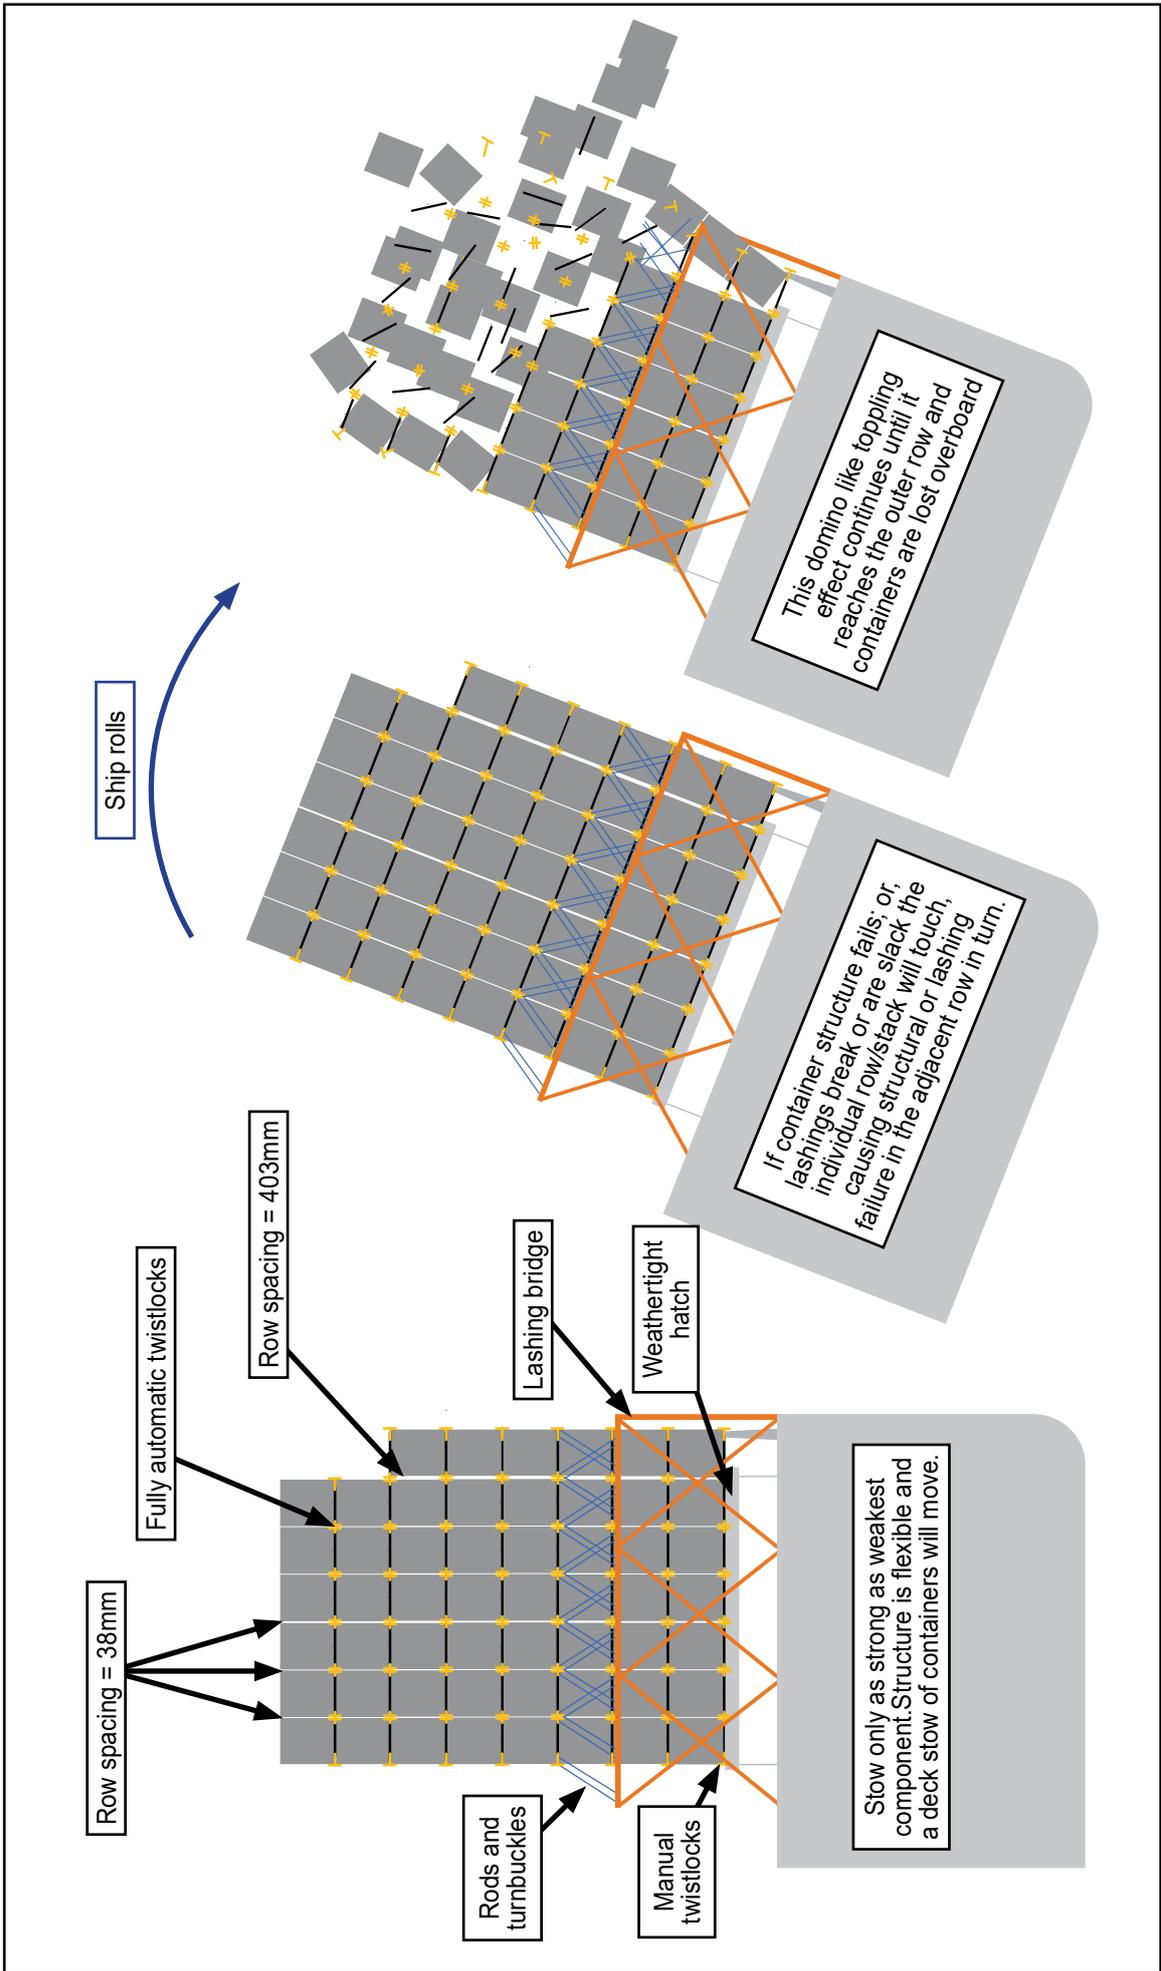
Figure 27: Principles of a container bay collapse
