Ship Recycling in Turkey

Challenges and Future Direction

20 December 2023

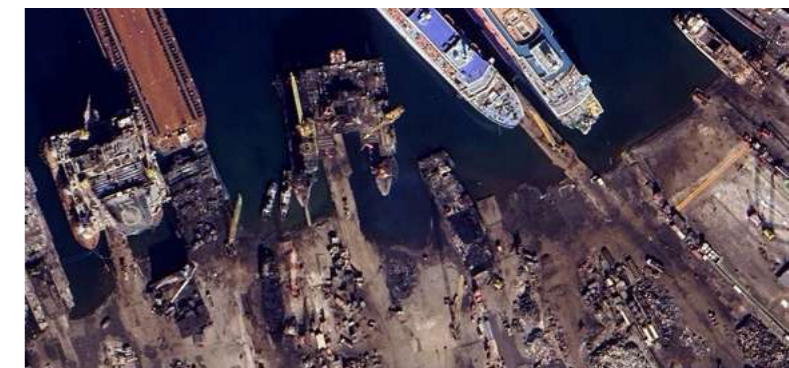
Continuous erosion

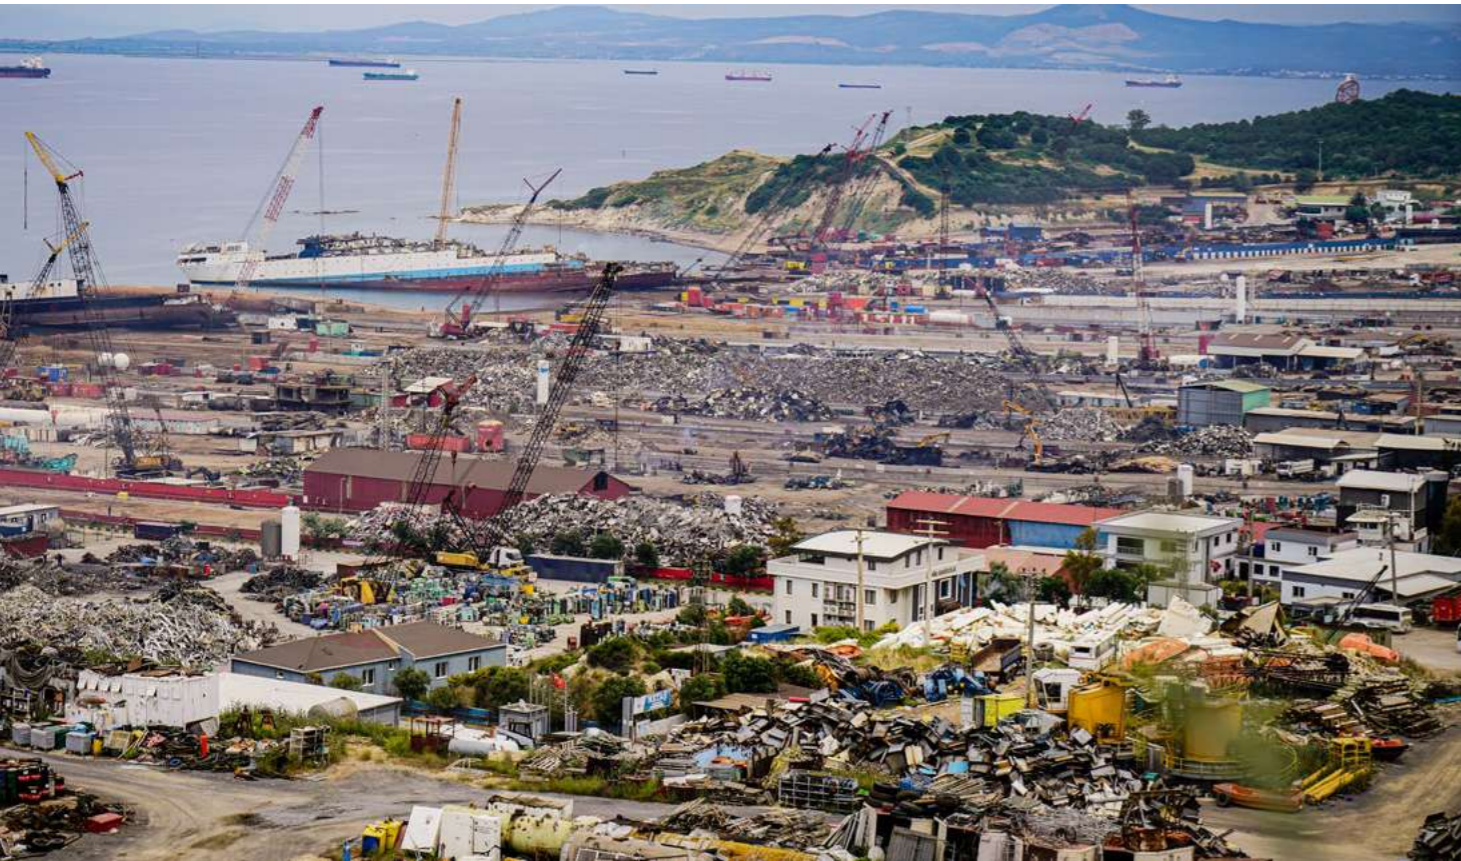
Storage on permeable floors
Credit: Doğu Eroğlu, 2023 May

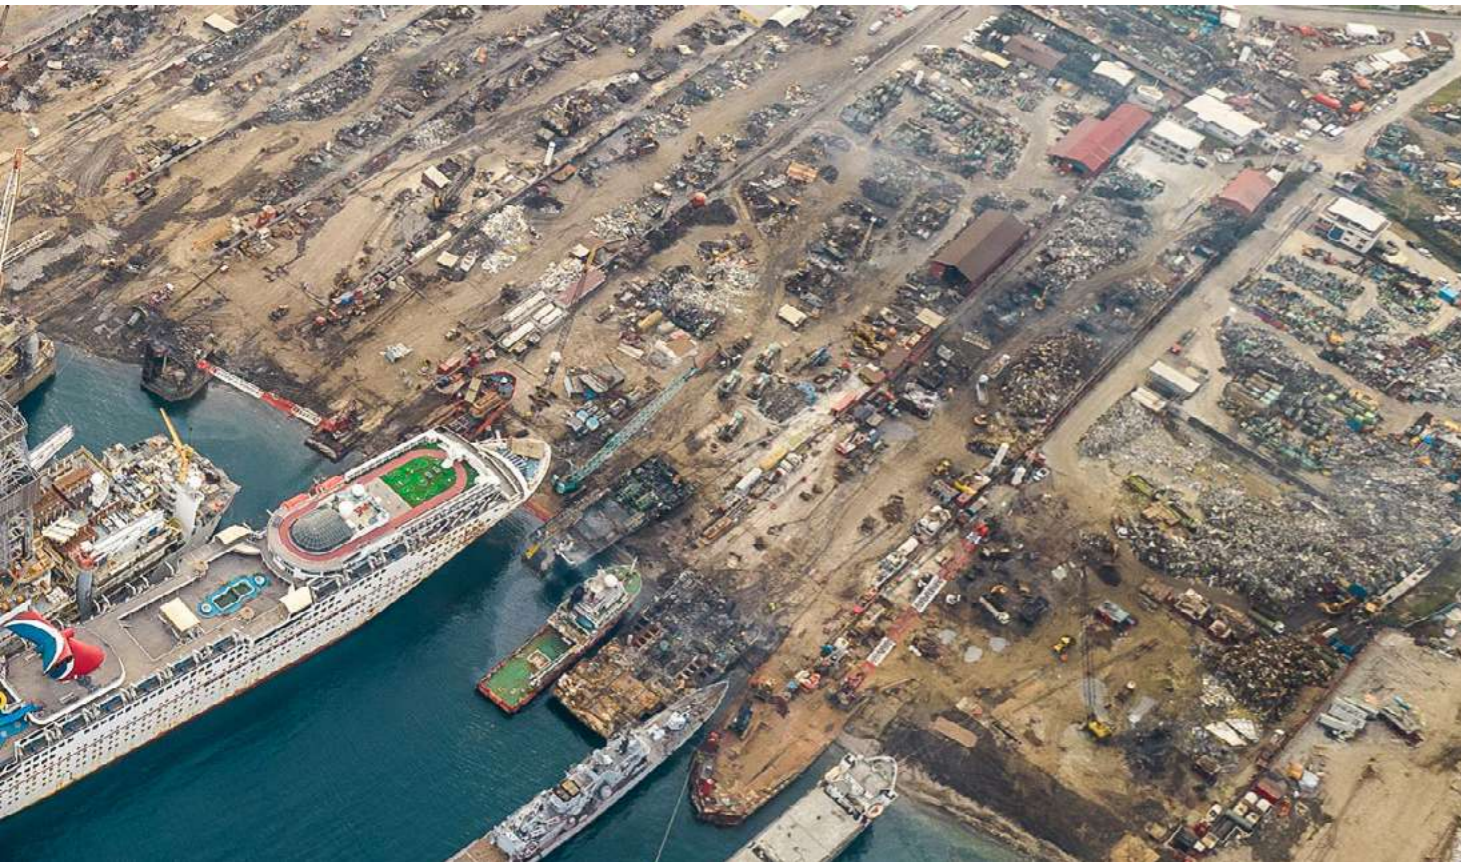
Satellite images furthermore reveal corrosion of the concrete floors of the yards. The corrosive effects can be attributed to the combination of exposure to seawater and the impact of ships being brought ashore. The constant pounding of ships against the coast leads to a weathered appearance of the shoreline, suggesting that the coastline undergoes continuous erosion. The table Shoreline History of the Yards shows the spatial change of the coastal zone across time.

Flooring of the Yards
Credit: Instagram account of @shipsengineer, January 2022

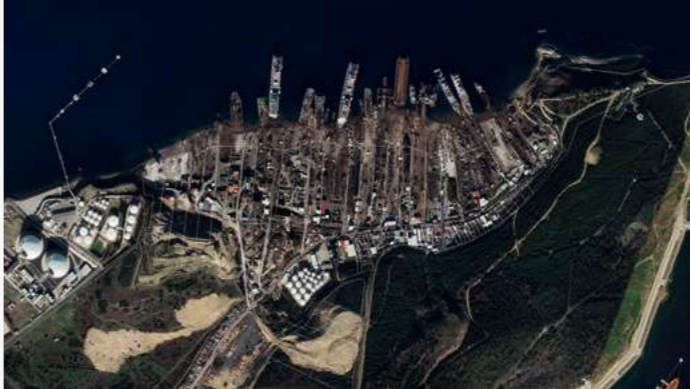
Year, Total Area (Ha)	Satellite View	Notes
2023 112.33 (Ha)

The massive increase in total area stems from the significant increase in dumpsites observed from 2021 to 2023. Three new dumpsites have been added to the areas where shipbreaking activities take place. The coastline appears heavily damaged (most likely signifying contamination of seawater) alongside damaged concrete surface (leakage to soil)

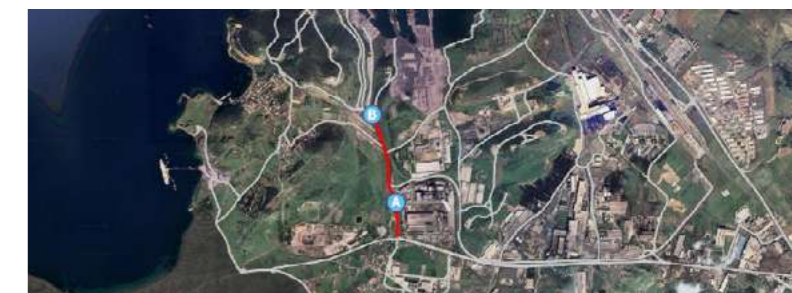
Aygaz Street

Aygaz Street, the only road used to transport scrap in the ship recycling zone and also used by other facilities in the region to carry dangerous goods and liquid cargo, is paved with bad asphalt.¹⁰⁶

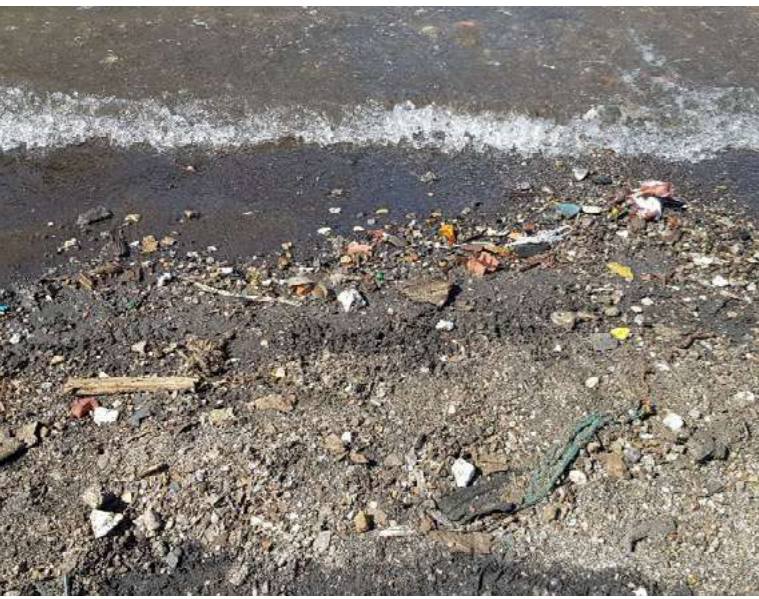
Debris, including EE-waste was observed in the permeable area between the seashore and the drainage line

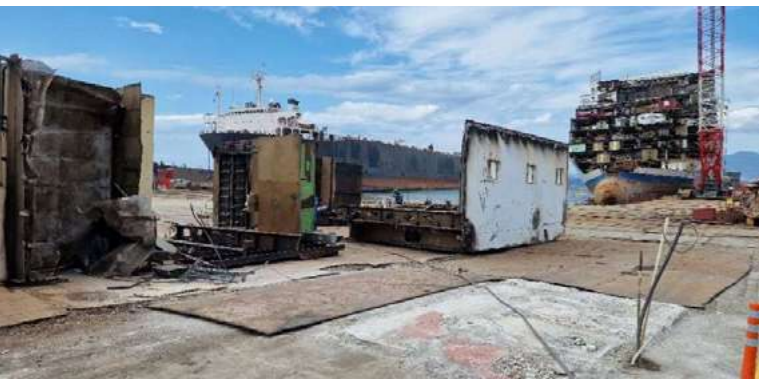
The EU evaluators noted that in certain areas a significant amount of recycled engines, equipment, and cranes were stored on permeable ground, and questioned why large quantities of machinery and scrap were retained long term at some facilities,¹⁴⁰ while other yards maintained a policy of getting rid of scrap as early as possible in a systematic way.¹⁴¹ Several facilities inspected by the European Commission did not have clearly stated cutting plans and procedures¹⁴² specified in the QMS or SRFP. These facilities instead based cutting operations on verbal communication and experience, as was also confirmed by interviewed workers. In an accident that occurred in the yard of Dörtel in July 2022, a worker cut the pipe section of a hydraulic tank with a torch. The accident report stated that the pipes

Secondary cutting area
Midterm review report of Sök (14.6.2023)

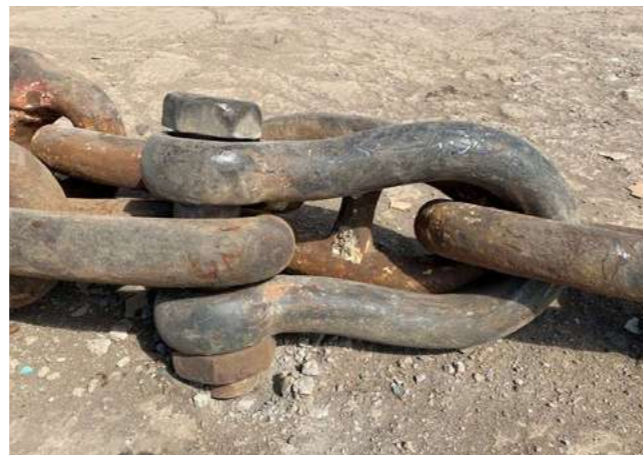
components in the pulling calculations,¹⁶⁶ leading the evaluators to request additional documentation on the capacity of modified components.¹⁶⁷ Some of the yard's equipment was also found to be deformed¹⁶⁸ and it was highlighted that damaged pulling equipment should be documented, addressed as an incident, and corrective measures be developed.¹⁶⁹ In one case, EU evaluators recommended that a facility obtain the services of an independent engineer to verify the design and capacity of the pulling system since the service supplier did not identify the damages in their own inspection.¹⁷⁰

Example of deformed pin and connecting plates in the pulling system arrangement

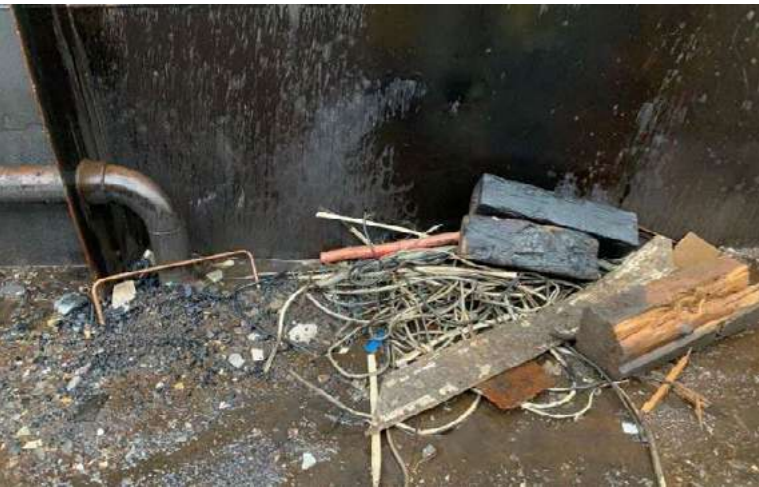
A 2019 report by the Ministry of Environment stated that the open burning of materials, including cables, released harmful emissions and posed a significant danger in the region.¹⁷⁶ In September 2022 the Izmir Directorate of the Ministry of Environment informed the EU evaluators that burning cables remained a concern,¹⁷⁷ and an EU inspection report dated June 2023 underscores the ongoing practice of burning cables to remove the insulation in order to sell the remaining metal.

Debris onboard the vessel being dismantled
Signs of fires were present
Source: Site Inspection Report of Dörtel (5.6.2023)

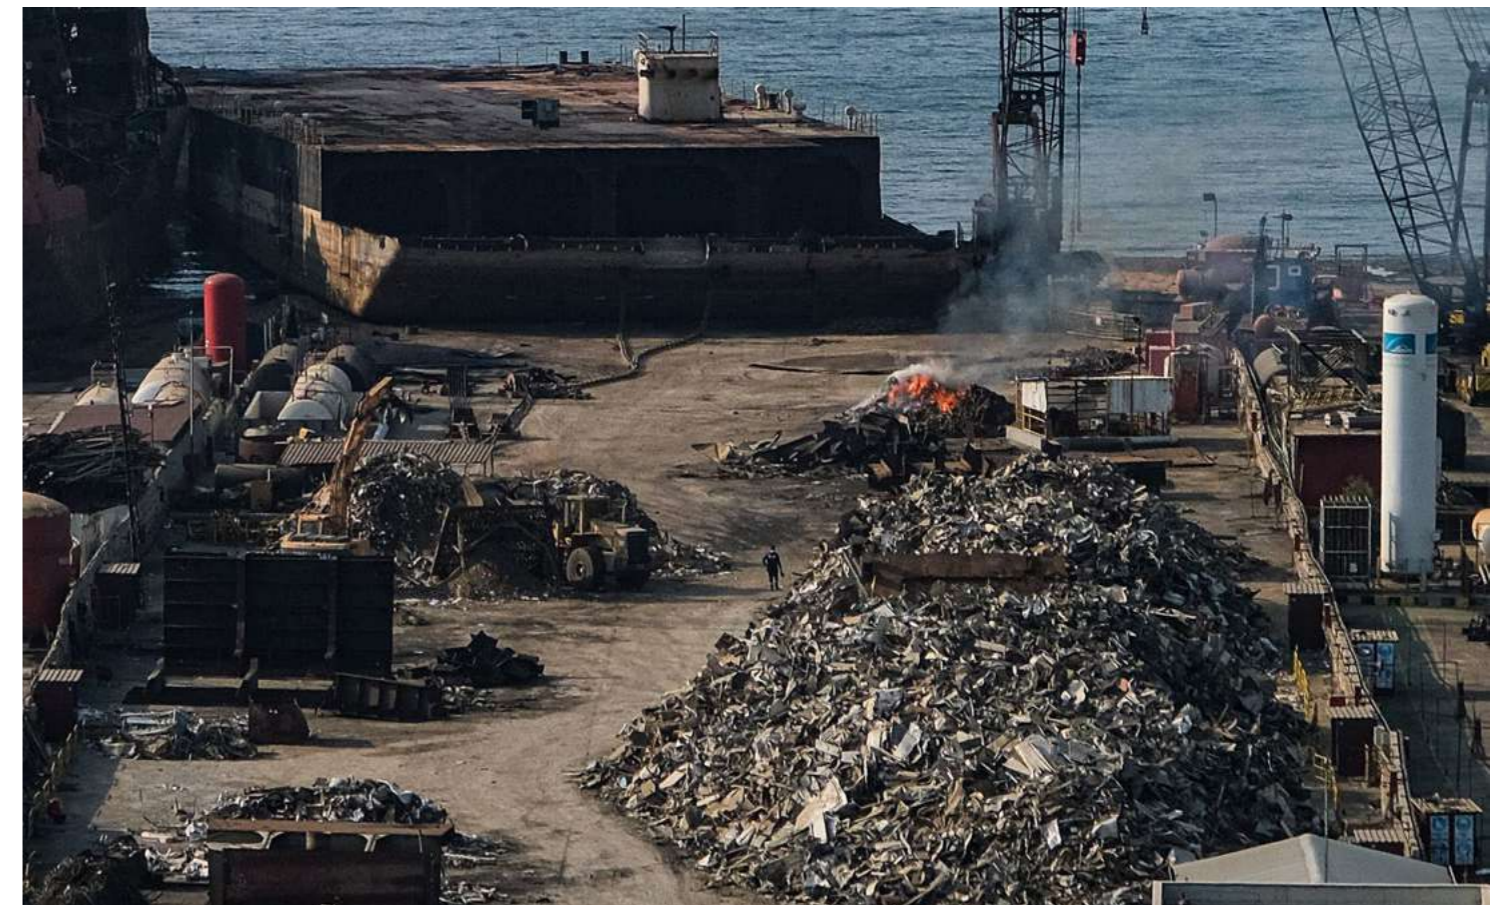
Open burning

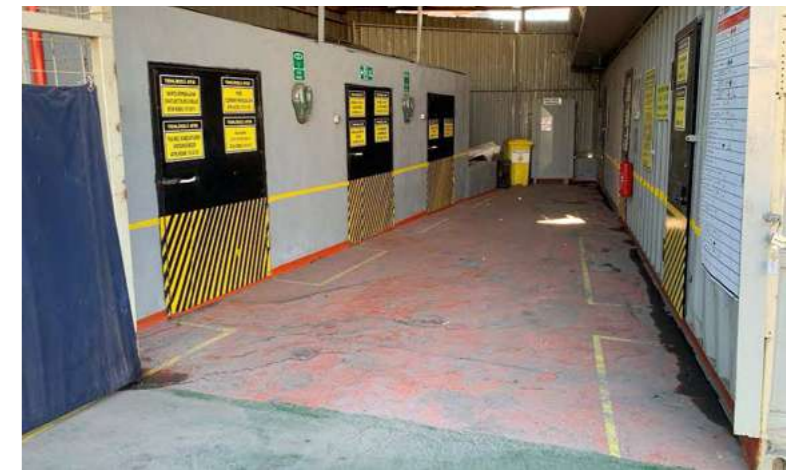
View inside the hazardous waste temporary storage area
Source: Site Inspection Report of BMS (19.9.2022)

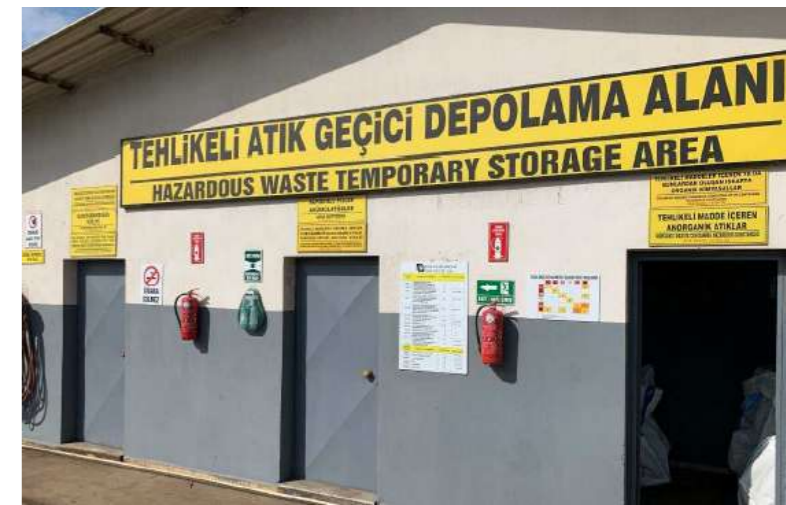
Temporary storage area for hazardous waste
Source: Site Inspection Report of Ege Gemi (25.1.2022)

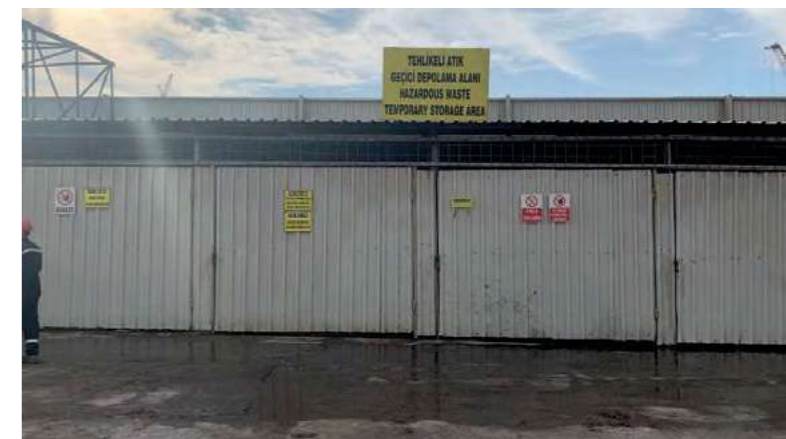
Temporary storage area for hazardous waste
Source: Site Inspection Report of Kılıçlar (10.10.2022)

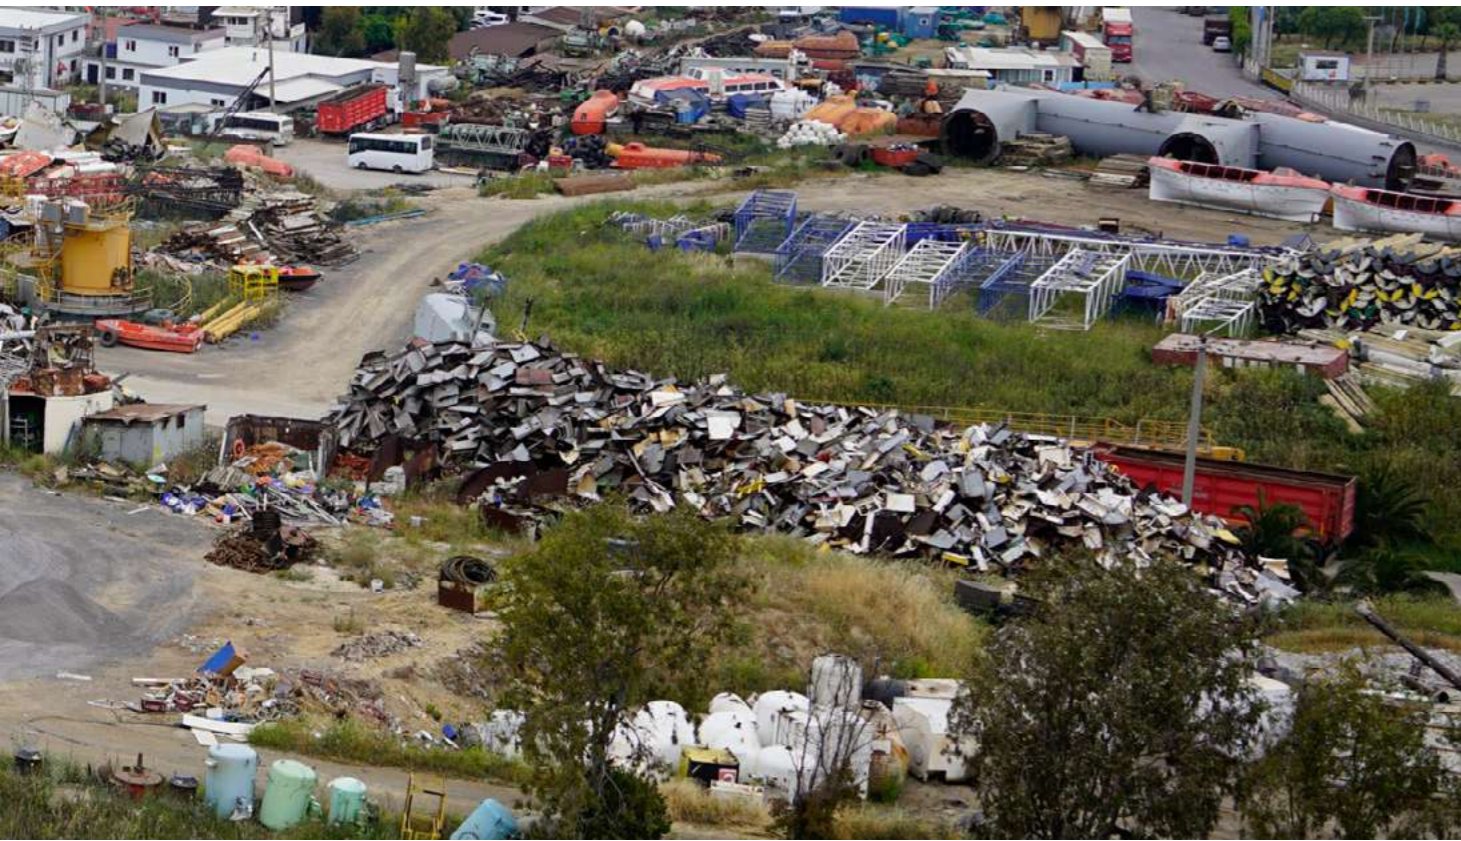
Storage on permeable floor

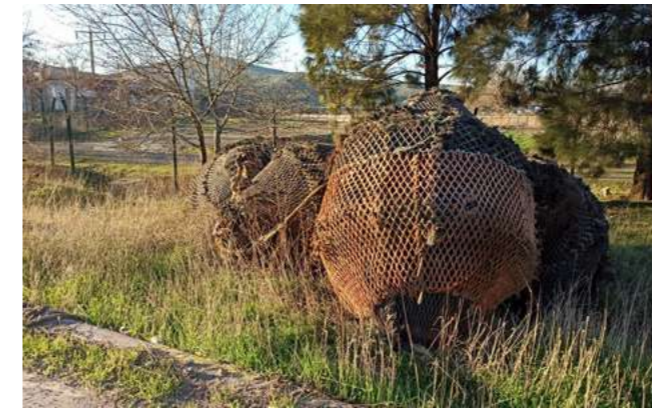
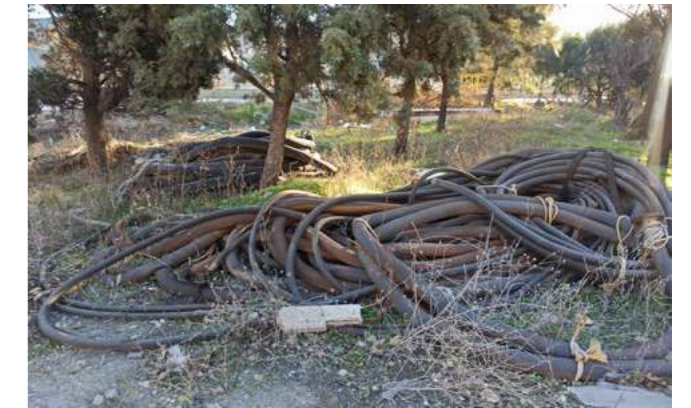
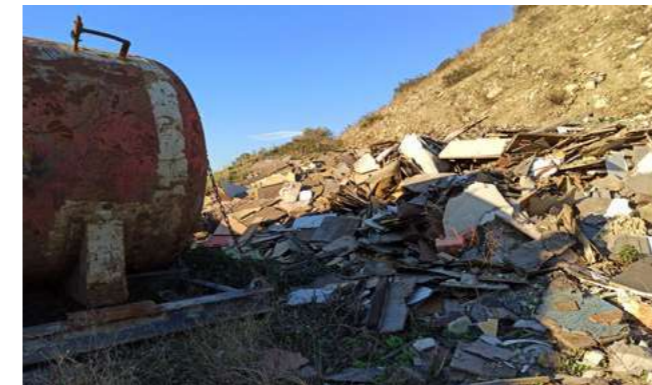
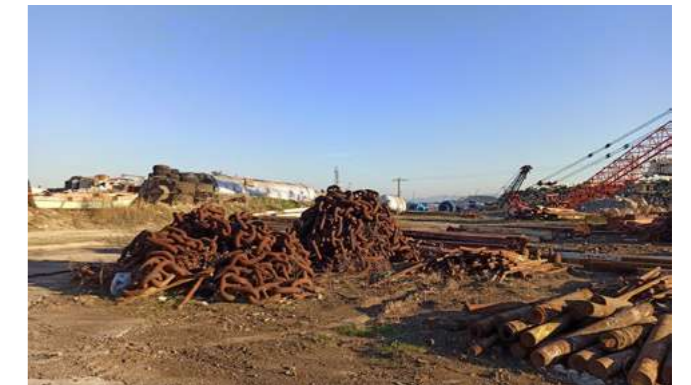
Waste around the the vicinity of the facilities

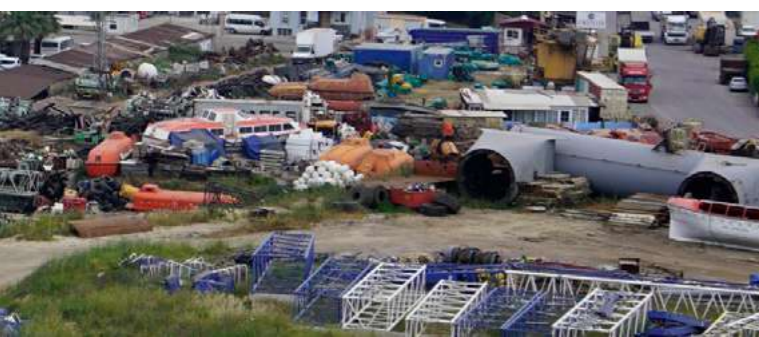
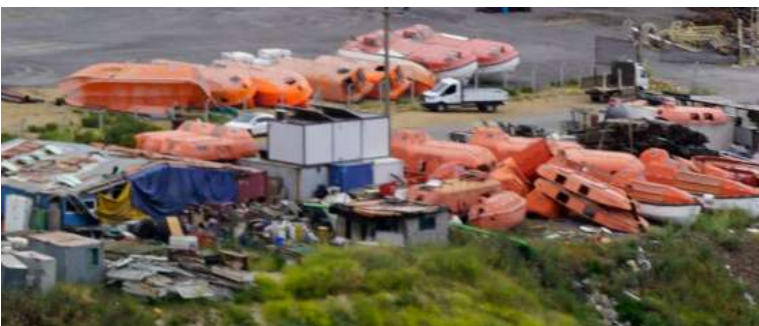
Lifeboats from end-of-life ships can include potentially hazardous materials such as fuel and lead-acid batteries. During its inspections, the European Commission noted that lifeboats should not be stored on permeable floors unless they were free of hazardous materials. Yet, some EU inspection reports observed lifeboats with hazardous materials are being stored

Lifeboats

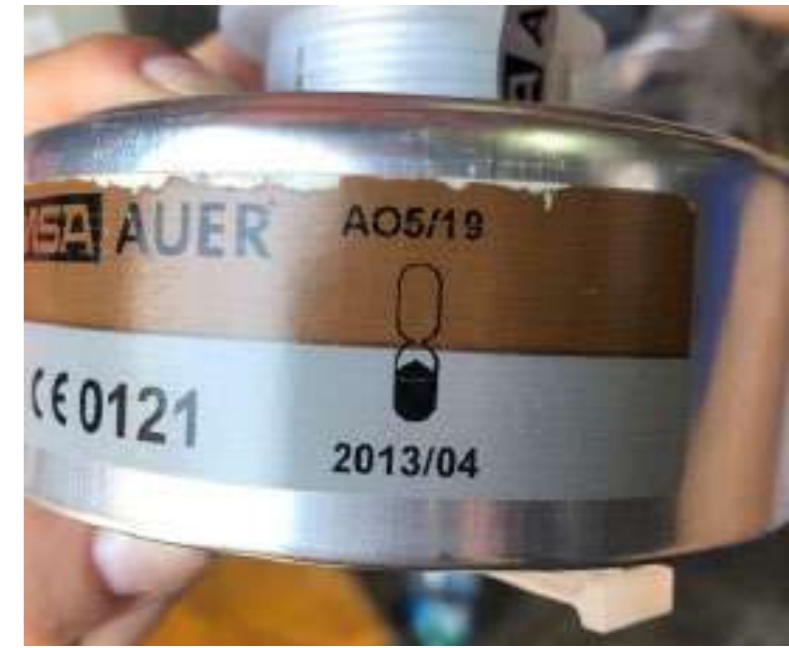
According to the mid-term reports of Sök and Ege Çelik, for example, evaluators concluded that the facilities did not purchase filters on a regular basis after comparing copies of PPE purchase orders with the number of workers and total work hours.²⁷⁷ In addition, during the mid-term review of Öge, the evaluators observed that the facility purchased filters irregularly and the number of filters suggested that these were not offered on a daily basis, and thus did not fully comply with the relevant rules in the EU Ship Recycling Regulation.²⁷⁸ During

All filters stored in the emergency room had expired
Site Inspection Report of Blade (13.1.2023)

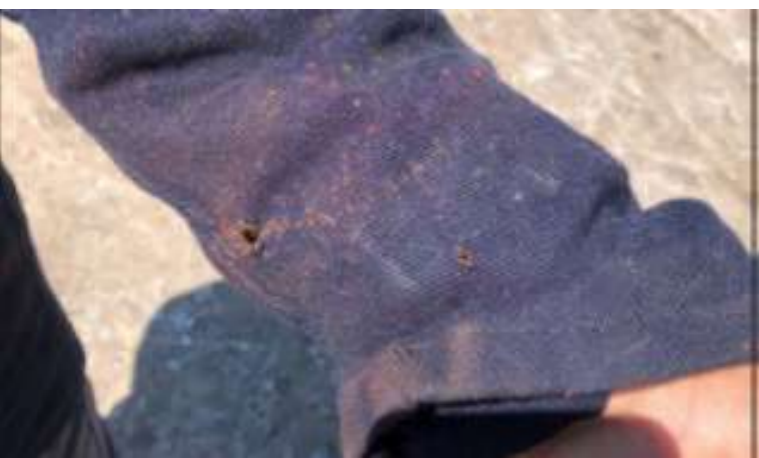
Moreover, Blade, Sök, Öge and Dörtel failed to demonstrate, during the EU evaluation, that they provided workers exposed to heat and flames with flame retardant clothing.²⁸² All interviewed workers said they bought their own clothes. According to the law, the employer cannot transfer the cost of occupational health and safety measures to its employees.²⁸³ All personal protective equipment and work clothes must be provided to workers by the employer.

Burn marks on clothes

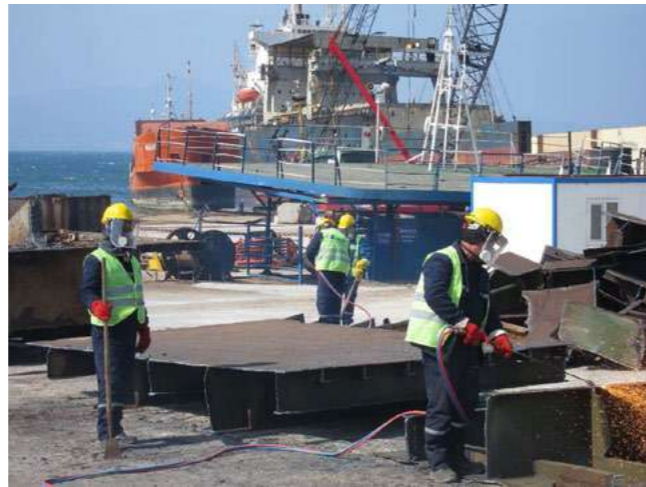
Cutters were observed to wear clean and new PPE during the inspection

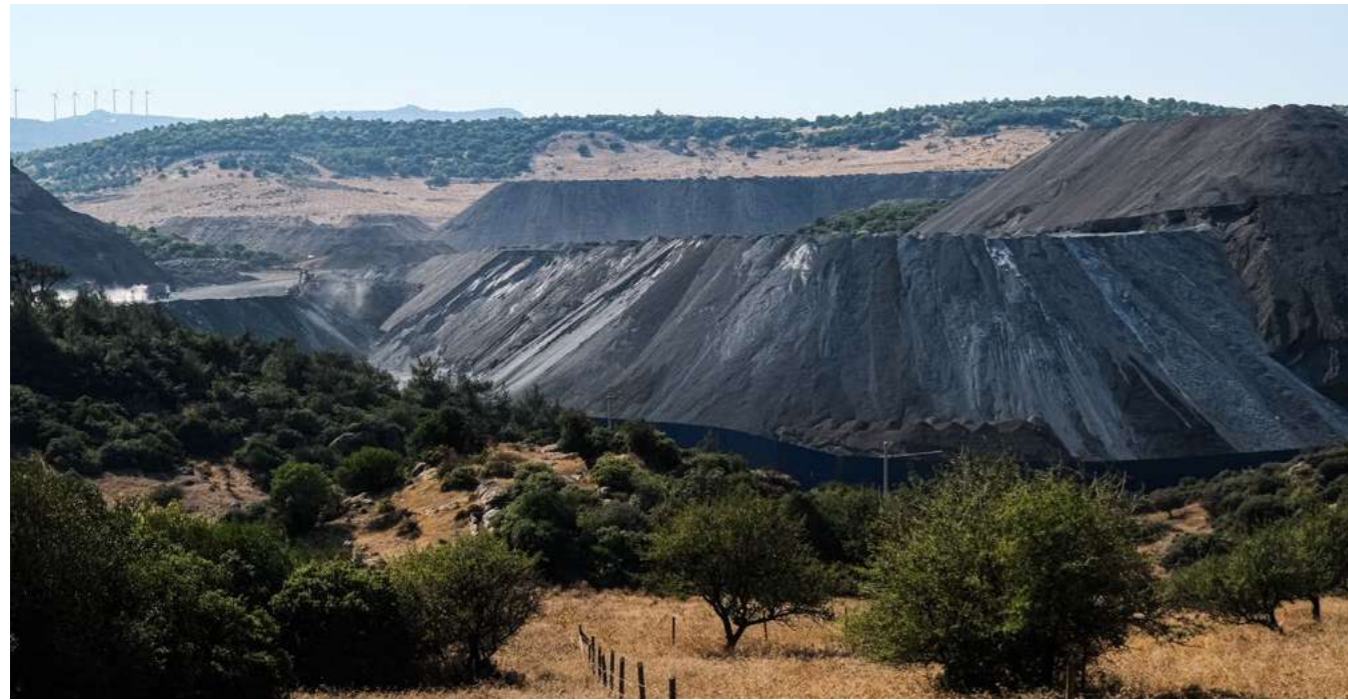
Unsanitary landfilling of slag in İzmir
