Propulsion failure and near stranding of *Portland Bay*

On the coast 22 km south of Port Botany (Sydney), New South Wales, on 4 July 2022

ATSB Transport Safety Report Marine Occurrence Investigation (Systemic) MO-2022-006 Final – 15 May 2025 Cover photo: Svitzer Australia

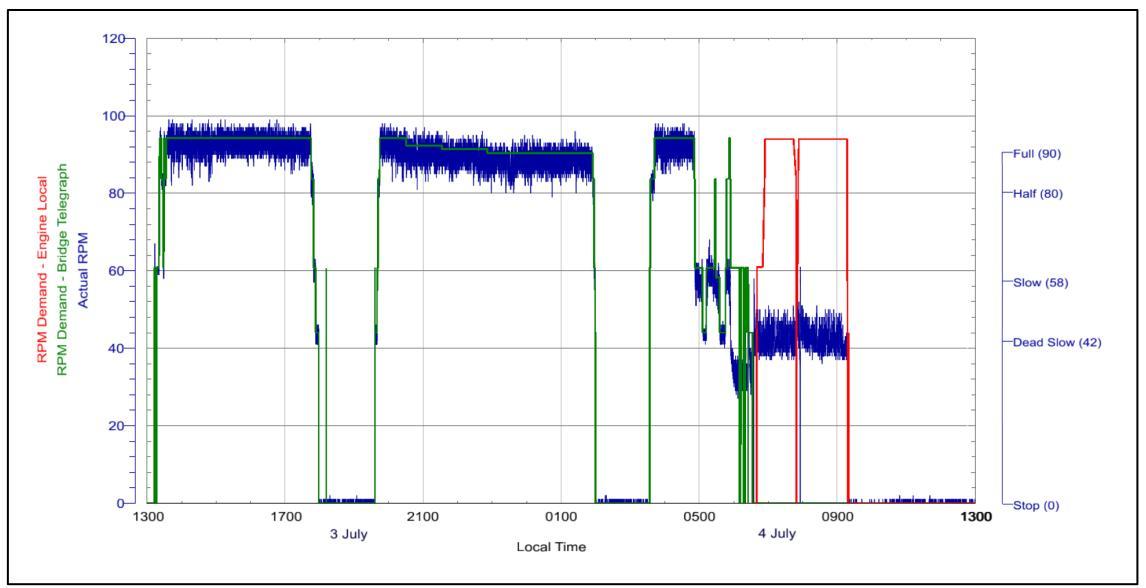
Figure 9: Engine speed demand (green or red) and actual speed (blue) on 3 and 4 July

After *Portland Bay* left Port Kembla on 3 July and the pilot disembarked, the main engine order (demand) was set at full ahead (90 rpm). The engine rpm achieved fluctuated widely about the demand (90 rpm) as the ship (in ballast condition) rolled and pitched heavily in the prevailing weather conditions with its propeller not always fully immersed (Figure 9).

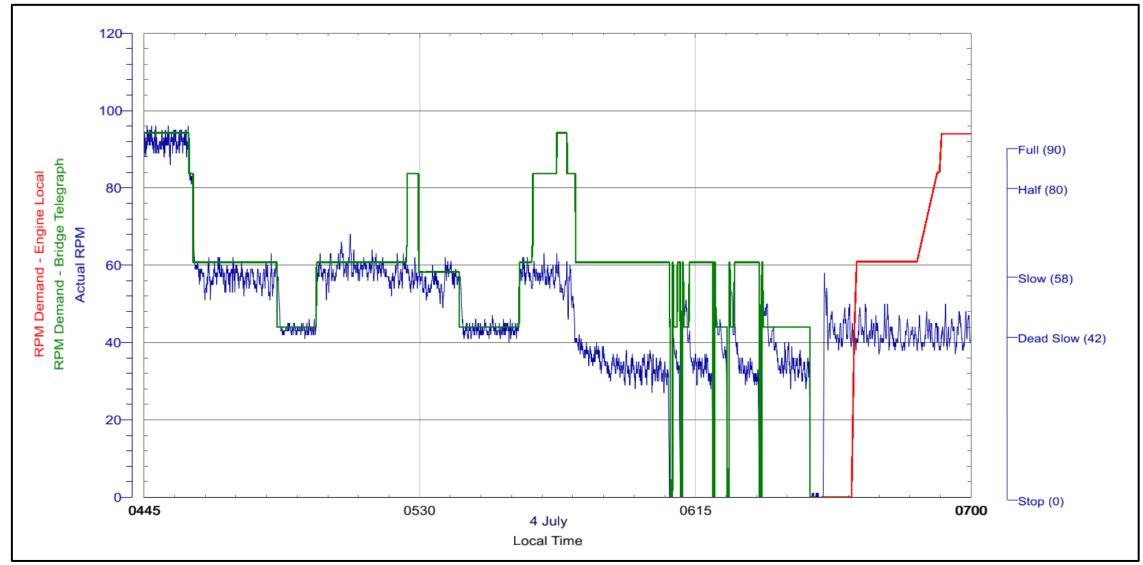
Figure 10: Speed demand (green or red) and actual speed (blue) from 0445 to 0700, 4 July

After the failure of auxiliary blower number 2, the engine speed continued to follow the demand for dead slow and slow ahead. However, after about 0550, when attempts were

made to increase speed beyond slow ahead, the engine did not respond to the speed demand (Figure 10).

The varying engine load and speed led to adverse engine operating conditions, including:

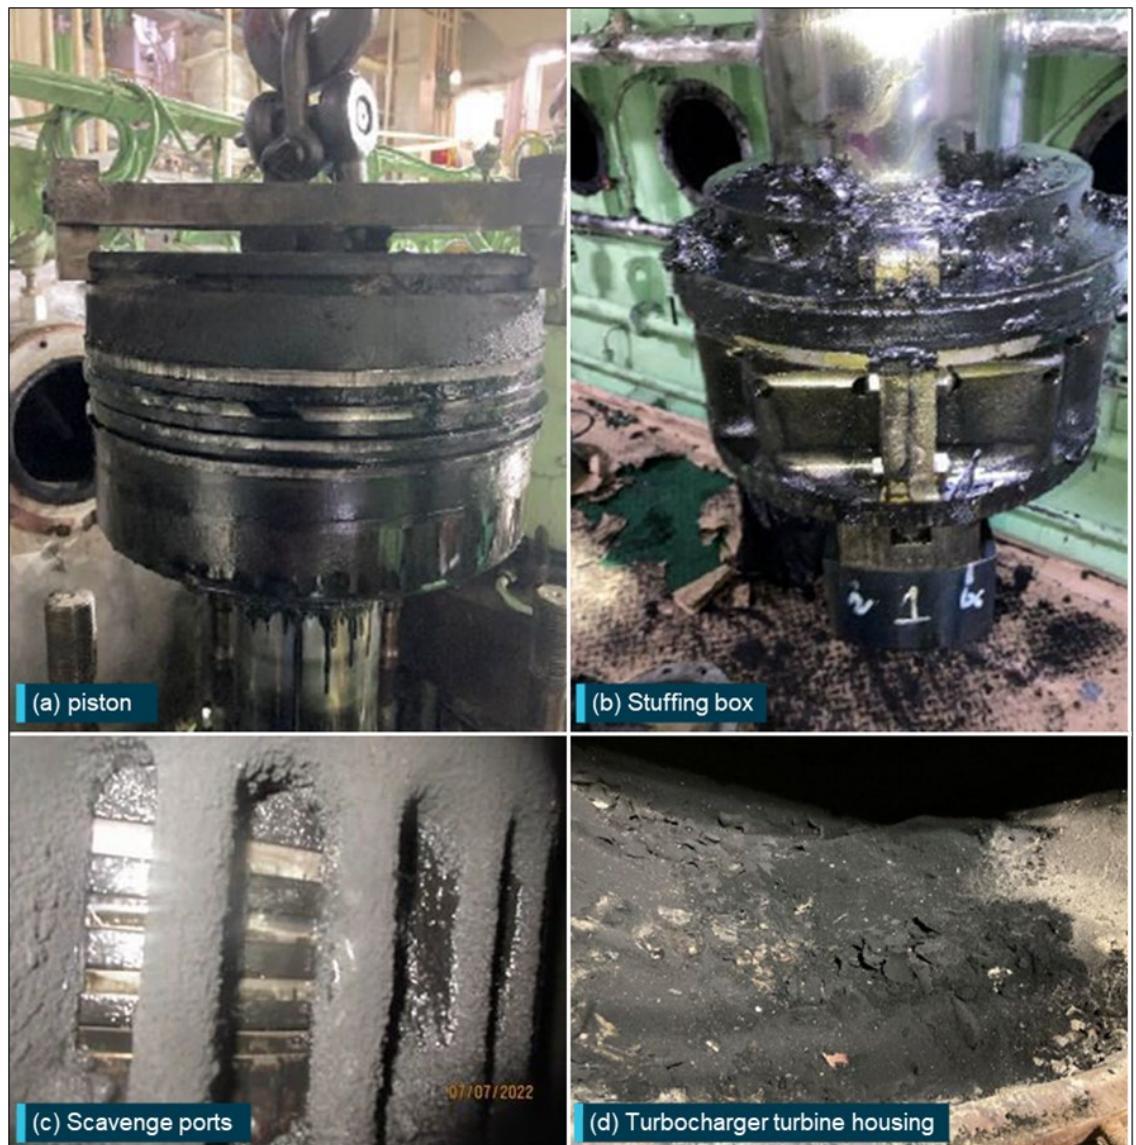
Figure 11: Condition of some engine components

A build-up of carbon, fuel and deposits throughout the scavenge system, pistons, turbocharger and other engine components was also evident. Figure 11 shows the condition of a piston (a), stuffing box (b), scavenge ports (c) and turbocharger turbine housing (d).

The build-up of carbon, fuel and deposits was assessed as probably being the result of:

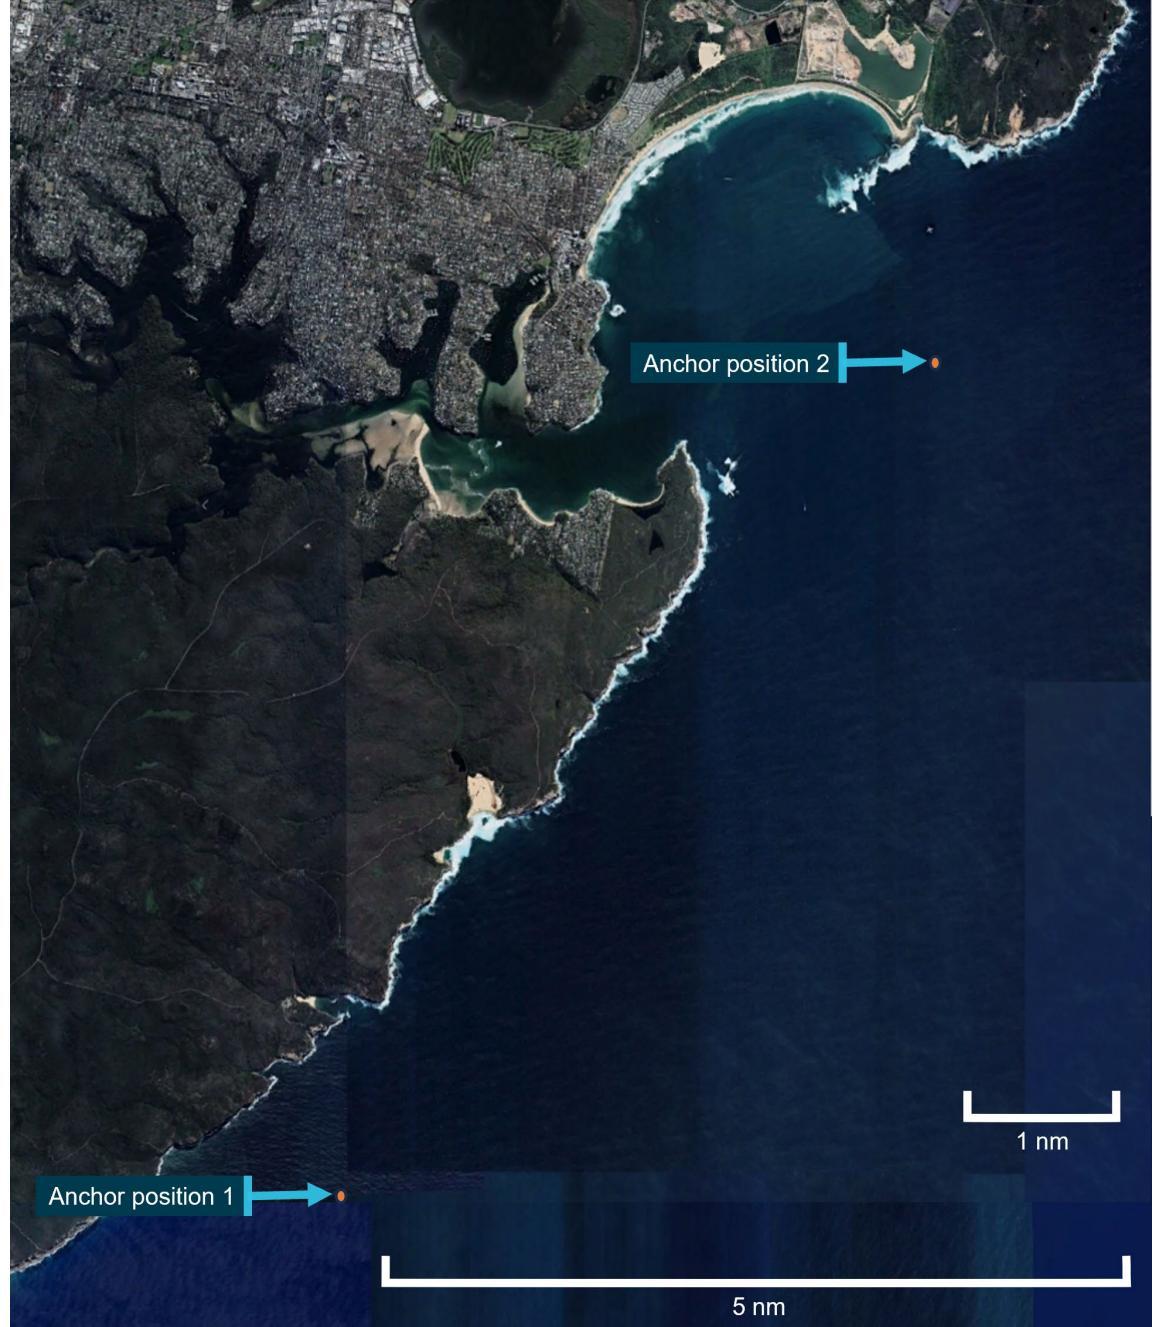
Figure 12: Anchor positions off Eagle Rock and Bate Bay on 4 July 2022

As previously described, *Portland Bay* anchored in 2 separate locations, each off a dangerous lee shore (Figure 12).

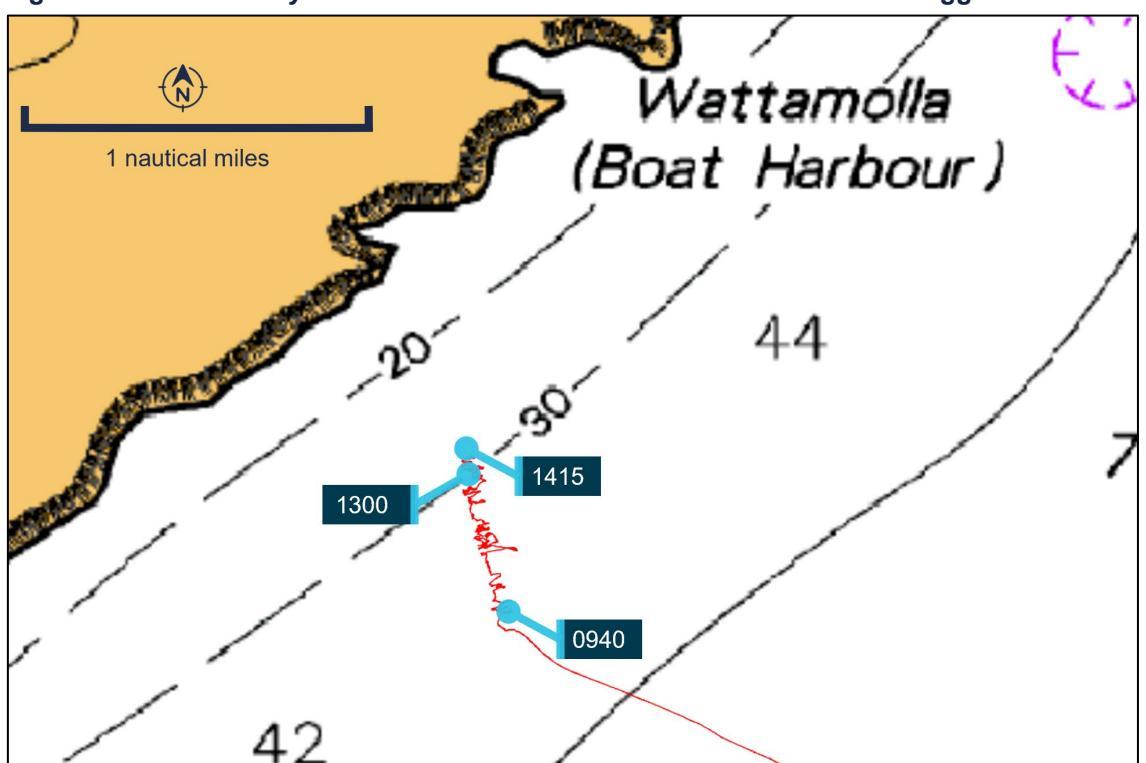
Figure 22: *Portland Bay*'s movement towards the shore as its anchors dragged

The ship had continued dragging its anchors and recorded data showed that, between 0940 and 1300, the ship moved 665 m closer to the shore (Figure 22). At about 1300, *Portland Bay*'s master reported adjusting the starboard anchor cable and effectively arresting the dragging of the anchors. The ship's movement then slowed and, over the next hour, it moved 70 m.
