Leaking cargo hatch covers caused cargo damage

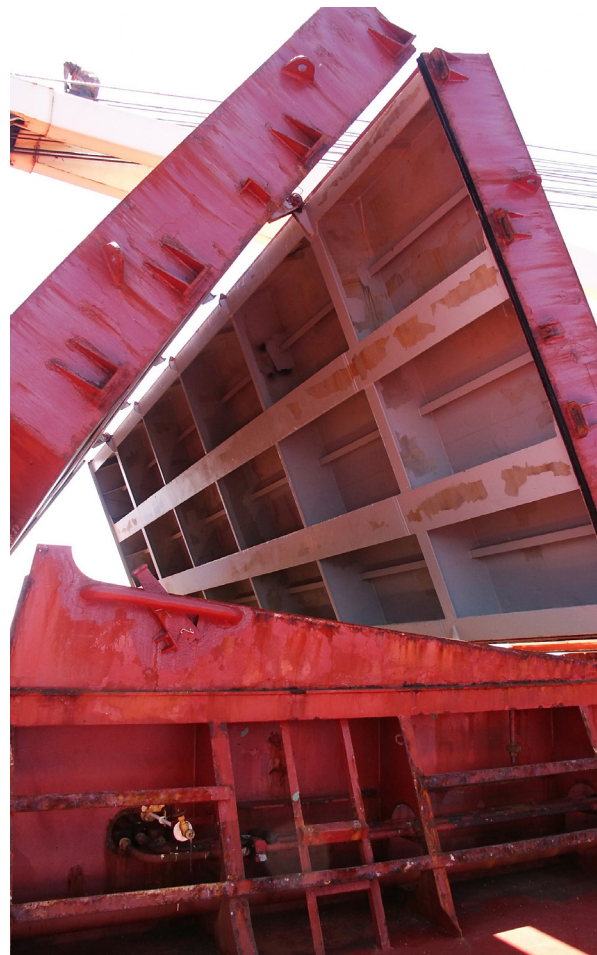
A surveyor carried out an inspection and found the following hatch cover parts to be in poor condition:

- Hatch cover panels
- Hatch coamings
- Water drain channels
- Non-return valves
- Quick cleats
- Rubber gaskets

The survey indicated that seawater had leaked through the middle cross joint drain channel and through the corner of the hatch coamings. ■

Before leaving port, the crew should inspect the hatch covers to ensure they are in a weathertight condition.

Ensure that gaskets and coamings are in good condition.

It is essential that cargo hatch covers are inspected and tested at regular intervals to ensure that the weathertight integrity is maintained and that the vessel is in a cargo worthy and seaworthy condition.
