National Transportation Safety Board

Marine Accident Brief

Barge Breakaway and Contact with Webbers Falls Dam

Accident type	Contact	No. DCA19FM035
Vessel name	<i>Barges MTC 7256 and LTD 11140</i>	
Location	Arkansas River, mile 367; Webbers Falls, Oklahoma ¹ 35°33.22' N, 095°10.19' W	
Date	May 23, 2019	
Time	1200 central daylight time (coordinated universal time – 5 hours)	
Injuries	None	
Property damage	\$4,751,249 est.	
Environmental damage	None	
Weather	Mostly cloudy skies with visibility at 10 miles, winds southwest at 5.6 mph with gusts up to 17.0 mph, air temperature 78.6°F, pressure 29.73 in	
Waterway information	The Arkansas River is part of the McClellan-Kerr Arkansas River Navigation System. The Grand River meets the Arkansas River in Muskogee at mile 394.2. At the time of the initial breakaway on May 22, 2020, the Arkansas River gage near Muskogee was over 38 feet and the current was about 7 mph. (Flood stage was in effect at 28 feet.)

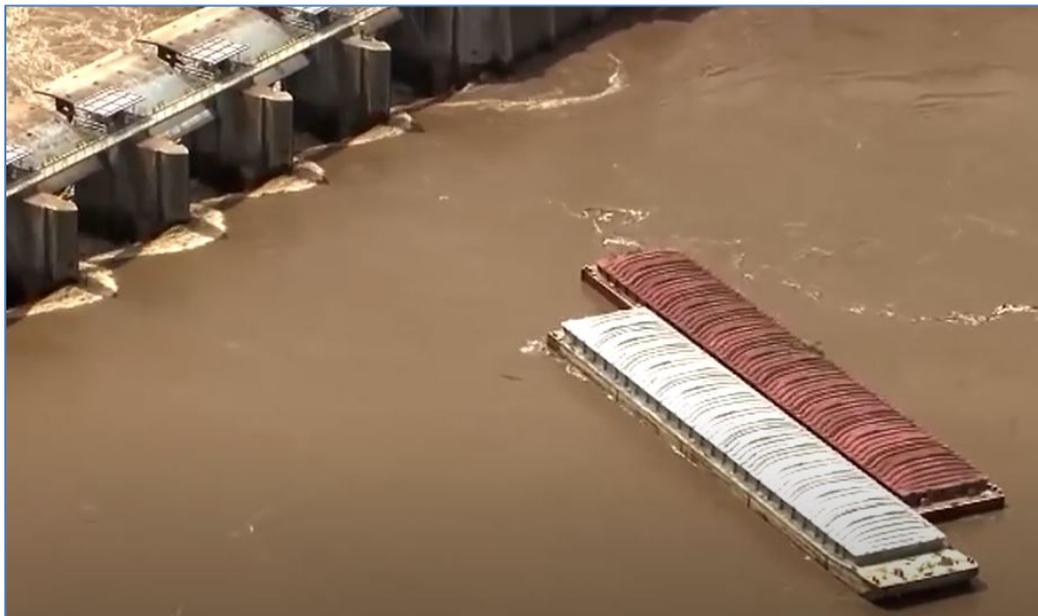
Barges *MTC 7256* and *LTD 11140* shortly before striking Webbers Falls Dam. (Source: KJRH-TV)

feet, the barges floated free of the sand bar and drifted down river. At 1118, Oklahoma highway patrol officers observed the barges at mile 373 and estimated their speed at 8 to 9 mph. Within the hour, at 1200, May 23, the barges struck the Webbers Falls Lock and Dam 16. Both barges were pinned against four of the dam gates, and the rushing river forced the upriver sides of the hopper barges downward, filling them with water until each sank.

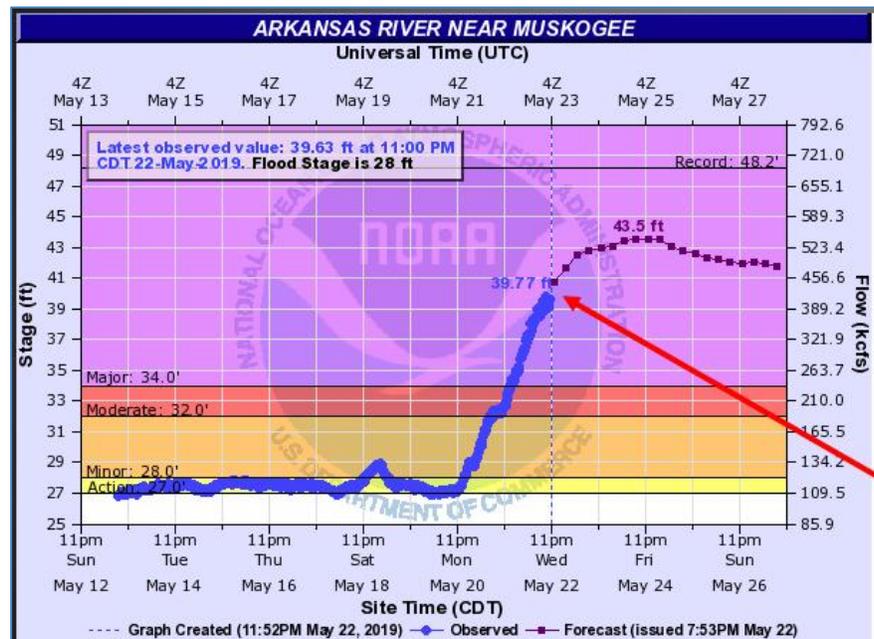
River stage and flow for the Arkansas River near Muskogee Oklahoma. Arrow indicates where the river hit the second highest level on record. (Source: National Weather Service)

Early in the morning on May 21, the Arkansas River near Muskogee rose above flood stage of 28 feet, and the captain of the *Dennis Collins*, concerned with an eddy current that pushed the head of his tow into the river, was permitted to move farther up the Grand River. At 0805, the crew of the *Dennis Collins*, with the assistance of the towing vessel *Legacy*, backed up about 1,000 feet into the Grand River and attached two lines from the *A F 15* to the barge *MTC 7256*. The *MTC 7256* was secured abreast of the *LTD 11140*; both were loaded with diammonium phosphate. The *LTD 11140* was secured to a mooring cell anchored in the riverbank, near the power lines that crossed the Grand River, with two fleet mooring wires, one at each shoreside corner. The *Dennis*

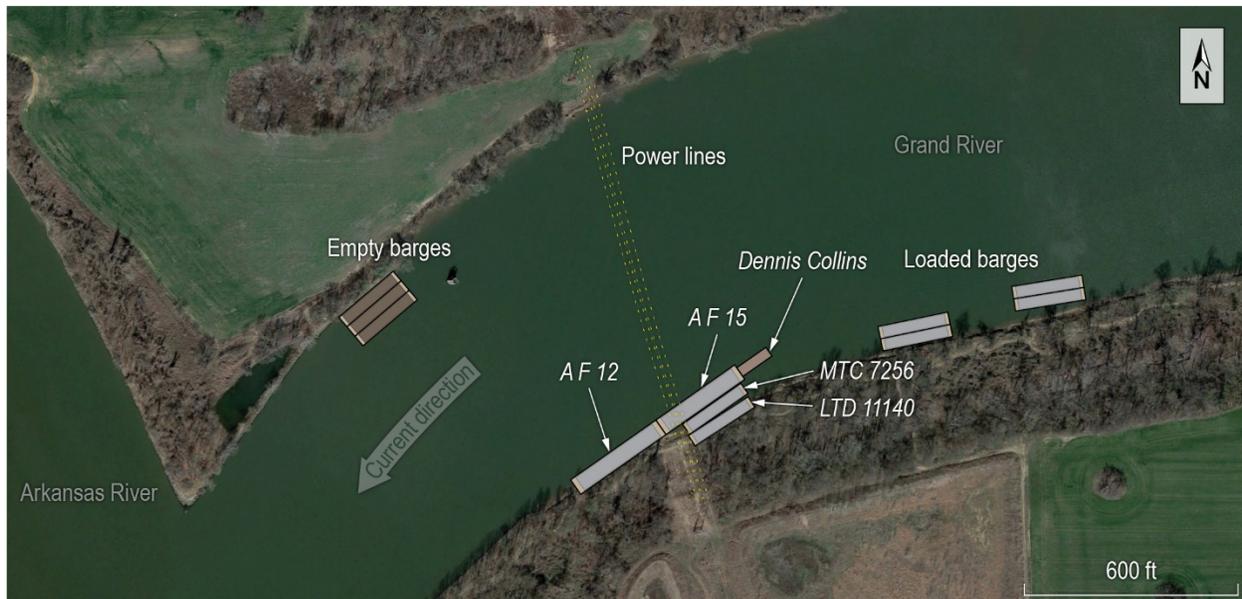
Graphic showing approximate locations of vessels in the Grand River fleeting area. At the time of the breakaway on May 22, the shorelines shown here were under approximately 9 feet of water. (Background source: Google Maps)

At 1213, all three shore wires securing the *LTD 11140* to the mooring cell broke. The captain, who was in the wheelhouse at the time of the breakaway, increased the engine speed to full astern to hold the barges in, but despite his efforts, the *Dennis Collins* and all four barges slowly moved down river. The *Dennis Collins* stern swung to starboard and into the river, and the captain ordered the crew to let go the lines connecting the *AF 15* with the *MTC 7256*. Within about 3 minutes, the *Dennis Collins*' antennas struck the power lines, disabling wheelhouse equipment, including the electronic chart system, radios, and AIS transmitter. The captain maneuvered the *Dennis Collins* and its two barges across the river and successfully tied up to three empty barges already moored near the mouth of the Grand River on the opposite bank. The *MTC 7256* and *LTD 11140* continued to drift downriver.

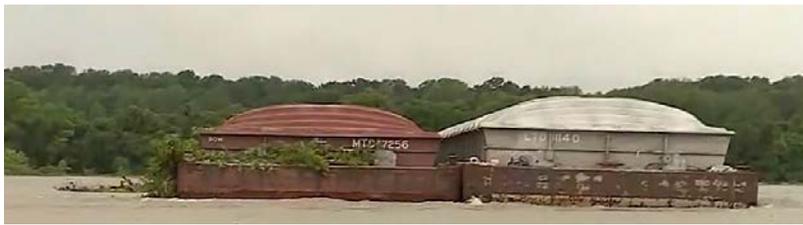
***MTC 7256* and *LTD 11140* on a sand bar at Arkansas River mile 377. (Source: KOCO)**

377 stranded on a sand bar. The Corps of Engineers wanted to send personnel to secure the barges but decided not to because the roads were flooded in the vicinity and high-water conditions prevented boat access. At 1040, with the Arkansas River level rising to 42

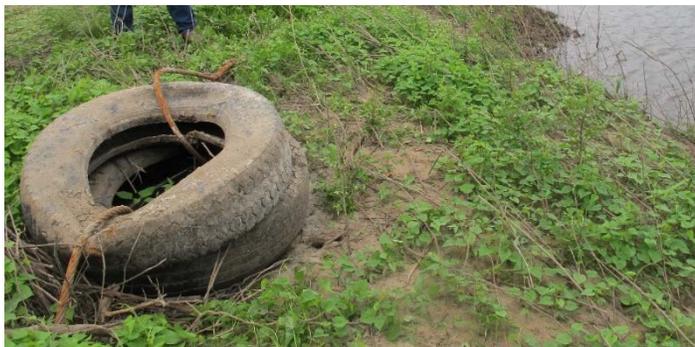
The bank of the fleeting area with a wire line arrangement like the one used by the *Dennis Collins*. One end of the wire line was anchored to buried timbers and secured to a tire. Another wire was secured to the tire and then to the barge.

There were two pairs of loaded barges moored just upriver of the *MTC 7256* and *LTD 11140*, each with two mooring wires, that did not break away. Each mooring line used in the Grand River fleet area consisted of a 1-inch diameter wire from its mooring anchor, buried in the earth and connected to a tire for flexibility, and a 7/8-inch diameter wire from the tire to its end that would be attached to a barge. The 7/8-inch wire had a minimum breaking strength of 79,600 pounds.

When the vessels broke free, the pilot and captain of the towing vessel *Dennis Collins* observed the upriver wire holding the *LTD 11140* parting first and the other wires parting seconds later. After the accident, investigators found parted cables attached to the mooring anchors. It is likely that the strain was not distributed evenly between the three wires, resulting in one line taking a large portion, or all the load, if the others had become slack. Once one line failed, the strain would be placed on the next line with the least amount of slack, which would also fail, until the breakaway occurred.

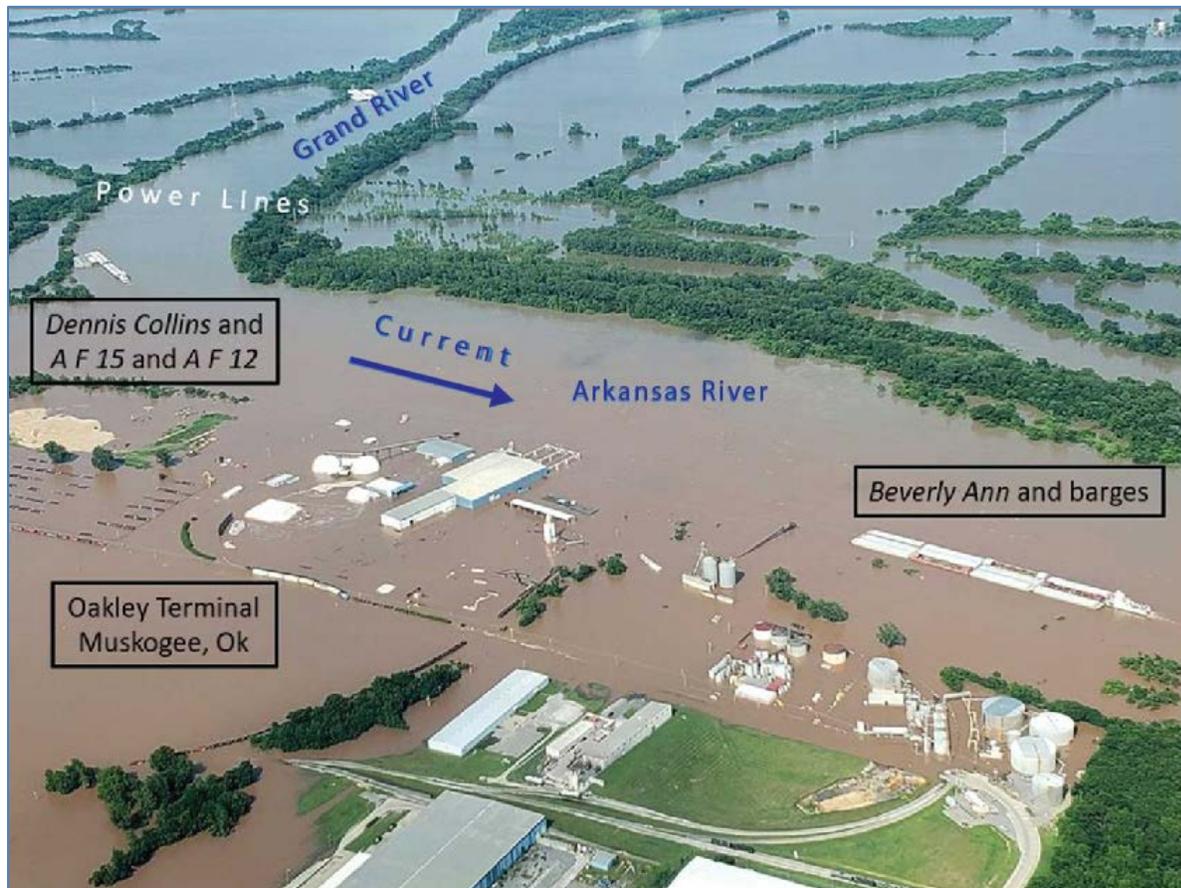
Muskogee, Oklahoma, where the Grand River meets the Arkansas River. Photograph taken three days after the breakaway, at 1600 on May 25 when the Arkansas River stage and flow in Muskogee were 46.28 feet and 595,000 cfs. (Source: Coast Guard)
