SAFETY INVESTIGATION REPORT

REPORT NO.: 20/2020

MV *FILIA T* Fire in container in position 12° 39' N 109° 44' E, 11 November 2019

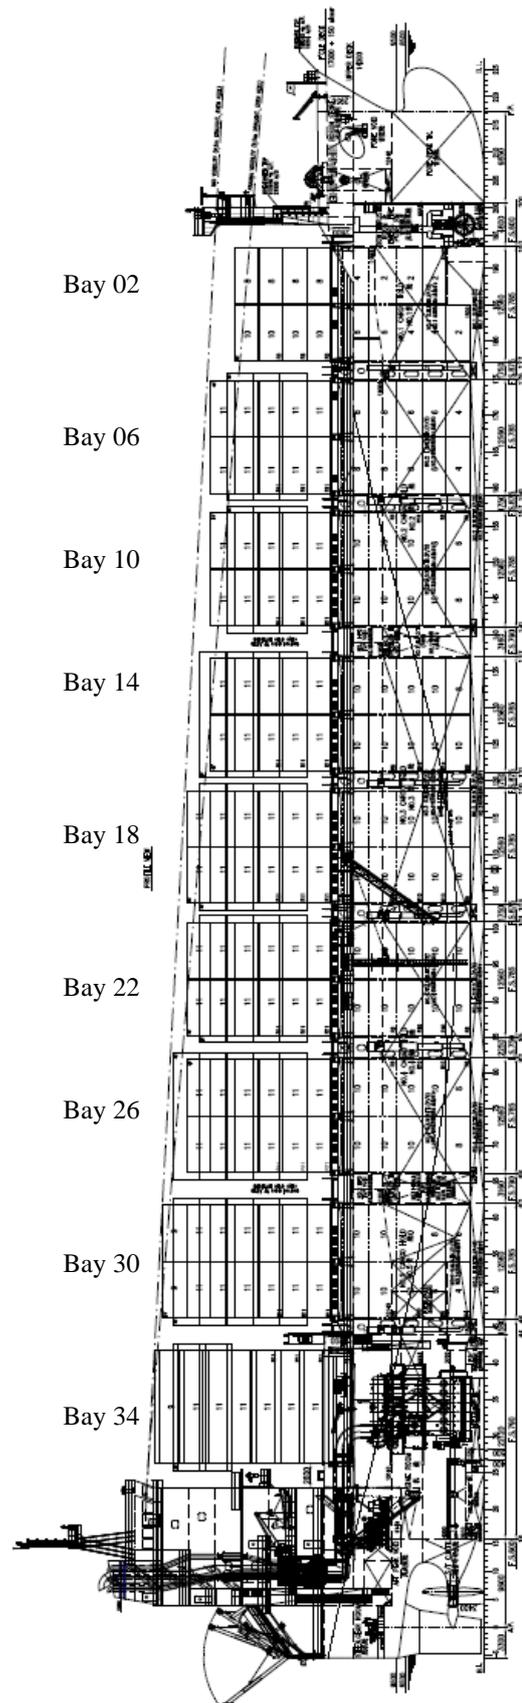
Figure 1: General Arrangement plan of *Filia T*, indicating the vessel's bays

Filia T (Figure 1) was a container ship of 19,035 gt, 1,800 TEU, owned by Filia T Shipping Limited and operated by Virono Shipping S.A., Greece. The vessel was built by Jiangsu New Yangzi Shipbuilding Co. Ltd., China, in 2019 and was classed with Lloyds Register (LR). The vessel had a length overall of 172.00 m and a moulded breadth of 28.40 m. The vessel's summer draft was 9.50 m, corresponding to a summer deadweight of 23,421 metric tonnes. At the time of the occurrence, the vessel was drawing a maximum draft of 7.70 m.

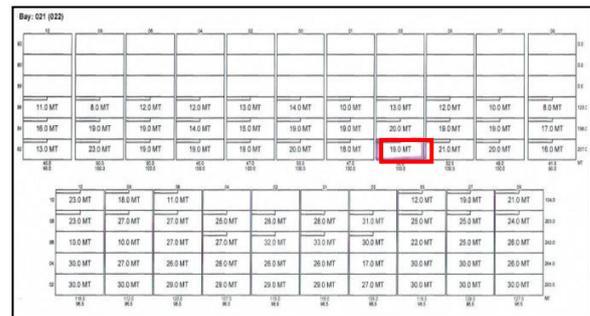
Figure 2: Stowage plan for bay 22, indicating the position of the container which was emitting smoke

At around 0900, as soon as the bosun reached bay 22, he noticed smell of burning material and observed smoke billowing from one container stowed in that bay (Figure 2). He immediately alerted the chief officer about the smoke which was coming from the container door's rubber seals (top and bottom), who in turn alerted the bridge.

The container was loaded on board *Filia T* in Hai Phong, Vietnam, on 07 November 2019, in position Bay 22 Row 03 Tier 82 (220382). Its final port of unloading, as listed in the container's bill of lading, was Nhava Sheva, India. This container was meant to be unloaded at Singapore from *Filia T*, and then transhipped via another vessel to its final destination.

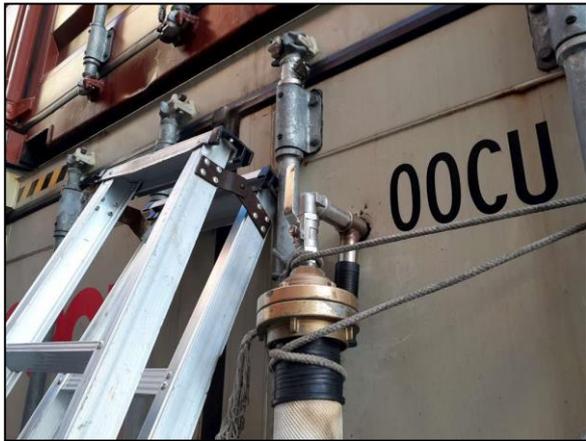
Figure 3: Water mist lance inserted in container and secured with rope

Two hours later, the temperature at the bottom of the door had reached 84 °C. At this time, the master instructed the crew to pierce a hole in the upper part of the container door and to flood the container with water, using the water mist lance (Figure 3).

Once this was done, the crew observed water running out of the container together with carbonized parts of the cargo. Burnt/charred pieces of cinnamon leaves were reportedly observed flowing out from the bottom of this container. A few minutes later, the chief officer reported that the temperature of the container was dropping.

As a precaution, the container was flooded with a continuous flow of water until 0755 of the next day. During this time, the container was also kept under continuous supervision. Temperature readings were taken again at 0830, which gave the following readings: top 27 °C, middle 27 °C and bottom 28 °C.

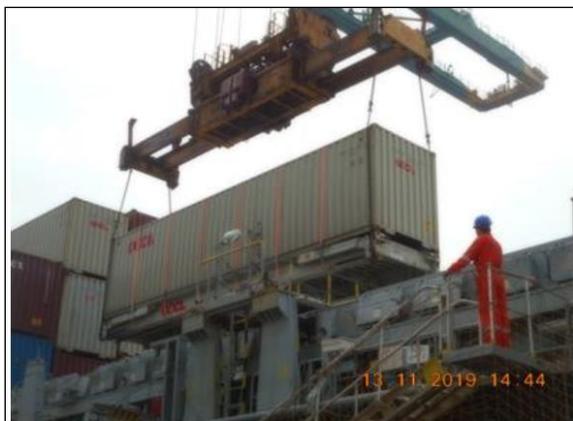
Figure 4: The fire-stricken container being discharged in Singapore

On 13 November 2019, the container was unloaded at Singapore (Figure 4).

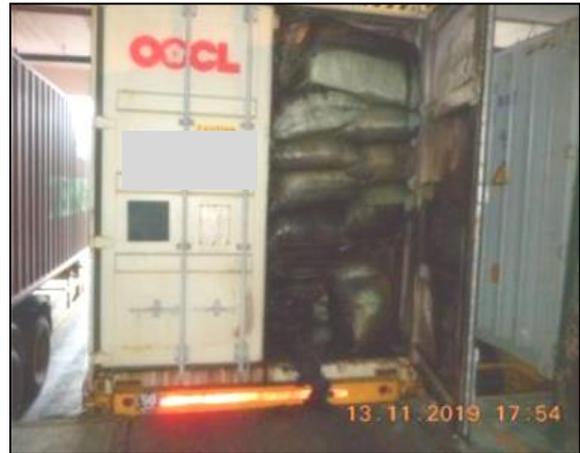
Figure 5: Right rear door open, showing burnt bags

right side of the door was opened, a very strong/pungent smell of burnt cinnamon leaves was noticed (Figure 5).

Reportedly, it appeared that most of the bags stowed in way of the rear door were affected by the fire. It was also reported that some of the bags from the other adjacent row, further

into the stow, may have been affected by the fire. It was estimated that 32 bags of cinnamon leaves were affected by the fire and another 16 bags were affected by the water used for fire-fighting purposes. From the surveyors' observation, it was deduced that the total consignment had been affected because of the smoke, fire and/or water.

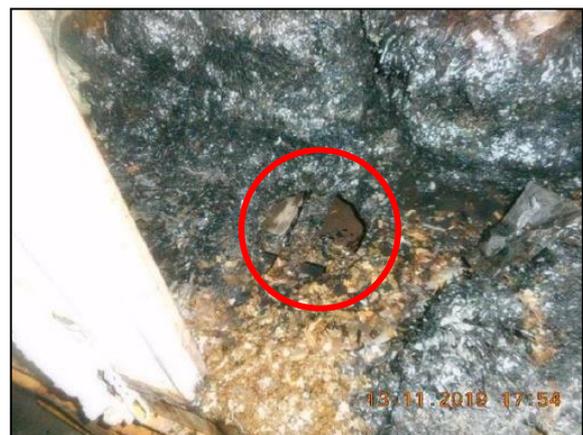
Figure 6: Hole located on the container's bottom

Several bags on the bottom stow, located near the rear doorway, were noted to be missing. Additionally, a hole (approximately 200 mm in diameter) was observed on the bottom wooden floorboard. The location of this hole was above the first bottom cross-member, located approximately 500 mm length-wise into the container from the rear end (Figure 6).

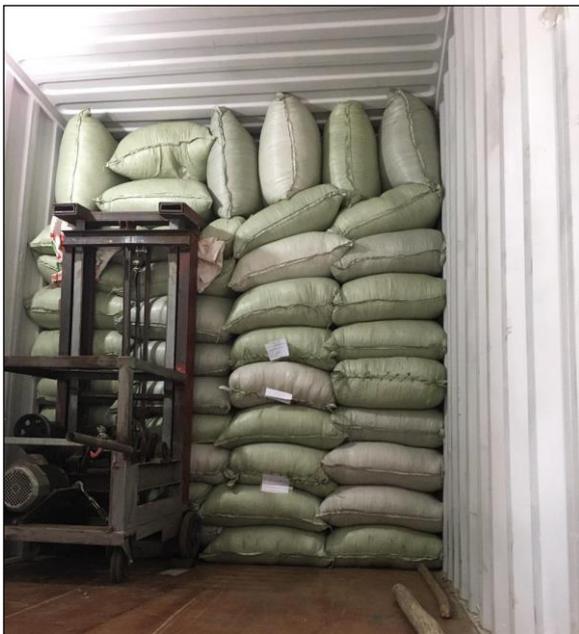
Figure 7: Indication of how the cinnamon leaves in bags were stowed inside the container

Information received from the container charterers suggested that the fire was caused by the nature of the cargo, *i.e.* dry, crisp and/or brittle cinnamon leaves in polypropylene bags. It was also suggested that since the bags were stowed from panel-to-panel, thus exposing them to the effects of the weather, spontaneous combustion of the cinnamon leaves may have occurred.

Figure 7 gives an indication of how the cinnamon leaves in bags were packed and stowed inside the container.

The container used was a 40-foot-high cube³ container, packed with 479 polypropylene bags of cinnamon leaves that occupied 60 m³ of space, with a gross weight of 14,417.90 kg.

Furthermore, as mentioned earlier in this safety investigation report, the bags were stowed from panel-to-panel. Therefore, it was hypothesized that the high temperature coupled with high relative humidity further

led to self-heating of the cargo, probably followed by self-combustion.
