Mooring Line and Mooring Systems Management

Issue date: 03 March 2021

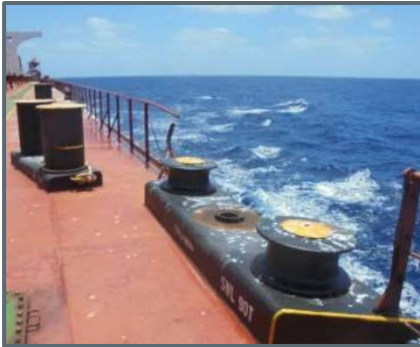
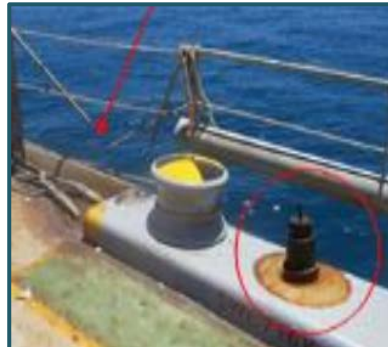
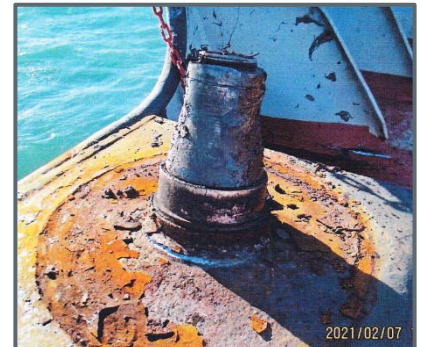
4.2 Observation:

The deteriorated condition of roller fairleads has led to the failure of fairleads during towage operations.

4.3 Recommendations:

- a. Condition of mooring winches, fairleads, bollards must be regularly monitored to identify any early warning signs of failure or damage. Vessels PMS should include regular and detailed condition checks of the roller fairleads (including its mounting arrangement) and other mooring fittings onboard.
- b. All Fairleads, chocks and bollards should have the SWL marked. The SWL being informed to the Pilot / Tugs should be the minimum SWL of the fairleads or bollards of the system.
