# Surviving disaster – The Titanic and SOLAS

In 1914, two years after the Titanic disaster of 1912, in which 1,503 people lost their lives, maritime nations gathered in London adopted the International Convention for the Safety of Life at Sea (SOLAS Convention), taking into account lessons learned from the Titanic. The 1914 version was superseded by SOLAS 1929, SOLAS 1948, SOLAS 1960 (the first adopted under the auspices of the International Maritime Organization) and SOLAS 1974. SOLAS 1974 is still in force today, but it has been amended and updated many times. The regulations relating to life saving appliances and arrangements, contained in chapter III of SOLAS, a new version of which entered into force on 1 July 1998, are intended to ensure that in the event of a catastrophe at sea, passengers and crew have the greatest chances of survival. Improved design and equipment, better fire protection, satellite communications, rescue planes and helicopters and trained personnel also contribute to improved safety at sea.

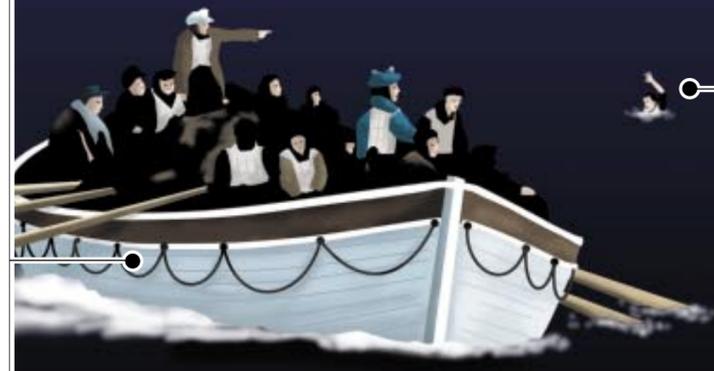
**Speed of navigation around ice**  
The Commission into the Titanic ruled the loss was due to collision with an iceberg brought about by excessive speed at which she was being navigated. Under SOLAS, when ice is reported on or near his course the master of every ship at night is bound to proceed at a moderate speed or alter course.

**Public address system**  
There was no public address system on the Titanic and news filtered to the passengers slowly, adding to the disorder and confusion. Under SOLAS, all passenger ships must be fitted with a public address system.

**Lifeboat design**  
Some people died from hypothermia in the Titanic lifeboats because they were open and gave no protection against the cold. Under SOLAS, lifeboats must be fully or partially enclosed. On passenger ships, partially enclosed lifeboats can be used as they are easier to get into, but they must have a collapsible roof to fold across.

**Training of crew in lifeboat drill**  
The crew of the Titanic lacked training in loading and lowering the lifeboats and few knew which boat they were assigned to. Lifeboats were not filled to capacity because senior officers did not know the boats had been tested and were strong enough. Under SOLAS, every crew member must participate in regular practise drills and have easy access to training manuals.

**Distress alert**  
The Titanic used radio which had a limited range of 200 nautical miles. Ships can now communicate globally via satellites.

Marconi radio wires

**Lifeboat drill**  
No lifeboat drill was held on the Titanic. Under SOLAS chapter III an 'abandon ship' and fire drill must take place weekly on all passenger ships.

**Evacuation chutes**  
Passengers on the Titanic jumped from windows and doorways into the lifeboats as they were lowered, often injuring themselves or other passengers. New emergency evacuation chutes are both safer and quicker.

**Number of lifeboats**  
The Titanic did not have enough lifeboats for all passengers. Under SOLAS, passenger ships must carry enough lifeboats (some of which can be substituted by liferafts) for all passengers, plus liferafts for 25%.

**Immersion suits**  
The sea temperature when the Titanic sank was below freezing point and many people died in the water from hypothermia. Under SOLAS, a specific number of immersion suits must be carried on both passenger and cargo ships, mainly for the crews of rescue boats.

**Location**  
The land station at Cape Race, Newfoundland and ships other than the Carpathia and the Californian heard the Titanic distress call but the airwaves were crackling and the Titanic's position was misinterpreted. With EPIRBs and global positioning systems, the position of a ship in distress can be automatically sent.

**The Carpathia**  
Received distress call at 12.25am. Travelled 58 miles and picked up first lifeboat at 4.10am.

**The Californian**  
Stopped because of the ice less than 20 miles from the Titanic. Did not approach until after 6.00am when the Carpathia was spotted. Arrived at 7.30am - too late to rescue any survivors.

**The Titanic**  
Hit iceberg at 11.40pm and sank at 2.20am.

**Distress watch**  
The Californian was less than 20 miles away but the radio officer had gone off duty when the distress messages were sent. Under SOLAS, every ship while at sea must maintain a continuous watch on the distress and safety frequencies.
