engine damage

Introduction

Case study 1

Poor fuel management and sloppy maintenance routines leads to salvage operation

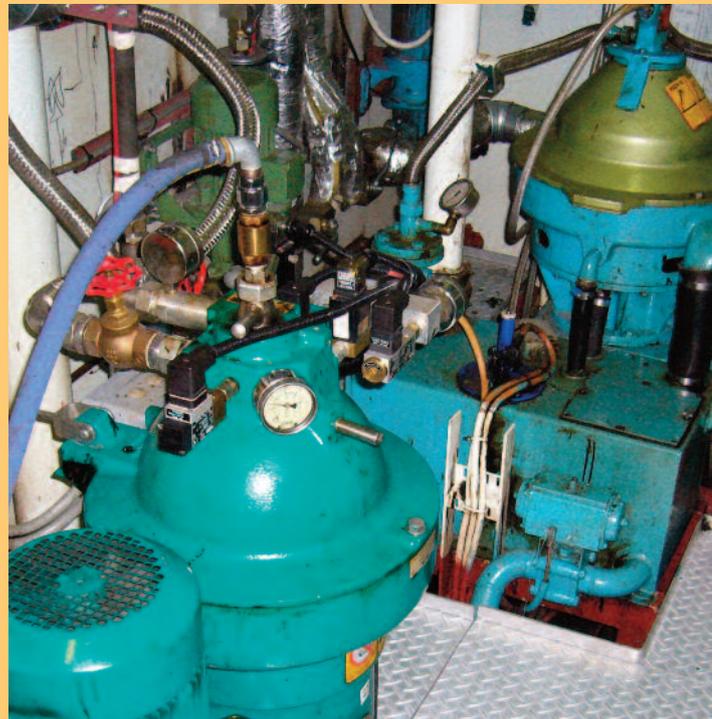
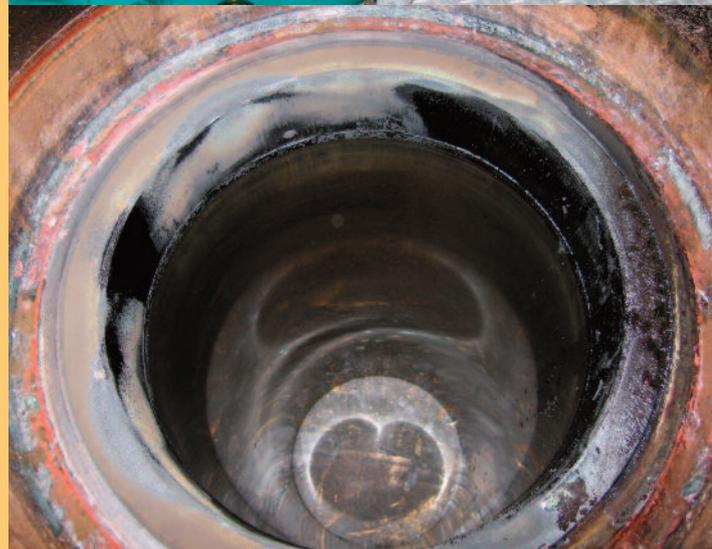
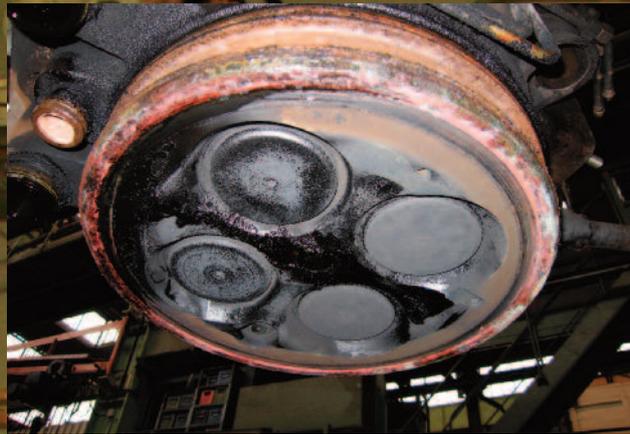
A few hours later I heard a knocking noise and saw a leak coming from the no. 2 cylinder cover on the no. 1 diesel generator. We were worried that the valves were misaligned and so we shut down the diesel generator and stopped the main engine.

“A few hours later I heard a knocking noise and saw a leak coming from the no. 2 cylinder cover on the no. 1 diesel generator.”

The technicians showed us that the seal rings were damaged, and when they opened the drain both water and oil came out. They told us that when they inspected components from the main engine and the diesel generators, they could see wear, pitting and deposits on the valves and linings, proving that there were water and impurities in the fuel. ”

To consume untreated heavy fuel is never a good idea. In hindsight, with the fuel treatment system out of order the engine crew should have immediately switched over to marine gas oil whilst the problem with the purifiers were rectified.

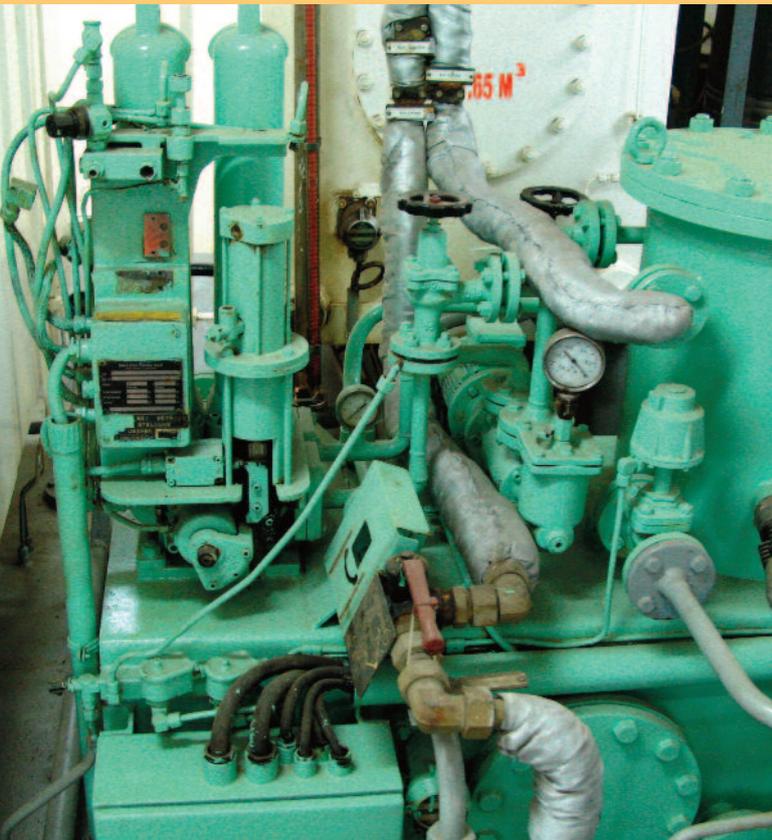
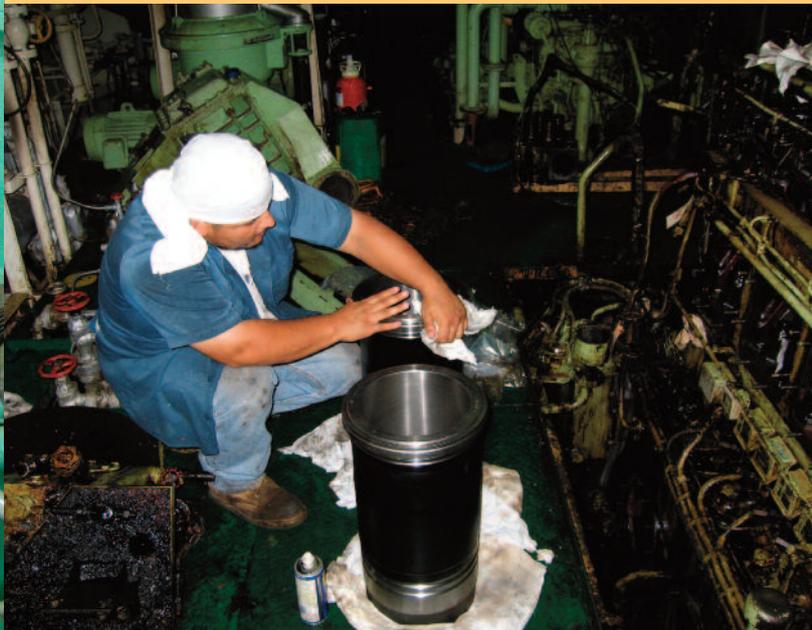
The investigation revealed that the casualty originated from careless handling of the mesh filter elements in the lube oil filter for the no. 2 generator. Filter cartridges in steel mesh, which are quite fragile, are cleaned by means of ultrasound washing in a dedicated basket. Instead of using the specified basket the engine crew had tossed the filter elements directly into the cleaner where they had sustained damage when rubbing against each other during the cleaning process. As the filter disintegrated, broken parts of the filter element spread throughout the lubrication oil system of the no. 2 diesel generator engine and caused severe damage to bearings and journals.

The initial contamination of the oil in the no. 2 diesel generator caused metal particles to contaminate the lubricating oil system. Subsequently, the contaminated lubricating oil entered the no. 3 diesel generator through the lubrication oil drain tank, causing damage to its major moving components.

The root cause for the casualty was the inability of the engine crew to follow the manufacturer's instructions on procedures for maintenance.

In addition, one can always argue that having an interconnected lube oil system for different engines is not good practice and should be avoided to safeguard from contamination of both engines lube oil systems should there be problems with the other.
