Report 2021/003857

Report on the investigation
into a serious injury on board
mts CENTRAL PARK

in the port of Antwerp
on June 3rd 2021.

Federal Bureau for the Investigation of Maritime Accidents

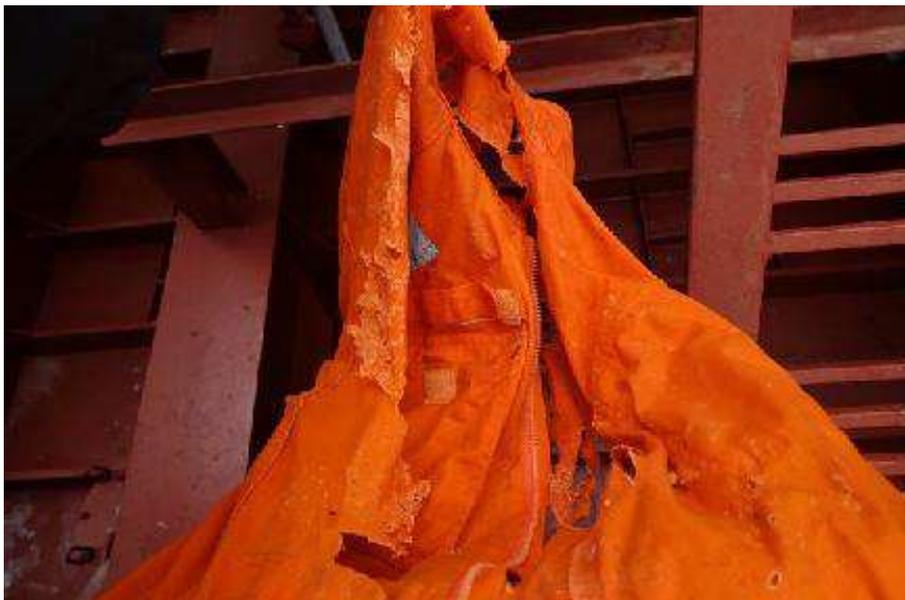
Figure 5 - Contaminated coverall

Figure 5 shows how the sulphuric acid degraded the tissue of the coverall.

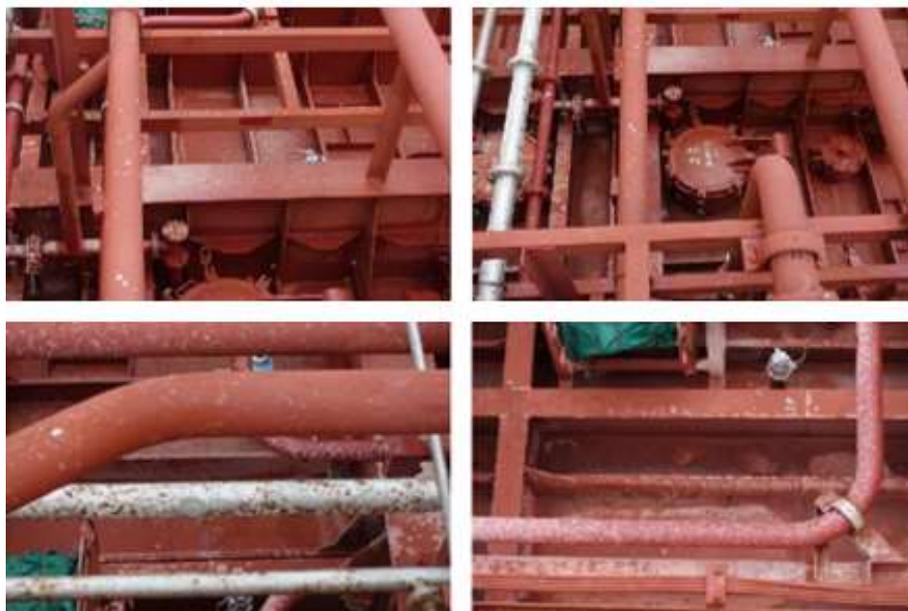
Figure 6 - Affected deck area

Traces of sulphuric acid were found in a wide area behind cargo only tanks N°1, as shown in Figure 6.

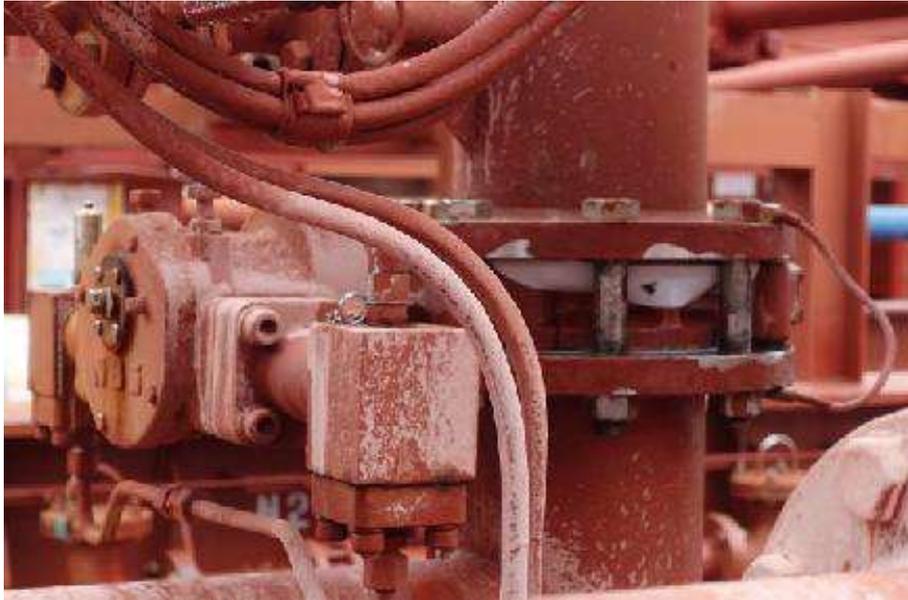
Figure 7 - Master valve of cargo only tank N°1P

It was noted that the upper Teflon³ gasket of the master valve of cargo only tank N°1P was damaged. The master valve of cargo only tank N°1P was found in closed position and should have been in open position during line blowing.

The Chief Officer pointed out the master valve of cargo only tank N°1P as the source of the spill. The WNW wind blew the particles of sulphuric acid in the direction of the vessel's stern, towards the location where the AB was standing. This location was approximately 10 m away from the master valve of cargo only tank N°1P where the spill occurred.

1. The spill of sulphuric acid on board mts CENTRAL PARK occurred because the closed master valve of cargo line N°1P caused a steam hammer effect when pressurized air was released into the partly filled cargo line.

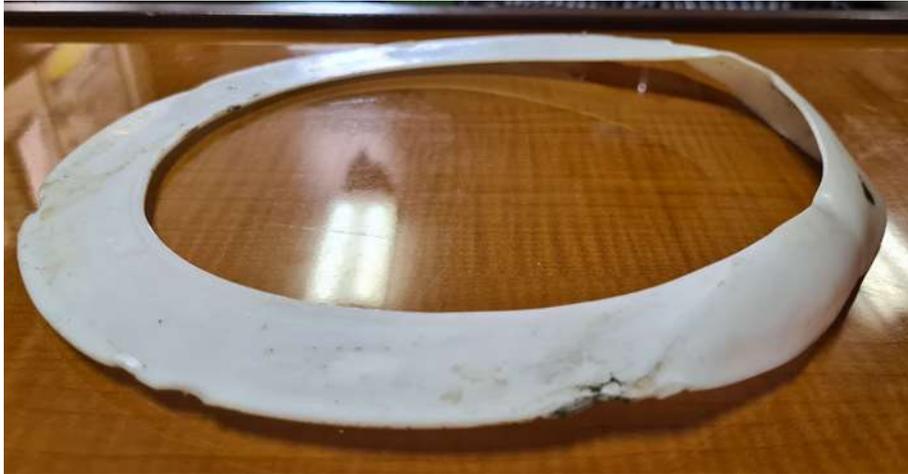
Figure 9 - Damaged gasket after disassembly

The Teflon gasket was replaced by a new one. The damaged gasket is shown in Figure 9.

The remote operation of the valves was checked after the incident, but no anomalies were found.

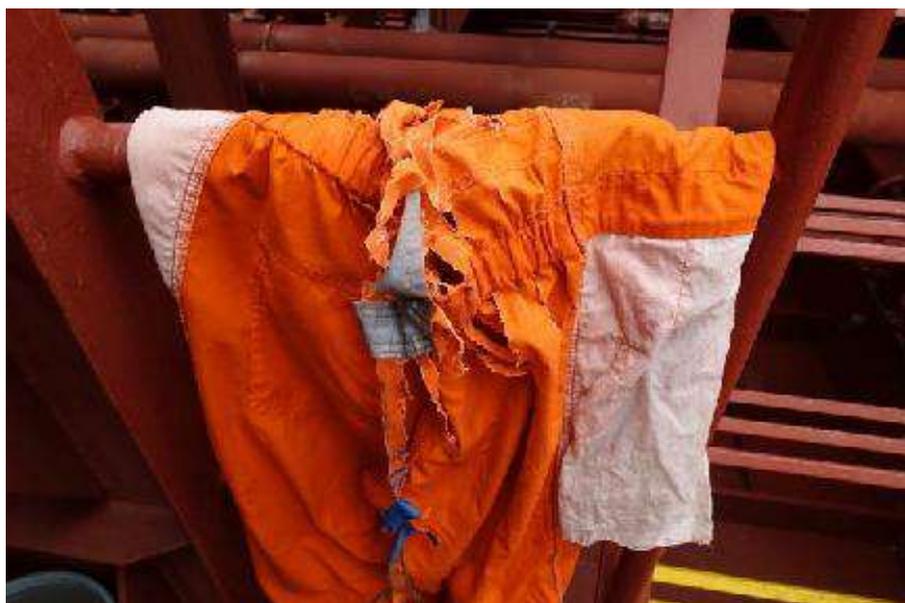
Figure 11 - Coverall worn by the injured AB

The coverall that the AB was wearing is shown in Figure 11. The tissue had become wasted by the spilt sulphuric acid.

The sulphuric acid caused second degree chemical burns on 9% of the total body surface of the AB.

1. During line blowing operations, the involved crew on deck was wearing a hazmat suit. The coverall worn by the AB that escorted the surveyor was not resistant against corrosives. The type of coverall contributed to the amount and severity of chemical burns.

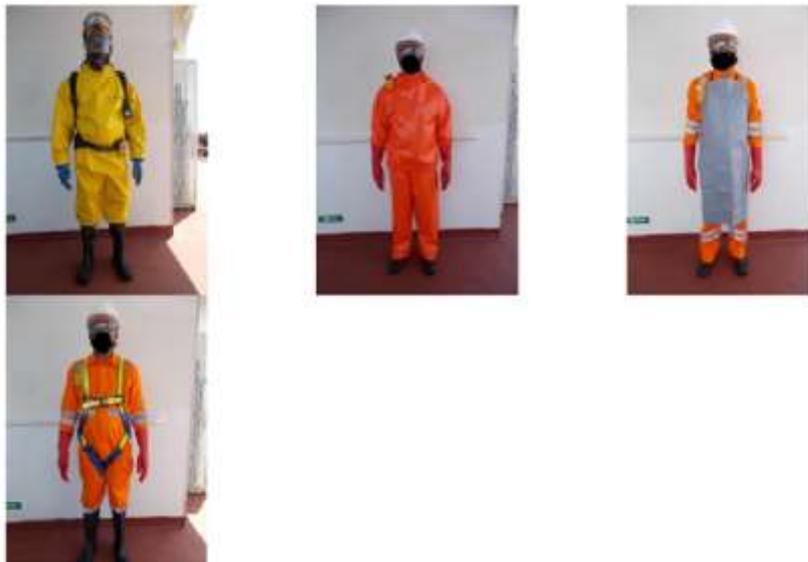
Figure 12 - Levels of PPE

1. A high exposure risk task, line blowing, and a low exposure risk task, escorting the cargo surveyor, were executed at the same time and in vicinity of each other. Both tasks required another level of PPE on board. No risk assessment or company procedure was in place to determine the conditions to simultaneously execute both operations.
2. Different levels of PPE for cargo related activities were defined on board, as shown in Figure 12. The use of the different PPE was explained in a PPE matrix that was available on board. As various types of cargoes could be transported by the chemical tanker, the required level of PPE was not always clear.

A coverall could only be worn if no contact at all with corrosive cargo was possible.

Escorting the cargo surveyor during sampling involved the carriage of sampling equipment and required a higher level of PPE than a coverall.
