Safety Alert No. 463

Adaptation and Modification of Tool Results in Injury

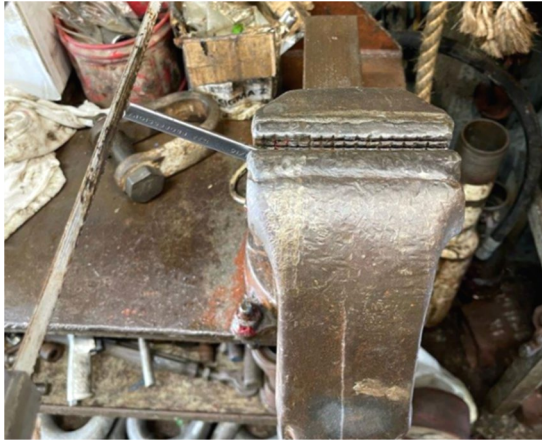
Wrench in vise with hacksaw.

A worker was recently injured while attempting to install a hydraulic line on a pipe handling machine during offshore energy operations. The worker determined the combination wrench on hand was too long for this particular use and attempted to alter the tool by placing the wrench into a vice to

manually shorten the length by using hacksaw. During the wrench alteration process, the worker cut a gloved hand with the sharp edge of the altered wrench handle, resulting in a laceration requiring sutures.

- Rig managers will order close radius hand tools.

- Rig managers will conduct a high-level overview of the incident with all crewmembers onboard to emphasize the importance of proper pre-job planning and hazard assessment.
- Rig managers will stress the importance of any lone worker applying the option to ask for assistance when reviewing a hazard identification and mitigation card / compass card.
- Rig managers will set expectations to all crew members that the alteration of Original Equipment Manufacturer (OEM) tools, equipment, etc. is unacceptable and discuss potential consequences.

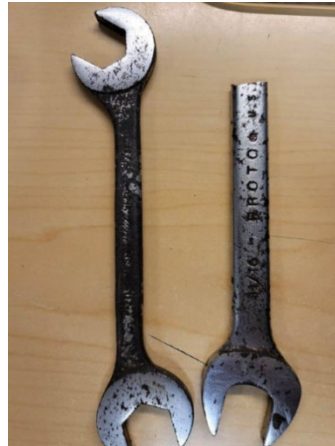
Modified wrench.

- The worker did not pause or stop work to consult with a supervisor when the job scope changed and/or the proper tool was unavailable. The decision to modify the combination wrench was not discussed with the supervisor before modifying the tool.
- The worker did not explore the potential for other avenues and/or options for locating the proper tools (i.e., checking with other work groups).
- A proper wrench that would fit in the tight area was not readily available on the rig floor.
- When the worker decided to alter the hand tool, the worker chose a readily available hand saw versus a more appropriate/potentially safer method, i.e. a bandsaw.

- Reviewing safety alerts with all relevant employees.
- Reviewing the corrective actions implemented by the operator.
- Ensuring proper tools are available.
- Reviewing all Hazard Analysis policies and procedures to ensure hazard identification and mitigation card / compass card is utilized and understood and used to circumvent the regulatory requirements of 30 CFR 250.1911.
