## The collision between the commercial fishing vessel *Vertrouwen* and recreational motor cruiser *James 2* resulting in the sinking of *James 2* and loss of three lives Shoreham-by-Sea 6 August 2017

### SUMMARY

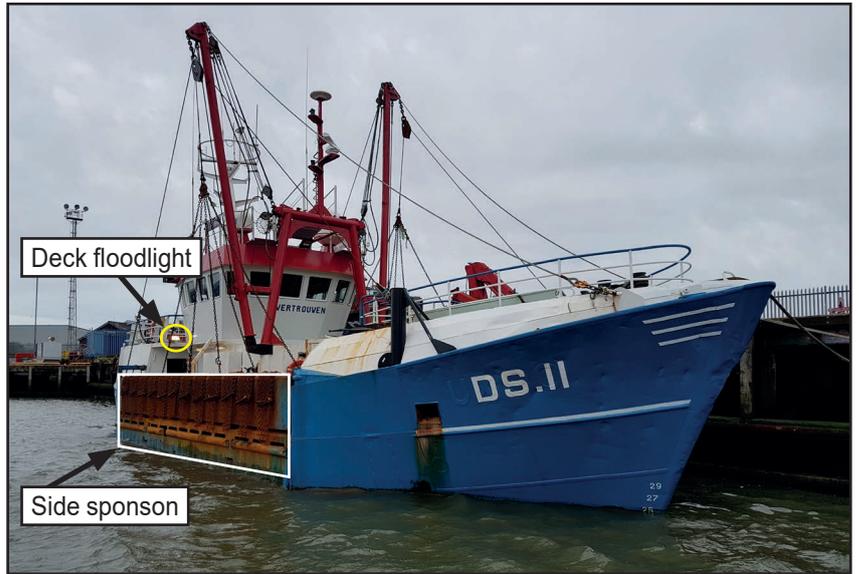
Figure 1: fv *Vertrouwen*

On 1 August 2017, the UK registered fishing vessel *Vertrouwen* (**Figure 1**) arrived at Shoreham harbour and entered the port's dry dock for repairs to a leaking propeller shaft seal. The vessel was scheduled to sail on Friday 4 August, but problems with the supply of spare parts and extra-emergent work delayed its departure by 24 hours.

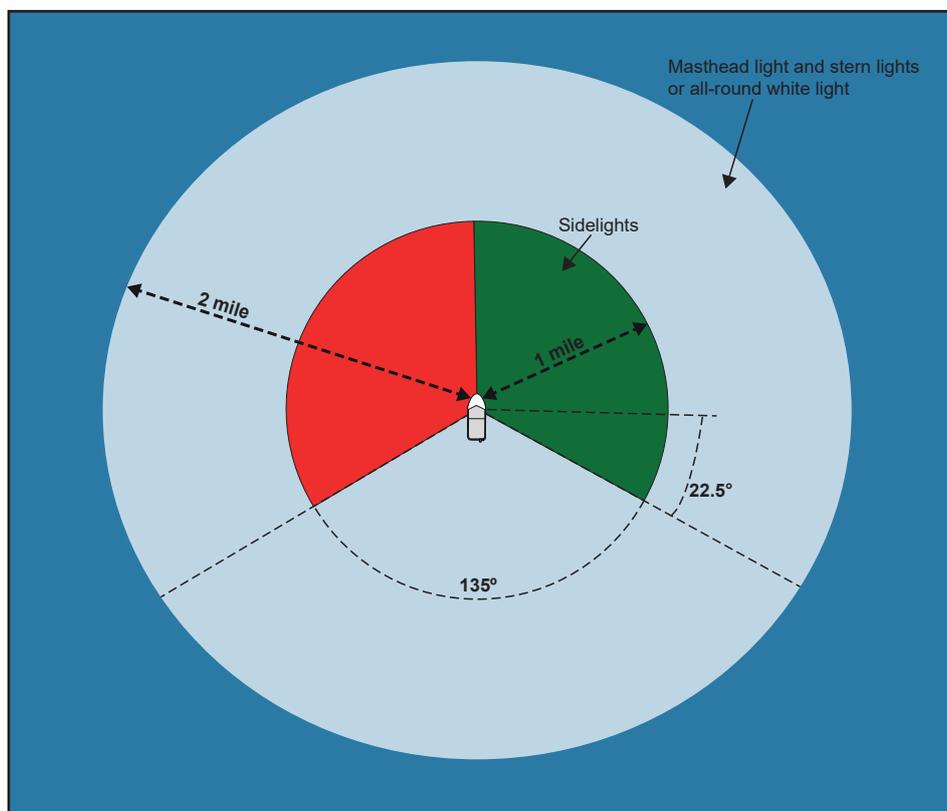
Figure 5: Navigation lights required for a vessel the size of *James 2*

The COLREGS set out the requirements for the visual identification of vessels during the hours of darkness. Power-driven vessels underway<sup>3</sup> are required to display a white masthead light, red and green (port and starboard) sidelights and a white sternlight. The minimum visible range of *Vertrouwen*'s masthead light was required to be 5 miles, and its side and sternlight 2 miles. For vessels less than 12m in length, such as *James 2*, a single all-round white light can be displayed in lieu of the masthead light and sternlight. The minimum range of the white navigation lights should be 2 miles and the sidelights 1 mile. The sidelights should be fixed to show the light from right ahead to 22.5° abaft the beam on its respective side (Figure 5).

*James 2* had port and starboard sidelights and these were on when the boat departed Shoreham (**Figure 2**). It did not have a masthead light, sternlight or all-round white light. Mircea used *James 2*'s forward-facing spotlights to assist his manoeuvre off the pontoon in the marina and out of Riverside Yard, but they were switched off before the vessel entered the lock and left the port. Mircea and Irinel wore LED head torches on the evening of the accident, and they also had hand torches available on board.
