MARINE SAFETY INVESTIGATION REPORT

Safety investigation into the fatality inside the elevator shaft
on board the Maltese registered bulk carrier

ABYO AUDREY

MARINE SAFETY INVESTIGATION REPORT NO. 06/2018

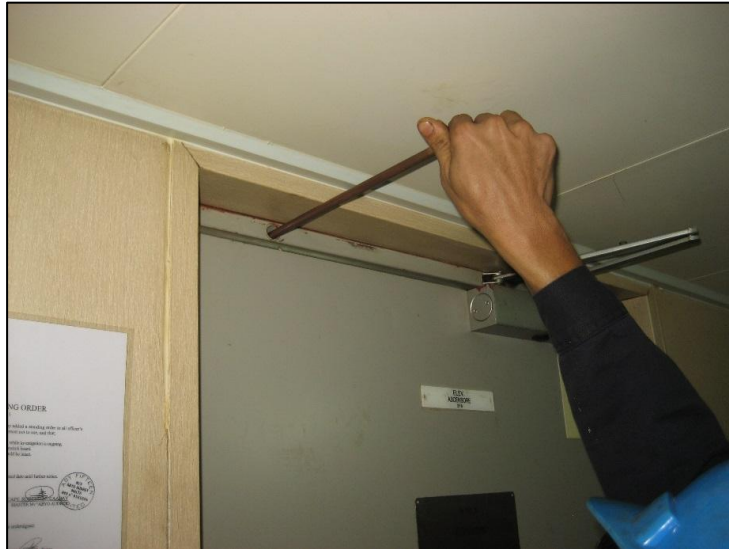
Figure 4: Emergency door tool

The chief engineer asked the electro-technical trainee to indicate the last place of work and they proceeded to the Deck B door, which was shut. Upon opening the door with the emergency tool (Figure 4), they found that the elevator car had moved downwards between decks. The electrician was sighted inside the elevator shaft with his right leg draped over the counterweight and his upper torso trapped between the counterweight and one of the counterweight guard beams.
