Report on the investigation of the
flooding and foundering
of the trawler

Ocean Way (LK207)

18 nautical miles north-east of Lerwick,

on 3 March 2017

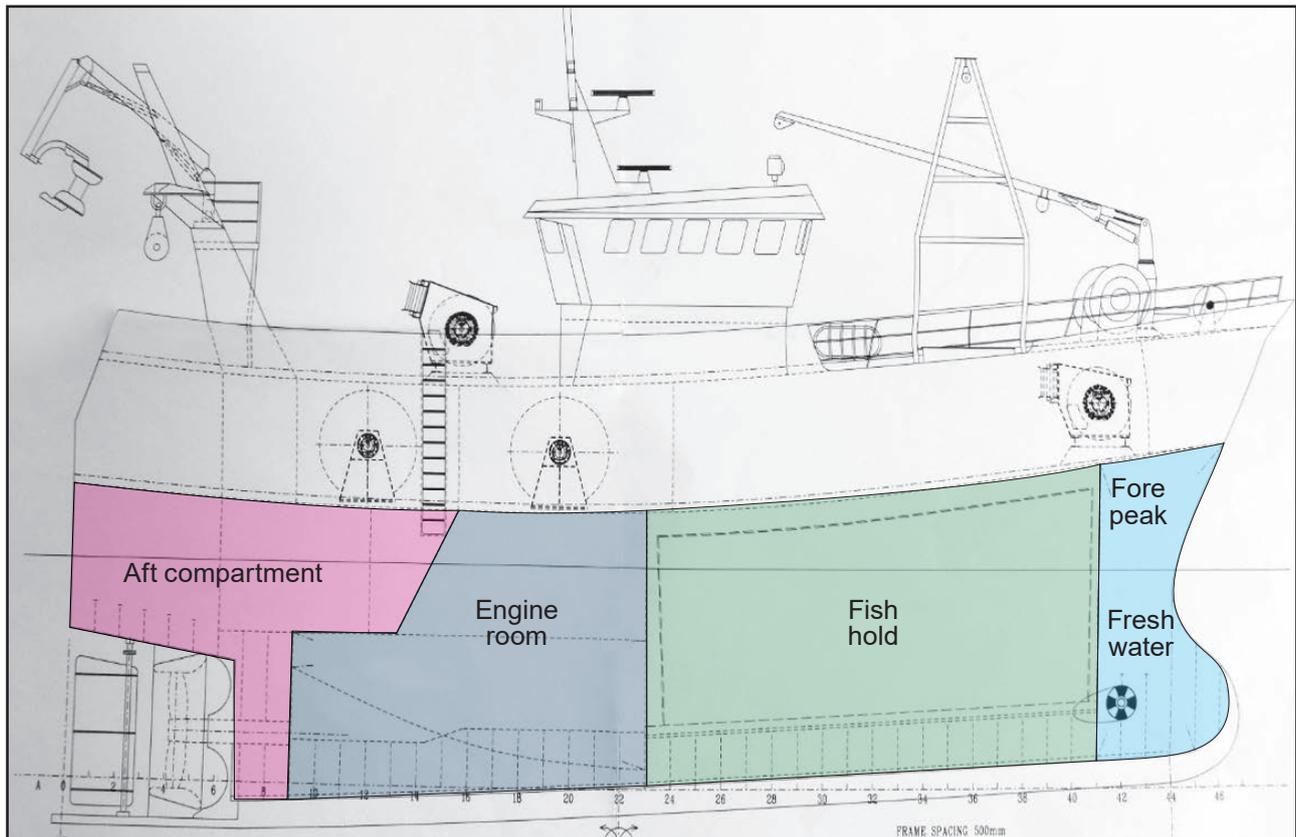
Figure 1: *Ocean Way* – general arrangement

Ocean Way was a twin-rigged stern trawler that operated from its home port of Lerwick. Internally, the vessel was subdivided into four watertight compartments (**Figure 1**). *Ocean Way*'s trawling configuration used three trawl warps to tow two nets and a central clump. The trawl winches had an automatic towing mode that payed out wire in the event of an excessive load. There were five crew on board: a skipper, an engineer and three deckhands. At the time of the accident, *Ocean Way* was engaged in trawling.

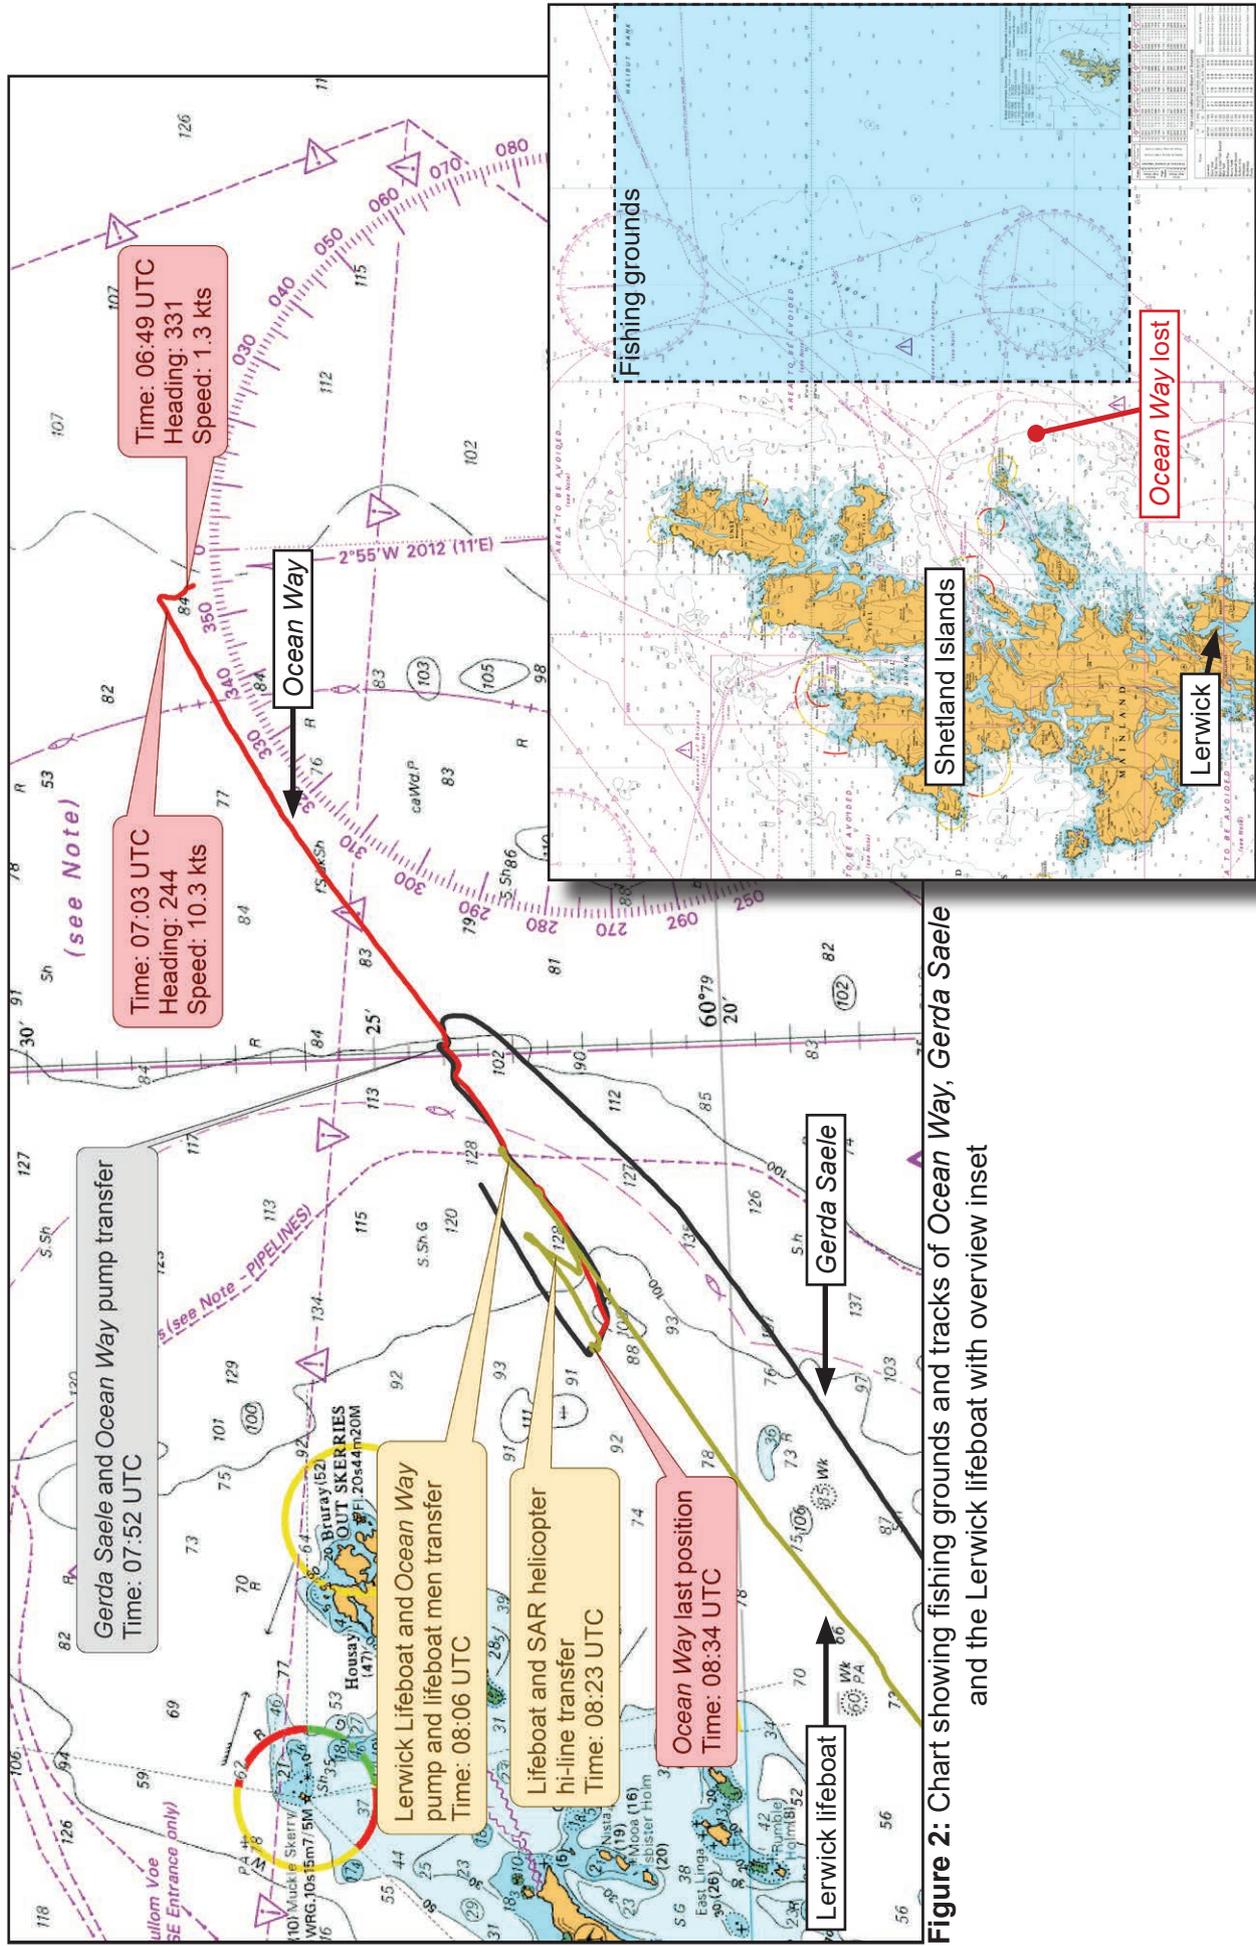
Figure 2: Chart showing fishing grounds and tracks of Ocean Way, Gerda Saele and the Lerwick lifeboat with overview inset

Ocean Way departed from Lerwick at 2100 on 28 February 2017 for fishing grounds east of the Shetland Islands (**Figure 2**). Fishing continued for the following 2 days with the crew conducting routine 6-hour duration trawls. At 0445 on 3 March 2017, the gear was shot away and the crew started sorting the catch from the previous haul.

in the Shetland Islands. The coastguard also alerted other vessels in the area. The Norwegian registered live fish carrier, *Gerda Saele*, which was 17.5nm away to the south-west, responded by VHF radio and started heading towards *Ocean Way*'s position (**Figure 2**).

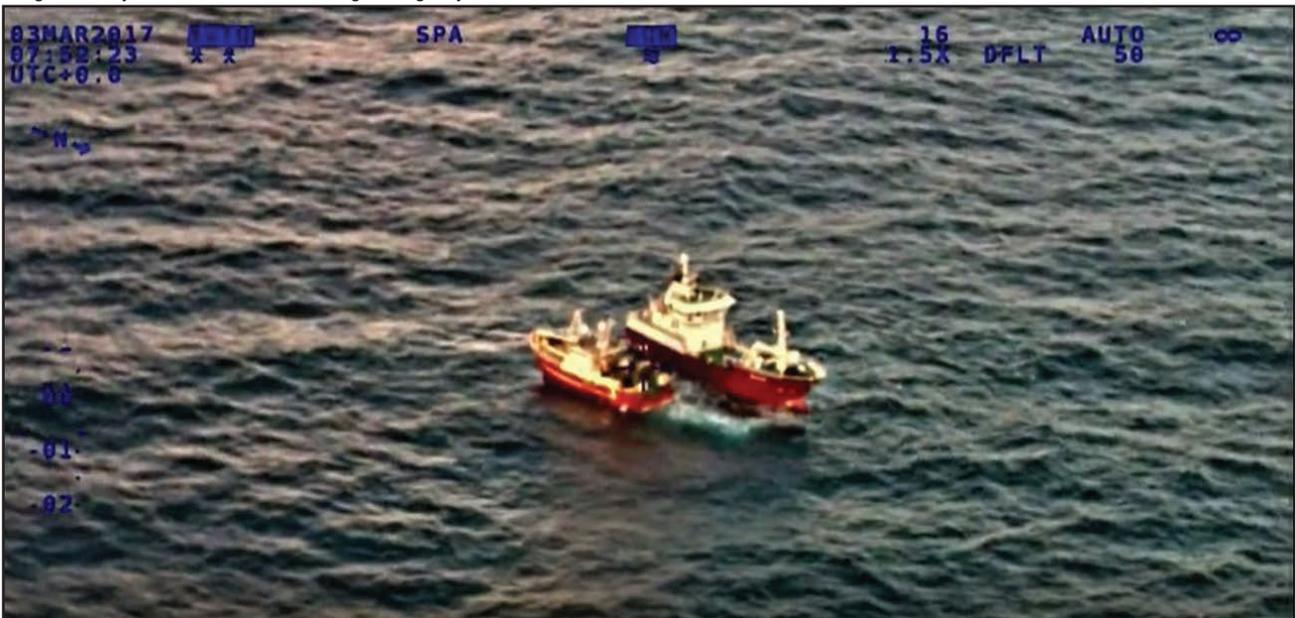
Figure 7: *Gerda Saele* alongside *Ocean Way* to transfer its portable pump

By 0703 *Ocean Way*'s crew had finished recovering the nets back on board so the skipper increased speed to the boat's maximum of 10kts and started heading south-west directly towards Lerwick. At 0745 *Gerda Saele* arrived on scene (**Figure 7**) and came alongside *Ocean Way* to transfer its portable pump³. *Gerda Saele*'s portable submersible pump was then rigged at the aft compartment escape hatch to evacuate floodwater from the aft compartment. After this, *Ocean Way*'s portable submersible pump stopped working⁴.

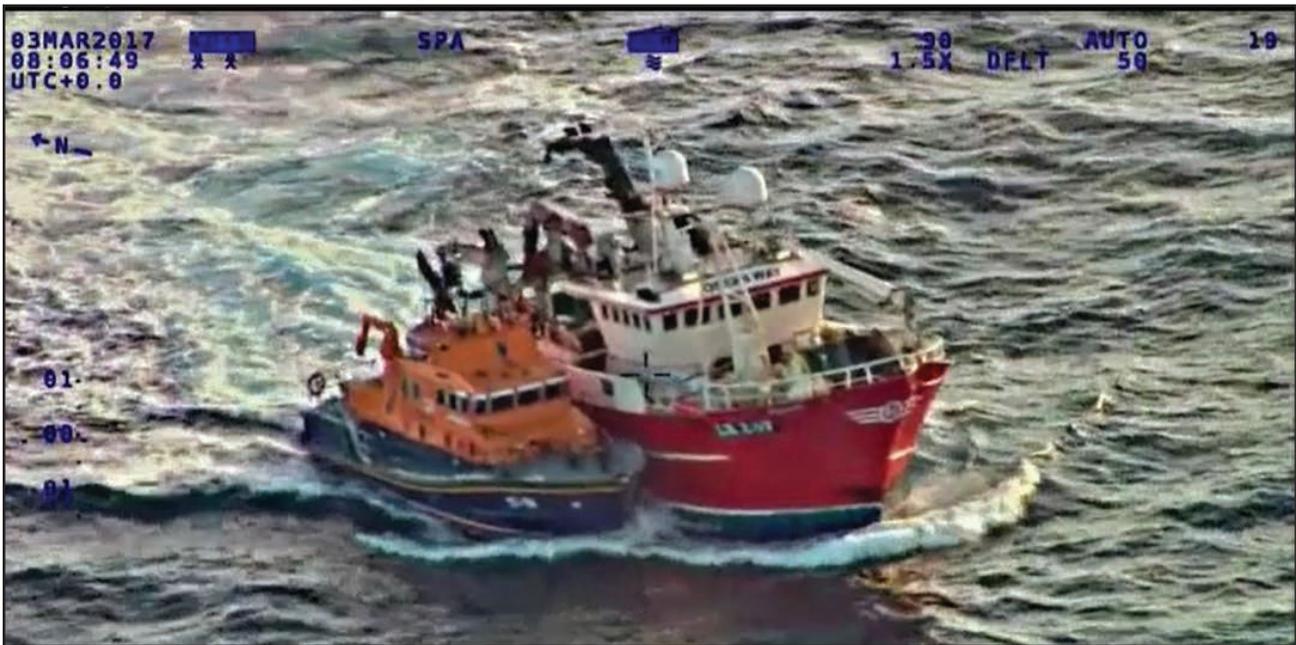
Figure 9: The Lerwick lifeboat alongside *Ocean Way* to transfer its salvage pump and two lifeboat men

The lifeboat arrived at 0804 and came alongside *Ocean Way* to transfer two crew members⁶ and a diesel-driven salvage pump⁷ (**Figure 9**). Once the RNLI crew members were on board *Ocean Way*, they set up their salvage pump at the aft compartment escape hatch. The lifeboat was then turned north-east, opening away from *Ocean Way*, in preparation for a high-line transfer of the helicopter's salvage pump.

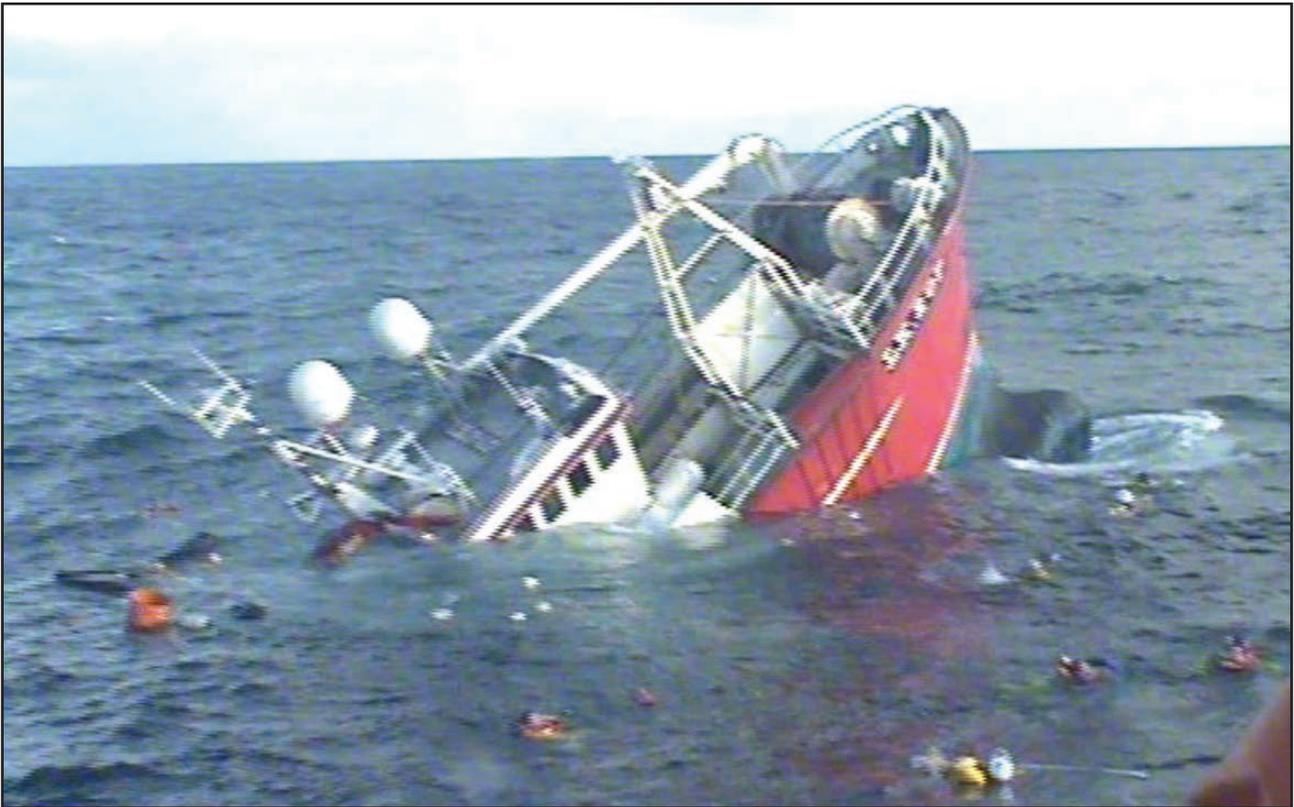
Figure 11: *Ocean Way* – final sighting

Ocean Way foundered at 0834 (**Figure 11**); both its hydrostatically operated liferafts were released to the surface and automatically inflated; the electronic position indicating radio beacon (EPIRB) also activated. Before leaving the scene, the lifeboat crew punctured the liferafts in order that they would sink, and the helicopter reported sighting some oily pollution at the surface where *Ocean Way* had sunk. The lifeboat arrived back in Lerwick at 1000, where *Ocean Way*'s crew were assessed by paramedics; there were no injuries.

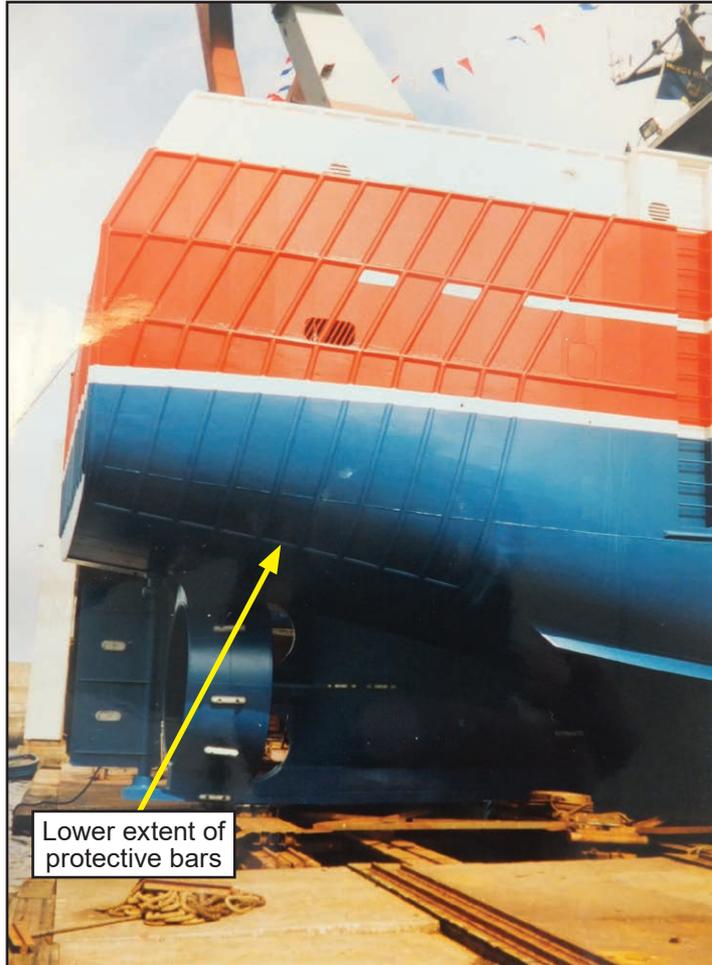
Figure 12: *Ocean Way*, then named *Copious*, prior to first launch showing protective bars at the stern area

The shell plating was 8 millimetre (mm) Grade A steel, increasing to 10mm thickness in the transom and gallows areas. Protective bars were welded around the hull at the main deck levels and, below the waterline, to half way around the rounded hull section adjacent to the gallows (**Figure 12**). A hull thickness survey in 2014 showed that there had been no significant loss of hull thickness.

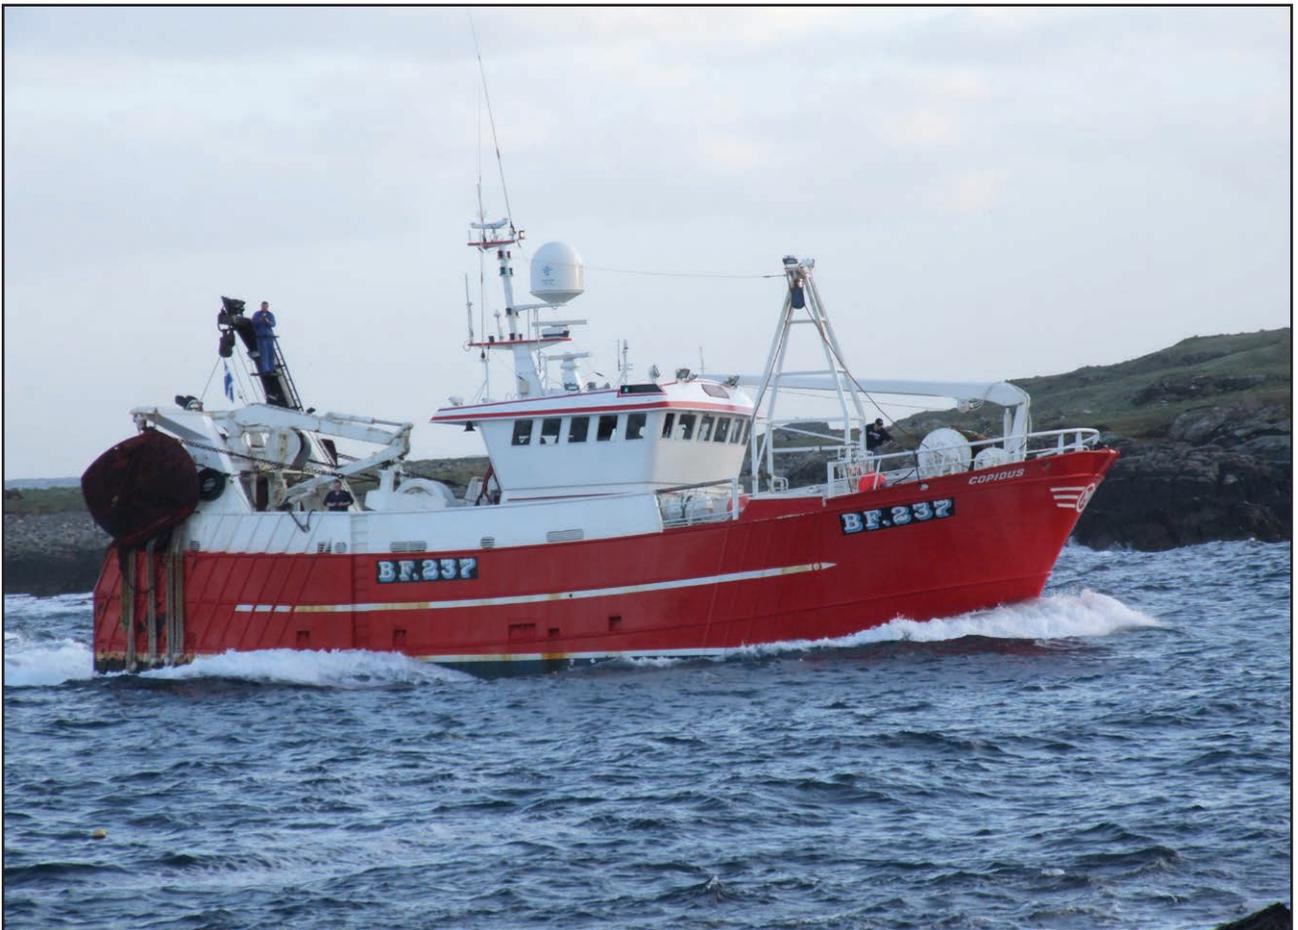
Figure 14: *Ocean Way*, then named *Copious*, with original oval trawl doors

Ocean Way's original trawl doors (**Figure 14**) were oval in shape, and these had been replaced with Thyborøn Type 12D doors (**Figure 15**). The Thyborøn trawl doors were constructed of a high tensile steel, and three of the four corners were sharp edged.
