## Catastrophic engine failure, resulting in a fire and serious injuries to the engineer on board *Wight Sky*, off Yarmouth 12 September 2017

### SUMMARY

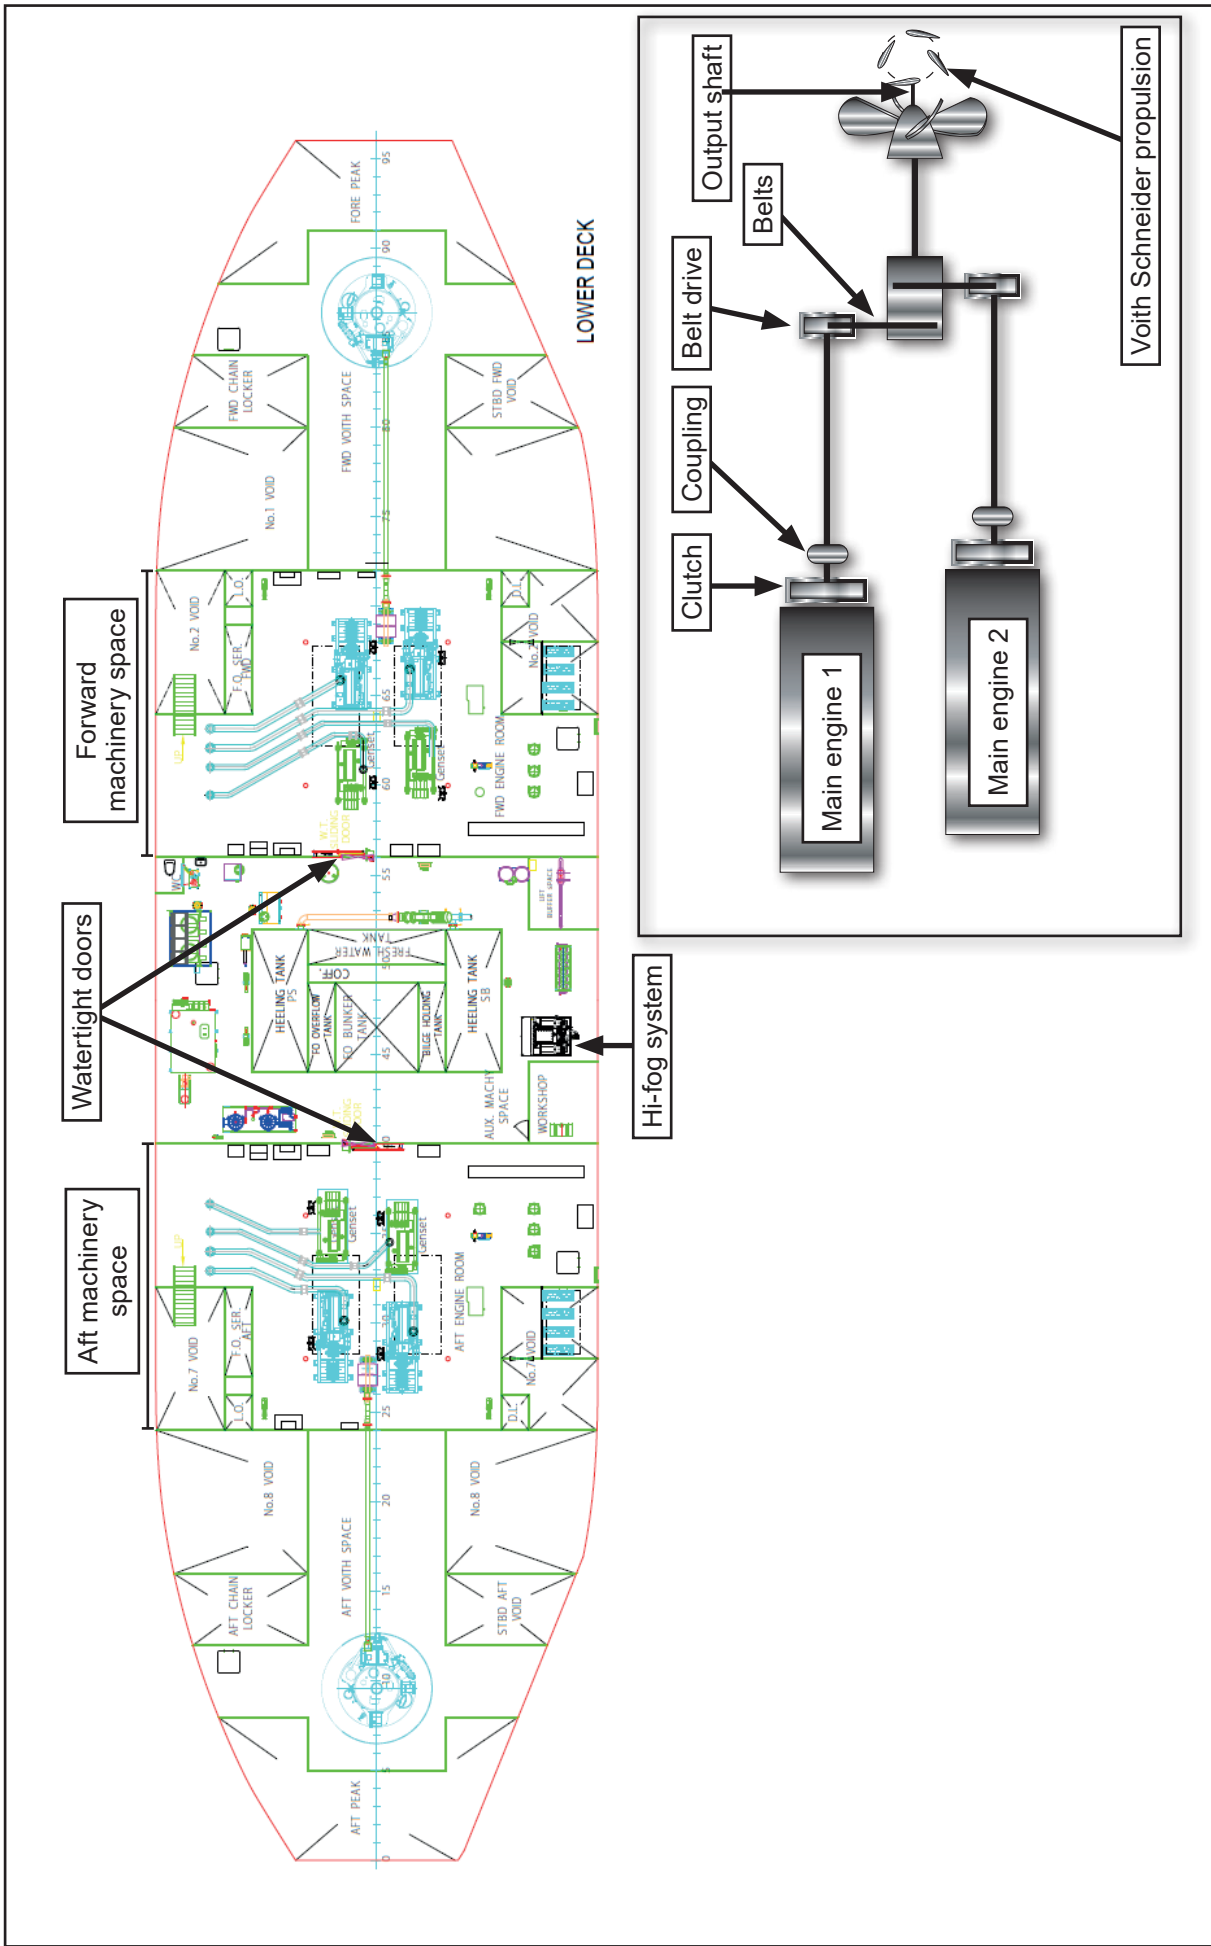
Figure 4: General arrangement of machinery spaces

*Wight Sky* had a Voith-Schneider cycloidal propulsion unit at each end of the vessel. Each propeller shaft was belt-driven by a pair of Volvo Penta D16C-A MH, six-cylinder engines, with an output of 485kW per engine at 1800rpm<sup>5</sup>. ME1 and ME2 were located in the forward engine room and ME3 and ME4 in the aft engine room. The Hi-fog fire-extinguishing system with its tanks, pumps and release switches was located in the space between the two engine rooms (**Figure 4**).
