Report on the investigation of the
fatal man overboard from fishing vessel

North Star

16nm north of Cape Wrath, Scotland

5 February 2018

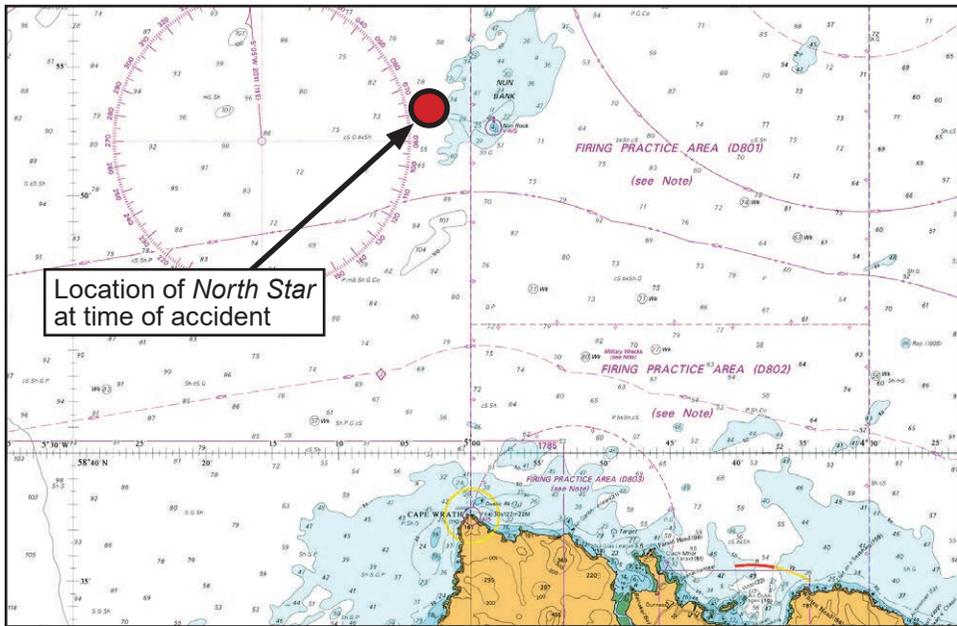
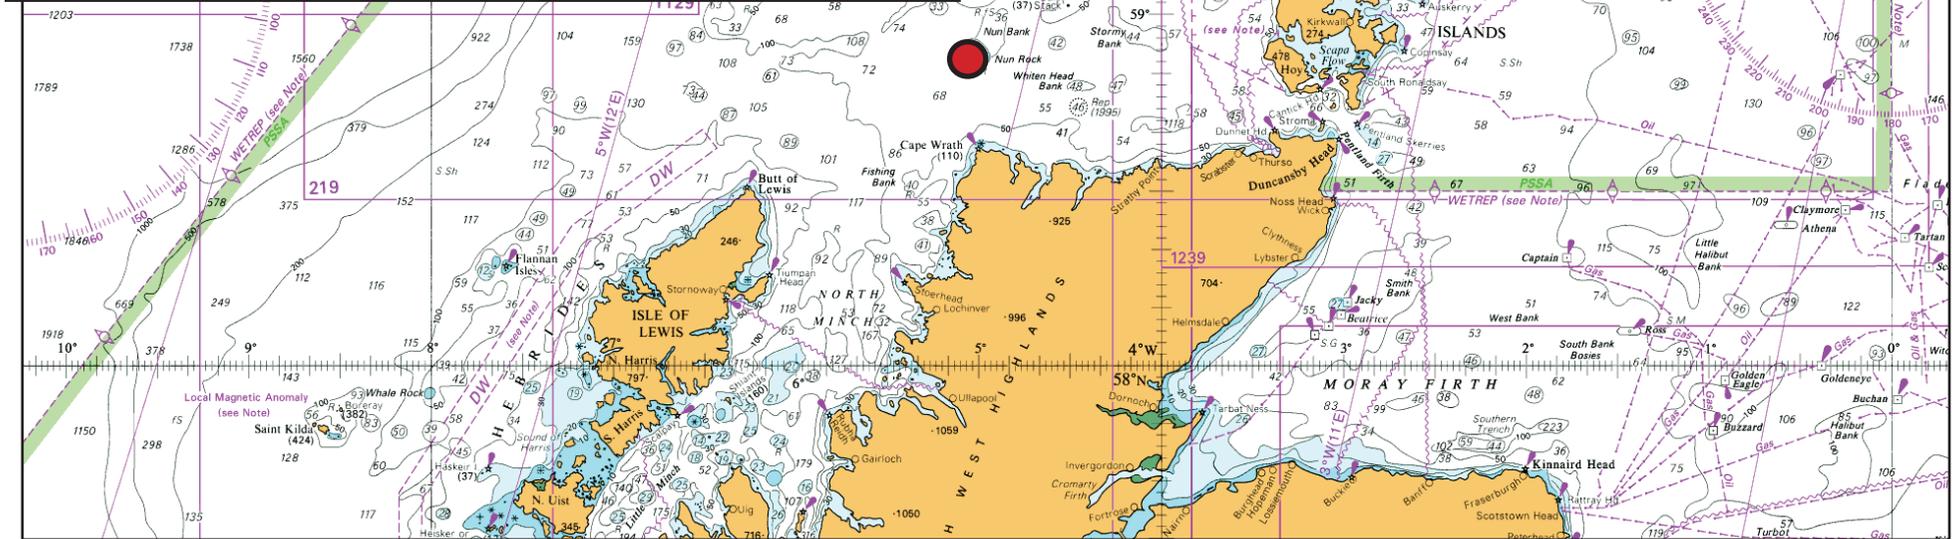
Figure 3: BA Chart 002 showing the location of *North Star* at the time of the accident, with inset of location on BA Chart 2720

At about 1815 on 5 February *North Star* was approximately 16nm north-west of Cape Wrath (**Figure 3**), following a north-easterly course at a speed over the ground (SOG) of 5 knots (kts). Its engine throttle was set to 'ahead'. The four deckhands were on the working deck (**Figure 2**) manually shooting a fleet of creels when the skipper heard a shout of "Easy"¹ over the tannoy. In response, he placed the engine throttle to 'neutral', and *North Star*'s SOG gradually reduced, although the vessel continued to make headway.
