Report on the investigation into
the capsize and foundering of the fishing vessel
Solstice (PH199)
resulting in one fatality
approximately 7 miles south of Plymouth, England
26 September 2017

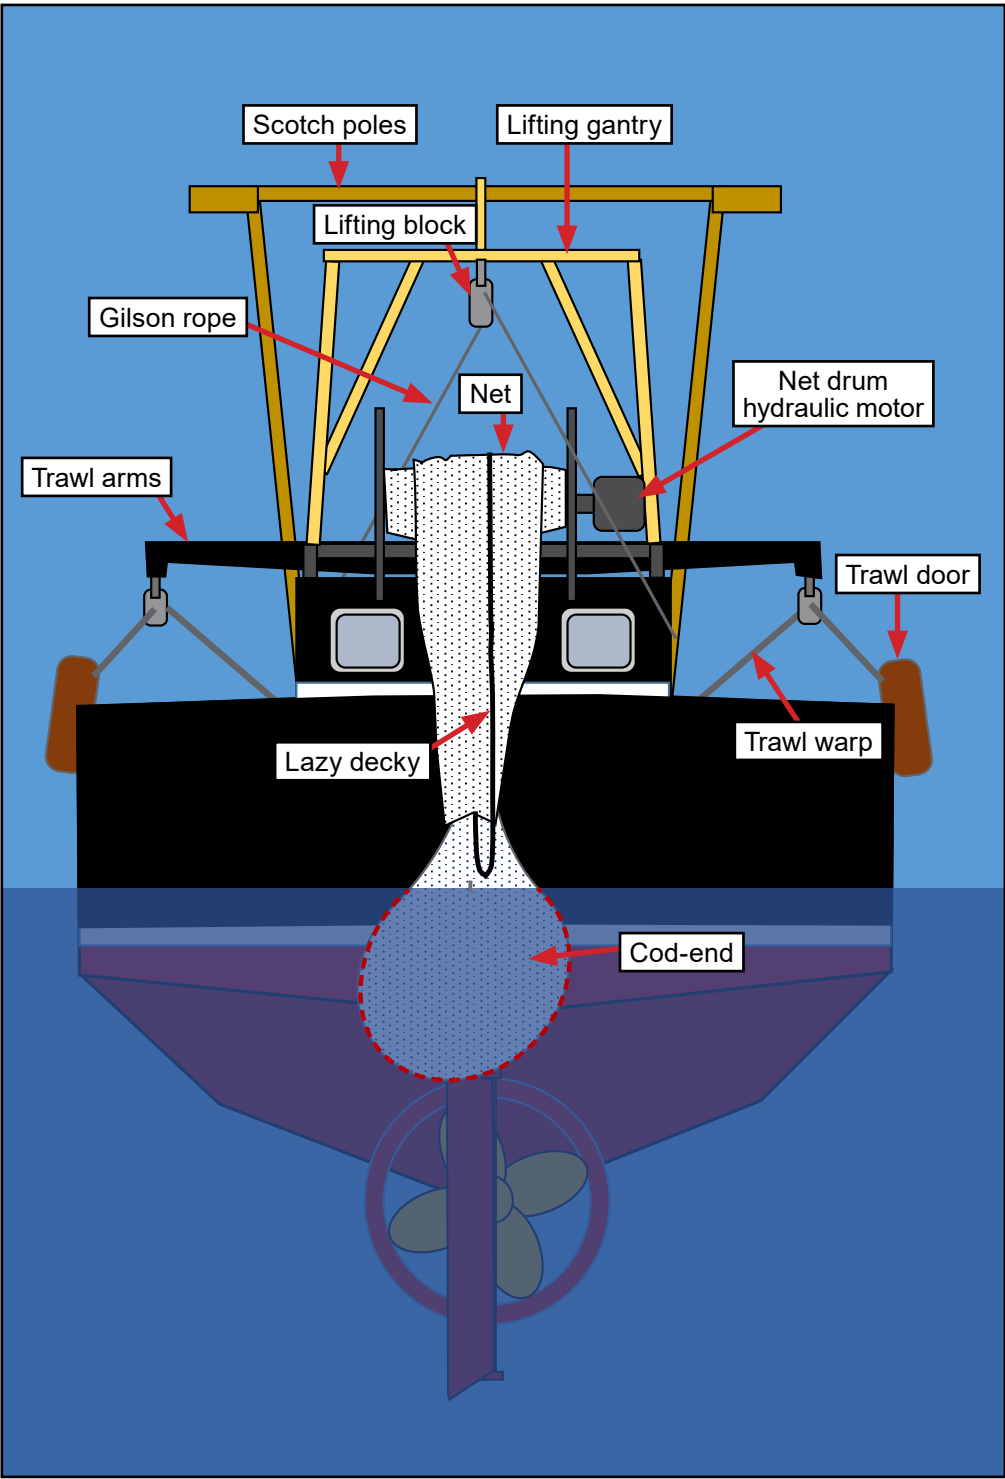
Figure 4: Recovery of cod-end – view from astern

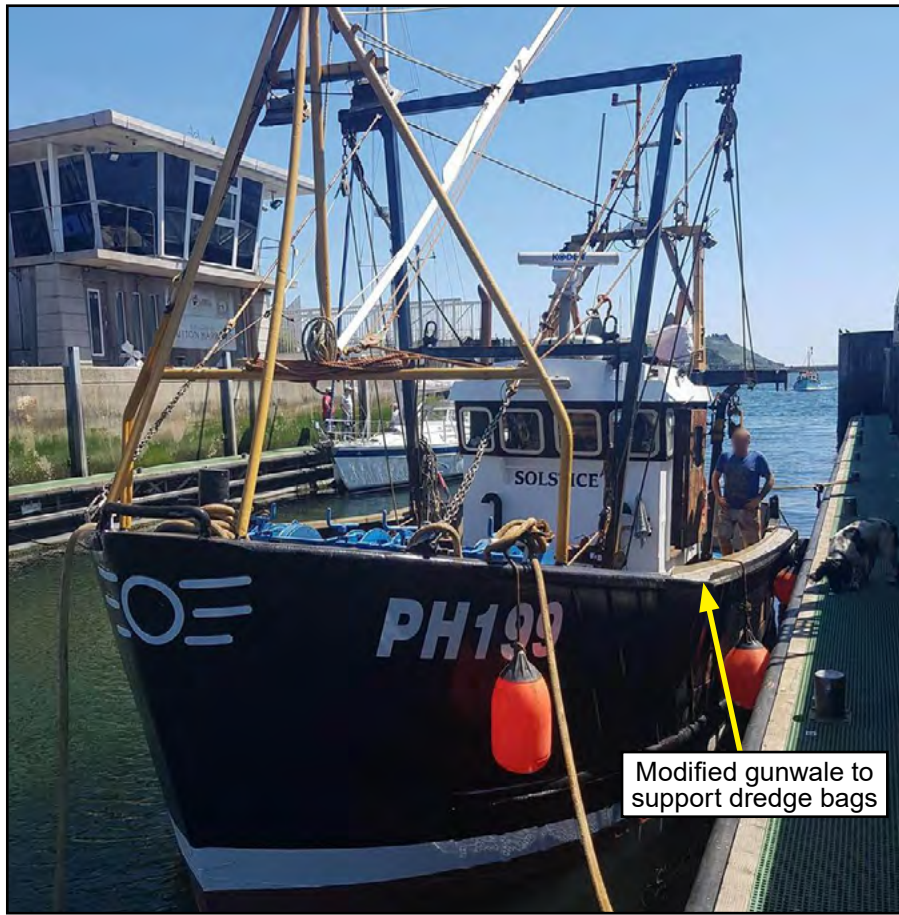
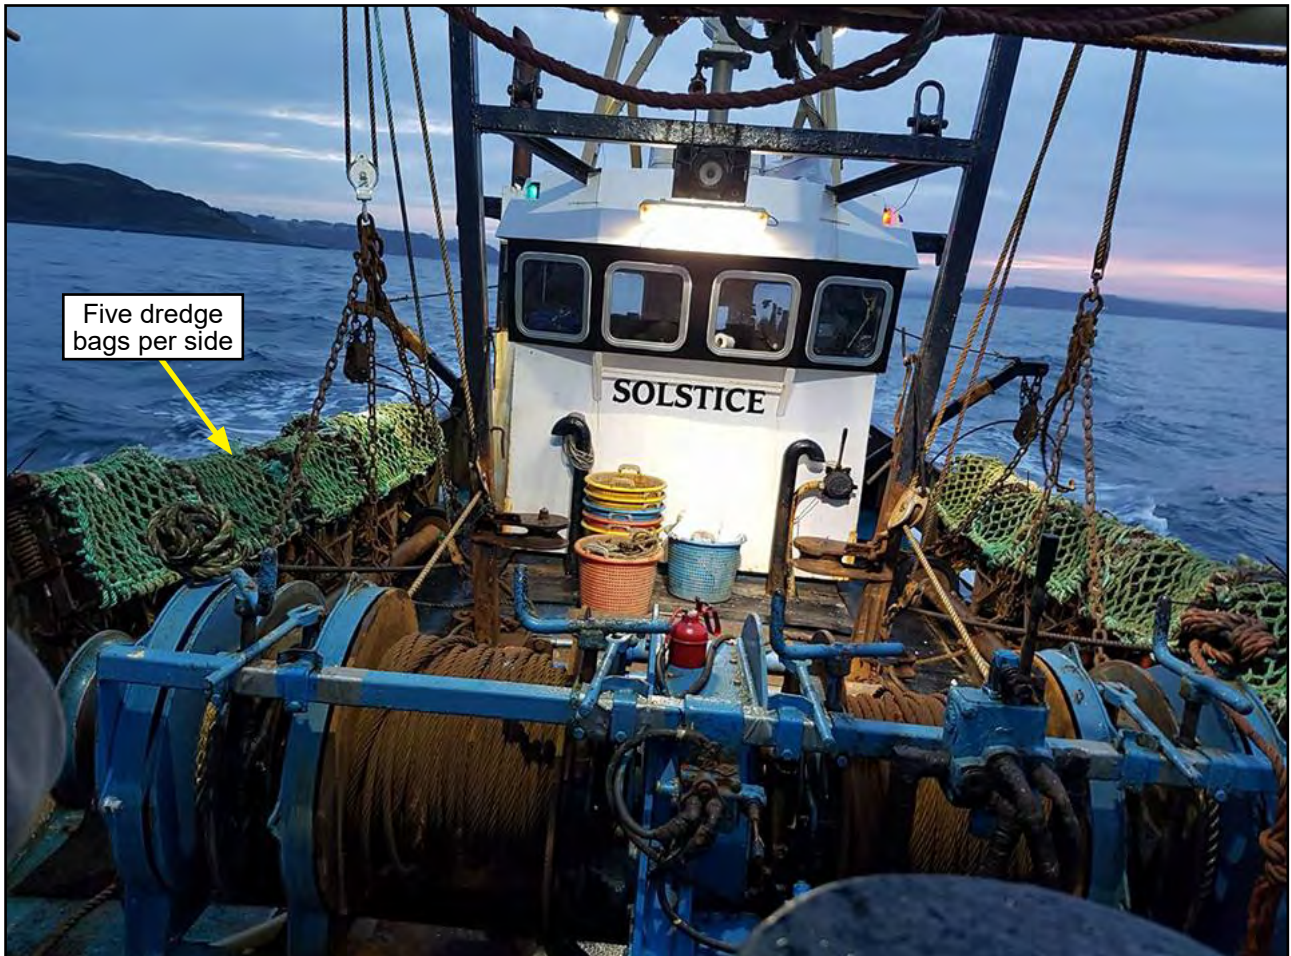
Between 23 May and 18 June 2017, modifications were made to *Solstice*'s bulwarks and dredge gear to improve working methods and increase the vessel's catch. Longer dredge beams with five bags instead of four were fitted and larger steel trays for landing the dredge bags were welded to the top of the forward deck gunwales (**Figure 16**).

Figure 16: Modifications carried out to *Solstice* in 2017 to improve dredging method

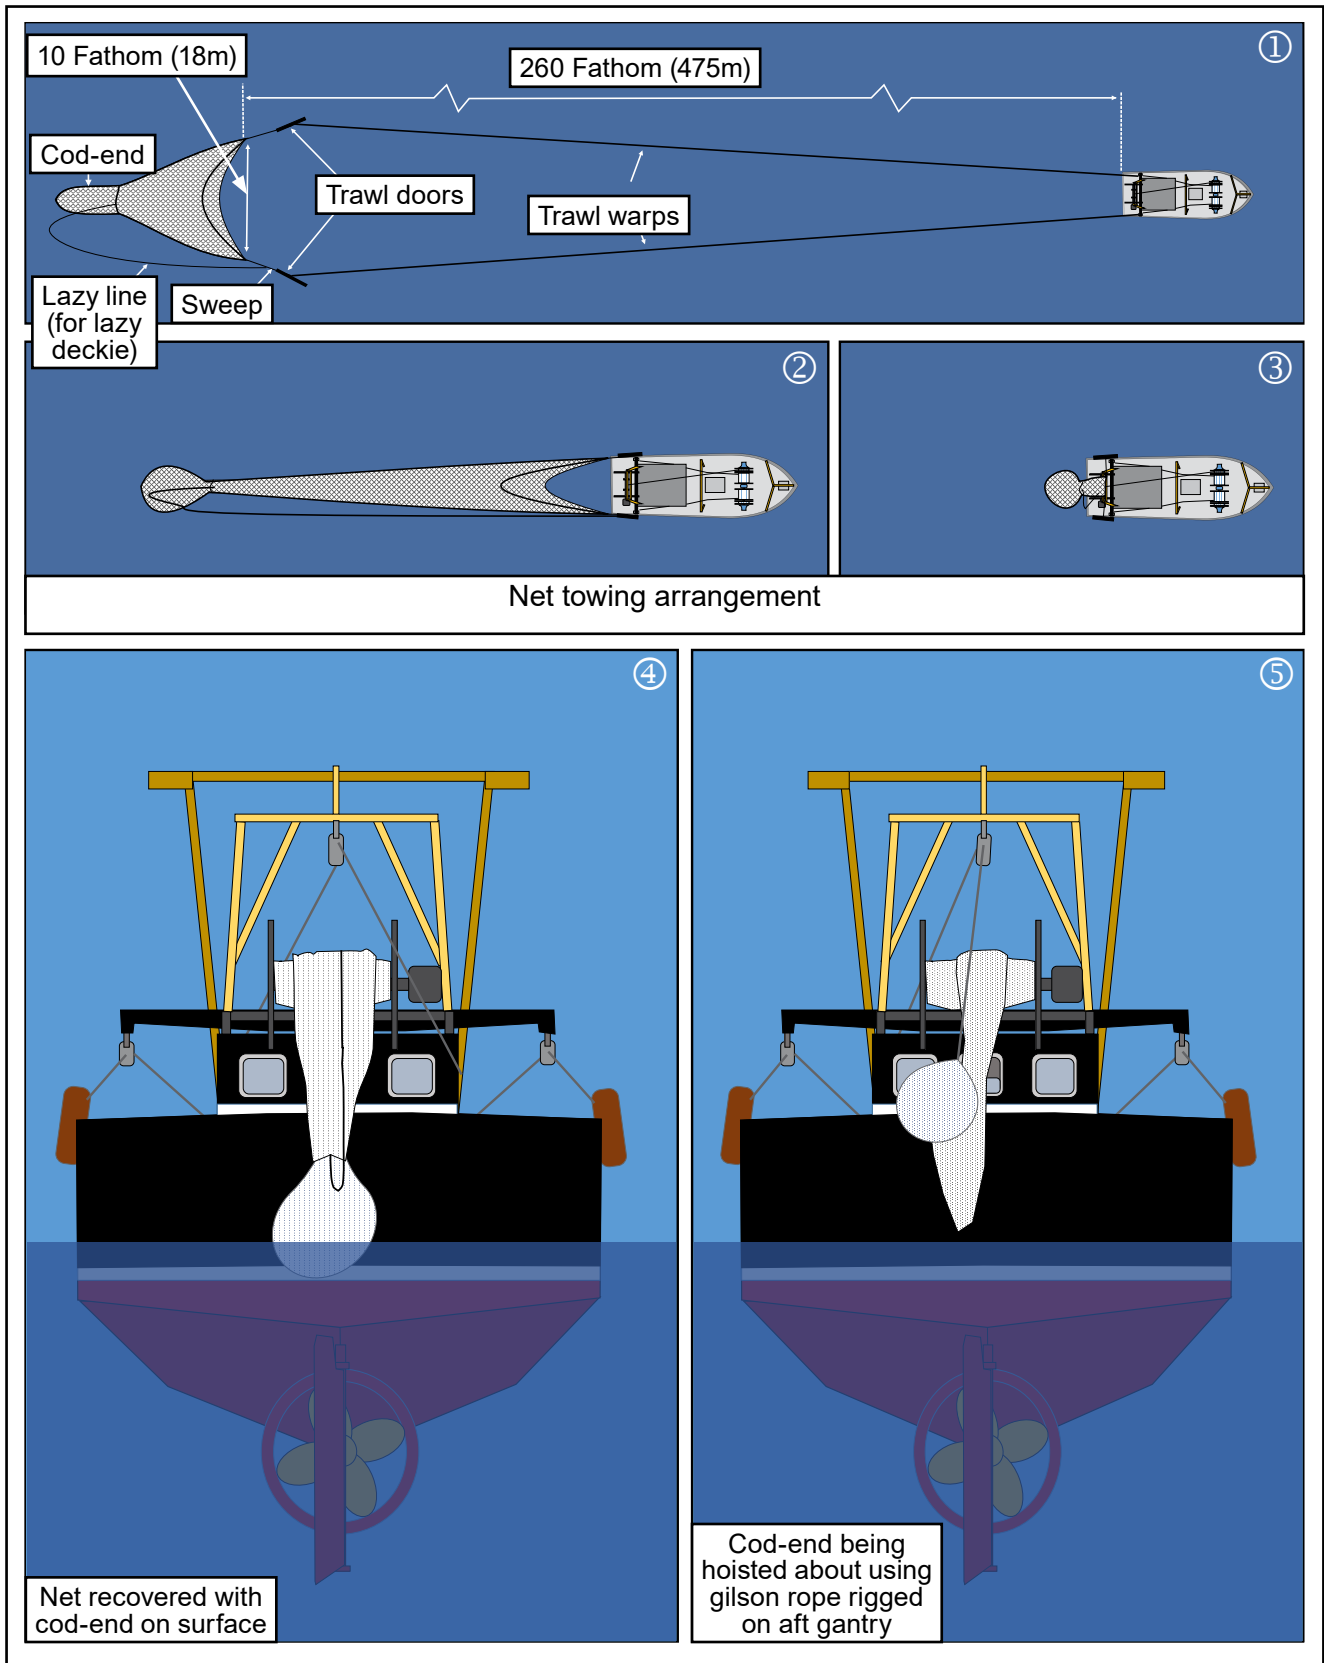
Solstice did not have a written risk assessment or safe system of work for trawling. The method (**Figure 17**) used by Tony to land the catch involved recovering the net over the stern and emptying the cod-end onto the deck area aft of the wheelhouse. To do this, the forward winch was used to haul in the trawl warps and sweeps. Once the trawl doors were secured, the net drum was used to haul the cod-end to the surface. The cod-end was then lifted over the stern deck bulwark using the deck winch and a gilson rope. The gilson rope was rigged through the block at the top of the aft gantry. The cod-end was emptied onto the aft deck between the pound boards (**Figure 18**). Once landed, the catch was processed, boxed up and taken forward to the fish hold.

Figure 17: Solstice net towing and catch recovery method

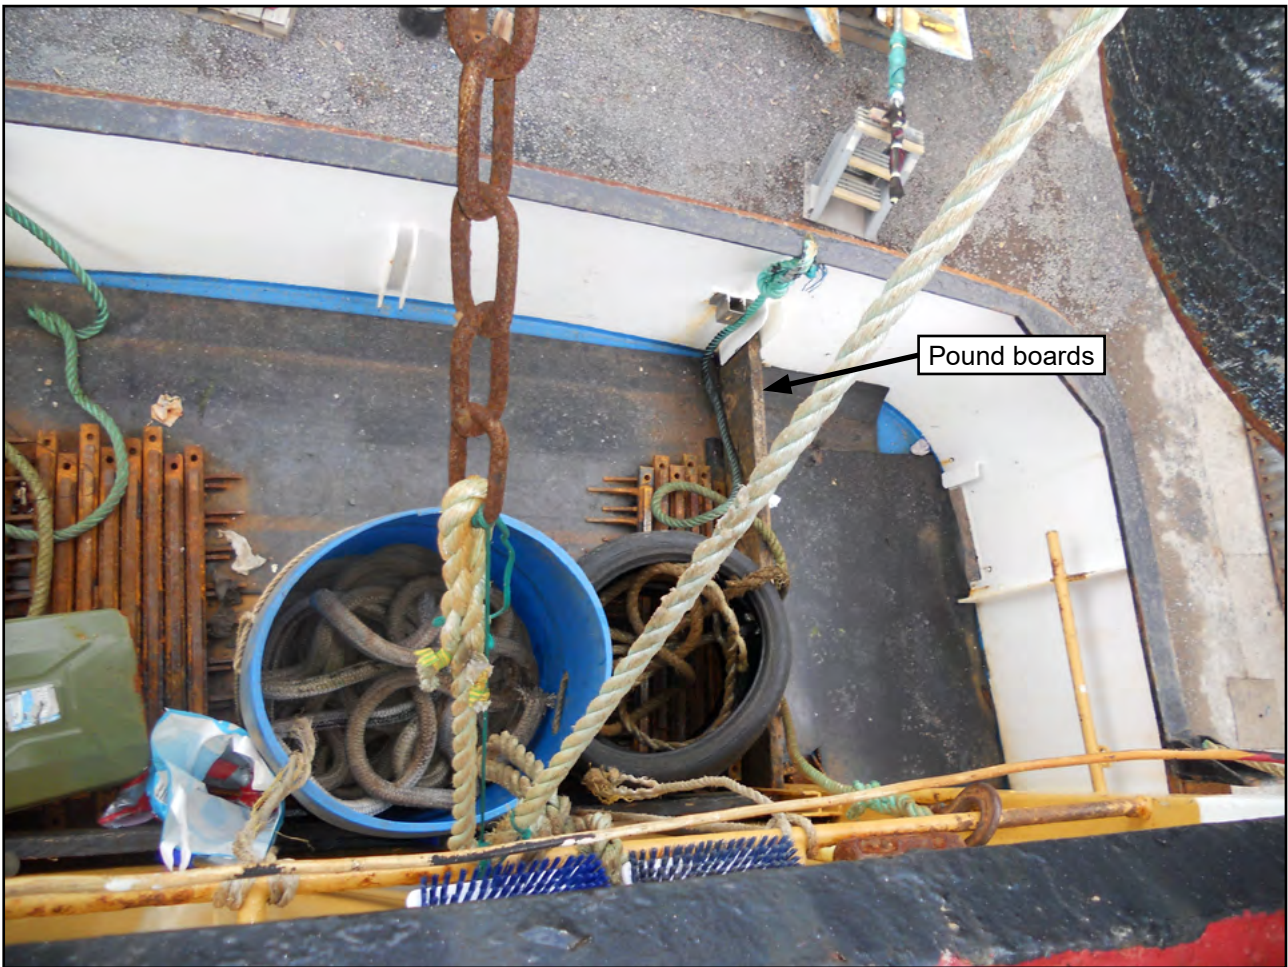
Figure 18: Aft deck

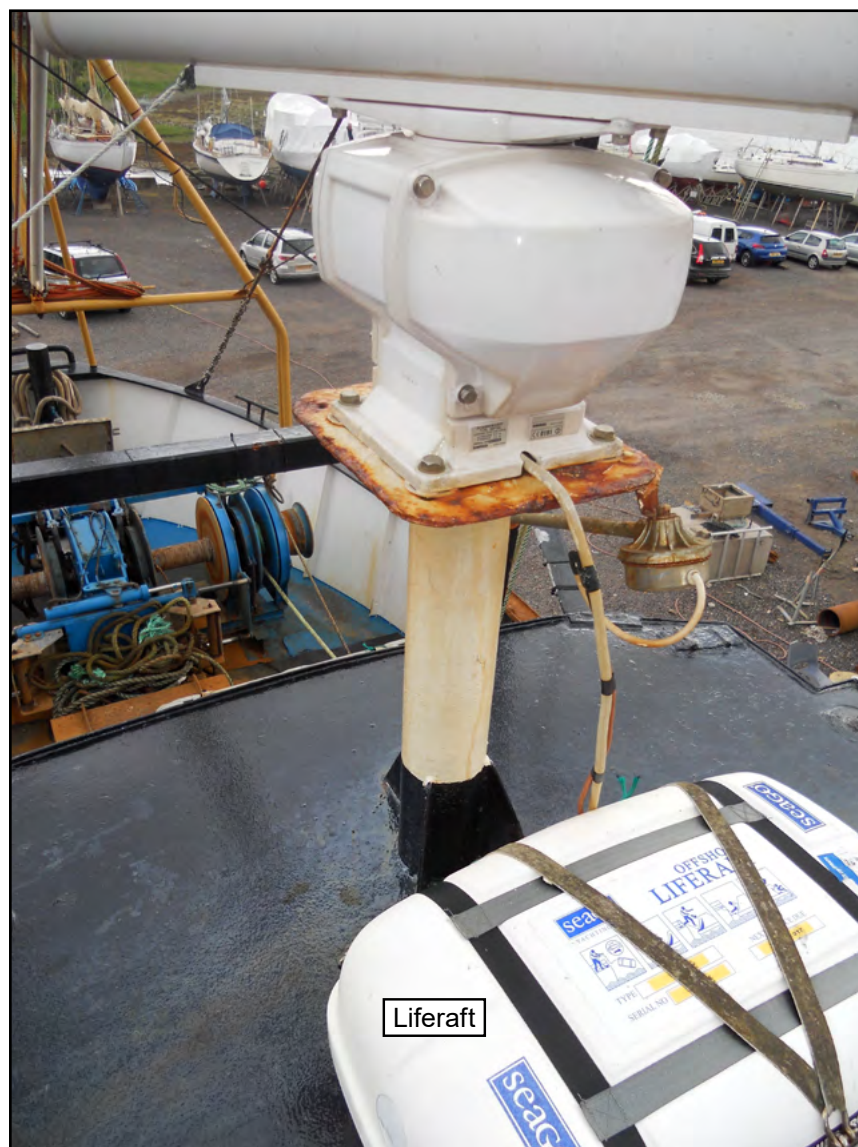
Solstice had two lifebuoys, one each side of the wheelhouse; the starboard lifebuoy had an 18m buoyant line. The vessel also had a four-person *Seago Offshore* liferaft that was stowed in a cradle on top of the wheelhouse roof (**Figure 19**) and secured in place by a hydrostatic release unit (HRU). The liferaft was on board when Tony purchased the boat and was overdue its periodic service (the service due date was May 2017).

Figure 19: Liferaft on top of wheelhouse

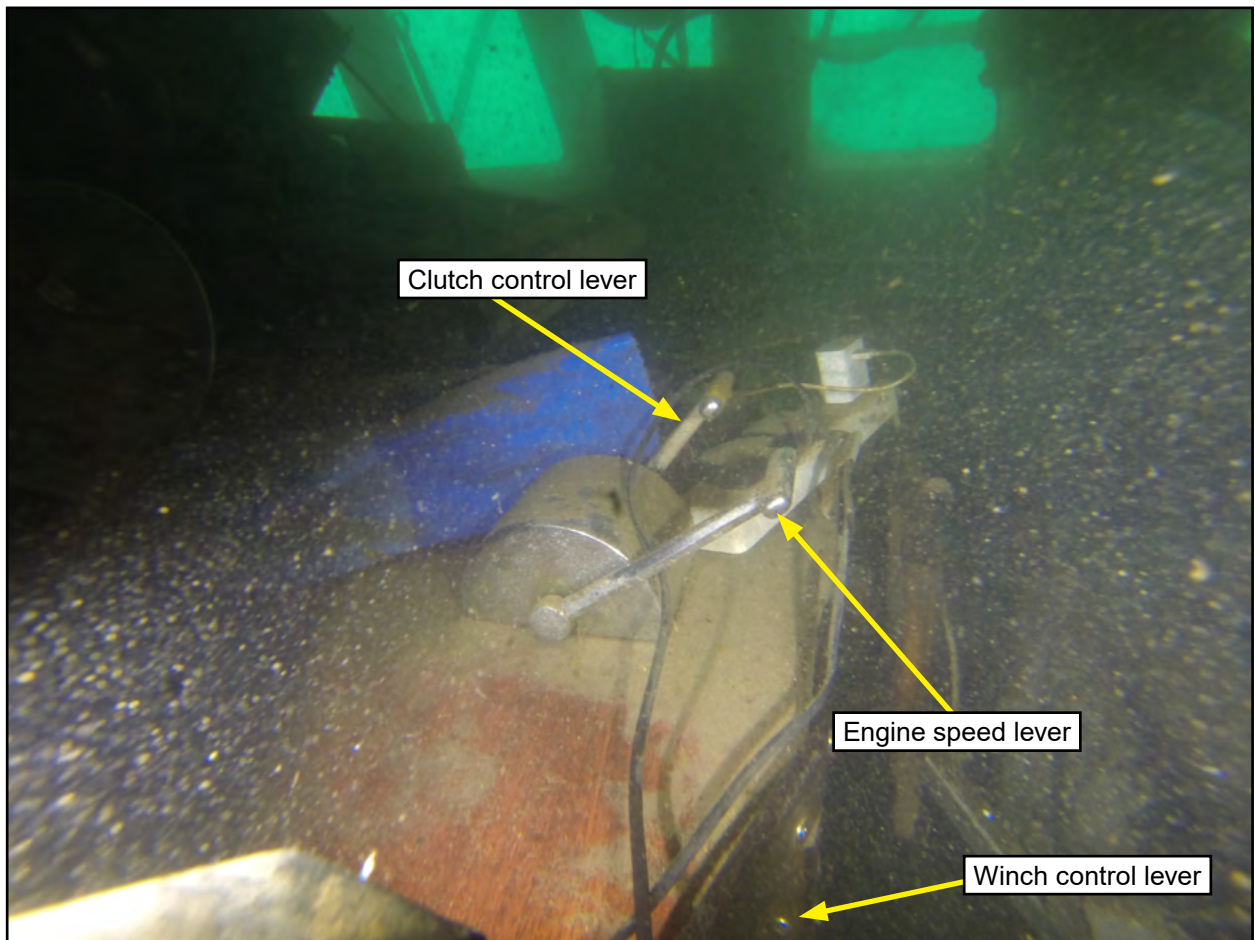
Figure 22: Wreck showing wheelhouse engine control

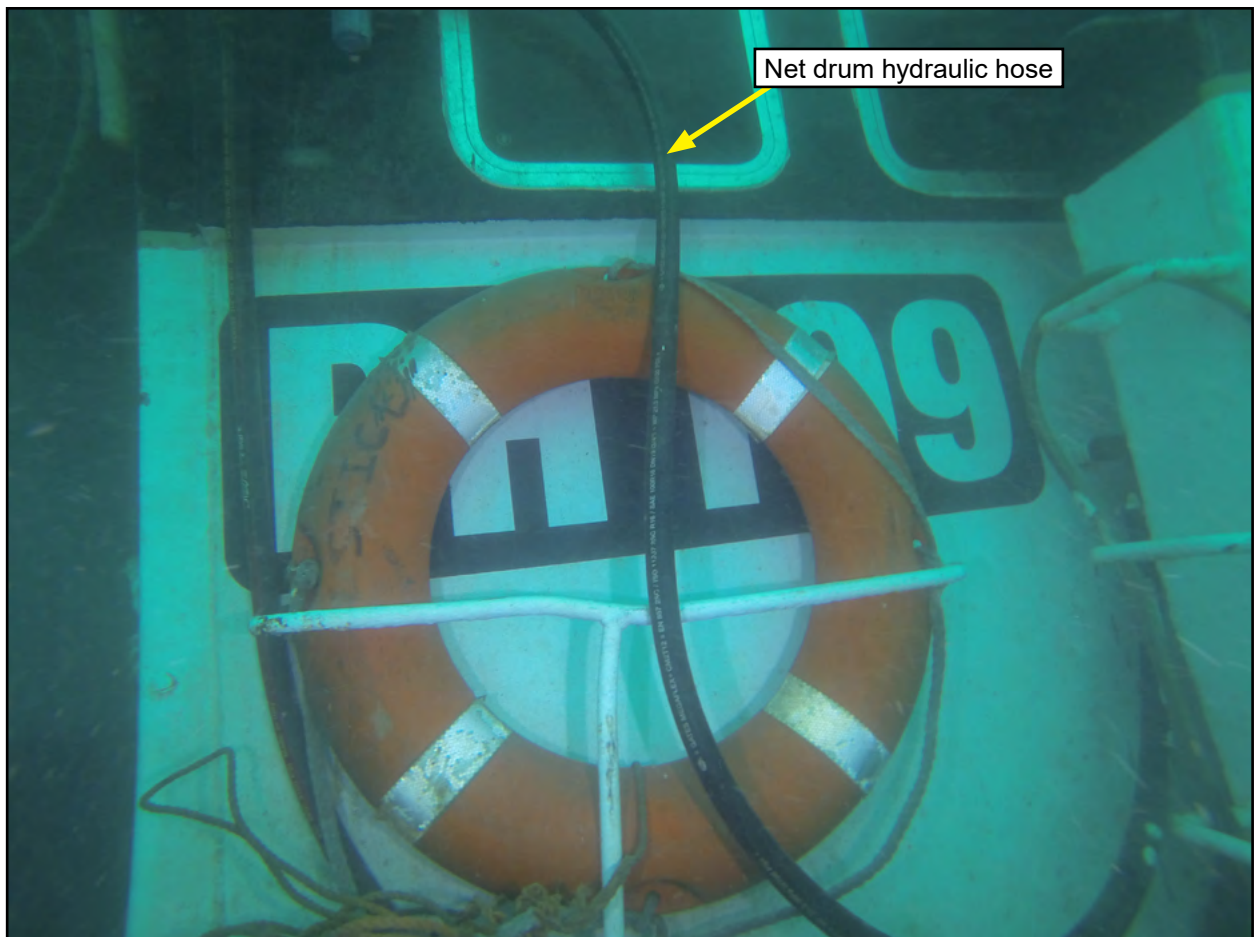
Figure 23: Wreck showing starboard lifebuoy

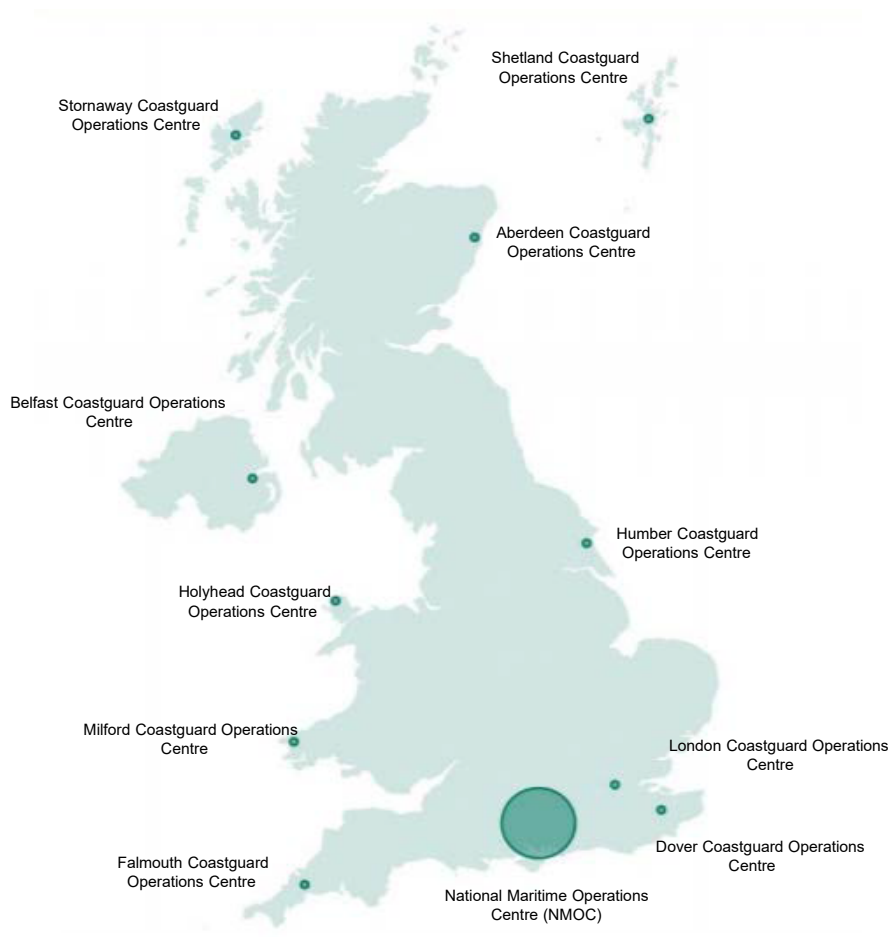
Figure 26: Locations of regional CGOCs and suggested staffing levels

Solstice capsized during the medium demand period and was reported overdue during the daytime shift. According to HMCG's suggested staffing levels (**Figure 26**), the minimum number of coastguard officers available for SAR on the network and on duty at Falmouth CGOC should have been 34 and 3 respectively. When the report was received, there were 38 coastguard officers on duty across the network and 2 coastguard officers in the Falmouth CGOC. The Milford Haven and Aberdeen CGOCs were also staffed by two operators; one below their suggested seasonal staffing levels.

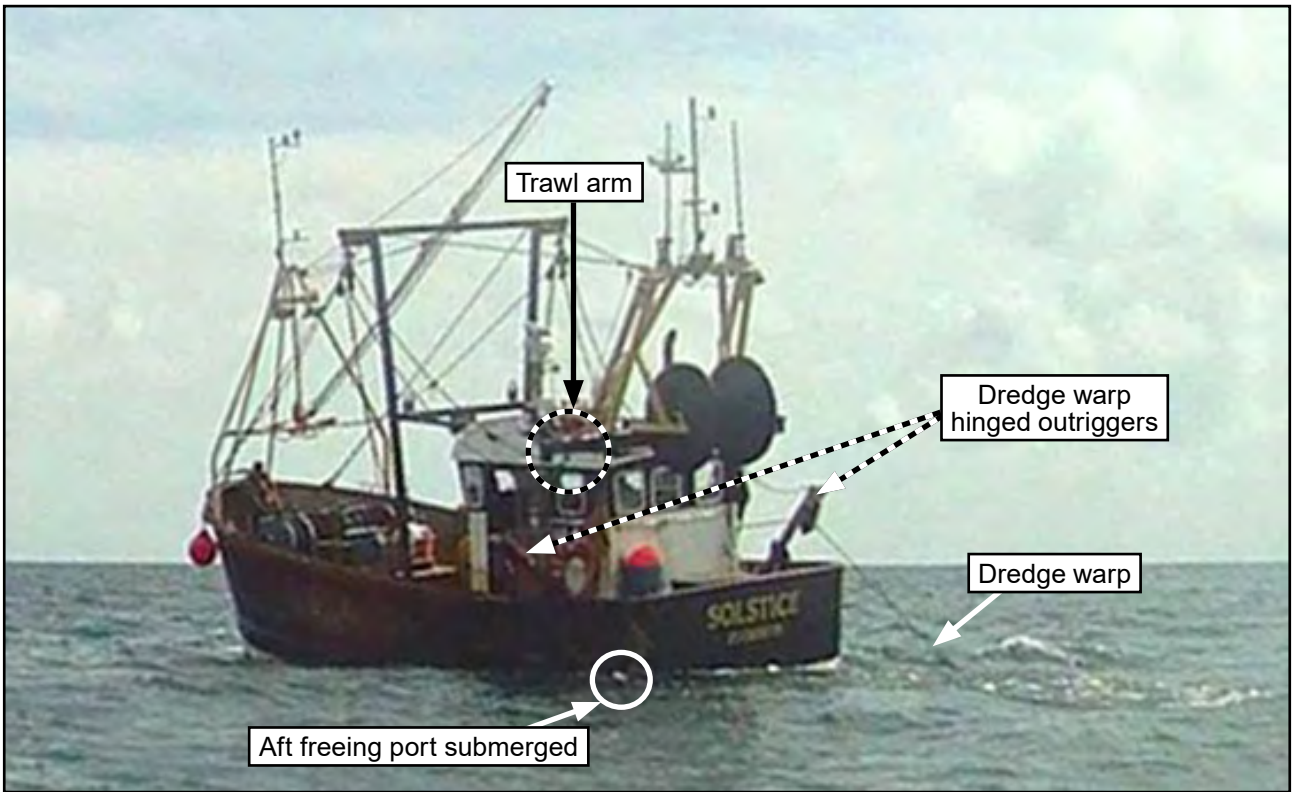
It was not unusual for water to wash onto *Solstice's* deck through its aft freeing ports when towing its dredge gear. This was due to the reduction of freeboard aft as the vessel trimmed by the stern (**Figure 33**).

Figure 33: *Solstice* trimmed by the stern and heeling to port

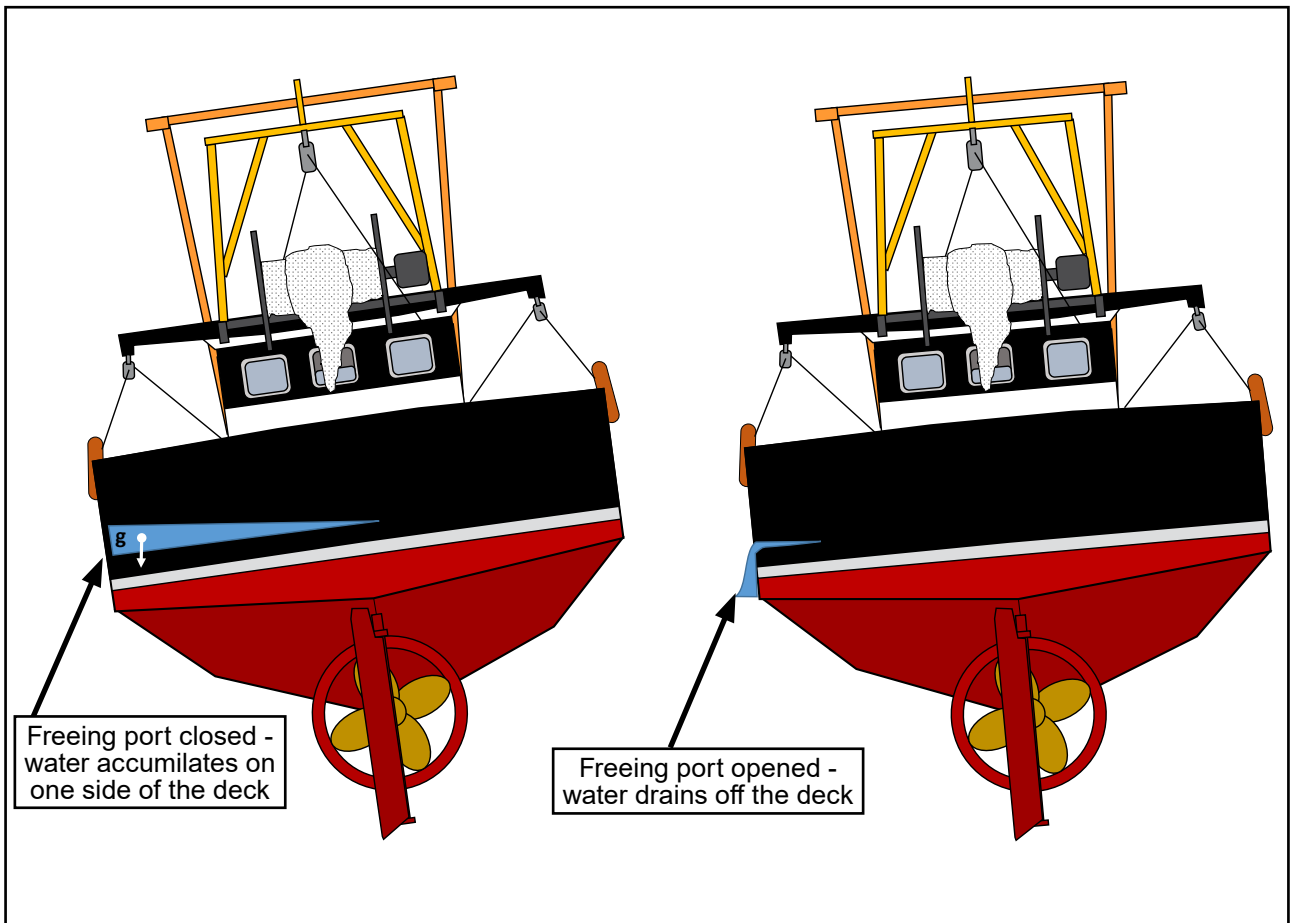
Water on deck presents a serious stability hazard. Not only will the weight of the water reduce the vessel's freeboard and raise its VCG, but it will also introduce a 'free surface effect' as it sloshes across the deck (**Figure 34**). It is therefore essential that water is moved off the deck as quickly as possible. This is achieved by the provision of freeing ports in the bulwarks. Freeing ports must be of sufficient size and should never be closed or blocked, especially during critical fishing operations and in bad weather.

Figure 34: Free surface effect

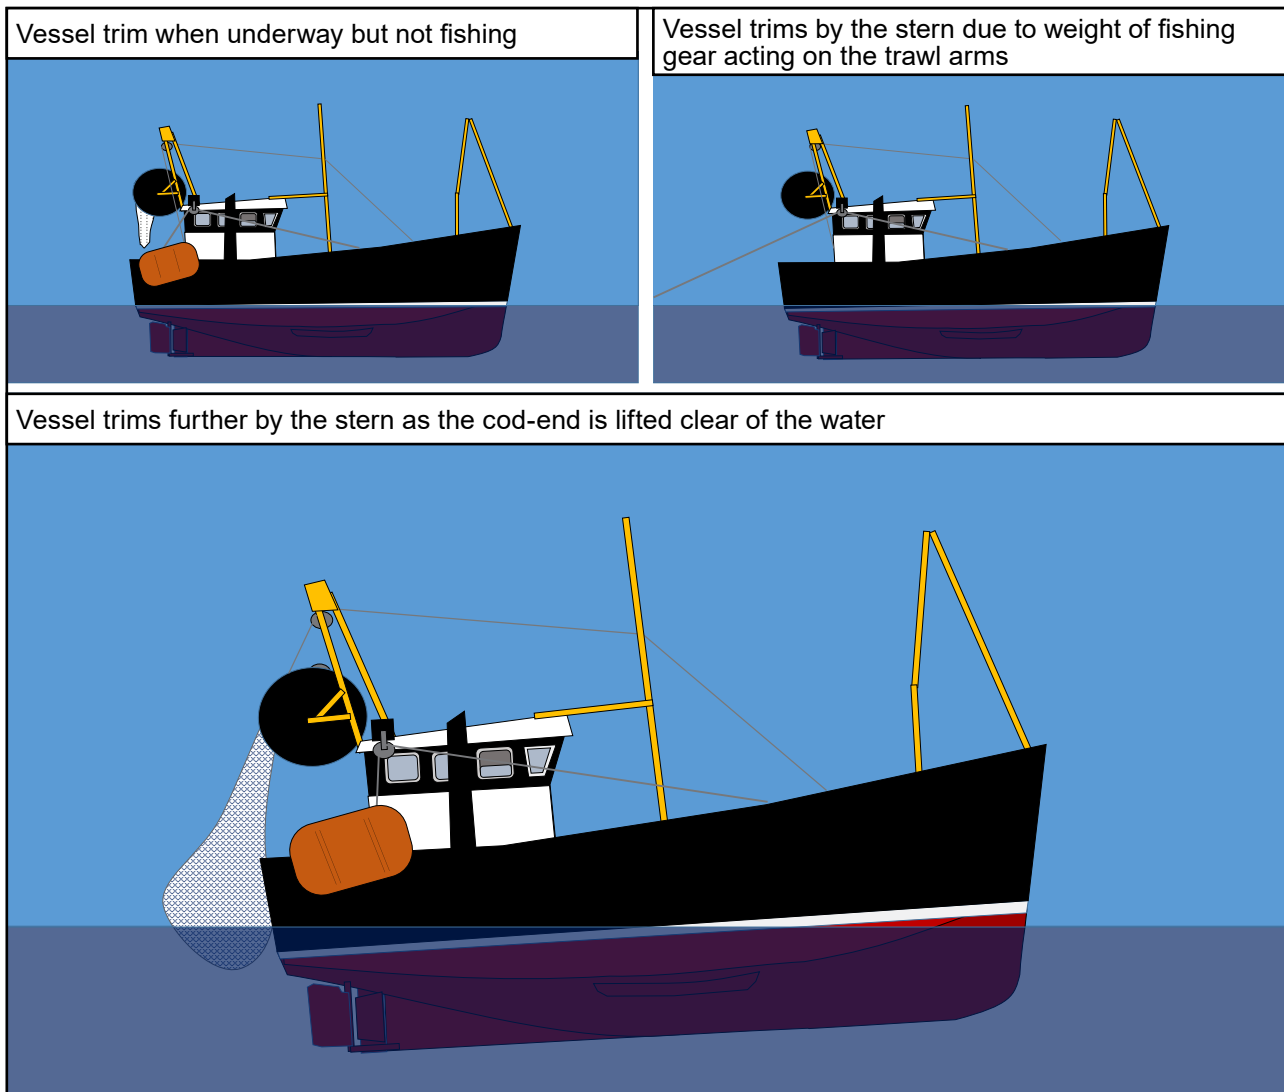
The wreck dive survey identified that the freeing ports on *Solstice's* aft deck had been wedged shut (**Figure 24**). The crew's reasoning for this was understandable as water on the aft deck would have been more problematic to the crew because that was their working area. Furthermore, the likelihood of the aft deck freeing ports being immersed would have been higher when stern trawling. This was because the trawl arms were positioned higher than the hinged dredge warp outriggers, which would have caused the vessel to trim further by the stern and therefore reduce the freeboard aft (**Figure 35**).

Figure 35: Large change of trim when lifting a weight at the stern
