## MARINE SAFETY INVESTIGATION REPORT

Safety investigation into the grounding of the  
Togo registered oil tanker

***HEPHAESTUS***

MARINE SAFETY INVESTIGATION REPORT NO. 03/2018

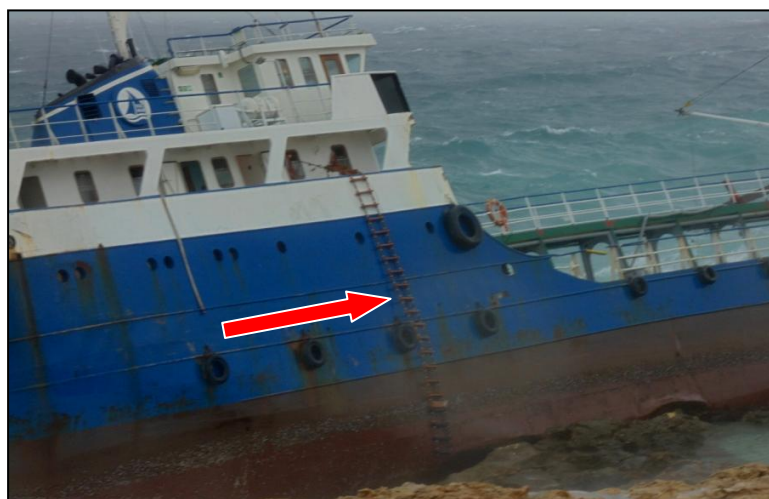
Soon after the ship ran aground, the crew members disembarked from the vessel directly on the rocky shore, using the vessel's pilot ladder (Figure 7) and wearing their lifejackets. They did not make use of other life saving appliances. According to the master, the rescue boat could not be used as this was not stowed in its designated amidships position, but lashed against the forecastle bulkhead.

**Figure 7: Pilot ladder secured against the accommodation block**

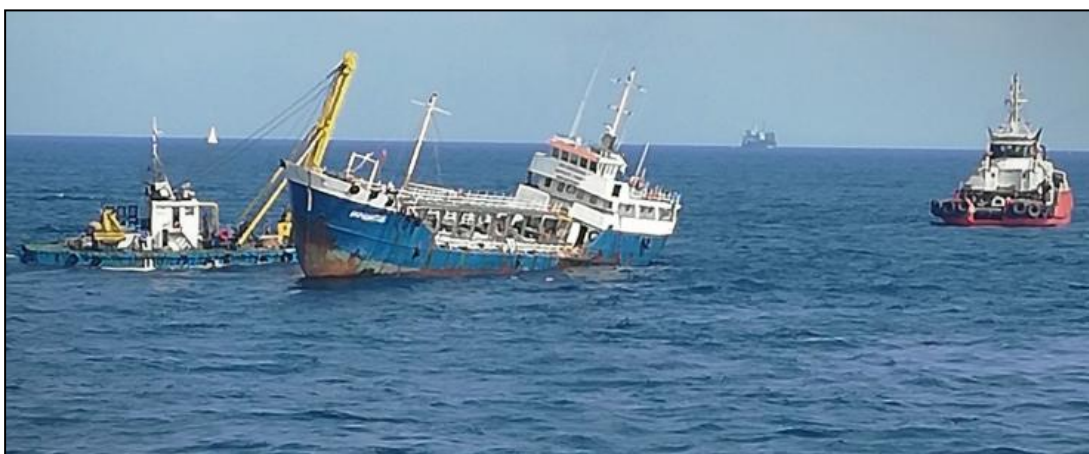
Following the necessary temporary repairs carried out by a local ship repair company, the vessel was eventually pulled off the rocks and refloated on 15 August (Figure 12).

Figure 12: *Hephaestus* afloat

During the preparation for the refloating operation, and after the vessel was afloat again, the salvors made no attempts to start the main engine. Hard aground, the vessel had lost her supply of compressed air for the control and starting systems. Moreover, one of the generators was found dismantled as a result of the grounding and the main electrical panel was submerged in water.
