MA2019-2

**MARINE ACCIDENT
INVESTIGATION REPORT**

Accident type	Fatality of a crew member
Date and time	Around 17:26 on September 18, 2018 (local time, UTC+9 hours)
Location	Mitsubishi Naoshima wharf, Naoshima-cho, Kagawa Prefecture On a true bearing of approximately 236° and at a distance of 460 meters from Sanuki Terashima lighthouse (approximately 34° 28.7' N, 133° 58.1' E)
Summary of the Accident	At around 17:26 on September 18, 2018, while the cargo vessel ERIK was moored at the Mitsubishi Naoshima wharf, with the master and 14 crew members on board, 4 crew members were performing the cleaning work of the upper hatch coaming of the cargo holds after unloading cargo, and an able seaman fell from the upper deck to the bottom floor of the cargo hold. The able seaman was pronounced dead after being conveyed from the cargo hold.
Process and Progress of the Investigation	(1) Set up of the Investigation On September 19, 2018, the Japan Transport Safety Board appointed an investigator-in-charge and four other marine accident investigators to investigate this accident. (2) Collection of Evidence September 19 and 20: On-site investigations and interviews October 3: Collection of quest

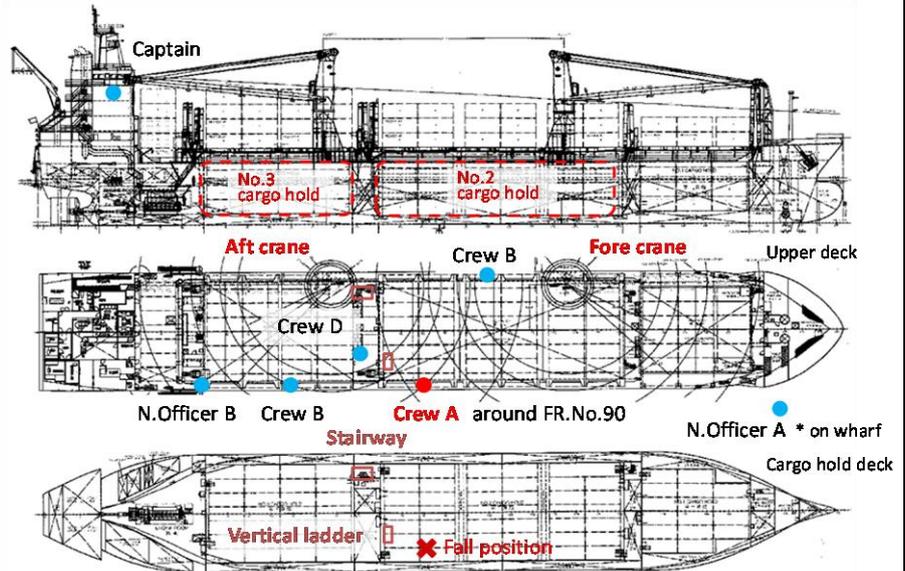
Figure 2 Position of crew members in general arrangement

The four crew members (Crew Member A, the boatswain (hereinafter referred to as “Crew Member B”), the other able seaman (hereinafter referred to as “Crew Member C”) and the ordinary seaman (hereinafter referred to as “Crew Member D”)) started “the cleaning work of the upper hatch coaming of the cargo holds on the upper deck” (hereinafter referred to as “the cleaning work”) at around 17:23 in the arrangement as shown in Figure 3.

The other navigation officer (hereinafter referred to as “N. Officer B”) was keeping the watch duty at a position around the starboard gangway and saw the four crew members working.
