MA2019-2

**MARINE ACCIDENT
INVESTIGATION REPORT**

Accident type	Fatality of a crew member
Date and time	Around 17:26 on September 18, 2018 (local time, UTC+9 hours)
Location	Mitsubishi Naoshima wharf, Naoshima-cho, Kagawa Prefecture On a true bearing of approximately 236° and at a distance of 460 meters from Sanuki Terashima lighthouse (approximately 34° 28.7' N, 133° 58.1' E)
Summary of the Accident	At around 17:26 on September 18, 2018, while the cargo vessel ERIK was moored at the Mitsubishi Naoshima wharf, with the master and 14 crew members on board, 4 crew members were performing the cleaning work of the upper hatch coaming of the cargo holds after unloading cargo, and an able seaman fell from the upper deck to the bottom floor of the cargo hold. The able seaman was pronounced dead after being conveyed from the cargo hold.
Process and Progress of the Investigation	(1) Set up of the Investigation On September 19, 2018, the Japan Transport Safety Board appointed an investigator-in-charge and four other marine accident investigators to investigate this accident. (2) Collection of Evidence September 19 and 20: On-site investigations and interviews October 3: Collection of quest

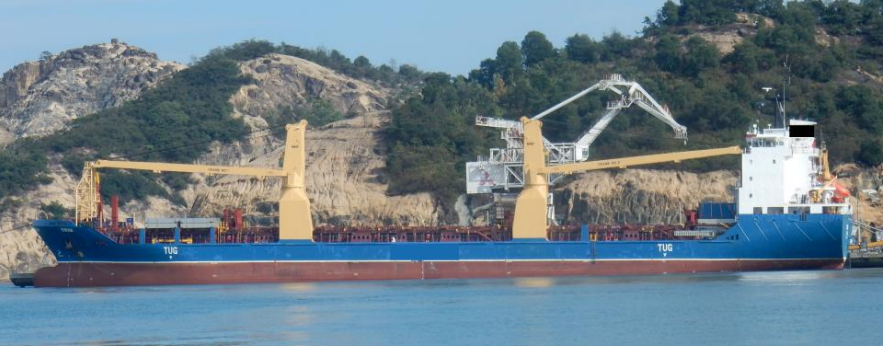
<p style="text-align: center;">Photo 1 ERIK</p>
<p>Information on the cargo hold, etc.</p>	<p>The ERIK (hereinafter referred to as “the vessel”) was a multi-purpose dry cargo vessel, which had three cargo holds numbered 1, 2 and 3 in order from the bow. Each cargo hold had pontoon hatch covers (hereinafter referred to as “hatch covers”), and was able to load containers on the hatch covers. (See Figure 1)</p>
