## MARINE SAFETY INVESTIGATION REPORT

Safety investigation into the collision involving the  
Maltese registered general cargo

***BRITANNICA HAV***

***Z121 DEBORAH***

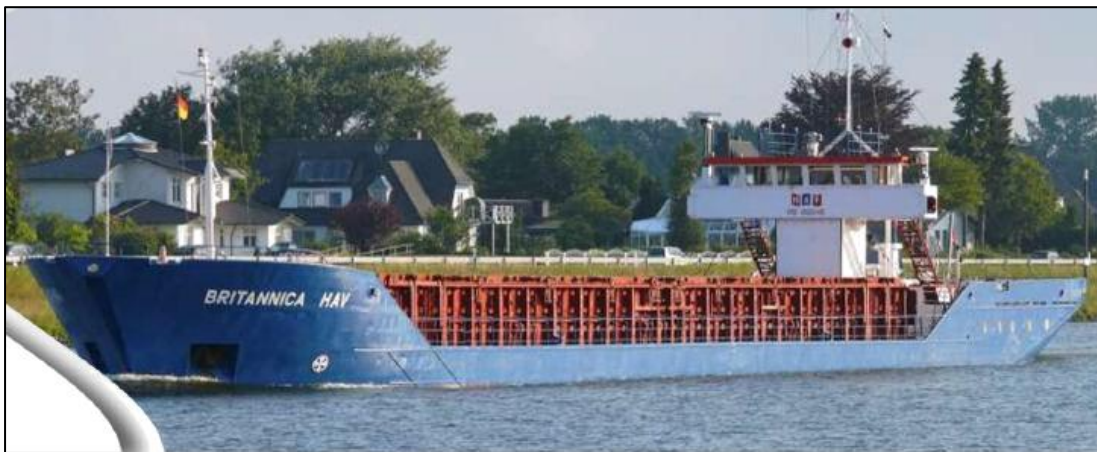
**Figure 1: MV *Britannica HAV***

*Britannica HAV* (Figure 1) was a 1,521 gt general cargo vessel, built in 1985 and was registered in Malta<sup>1</sup>. She was owned by Hav Bulk AS, managed by Hav Ship Management NorRus AS and was classed with Det Norske Veritas Germanischer Lloyd (DNV GL). The vessel's length overall was 82.21 m and her summer draught of 4.17 m corresponded to a summer deadweight of 2,289 tonnes.

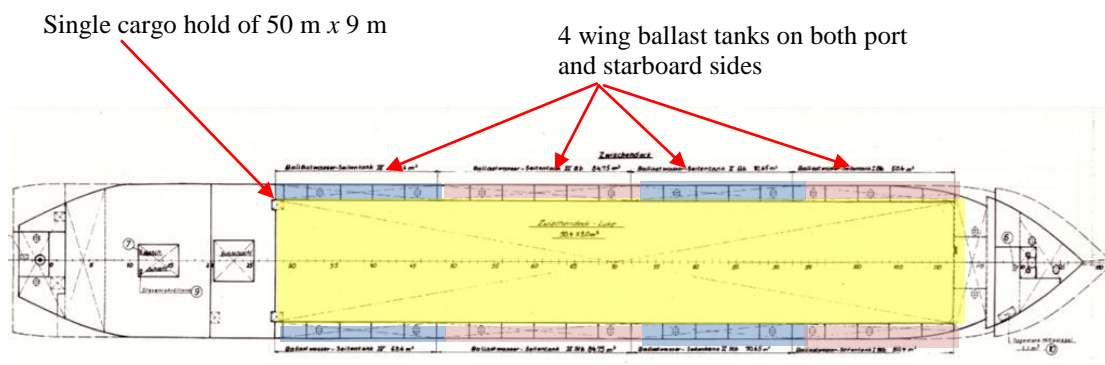
**Figure 2: Arrangement of the cargo hold and the ballast tanks**

*Britannica HAV* had a single cargo hold, with wing ballast tanks arranged in four pairs (total 8) and three pairs of double bottom tanks (total 6). Each pair of tanks were located on the port and starboard sides (Figure 2). These ballast tanks effectively made the vessel double skinned. The cargo hold was covered by a piggy back, multi-stack type hatch covers.

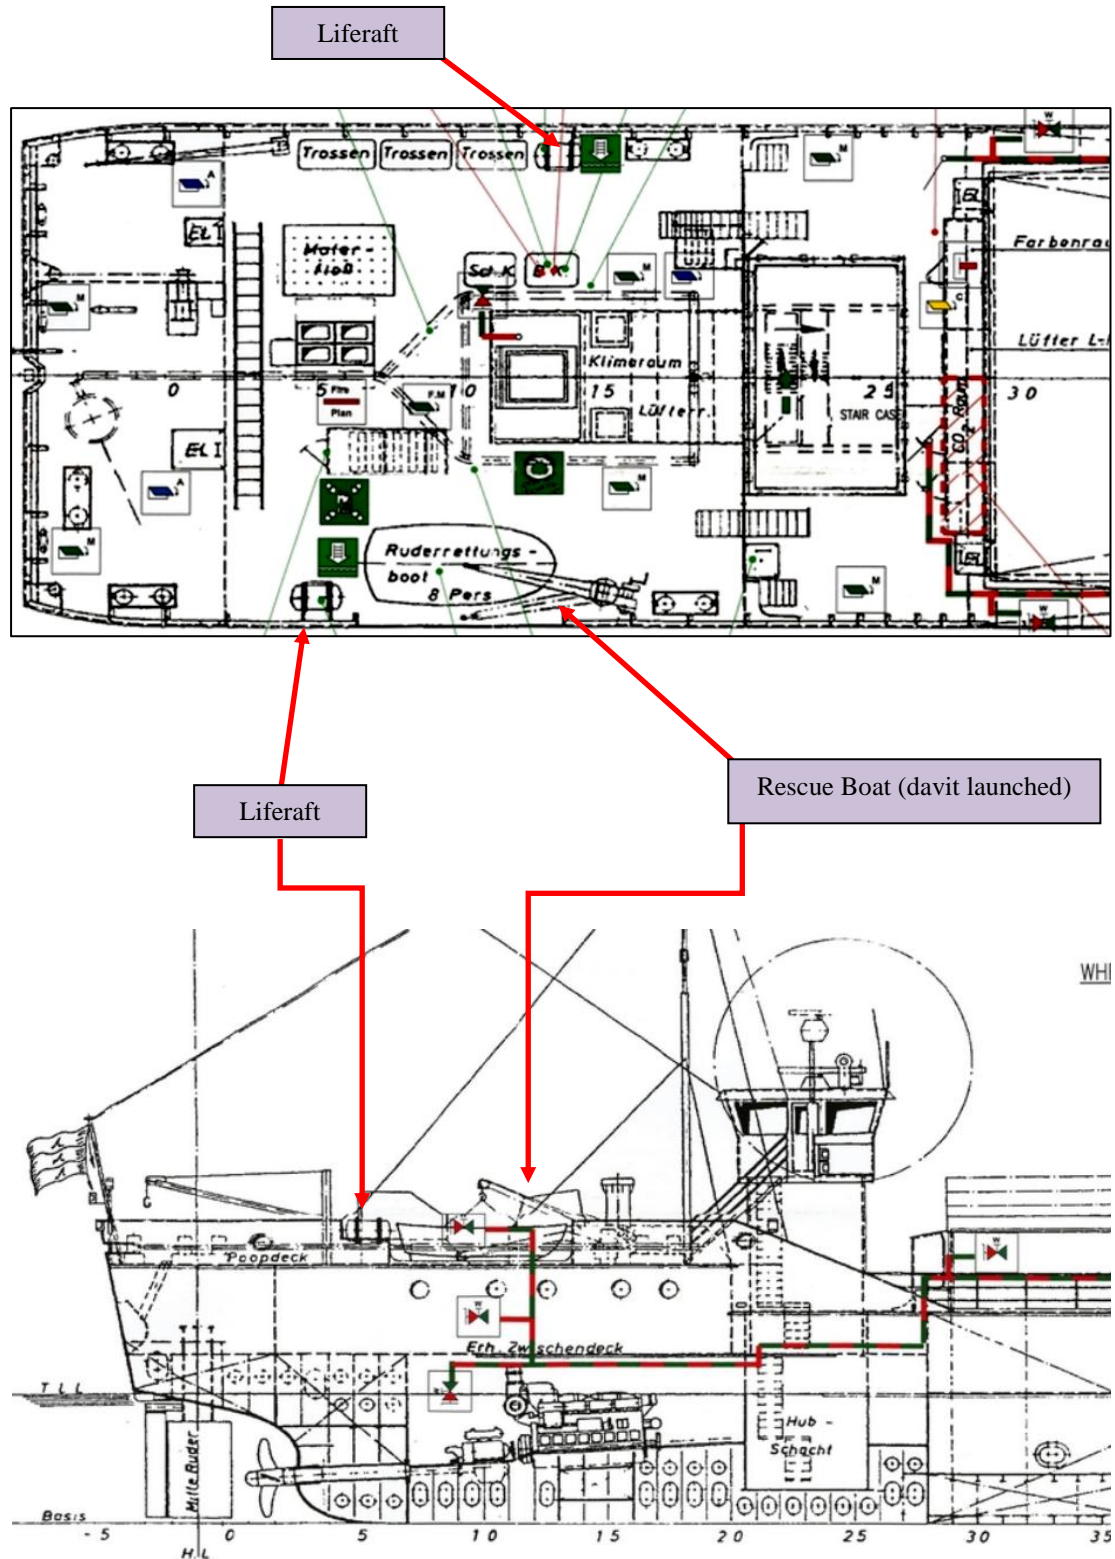
Figure 3: Location of liferafts and rescue boat on board *Britannica HAV*

*Britannica HAV* had an eight person rescue boat located aft on the starboard poop deck, as well as one eight person liferaft on the port side. There was another liferaft on the starboard side of the poop deck as shown in Figure 3.

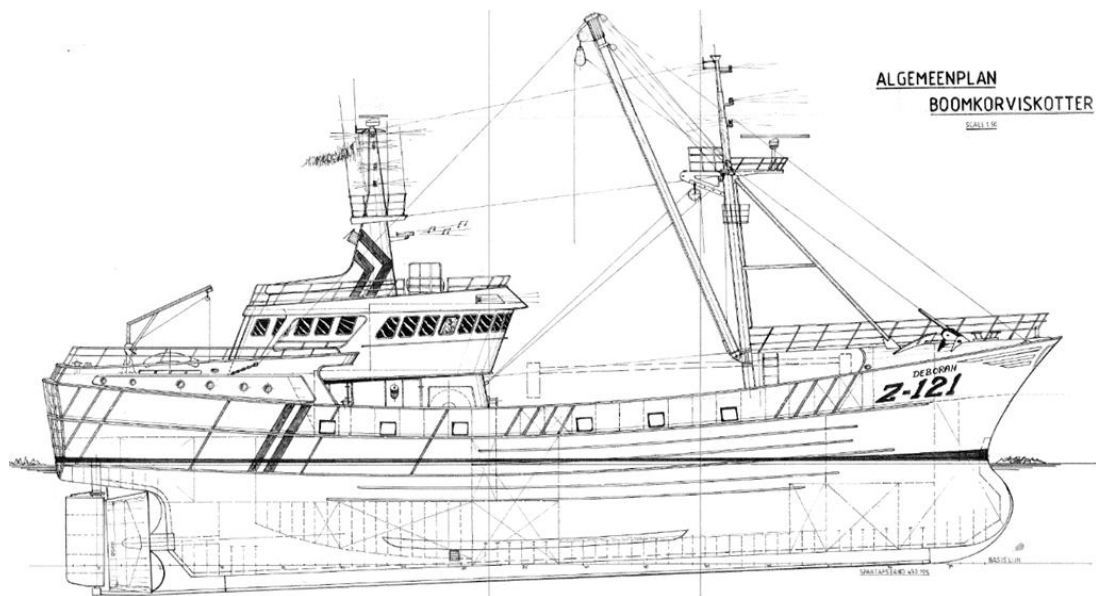
Figure 4: MFV *Z121 Deborah*

The fishing vessel *Z121 Deborah* (Figure 4) is a 385 gt Belgian flagged beam trawler built in 1992. She has a length overall of 37.87 m, a beam of 8.58 m, and a summer draft of 4.70 m.

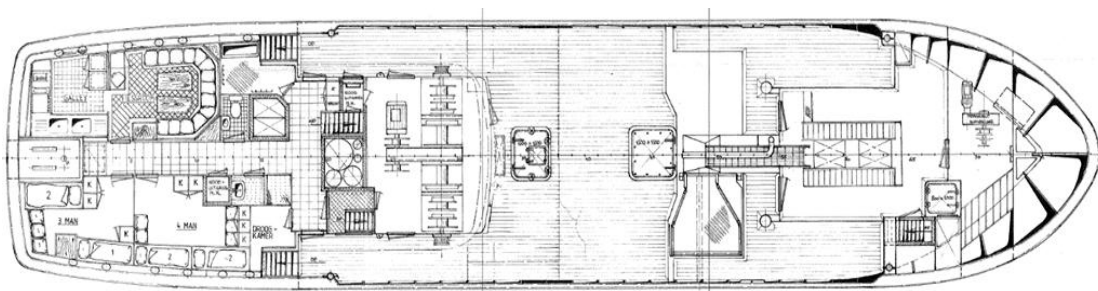
Figure 5: Wheelhouse and accommodation fitted aft of the vessel's centreline

The wheelhouse is fitted slightly aft of amidships, with the accommodation spaces located at the aft end of the vessel (Figure 5). At the time of the accident, *Z121 Deborah* was transmitting and receiving data by AIS. She had the facilities to use the radar to determine risk of collision as well as Global Positioning System (GPS positioning).

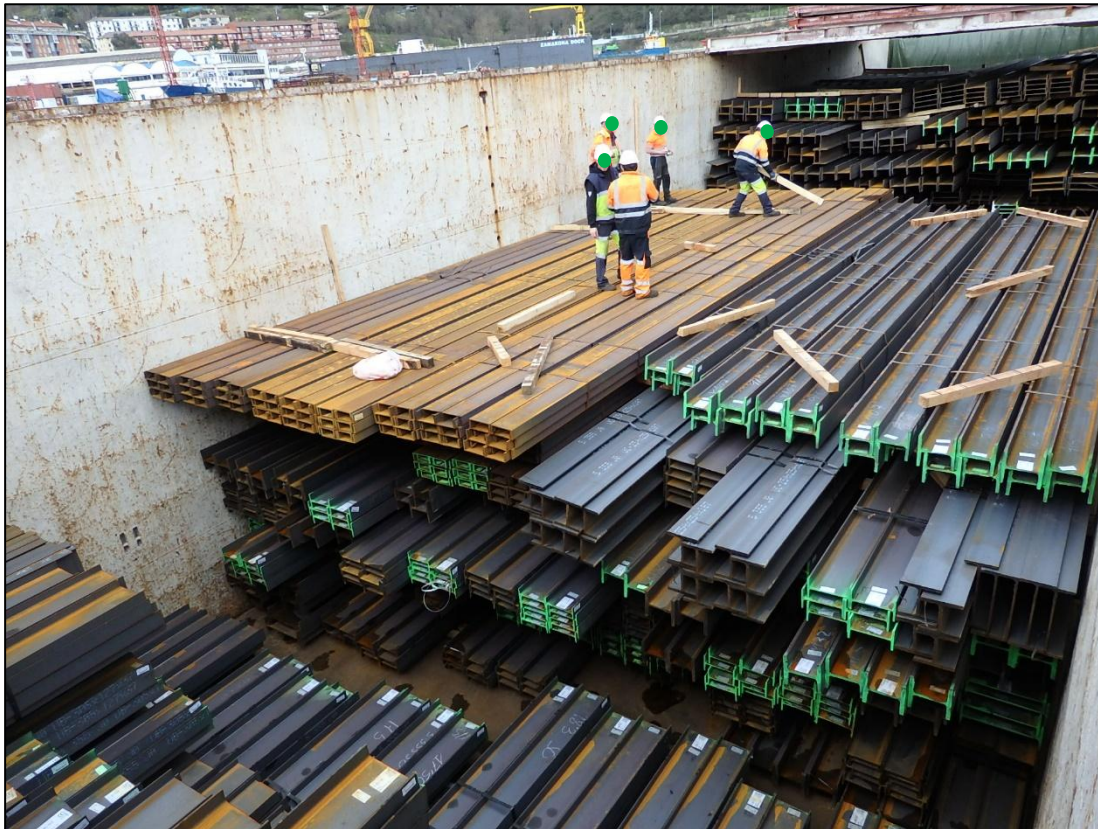
**Figure 6: Cargo loading operations at Pasajes, Spain**

On 16 March 2018, *Britannica HAV* sailed from Pasajes, Spain to Keadby, UK *via* the English Channel, with a cargo of steel profiles (beams). Her single cargo hold was not divided in any way, and the steel cargo filled a significant volume of the hold (Figure 6).

Following completion of the cargo loading operations, the cargo hold was covered by a piggy back multi-stack type hatch cover. The crew stated that the hatch covers had historically been very effective at preventing any water ingress into the cargo hold, either from weather or the sea.

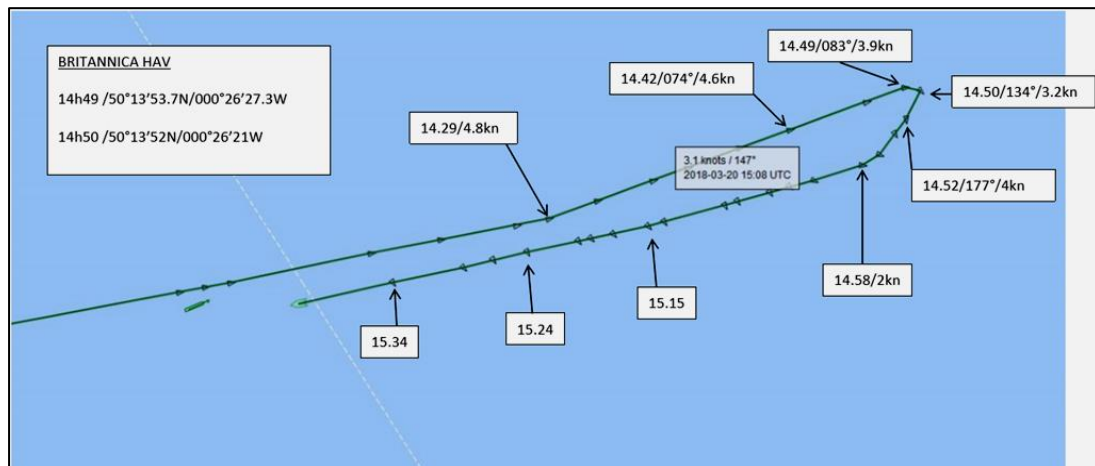
**Figure 7: AIS image of *Britannica HAV***

*Britannica HAV* was proceeding generally on an East Northeast route, with her main engine at full ahead, doing about 8.0 knots through the water, but only about 4.5 knots over the ground with a strong adverse current on the bow and some wave action from the port bow. The vessel was on autopilot, reportedly on a course of 074°. AIS image showing track of *Britannica HAV* is shown in figure 7.

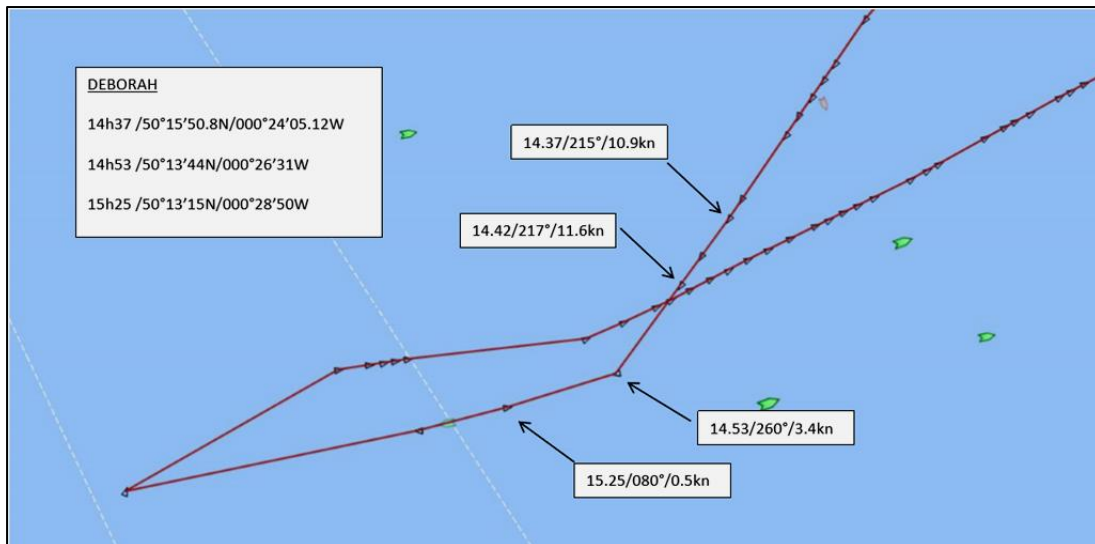
Figure 8: AIS image of Z121 Deborah

In the meantime, by 1430, the fishermen on board *Z121 Deborah* had secured their fishing nets and were proceeding to another fishing area near Le Havre, France, following the fishing operation in area 7D. The skipper had already set a course of about 214° and the fishing boat had reached a speed of about 10 knots. The skipper recalled that he observed no other vessels within a four nautical mile radius, neither by AIS nor radar. AIS image showing track of *Z121 Deborah* is shown in Figure 8.

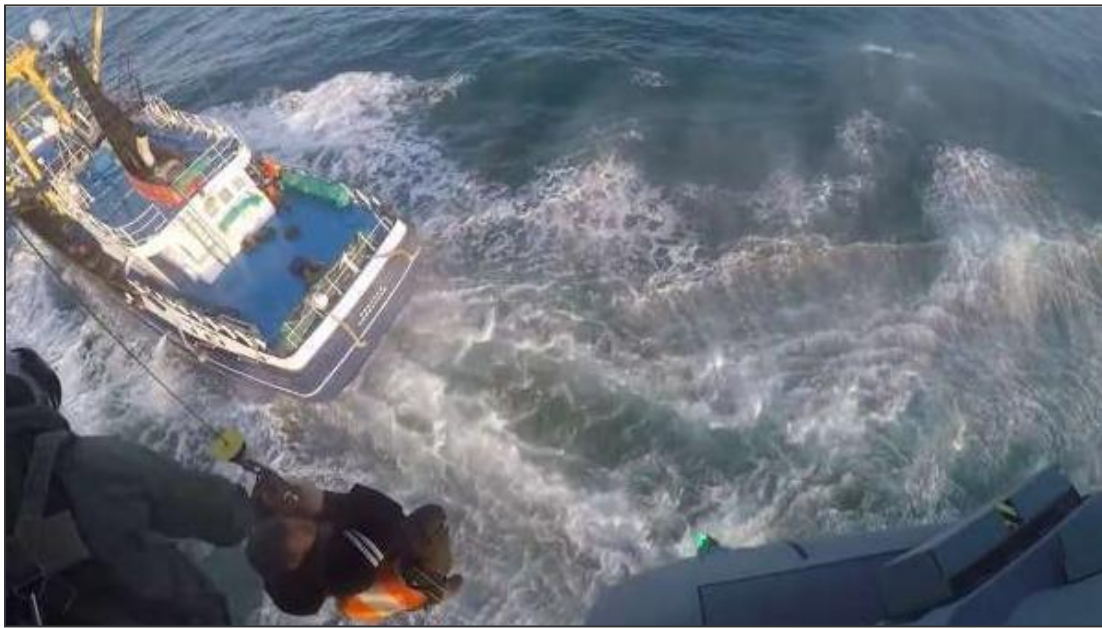
**Figure 13: *Britannica HAV*'s chief engineer being air lifted by the French rescue helicopter**

At about 1721, the survivors were lifted aboard the French rescue helicopter (Figure 13), arriving at Cherbourg at about 1811. The vessel was marked with a smoke buoy. *Z121 Deborah* subsequently proceeded to her home port of Zeebrugge under her own power. Hospital treatment was required for minor injuries for two crew members of *Britannica HAV* but both were discharged within a short time.
