UNITED STATES COAST GUARD

**REPORT OF THE MARINE BOARD OF INVESTIGATION
INTO THE
COMMERCIAL FISHING VESSEL DESTINATION
SINKING AND LOSS OF THE VESSEL
WITH ALL SIX CREWMEMBERS
MISSING AND PRESUMED DECEASED
APPROXIMATELY 4.4 NM NORTHWEST OF
ST. GEORGE ISLAND, ALASKA
ON FEBRUARY 11, 2017**

16732
27 February 2019

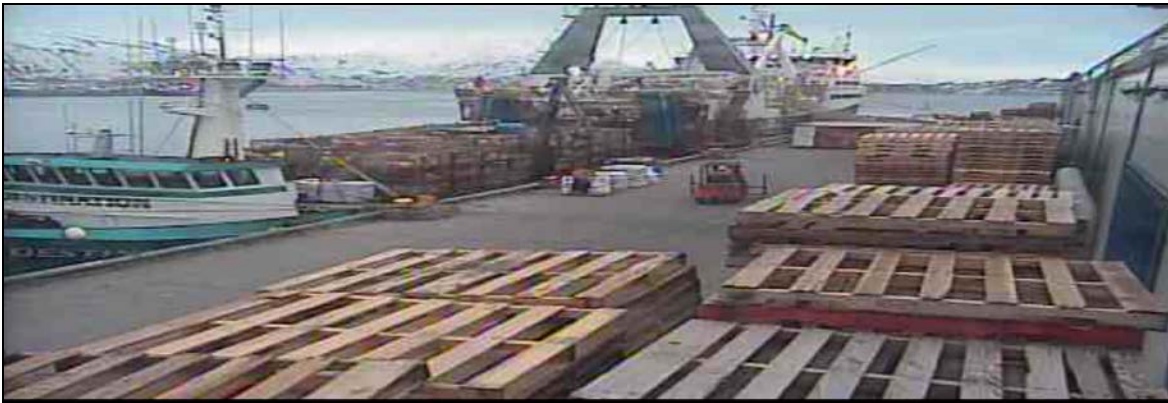
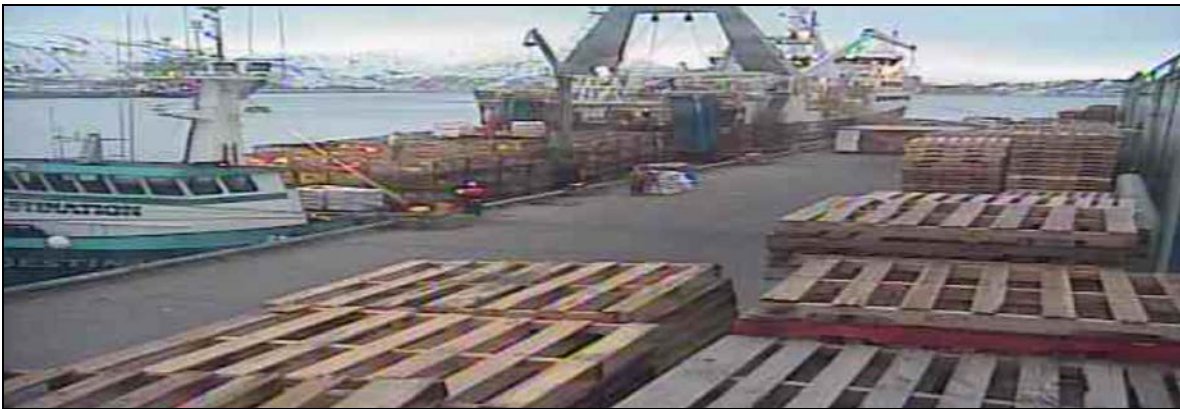
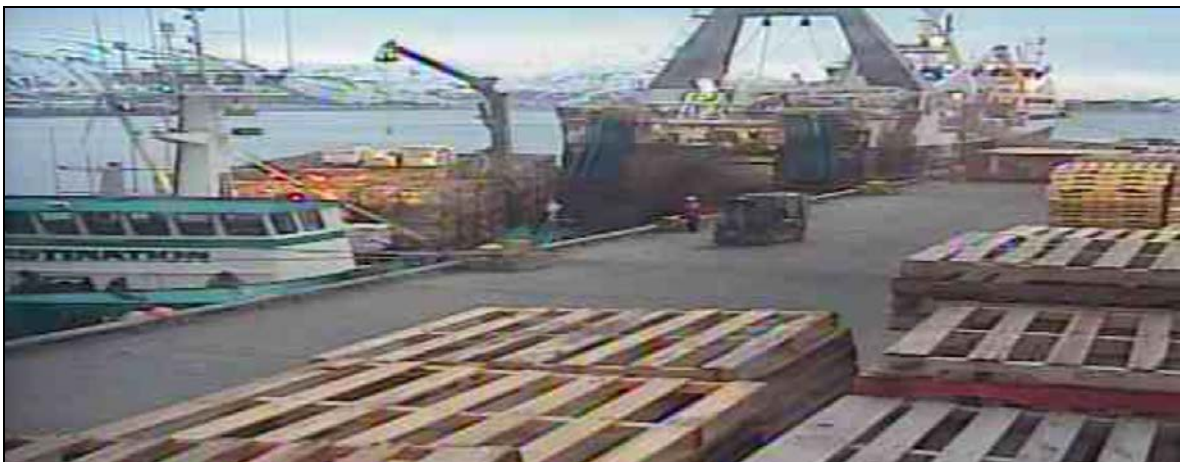
4.1.16. While moored at the Kloosterboer Cold Storage facility from approximately 1830 to 1900, the DESTINATION's crew loaded four pallets of squid bait weighing a total 7,060 pounds. The bait was loaded four-across on top of the crab pots, amidships, next to two totes and a sorting table. Figures 6, 7, and 8 are screenshots from the facility's security camera taken shortly after the vessel moored and as the vessel's crew loaded bait.

Figures 6. Still image from security camera video provided by Kloosterbor Cold Storage of the DESTINATION loading bait at their facility on February 9, 2017, at approximately 1830-1900.

Figures 7. Still image from security camera video provided by Kloosterbor Cold Storage of the DESTINATION loading bait at their facility on February 9, 2017, at approximately 1830-1900.

Figures 8. Still image from security camera video provided by Kloosterbor Cold Storage of the DESTINATION loading bait at their facility on February 9, 2017, at approximately 1830-1900.

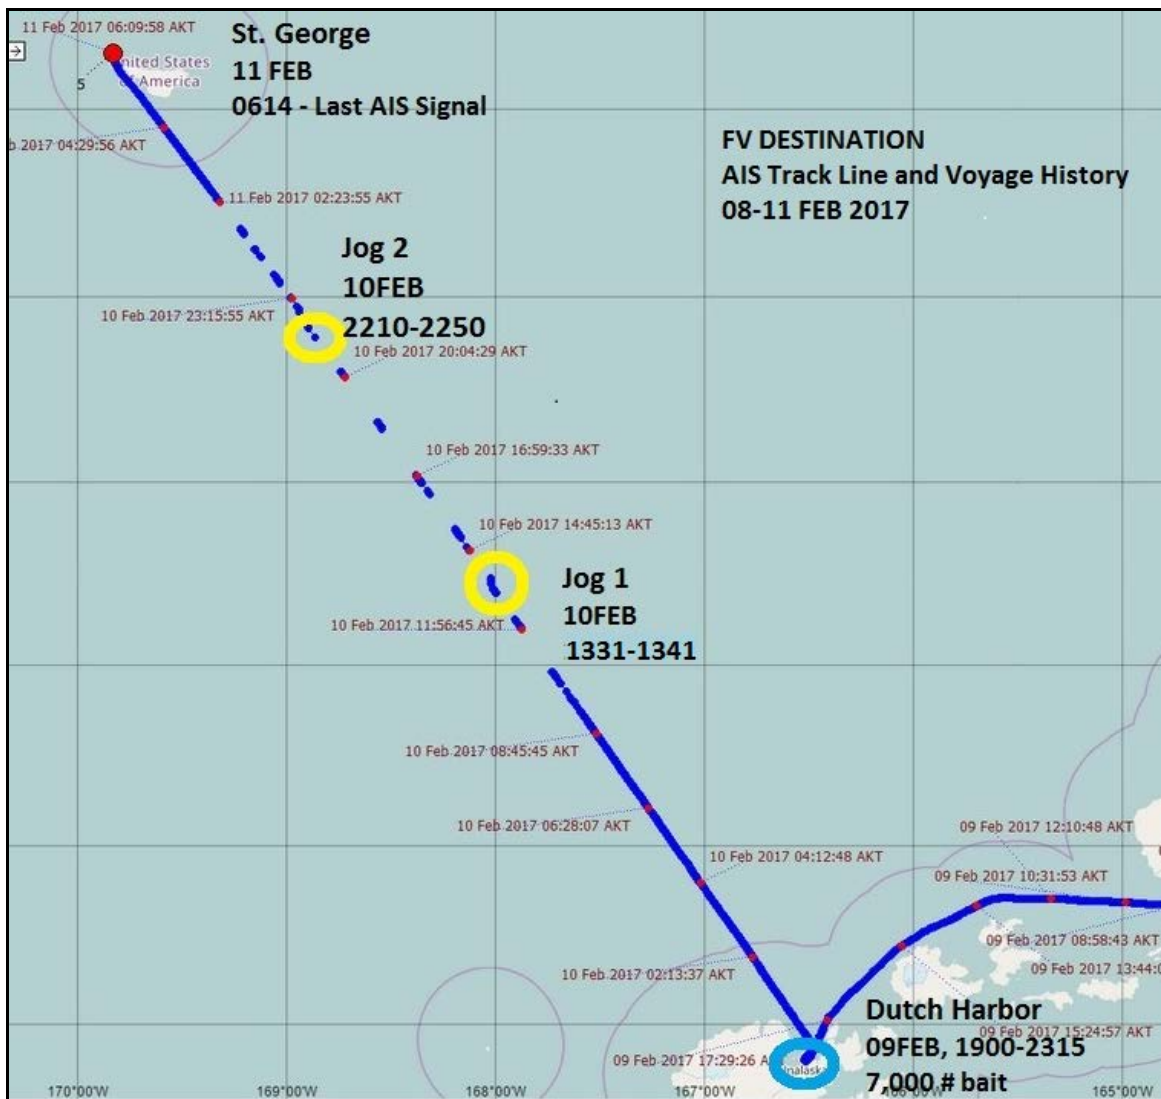
4.1.27. The DESTINATION’s AIS track indicates, on two separate occasions during the voyage to St. Paul, the vessel “jogged” into the seas (headed into the wind and/or slowed down). The first occasion was on February 10, 2017 from approximately 1331 to 1341 (10 minutes). The second jog occurred when the vessel reduced its speed from 6.5 knots down to 1.5 knots from approximately 2210 to 2250 (40 minutes). Figure 9 indicates the approximate locations and times of these jogs. Figures 10 and 11 provide more detailed AIS data of each jog.

Figure 9. AIS track line indicating the locations and times the DESTINATION conducted two jogs while en route to St. Paul. AIS track line provided by Alaska Marine Exchange. Illustration produced by the MBI.

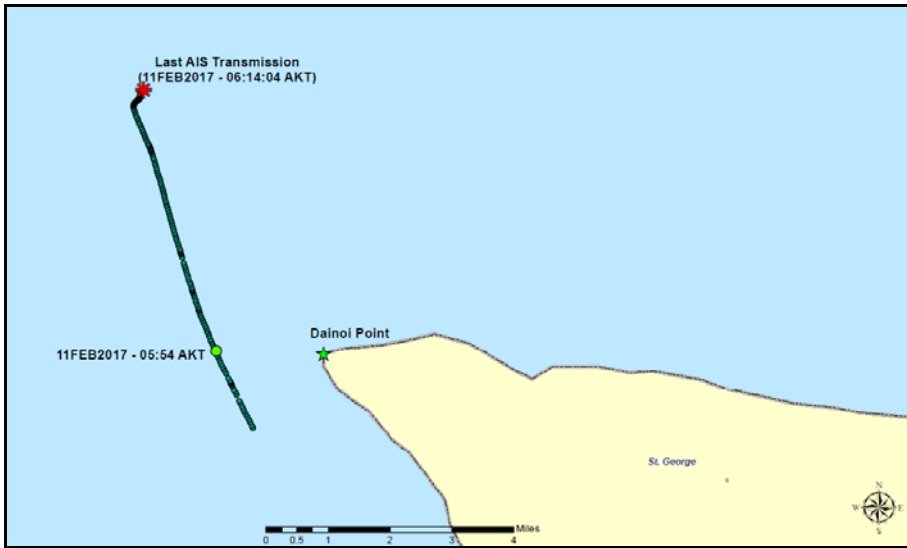
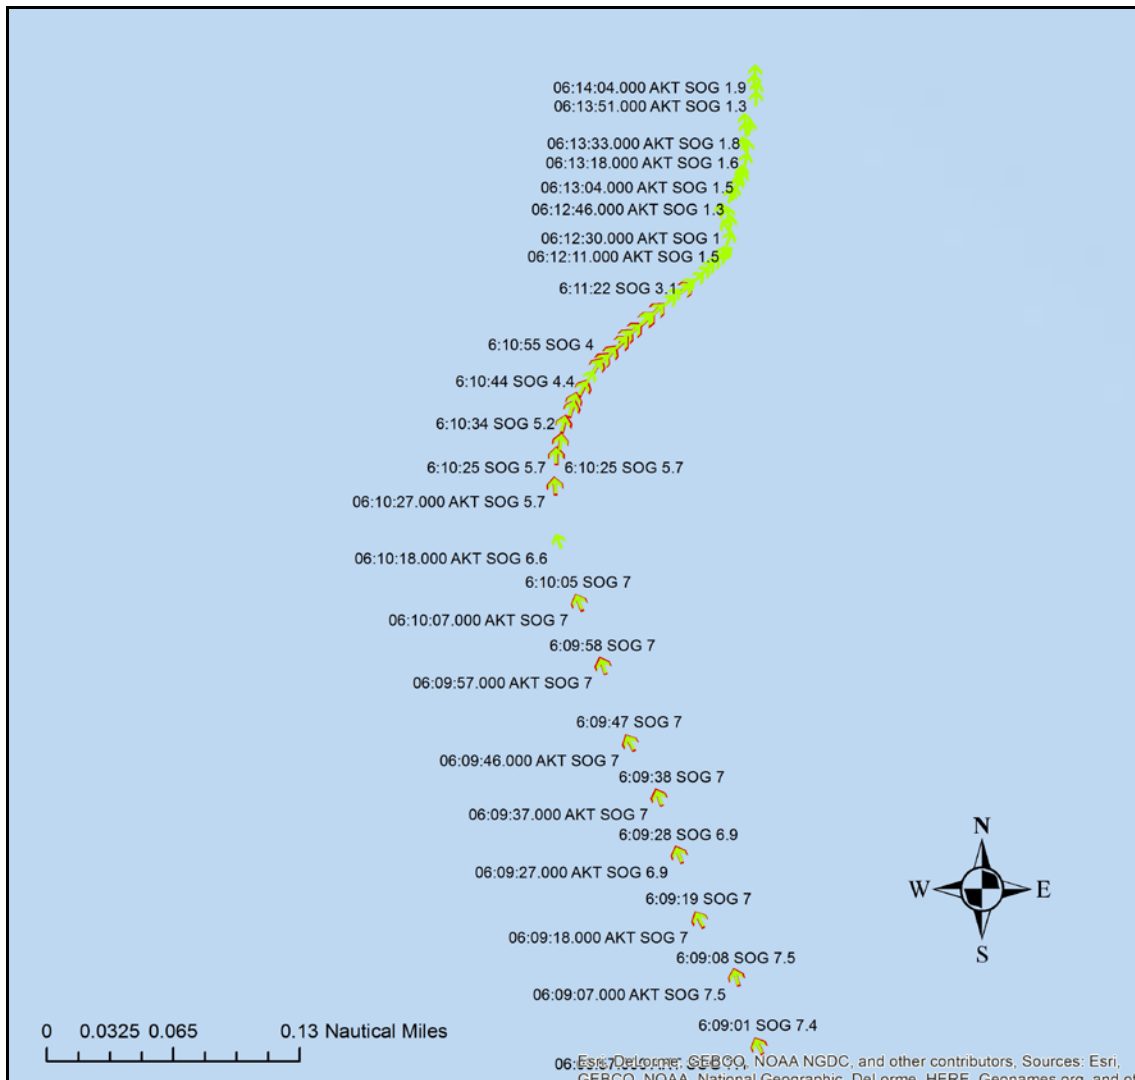
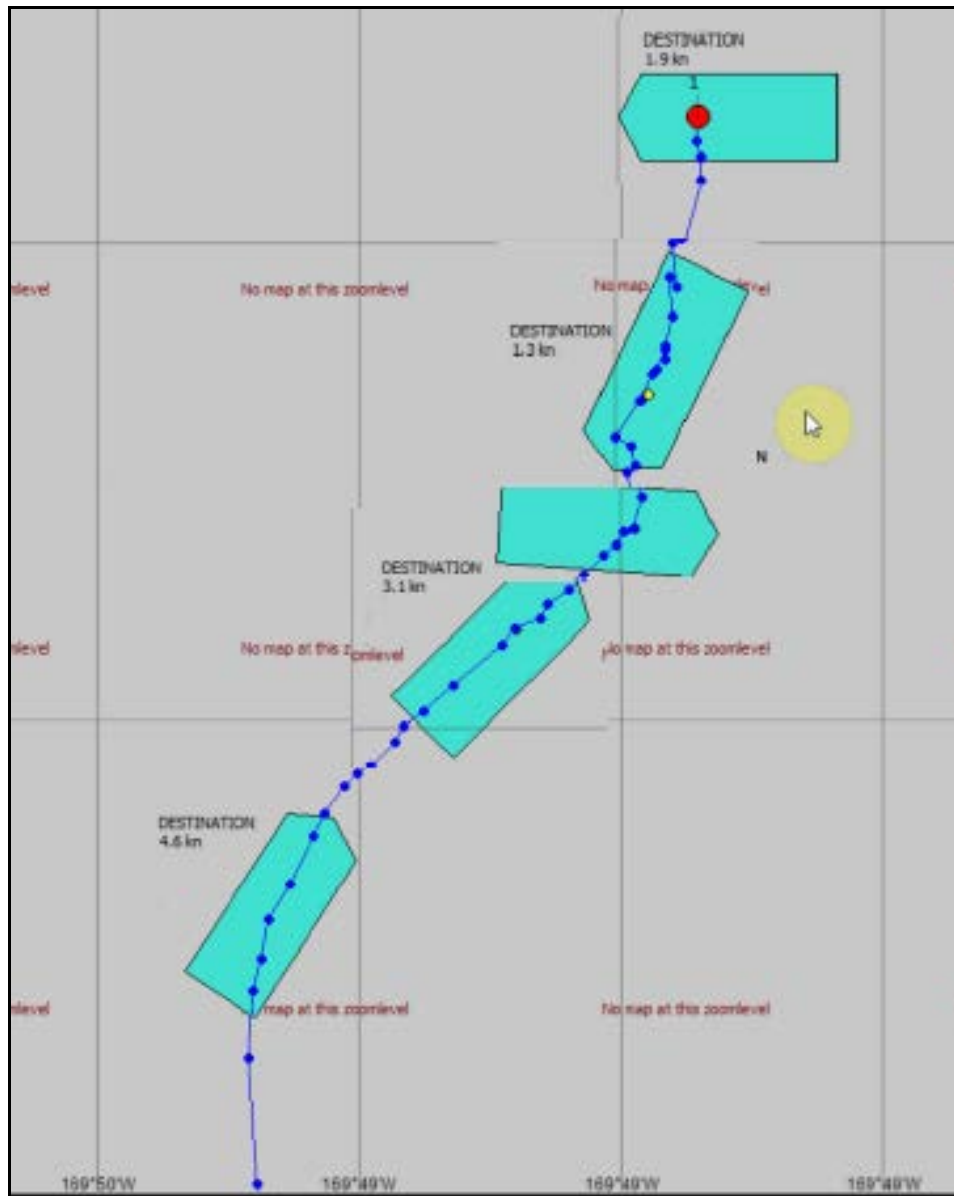
4.1.33. From approximately 0612 to 0614, the vessel's heading shifted to starboard from 090° to 270°. At the same time, the vessel's COG continued to the north at a SOG between 1-2 knots. Figures 14, 15 and 16 provide the vessel's AIS track which indicates the changes in heading, COG and SOG.

Figure 14. DESTINATION's AIS as it made its starboard turn on February 11, 2017 between 0554-0614. Image developed by MBI.

Figure 15. DESTINATION's AIS as it made its starboard turn on February 11, 2017 between 0609-0614. Image developed by Coast Guard Navigation Center.

Figure 16. AIS track information indicating changes to the DESTINATION's heading and COG on February 11, 2017, between 0610-0614. AIS track information provided by Alaska Marine Exchange and image developed by MBI.

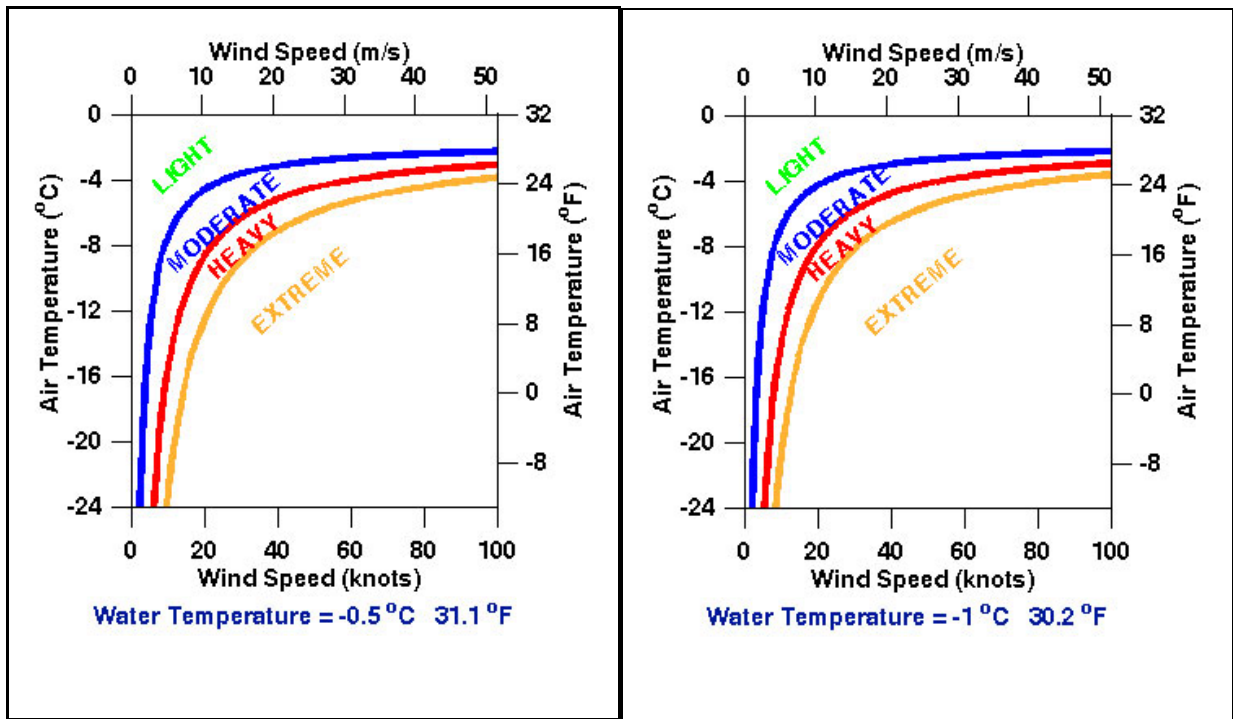
4.2.8. The Overland Method established sea spray ice accumulation graphs for vessels between 20 and 70 meters in length. Figures 17 and 18 provide examples of Overland Method graphs for water temperatures at various air temperatures and wind speeds.

Figures 17 and 18. Example Overland Method graphs. Provided by NTSB.

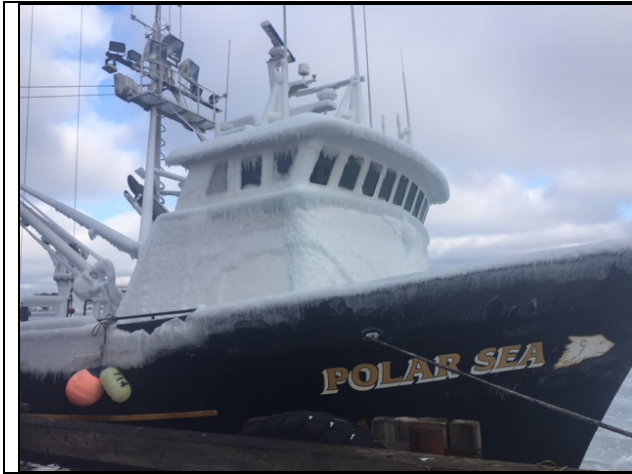
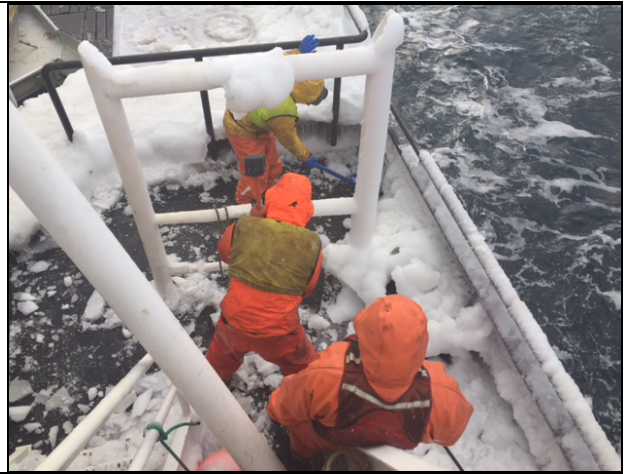
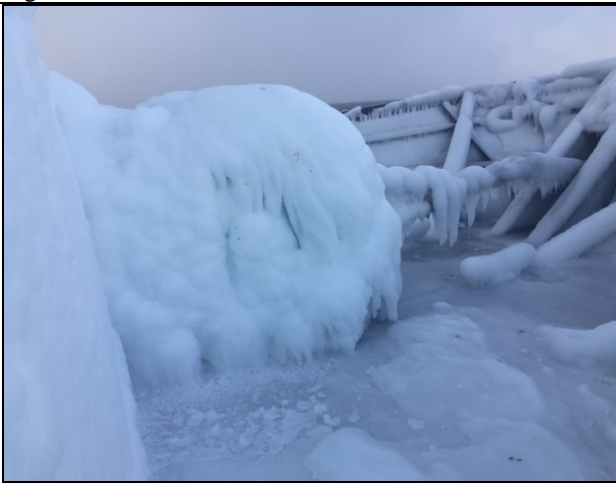
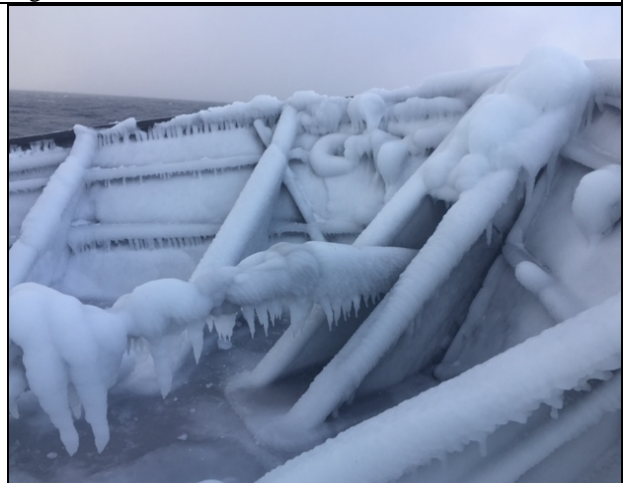
4.3.13. The captain of the POLAR SEA stated during the transit towards St. Paul Island on February 10, 2017, his vessel experienced "wind at about 35, 35 to 40 and I would say about a 15-foot sea." The vessel accumulated ice from freezing spray, requiring his crew to break ice off the decks. The captain stated that he stopped transiting four times on February 10, 2017 so his crew could work breaking off the ice, with each evolution lasting about five hours each. Figures 25-28 are pictures taken by the captain of ice accumulations on the POLAR SEA.

Figures 25-28. Photos taken by the captain of the POLAR SEA of ice accumulations during its transit towards St. Paul Island on February 10, 2017.

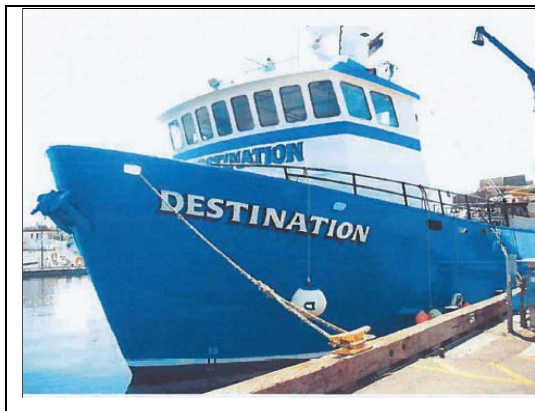
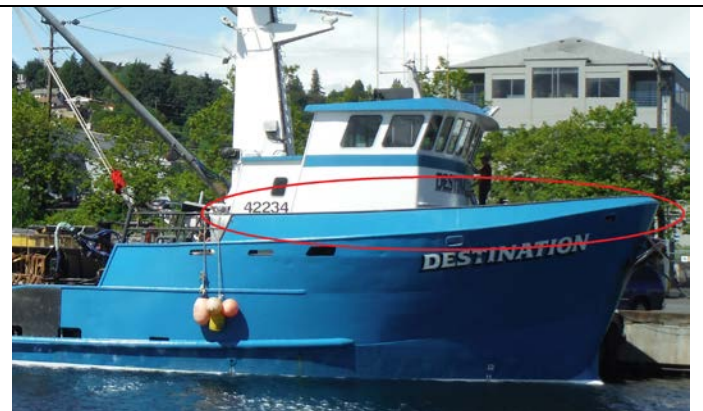
4.5.31. Figure 42 is a picture of the DESTINATION during a July 6, 2009 Report of Survey. Figure 43 is a picture of the vessel during its June 7, 2016 Valuation and Survey of Condition. These pictures illustrate a solid bulwark was installed between the 2009 and 2016 surveys.

Figures 42 and 43. Pictures of the DESTINATION taken by the Marine Surveyors during valuation surveys conducted in July 2009 and June 2016, respectively. Circled in red is the new bulwark installed in May 2011.

4.5.32. During the May 2011 dry-dock at Marine Fluid Systems Inc., the owner installed a new bulwark on the forecastle deck at the bow. A Marine Fluid Systems Inc. invoice dated May 9, 2011 described the installation as “bow additions/caprail” consisting of 264 square feet of 5/16-inch plate. Figure 43 illustrates the new bulwark.

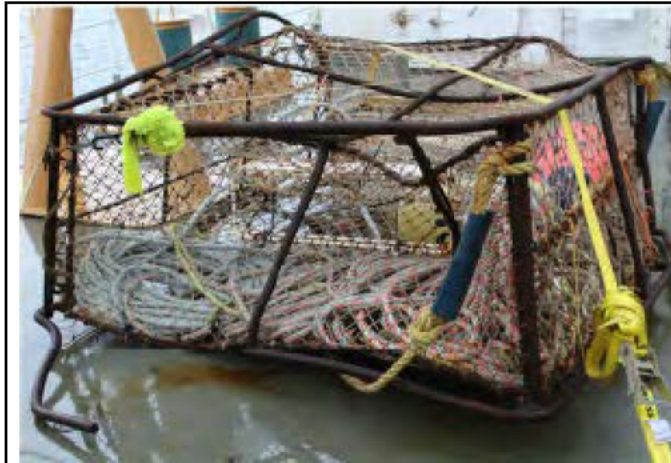
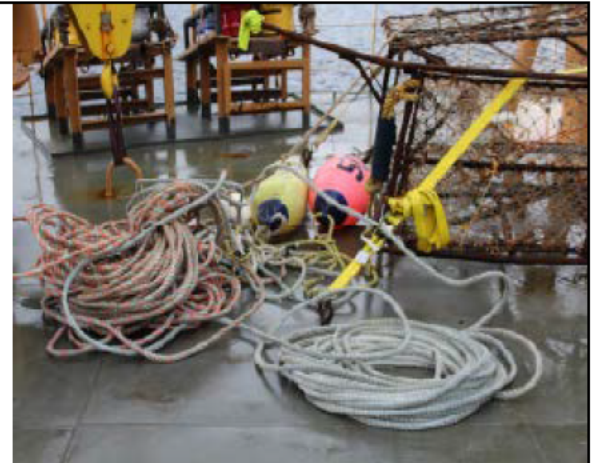
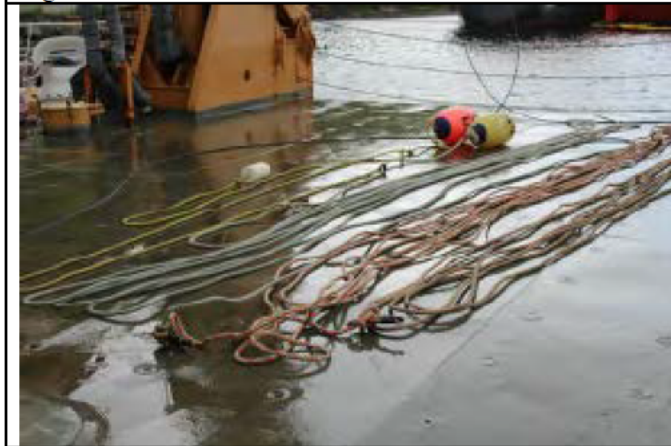
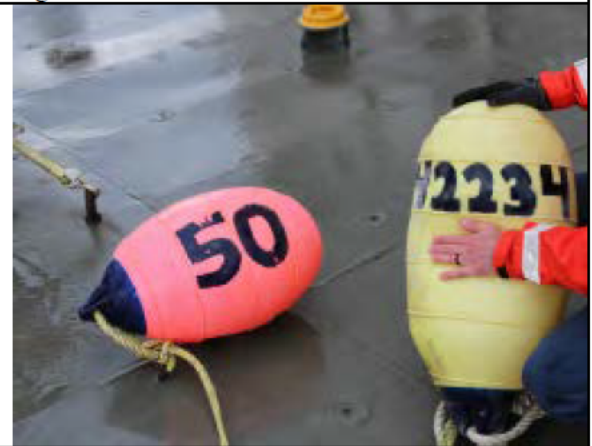
Figure 46

4.6.9. The crab pot was damaged, but measurements taken indicate a top bar length of 7 feet by 7 feet, and a depth overall of 32 inches. The pot contained two buoys, each stenciled with a number. The larger yellow buoy had “42234” and the smaller red buoy had “50”. The “42234” matches the DESTINATION’s ADF&G shellfish vessel registration number. There were three ¾ inch lines in the pot, two red and one light blue. When faked out on deck, the red lines measured at 177 and 197 feet, and the blue line measured at 189 feet. The combined weight of the gear (buoys and line) was 140 pounds, and the pot itself weighed 700 pounds, for a total combined weight of 840 pounds.

Figures 46-49. Photos of recovered crab pot examination taken by MSD Dutch Harbor vessel examiners.

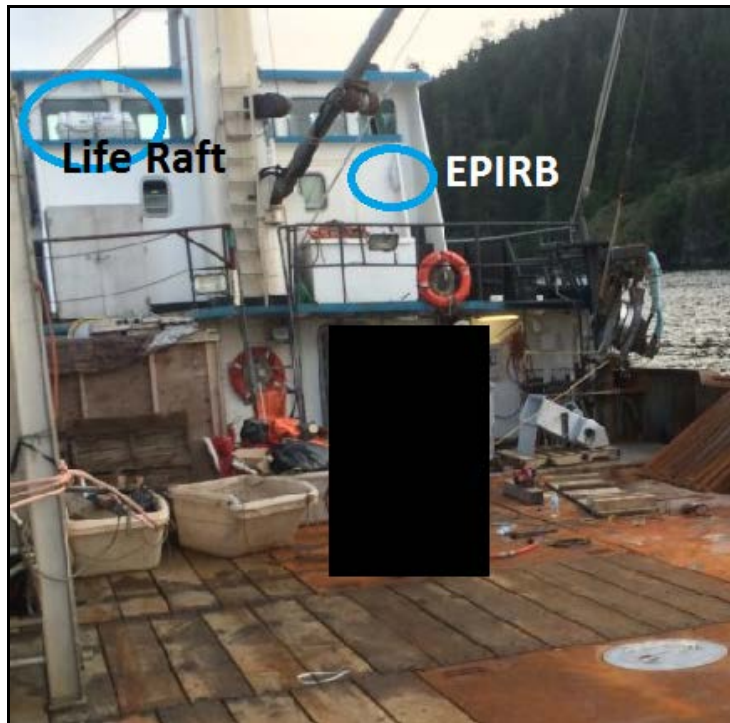
4.7.3. As illustrated in Figure 52, the inflatable liferaft was located on the port side on top of the captain’s cabin, aft of the wheelhouse. The EPIRB was stored on the starboard side, on the aft bulkhead of the captain’s cabin.

Figure 52. Locations of the liferaft and EPIRB.
Undated photo taken and provided by former crewmember.

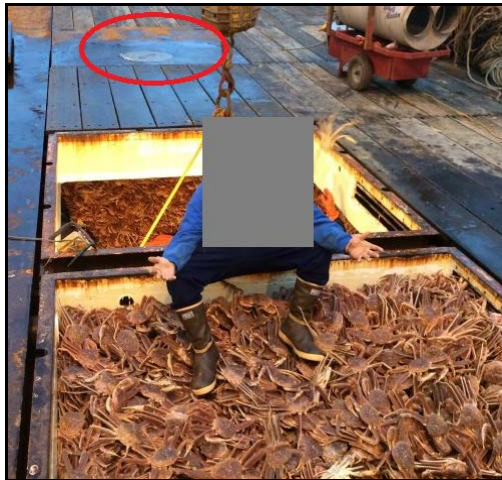
4.8.22. While in transit with pots on deck, the captain consistently directed the crew to keep access covers to number 1 and 2 holds closed and number 3 off. Figure 55 shows the access hatch cover to number 3 hold located on deck aft of the open number 2 hold hatch. The cover was typically stored on deck in close proximity to the number 3 hold.

Figure 55. Number 3 hold access hatch, circled in red.
Photo taken and provided by former crewmember.

4.8.23. One former crewmember stated, "When I was on the boat, I had a hatch cover open on the aft tank...The engineer said, [the captain] wants it that way, and that was the way it was." Another former crewmember stated, "Tank 3, we usually left the hatch off. Actually, we always left the hatch off."

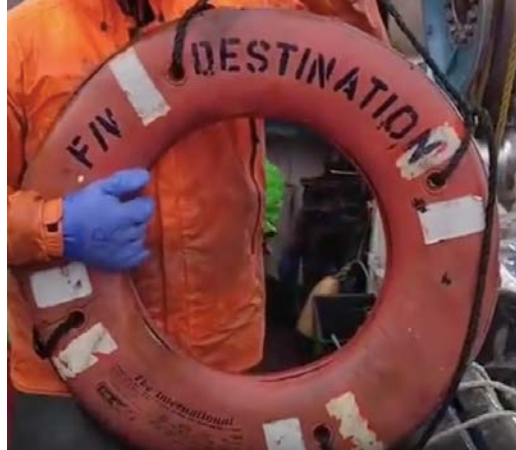
4.11.21. At approximately 1140, the SILVER SPRAY located and recovered a lifering bearing the name "DESTINATION". (see Figure 62).

Figure 62. Photo of recovered lifering taken by onboard the SILVER SPRAY.

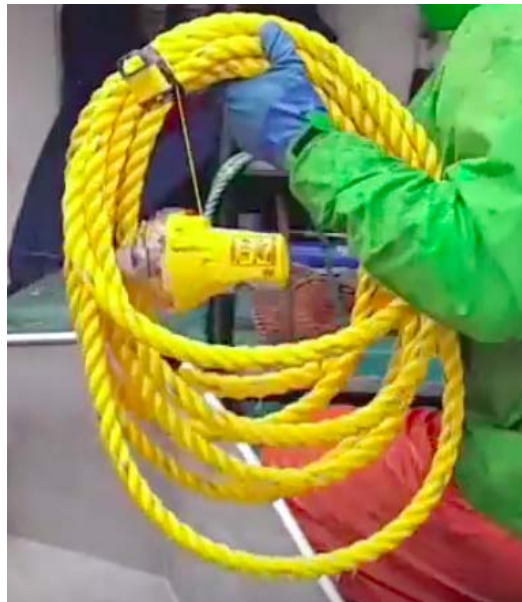
4.11.22. At approximately 1225, the SILVER SPRAY located and recovered the DESTINATION's EPIRB (Figure 63) and reported the NOAA registration number listed on the EPIRB to D17 CC. The SILVER SPRAY also reported they found the EPIRB's tether line attached with electrical tape to a floating yellow rope.

Figure 63. Photo of the recovered EPIRB taken onboard the SILVER SPRAY.

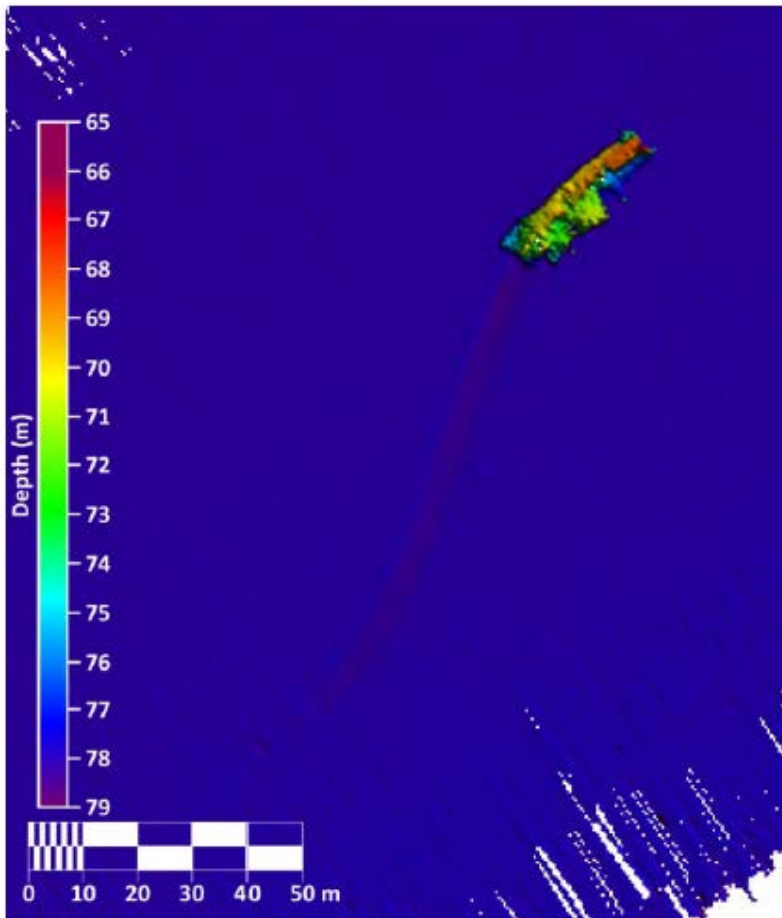
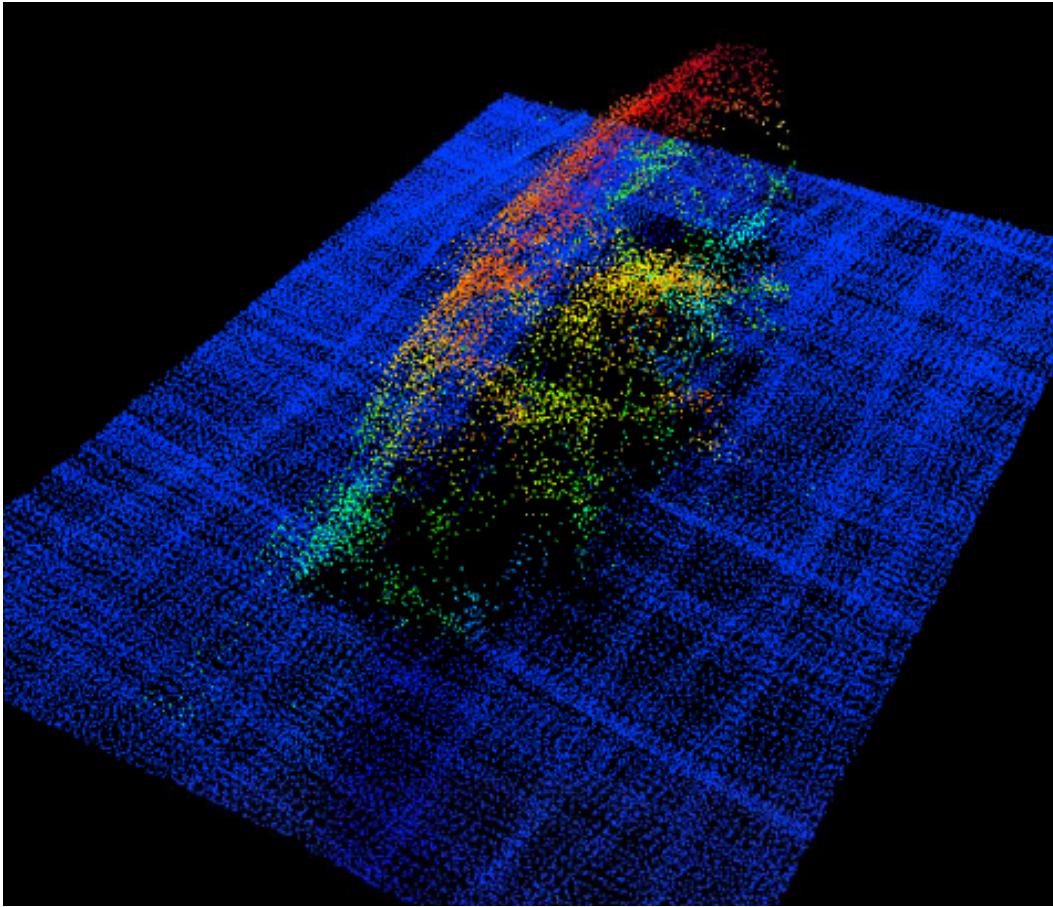
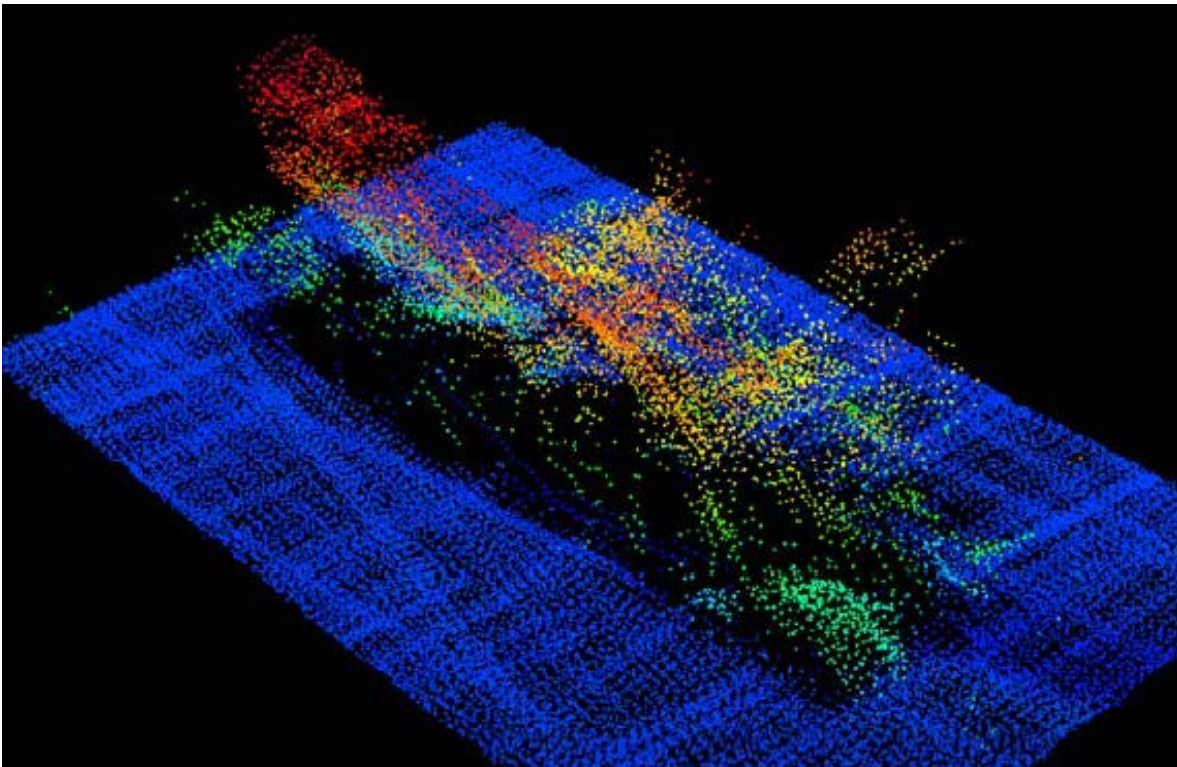
4.12.6. Figures 68, 69, and 70 shows the FAIRWEATHER collected side-scan sonar imagery indicating the DESTINATION lying on its port side, facing southwest in approximately 78 meters (256 feet) of water. A scour line extended approximately 100 meters (330 feet) southwest from the vessel.

Figure 68. NOAA side-scan sonar imagery of the DESTINATION. Provided by NOAA Ship FAIRWEATHER.

Figure 69. NOAA side-scan sonar imagery of the DESTINATION.
Provided by NOAA Ship FAIRWEATHER.

Figure 70. NOAA side-scan sonar imagery of the DESTINATION.
Provided by NOAA Ship FAIRWEATHER.

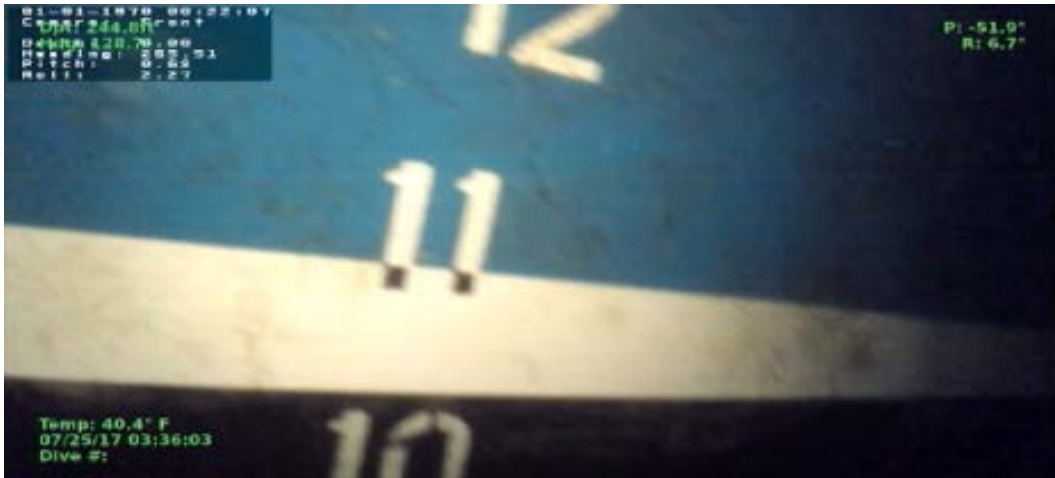
Figure 72. ROV imagery showing the DESTINATION's draft marks.
Photo provided by Coast Guard Dive Locker West.

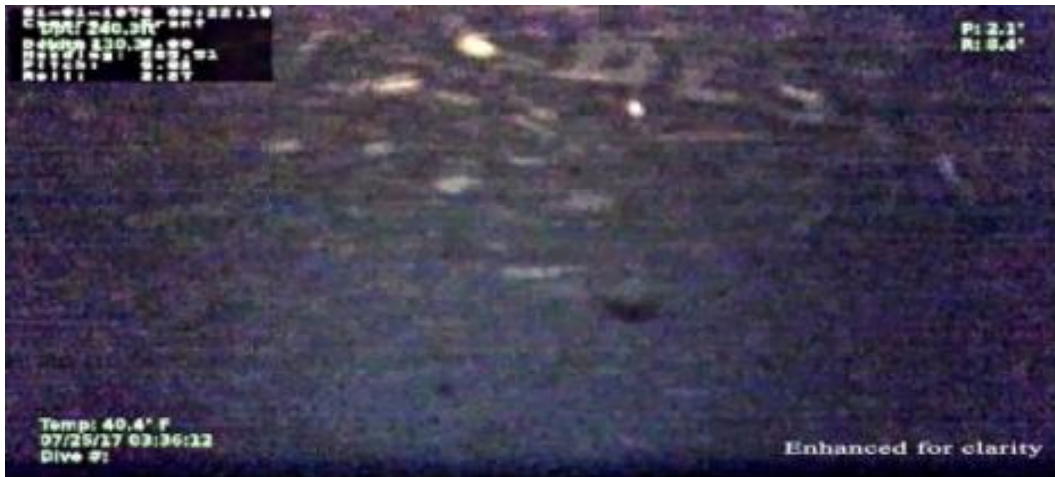
Figure 74. ROV imagery showing a portion of the DESTINATION's name.
Photo provided by Coast Guard Dive Locker West.

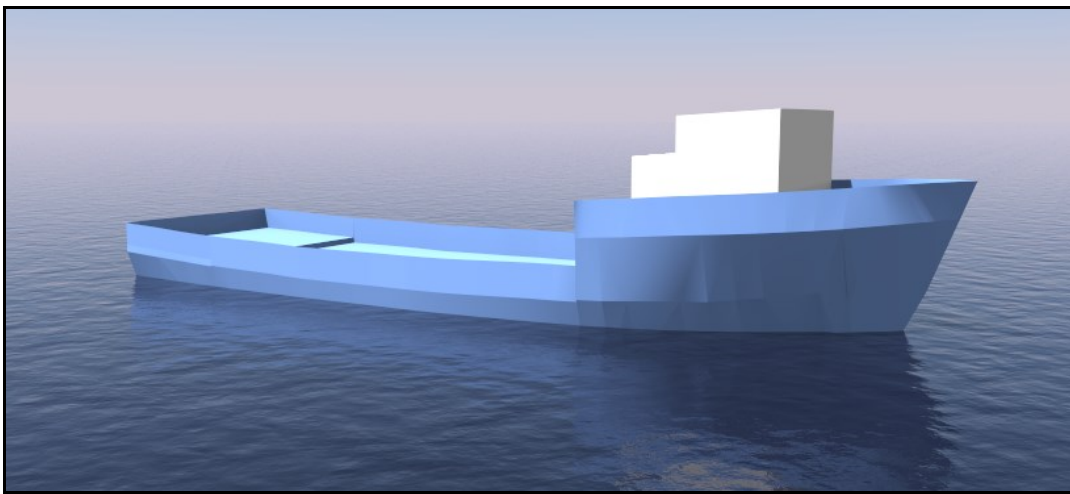
Figure 76. MSC Generated Hull Model of the DESTINATION: Starboard Bow Top View

MSC's independent analysis detected a disparity between the hull model they created based on the vessel's 1993 lines plans to the one developed and supplied by the naval architect reflecting his 2013 stability assessment. Contrary to the naval architect's model that showed the vessel met stability criteria, MSC's model results showed 8 out of 10 loading conditions did not comply with intact stability criteria across loading conditions found within the stability instructions.

MSC explained the disparity between the two results can be attributed to the differences in the hull dimensions, in which the naval architect had slightly longer dimensions for vessel length, beam and depth. For vessels of this size, even slight differences in hull dimensions can alter stability criteria. The extended length of the naval architect's model resulted in the vessel trimming significantly farther forward when the same loading conditions were applied. In general, MSC's results showed the bulbous bow reduced the righting arm values and provided no additional benefit to the vessel's stability as all stability criteria results further decreased.

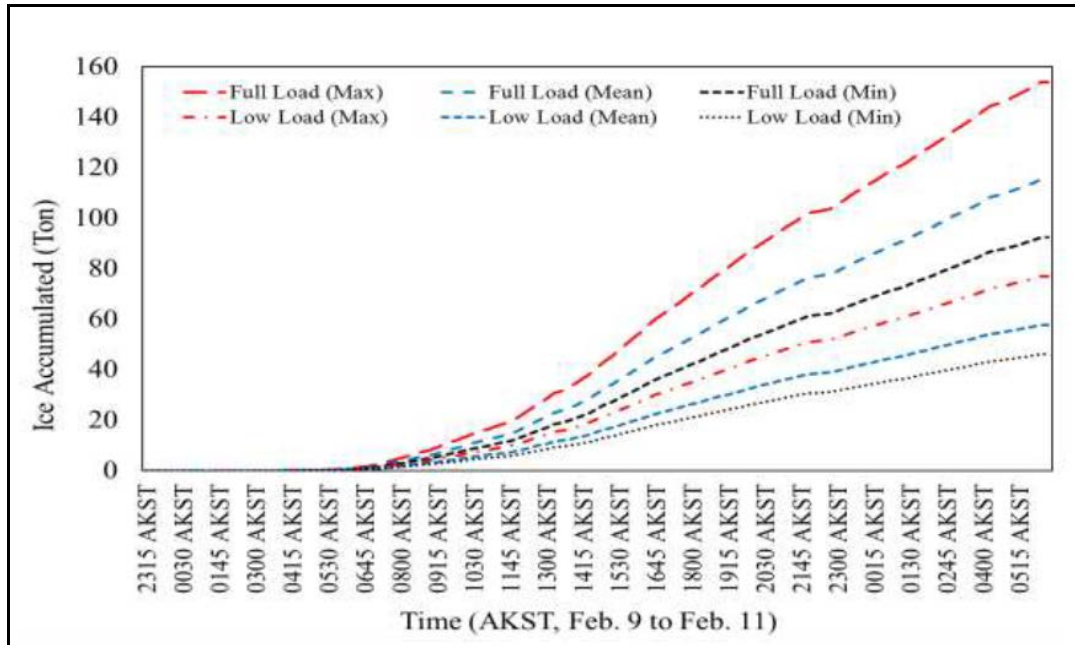
Figure 82. Simulated numerical solution of ice accumulation for the DESTINATION. Provided by Memorial University of Newfoundland, St. John’s, Canada.

Figure 82 is a graph of MU’s simulation solution. Full load (Mean) data shows the vessel could have accumulated approximately 108 LT (241,920 pounds) of ice.

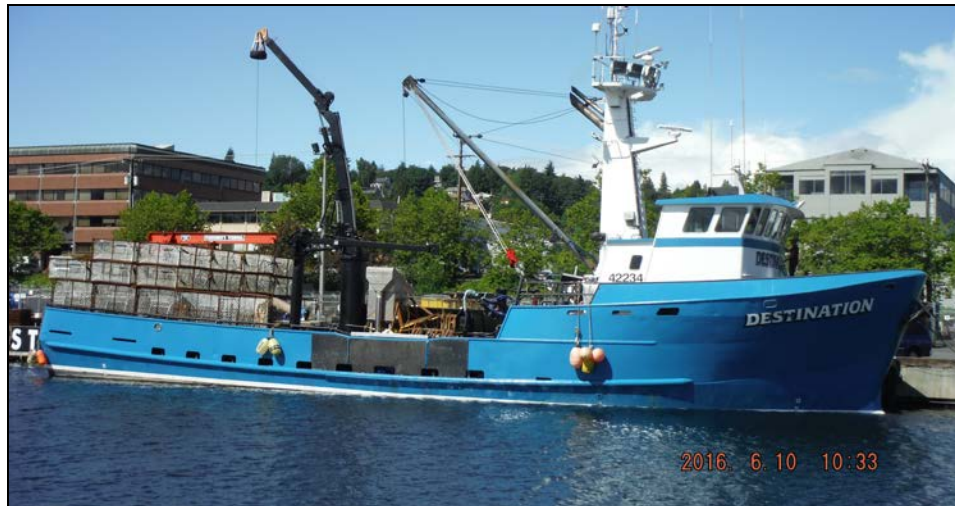
Figure 84. DESTINATION, June 10, 2016 in Seattle, WA.
Photo provided by a third party surveyor.

While the stability instructions indicate the DESTINATION's freeing ports comply with 46 CFR 28.555 requirements, it did not include its dimensions or aggregate area. Absent plans, MSC referred to a photo taken by the third party surveyor on June 10, 2016 (Figure 84) showing a detailed view of the vessel's starboard profile. Using this photo, MSC calculated the dimensions of the freeing ports using known measurements of the vessel, such as the vessel's draft marks.

The DESTINATION had nine freeing ports on each side of the main deck, with an estimated area of 120 square inches each, for a total of 1,080 square inches. In accordance with 46 CFR 28.555 requirements, with a bulwark length of 72 feet, the vessel is required to have 2,390 square inches of freeing port area per side. Only having 54 percent of required amount of aggregate clear area, the vessel failed to meet freeing port area requirements.

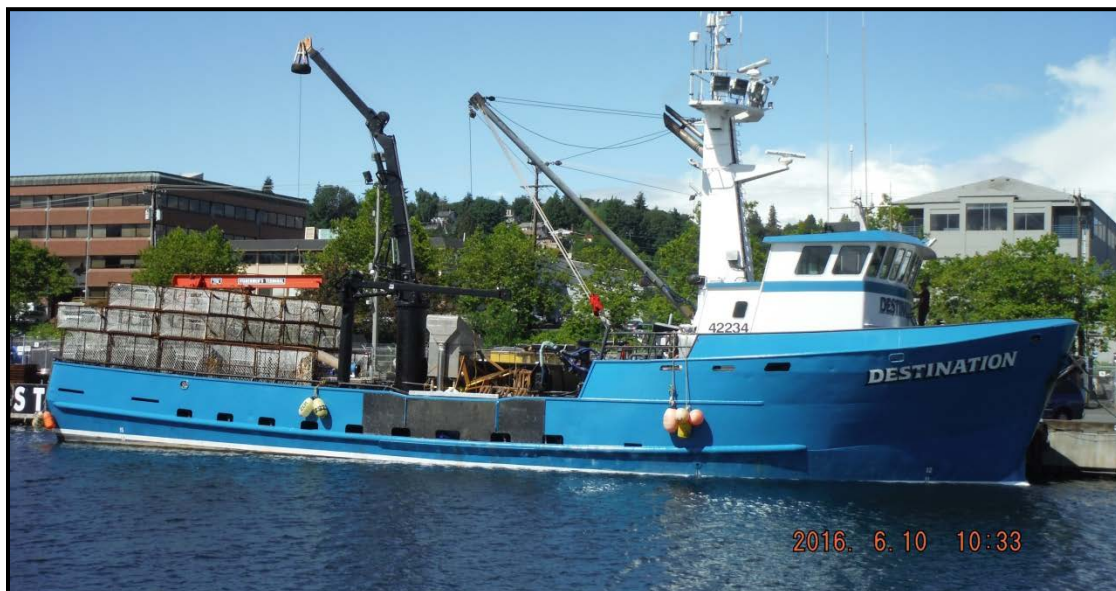
Figure (6): Starboard Profile Showing 9 Freeing Ports

As shown in figure (6) below, the vessel had nine freeing ports on each side. Reference (a) indicates that each had an estimated area of 120 in² resulting in a total freeing port area on either side of the vessel of 1,080 in². For a vessel with a bulwark length of 72 feet, in accordance with 46 CFR 28.555(d), the required freeing port area per side is 2,390 in² (16.6 ft²). The required freeing port area far exceeds the actual freeing port area (1,080 in²). Additionally, the port side of the DESTINATION had a raised shelter bulwark from the deckhouse to the midship crane. Per 46 CFR 28.555(e), this would increase the required freeing port area on the port side by an additional 550 in².

Figure (6) shows the starboard profile with the nine freeing ports. A vessel with insufficient freeing port area would likely result in more seawater becoming trapped on the main deck in foul weather. This water would add additional weight to the vessel, raise the

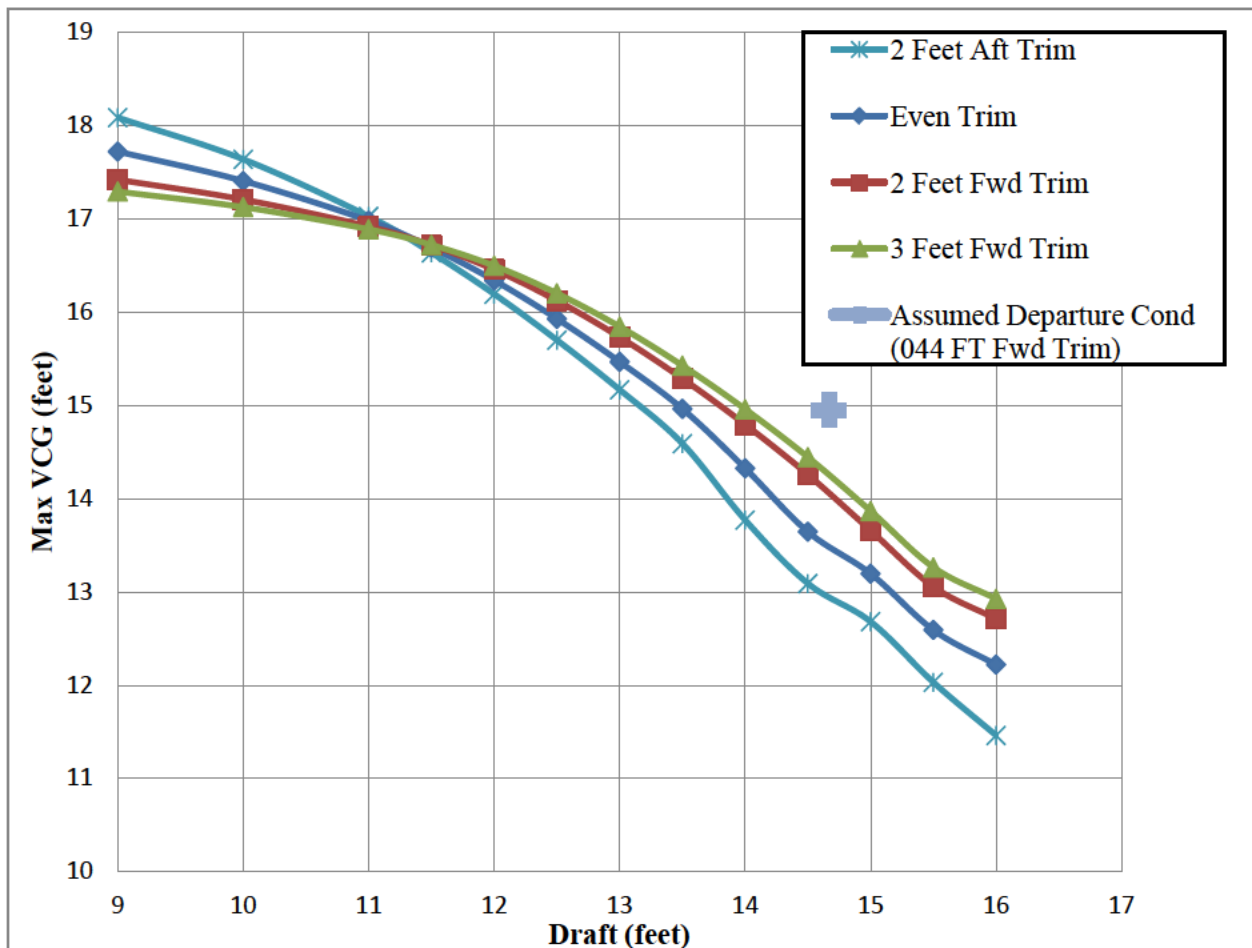
Figure (7): Maximum VCG Curves for Various Trims (46 CFR 170.173 Criteria)

Using GHS, we analyzed the maximum VCG curves at varying drafts and trims. The results are displayed below for the 46 CFR 170.173(c) stability criteria. As the drafts and displacements increase, the maximum VCG for which the vessel passes the applicable stability criteria decreases. A point representing the assumed departure condition from reference (e) is plotted on Figure 7. The assumed departure condition point clearly falls outside the maximum VCG curves. Our calculations indicate that a trim of 6 feet forward or greater would be required to allow the vessel to pass the stability criteria given the assumed loading condition VCG and draft. This draft is well outside the normal operating trims in which the vessel would have been operating.
