**MARINE ACCIDENT
INVESTIGATION REPORT**

Vessel type and name: Chemical Tanker GOLDEN SUNNY HANA

Accident type: Explosion (Cargo oil tank)

Date and time: Around 10:05, April 8, 2018 (local time, UTC+9 hours)

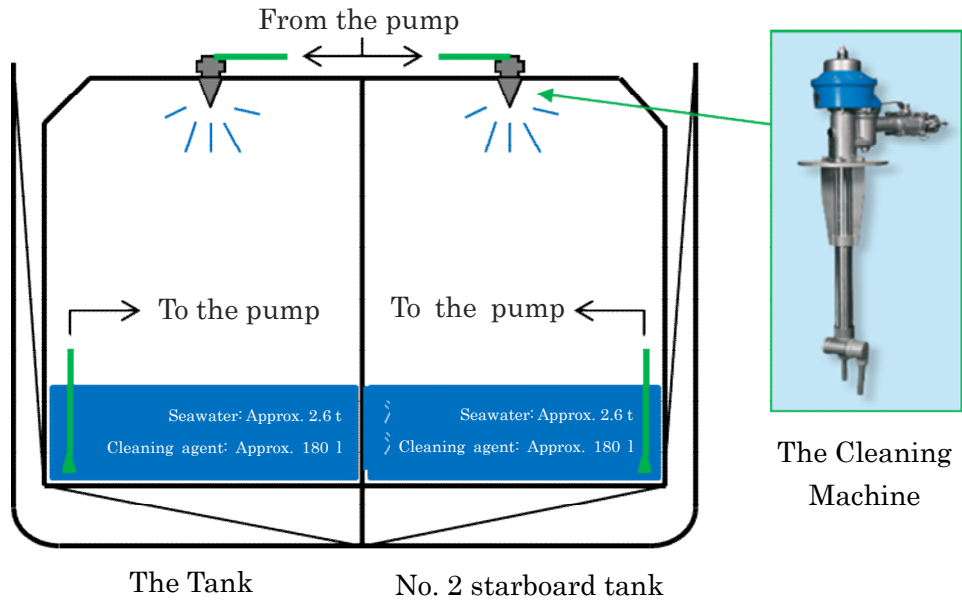
Figure 2 Circulation Work Diagram

The cleaning agent was incombustible and was used for the purpose of tank cleaning. At the time of the accident, it was stored on deck in a plastic drum and was sent directly from the drum into the Tank and the No. 2 starboard tank with a mobile air pump. (See Figure 2)

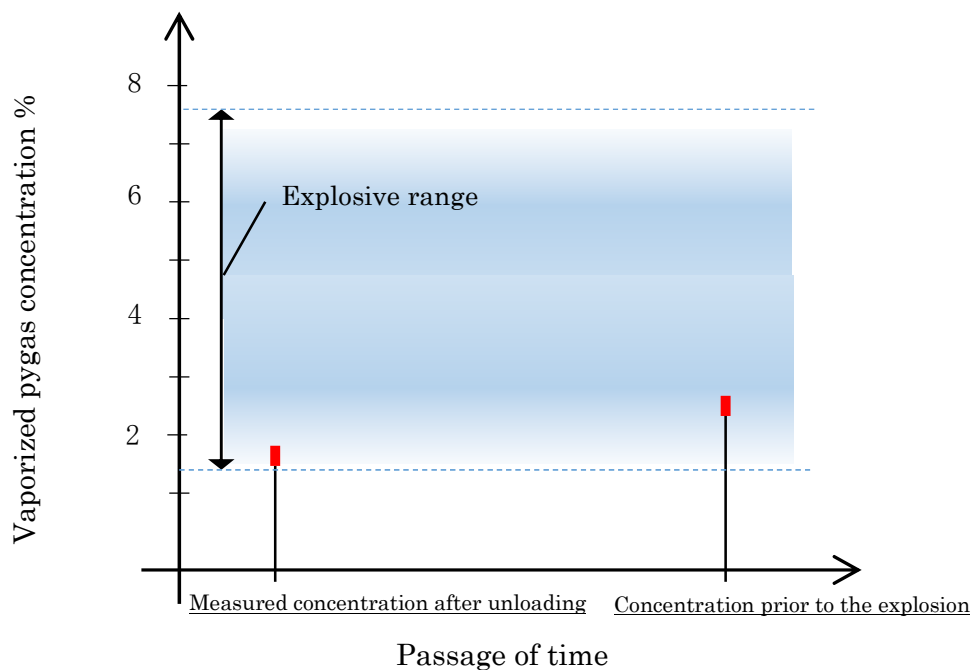
$$\begin{aligned} C_a &= C_b/V_{SW} \\ &= \frac{11.893 \text{ to } 13.308}{468.673} \\ &= 2.54 \text{ to } 2.84\% \end{aligned}$$

Minimum value (%)	Maximum value (%)
After unloading	1.4	1.7
Before the explosion	2.54	2.84
Explosive range	1.3	7.5
