REPUBLIC OF THE MARSHALL ISLANDS

STELLAR DAISY CASUALTY INVESTIGATION REPORT

Loss of Buoyancy and Foundering with Multiple Loss of Life

South Atlantic Ocean | 31 March 2017

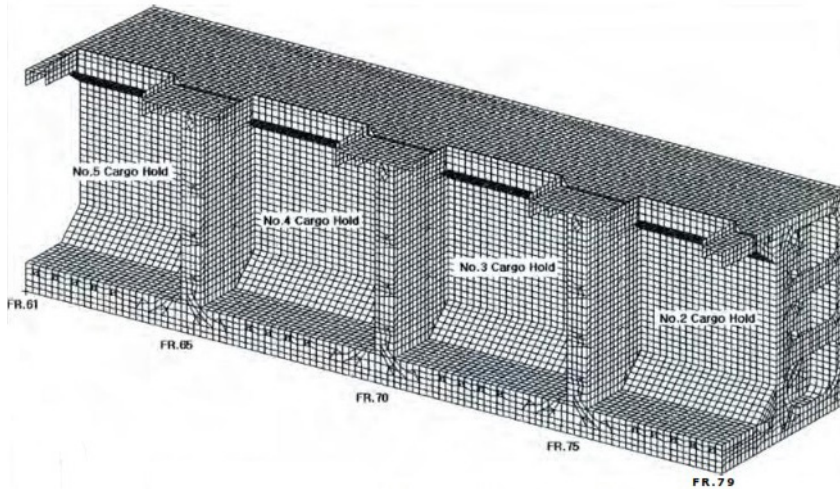
Figure 1: Midship half-breadth of STELLAR DAISY's hull that was modeled for the FEA. Note that Cargo Holds Nos. 3, 4, and 5 in the drawing refer to Cargo Holds Nos. 3F, 3A, and 4 on the General Arrangement Drawing.¹⁶

10. The FEA identified high shear stress in the web frame in way of where the new underdeck structure landed on the longitudinal bulkhead when the ship was loaded with a high density cargo. This was addressed by modifying the web frame to replace the existing grade AH plate with grade AH36 plate between longitudinal bulkhead longitudinals Nos. 5-7. The FEA also identified an area where the stress exceeded the allowed stress in the web frame in way of where the top of the hopper plate landed on the longitudinal bulkhead. The stress in this area was reduced by modifying the conversion design to include the installation of a girder at longitudinal bulkhead longitudinal No. 25 in each of the P/S voids and WBTs within the cargo length;¹⁷

12. The FEA concluded that although there were a number of areas where the stress was high, the conversion design was within the allowable limits for all loading conditions.²⁰

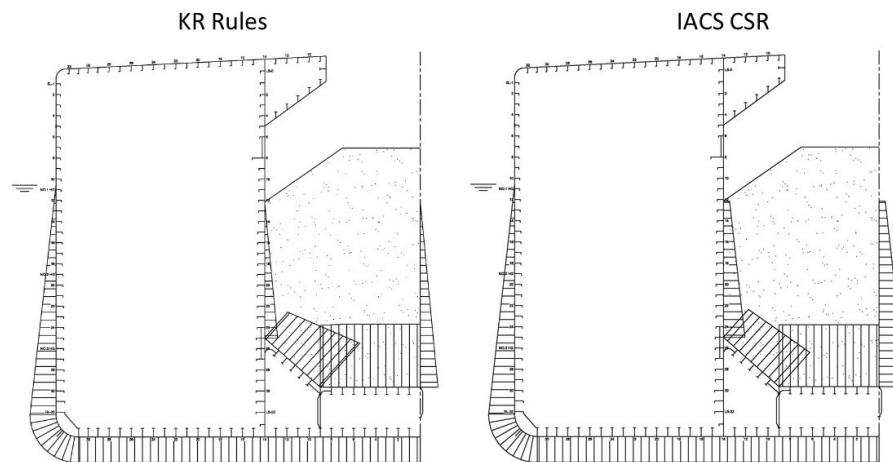
13. As part of the Administrator's marine safety investigation of the loss of STELLAR DAISY, Bruce S. Rosenblatt and Associates, LLC (BSR) was contracted to conduct an independent third-party FEA of the conversion design. The BSR FEA noted there was a difference between the cargo pressures on the boundaries of the cargo hold calculated using the KR Rules for Steel Ships and those calculated using the IACS Common Structural Rules, January 2006 edition as revised through Corrigenda 5 (CSR 2006, Corr.5) that were applicable when the design work for the conversion was being completed.²¹ These differences are most significant nearer the top of the cargo pile (see Figure 2). Therefore, load cases were developed and analyzed using both sets of rules. No areas of concern were identified with either load case. BSR did question whether these calculated pressures were adequate given that the pressure on the longitudinal bulkheads and supporting structure would increase due to the increased static list resulting from the flooding of wing tanks.²²

Figure 2: Scaled graphic representations of the static cargo pressures on the cargo hold boundaries based on KR Rules for Steel Ships (left) and IACS CSR 2006, Corr.5 (right). The pressures on the transverse bulkheads are shown to the right of the cargo pile.

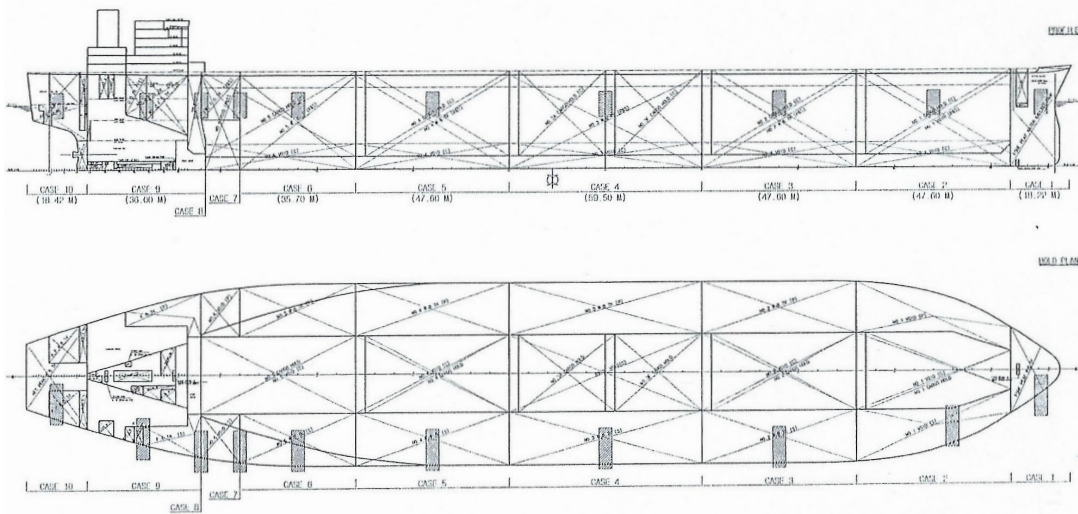
28. On 19 June 2009, KR approved the ship's intact stability and damage stability books.⁴² The approval was based on KR's determination that STELLAR DAISY complied with the requirements of the International Convention on Load Lines, 1966 as amended by the Protocol of 1988 (ICLL 1966 as amended by the Protocol of 1988), regulation 27(8) for a reduced freeboard assignment.⁴³ Ten damage conditions were considered as part of this determination. Of the seven damage conditions based on flooding of wing tanks in the cargo length, one involved flooding of Cargo Hold No. 1, which was sufficient to comply with the damage stability requirements of SOLAS regulation XII/4 (see Figure 7).⁴⁴

Figure 7: Damage conditions assessed to support the assignment of a reduced freeboard. The extent of the damage is shown by the grey rectangles. For the purpose of the assessment, it is assumed that the entire impacted space, or spaces, is flooded. (Source: Damage Stability Information.)

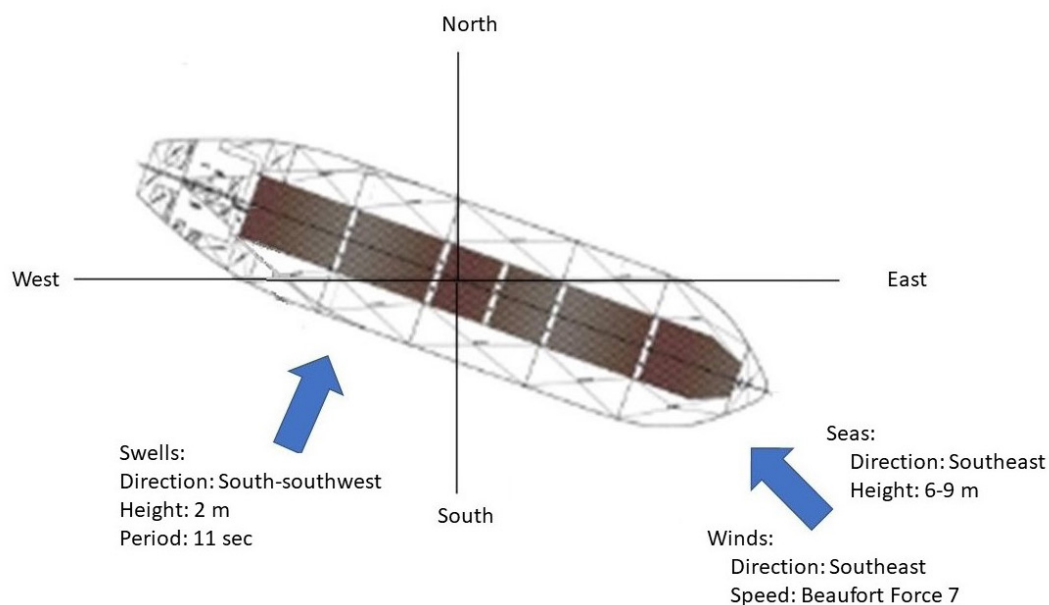
Figure 9: Wind and seas 29-31 March 2017.

After disembarking the Pilot on 26 March 2017, STELLAR DAISY maintained a southeasterly course toward the Cape of Good Hope. The weather worsened approximately two days after the ship's departure. Based on the ship's Noon Reports, Beaufort Force 7 winds and 6-9 m waves from the southeast were encountered for at least 72 hours before flooding was reported in the No. 2 P WBT. Based on the StormGeo forecast, there were also approximately 2 m swells from the southwest during this period (*see Figure 9*).

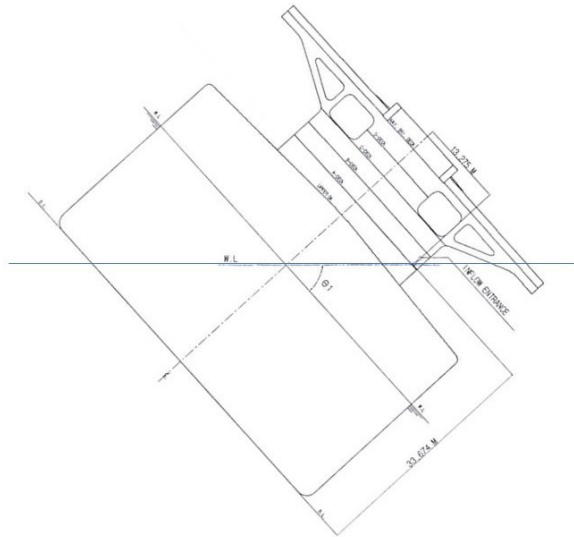
94. The AB stated that as the 3/O was making the distress call, he observed green water entering the Bridge through the door on the port side. He reported that the inclinometer indicated STELLAR DAISY had a 45° list to port (see Figure 10).¹³⁷ He also reported hearing a loud cracking sound on the port side but that he was not sure where it came from and that the ship rumbled like an earthquake. The AB reported he then ran out of the Bridge door and jumped into the water from the port side bridge wing. He did not provide an estimate of how long it was between when he first felt the ship start listing to port and when he entered the water.

Figure 10: Looking aft, waterline at a 45° list to port with a loaded draft of 20.2 m. The waterline shown does not take into consideration any draft increase due to flooding. (Source: Stability and Loading Manual.)

¹³⁷ Based on Polaris Shipping's calculations after STELLAR DAISY was reported lost, the down flooding angle was 43.338° , which is consistent with the value provided in the Stability and Loading Manual (p. 46).

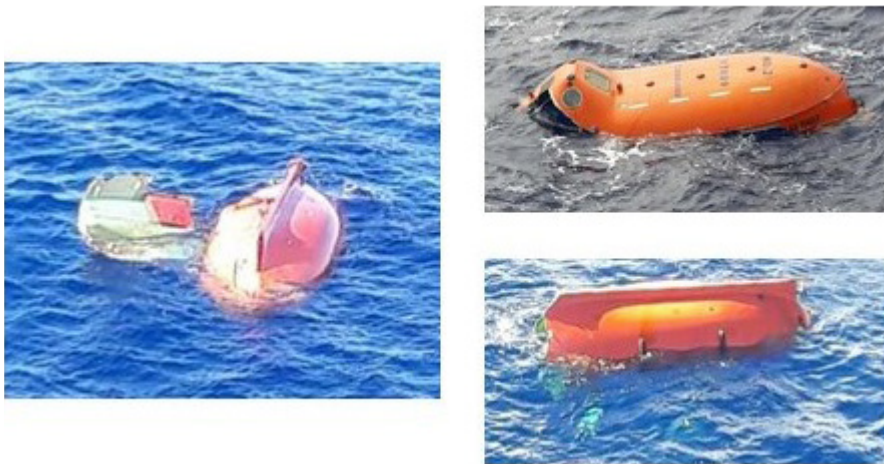
103. ELPIDA also reported sighting two life boats.¹⁴¹ Both life boats were floating capsized. The top of STELLAR DAISY’s No. 2 life boat was separated from the hull (*see Figure 14*). There were no indications that members of STELLAR DAISY’s crew were on board either of the life boats. Two additional life rafts were also sighted.¹⁴² One was reported to be floating upright in good condition without any of STELLAR DAISY’s crew onboard and the other was capsized.¹⁴³

Figure 14: STELLAR DAISY’s life boats. The No. 1 life boat is on the left. The top and the hull of the No. 2 life boat, which were found floating separately, are on the right.

The damage sustained by the Nos. 1 and 2 life boats indicates that both were torn free from their respective davits as STELLAR DAISY sank (*see Figure 14*). Given how quickly the ship lost buoyancy, it is not considered likely that the crew would have been able to enter and successfully launch the life boats, even if they had been directed to immediately proceed to their life boat stations after it was determined that the No. 2 P WBT was flooding.¹⁷⁰ The fact that the life boats were not launched is not considered to have contributed to the loss of 22 of STELLAR DAISY's crew.
