Final report RS 2019:01e

DECLAN DUFF – Accident in conjunction with discharging of cargo in Oxelösund, Södermanland County on 16 March 2018

File no. S-42/18

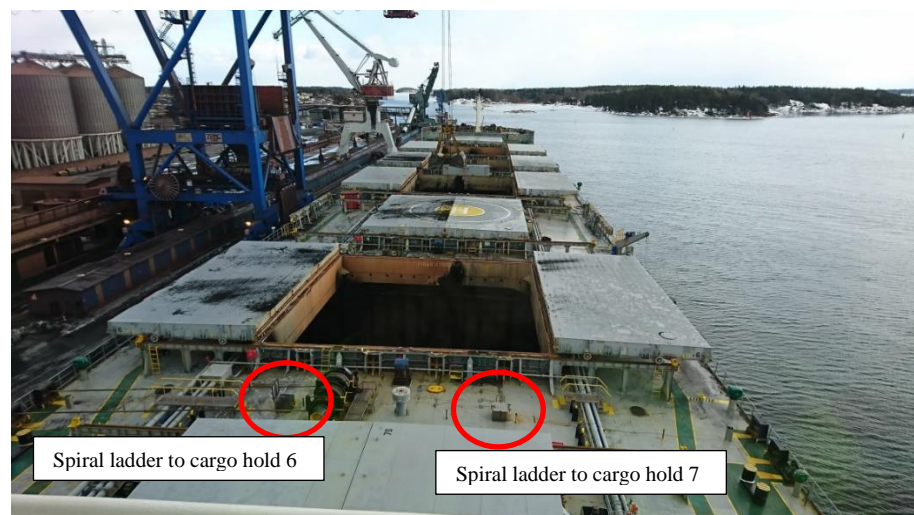
Figure 2. DECLAN DUFF. Photograph taken by the Swedish Transport Agency inspector the day before the accident.

From the photograph (see figure 2) taken by the Swedish Transport Agency inspector the day before the accident, it is clear that the entry hatch to the spiral ladder in cargo hold 7 was closed at the time of inspection. It is furthermore clear from the interviews with the port personnel that both the entry hatch to the vertical ladder and the entry hatch for the spiral ladder were closed after the loading hatch to cargo hold 7 had been opened by the ship's crew and the discharging was to begin. The entry hatch to the vertical ladder had then been opened by the port personnel. However, the port personnel have stated that it was only the entry hatch to the vertical ladder that they opened, and not the entry hatch to the spiral ladder.

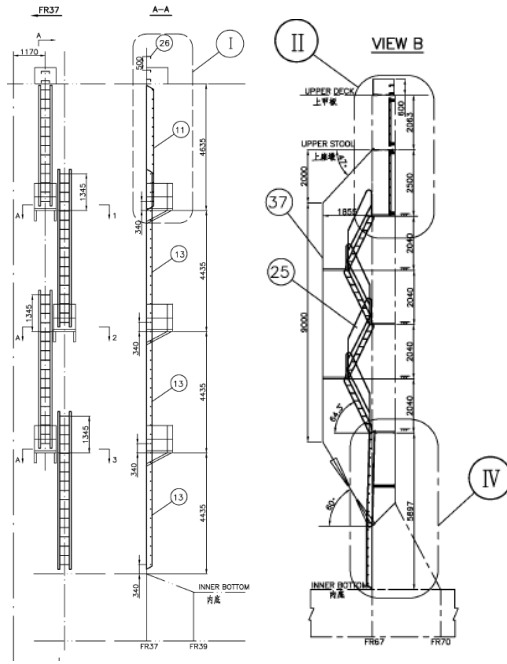
Figure 9. Vertical ladder

Spiral ladder
