Final report MO-2017-204: Passenger vessel *Seabourn Encore*, breakaway from wharf and collision with bulk cement carrier at Timaru, 12 February 2017

Marine inquiry MO-2017-204

Passenger vessel *Seabourn Encore*

Breakaway from wharf and collision with bulk  
cement carrier at Timaru

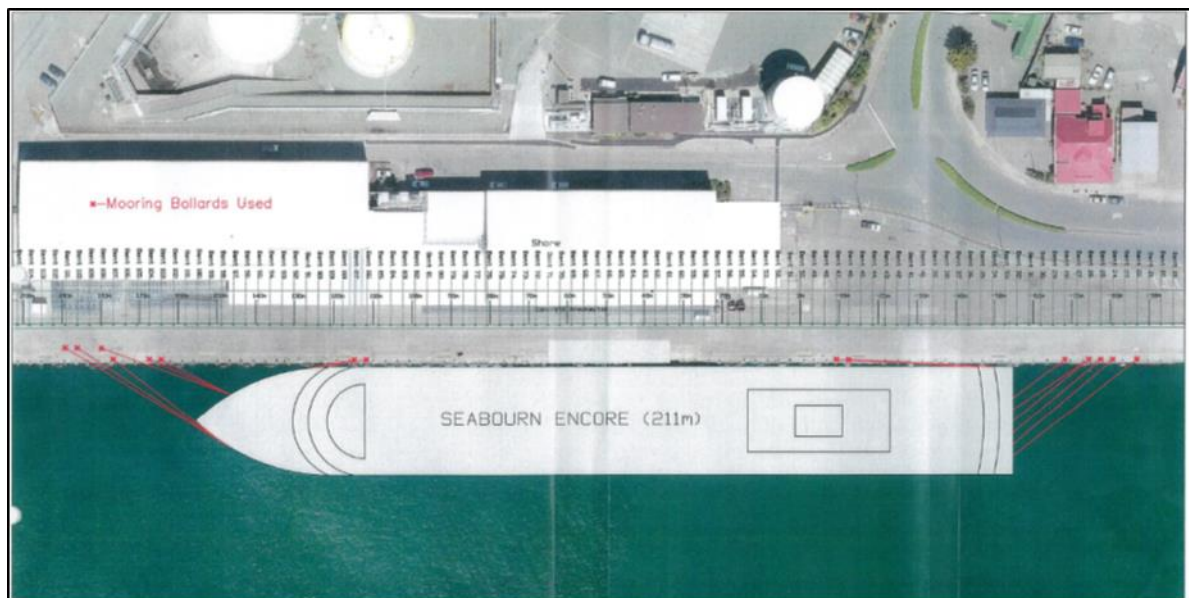
Figure 1  
Mooring arrangement alongside Number One Wharf

- 3.1.5. At 0825 the vessel was all secure with six head and six stern lines and two forward and two aft springs. The line of the berth was 048/228° (degrees) (see Figure 1).

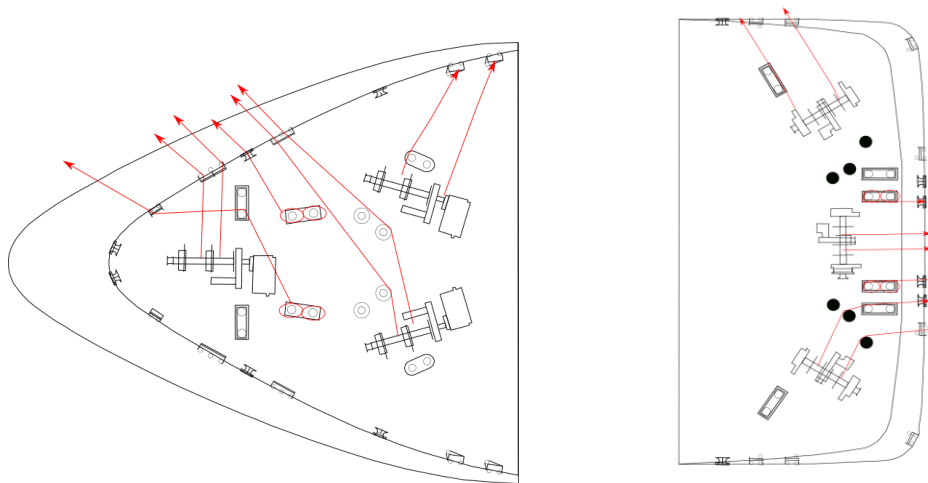
Figure 5  
Bow (left) and stern (right) mooring and securing arrangements

3.5.1. Figure 5 shows the mooring arrangements forward and aft on the *Seabourn Encore*. At the bow, six of the eight mooring lines were secured on dedicated split drum winches. The remaining two head lines were secured on mooring bitts. Seven of the eight lines were run through roller fairleads<sup>12</sup> and one head line was run through a panama fairlead.<sup>13</sup> Similarly, at the stern, six of the eight mooring lines were secured on split drum winches and the remaining two were secured to mooring bitts. Five of the eight mooring lines were run through roller fairleads and three were run through panama fairleads. All the mooring lines were fairly equally tensioned, and roller fairleads were later observed to be functioning correctly.

3.5.2. Figure 5 shows, to scale, the mooring line configuration and the shore mooring bollards used to secure the lines. All the lines were run to separate shore bollards with the exception of two stern lines placed on bollard 26.

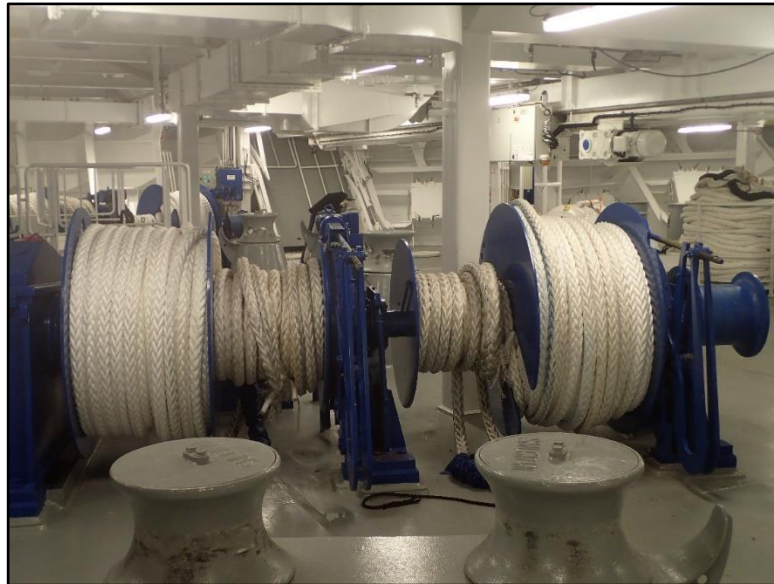
**Figure 6**  
Split drum mooring winch used to secure mooring lines on board the *Seabourn Encore*

3.5.3. The mooring winches could be used in auto-tension mode or manual mode. On the day of the accident the winches were in manual mode and the mooring ropes were secured on the brake of the split drum winches (see Figure 6). Two additional lines forward and aft were secured to mooring bitts.

- 3.6.2. Each of the split drum mooring winches were designed for a synthetic rope 64mm in diameter with a minimum breaking load of 59 tonnes. The mooring winches were certified by RINA in August 2015 and commissioned in December 2016. All mooring winches supported a static pull on the brake of 48 tonnes, which was 76% of the design mooring rope minimum breaking load (MBL) fitted on the winches.

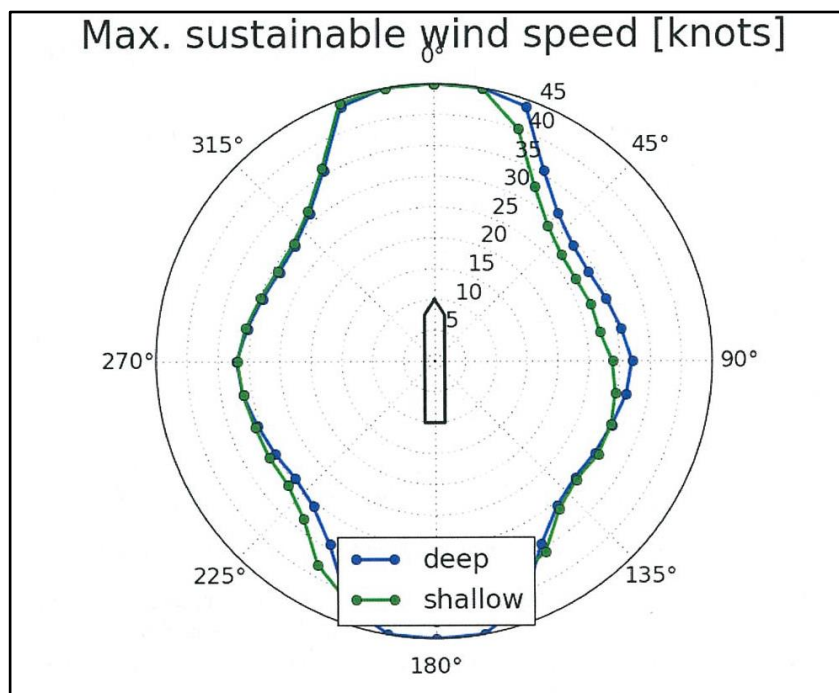
Figure 8  
Polar plot showing the crabbing capability – quay on port side shallow water

- 4.2.9. As the bow and stern thrusters became available, an attempt was made to stop arrest the stern swinging down onto the *Milburn Carrier II* and subsequently Number Two Wharf. By design the vessel was only capable of moving sideways into a prevailing wind (from the same relative direction) of approximately 35 knots (see the polar diagram in Figure 8). This required all thrusters and main propellers to be available. At best it may have been possible to arrest the swing but it was more likely to have reduced the rate of drift towards Number Two Wharf.

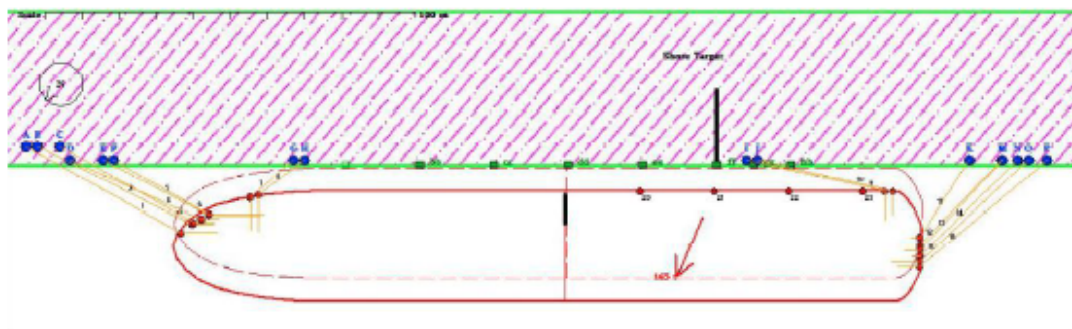
Comment: Similar to Situation B2, vessel (at midships) has moved 5.9 m out from the wharf, and line loads increase with bow springs at 44-53% strength, and stern lines L/M at 57% strength. Mooring arrangement is secure provided bollards hold.
