National Transportation Safety Board

Marine Accident Brief

Explosion and Fire aboard Articulated Tug and Barge *Buster Bouchard/B. No. 255*

Accident type	Fire/explosion	No. DCA18FM002
Vessel names	<i>Buster Bouchard, B. No. 255</i>	
Location	Aransas Pass Fairway Anchorage, 3.25 miles ¹ off Port Aransas, Texas 27°49.80' N, 096°59.40' W	
Date	October 20, 2017	
Time	0430 central daylight time (coordinated universal time – 5 hours)	
Injuries/fatalities	Two fatalities	
Property damage	>\$5 million est.	
Environmental damage	About 2,000 barrels (84,000 gallons) of crude oil released to the sea and atmosphere	
Weather	Visibility 8 miles, winds north at 6 knots, seas 3–4 feet, air temperature 75°F, water temperature 78°F	
Waterway information	Open waters of the Gulf of Mexico; charted depth at the accident site was 45 feet.

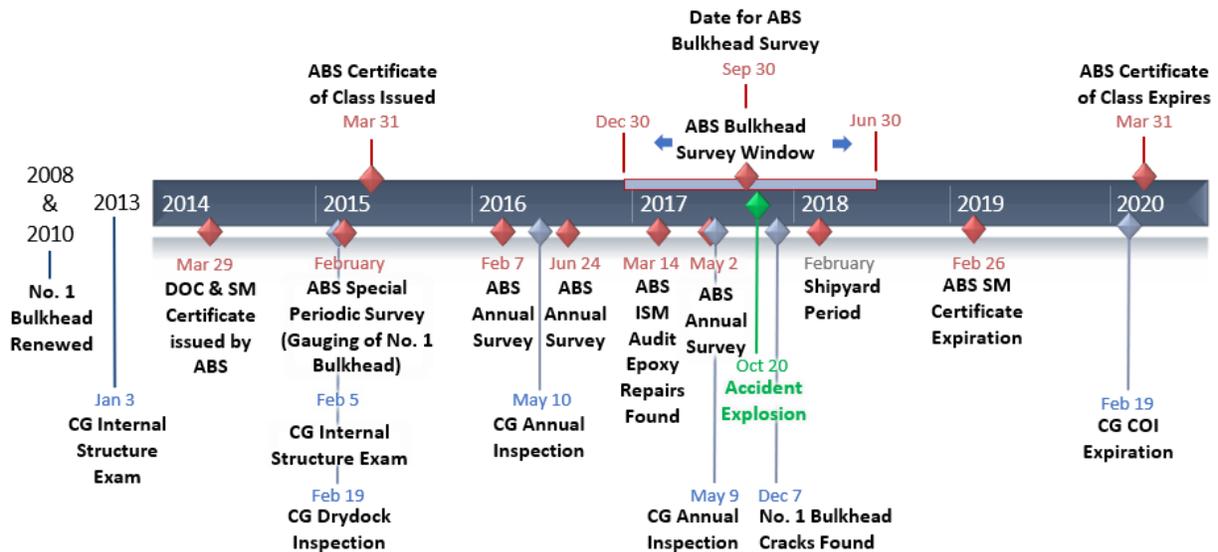
Barge B. No. 255 ABS and Coast Guard Survey and Inspection Overview

- **September 08, 2017:** (29 days after the requirement for the no. 3 cargo pump was met) A vapor tightness test was conducted at Boland Shipyard; the barge was found to be in satisfactory condition.
- **October 11 and 13, 2017:** The vessel's deck log indicated that a mechanic was on board to fix the no. 2 generator. Two days later, a mechanic and an electrician were on board for repairs to the no. 1 generator. The explosion occurred 7 days afterward.
