## MARINE SAFETY INVESTIGATION REPORT

Safety investigation into the grounding  
of the bulk carrier

***OLIVA***

MARINE SAFETY INVESTIGATION REPORT NO. 14/2012

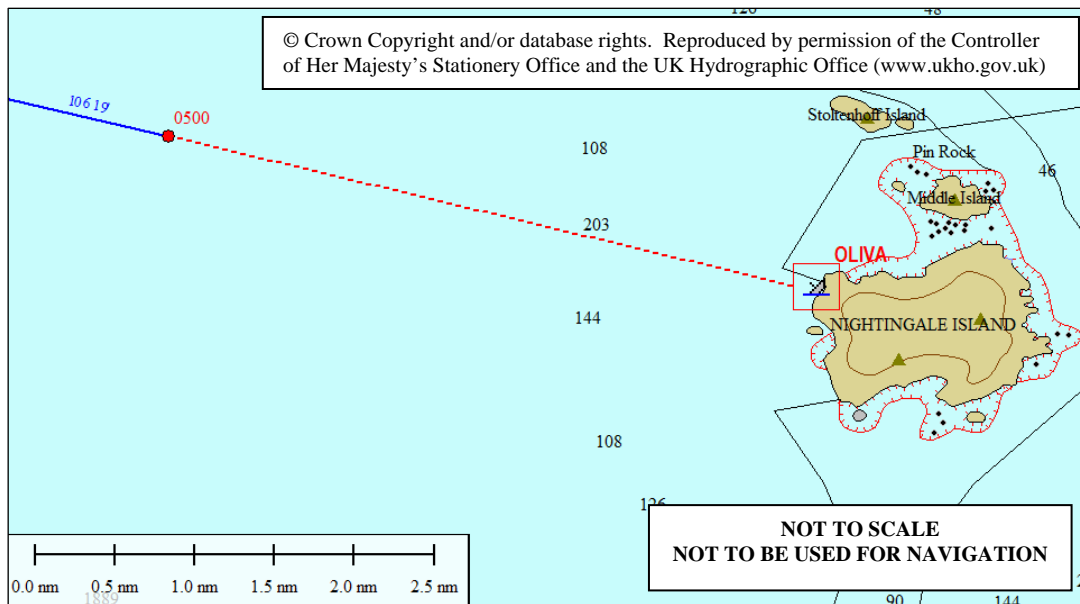
The vessel developed a port list of 12° and assumed a heading of 091°. The master ordered the second mate and chief mate to take soundings of the ballast tanks. The third mate plotted the position of the ship (Figure 6) which placed the vessel on Nightingale Island, one of the three large islands that forms the Tristan Da Cunha Group.

Figure 6: Position of *Oliva* aground

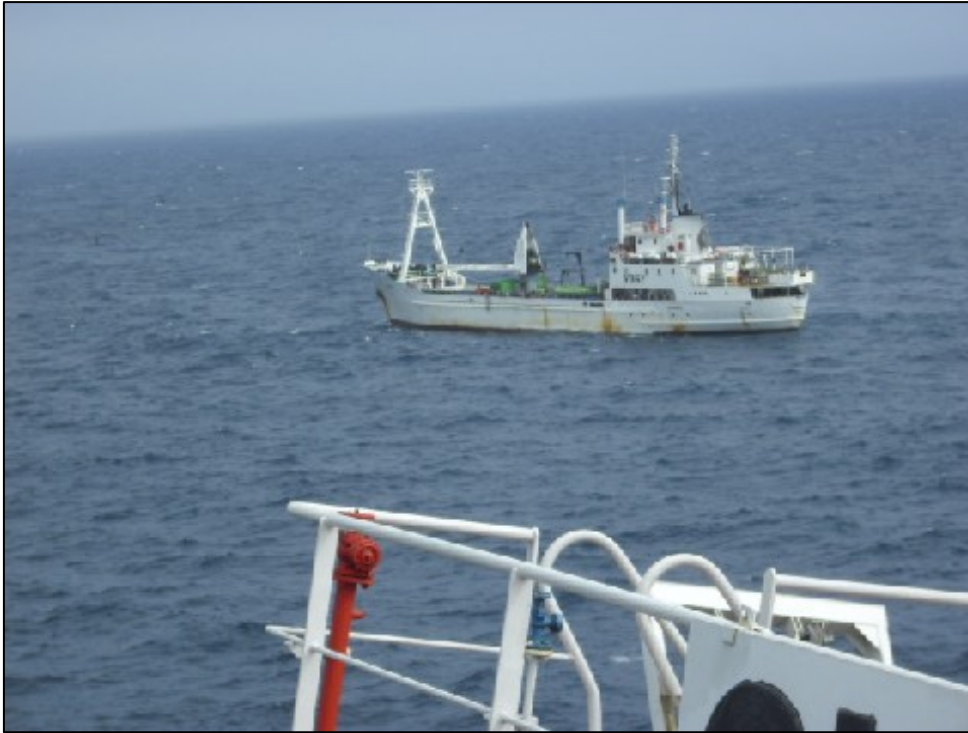
**Figure 7: Fishing vessel *Edinburgh* standing by to render assistance**
