Report on the investigation of
work undertaken in a dangerous enclosed/confined space
and the consequent attempted rescue on board

ERRV Viking Islay

resulting in the loss of three lives
at the Amethyst gas field, 25 miles off the East Yorkshire coast, UK

Report No 12/2008
July 2008

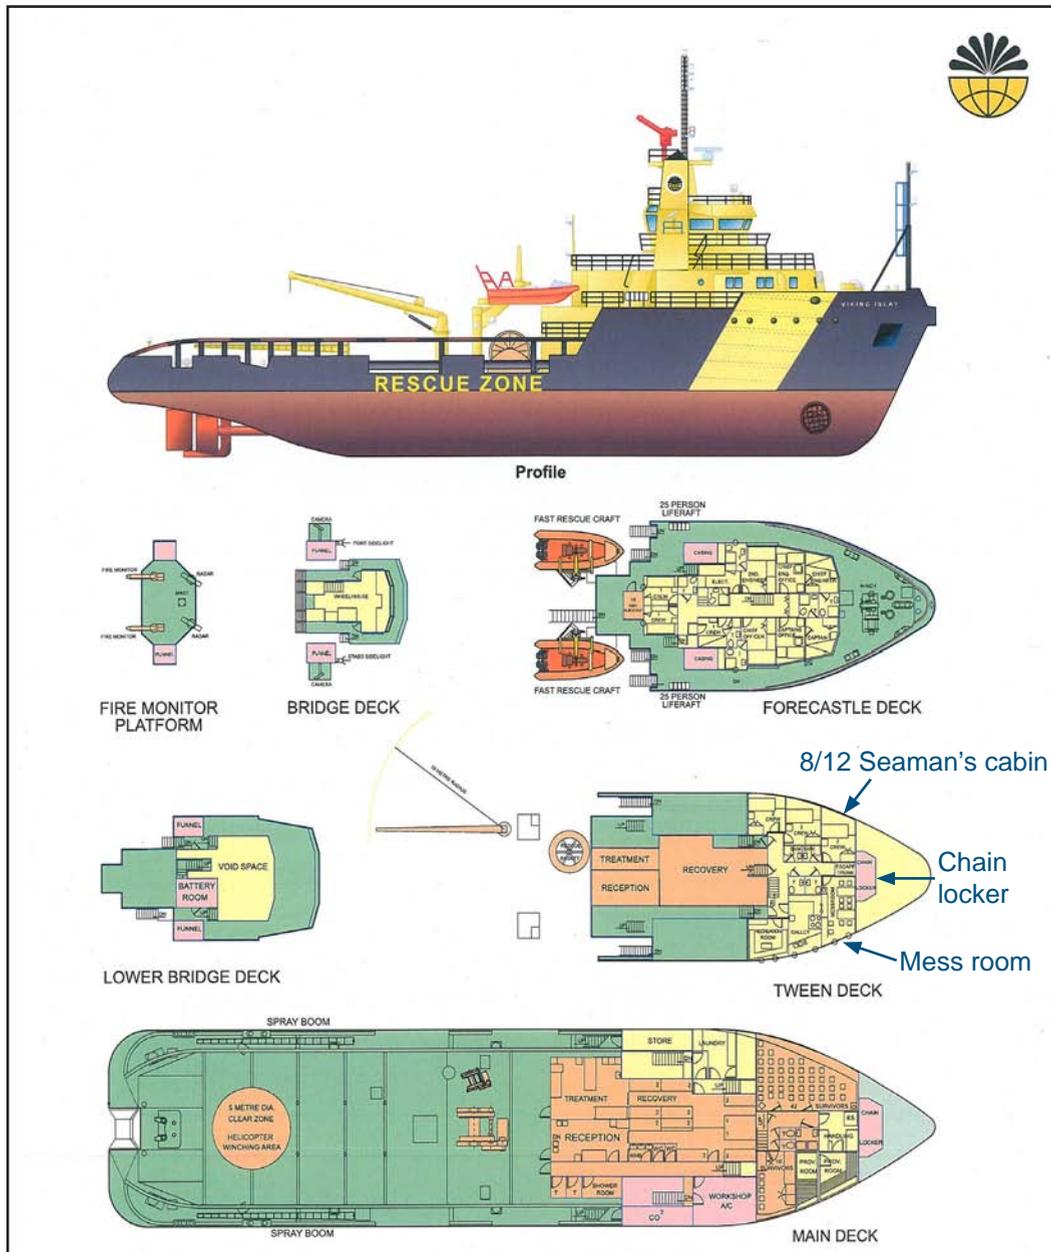
Figure 3

Due to the motion of the ship during the night, the starboard anchor chain began to bang against something within the chain locker, probably the spurling pipe. This disturbed the 8/12 seaman², Mr MacFadyen, whose cabin shared a common bulkhead with the chain locker. It is possible that others were aware of the noise, as the mess room also abutted the spray boom (Figures 3 and 4).

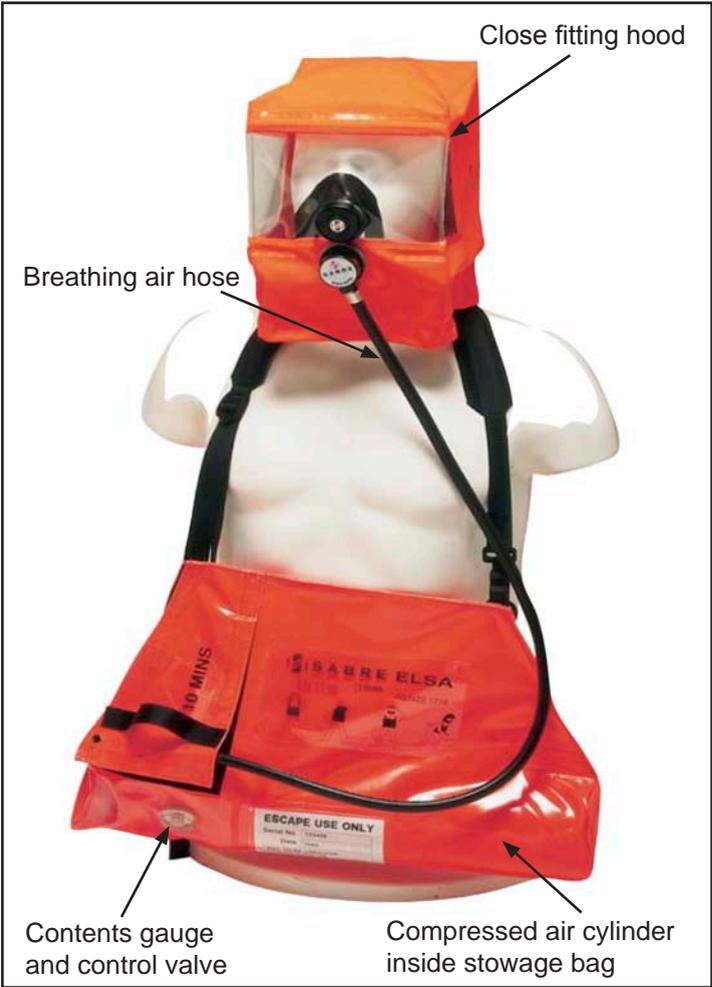
Figure 10

The Sabre ELSA is a self-contained, open circuit, compressed air, constant flow EEBD. It comprises a compressed air cylinder with a combined reducer/cylinder valve, attached to a close fitting escape hood by a breathing hose. The whole unit is contained within a stowage bag ready for immediate use. The high-visibility bag is clearly marked **ESCAPE USE ONLY (Figures 10 and 11)**.

¹² Paragraph 2 of the Annex to MSC/Circ.849 of June 1998 states: *An EEBD is a supplied-air device only used for escape from a compartment that has a hazardous atmosphere...EEBD's are not to be used for fighting fires, entering oxygen deficient voids or tanks, or worn by fire fighters.* This is repeated in Annex 1 of MGN 215 (M+F), dated March 2002.
