Editorial

Removal of heat protection from machinery

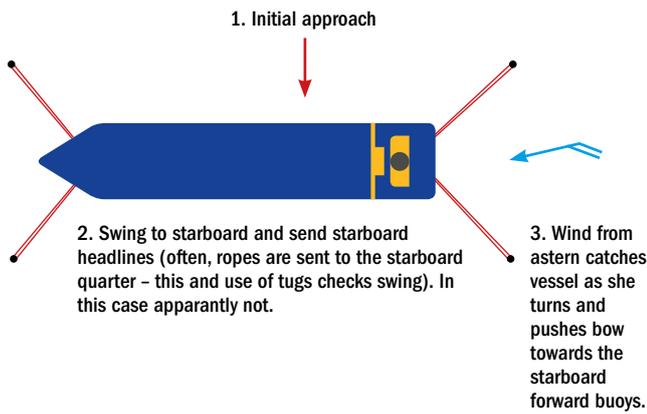
Schematic of a Conventional Buoy Mooring system

Having discussed this report, the Maritime Advisory Board agreed that a lack of communication was central to this incident and that all aspects of the intended operation including hazards should have been covered at the pre-mooring meeting.

And what of the tug? The prevailing weather conditions should have made it clear that the tug would be required to pull astern to check the vessel. In addition, the pull (if on the starboard quarter) could have checked the natural transverse thrust caused by the astern movement.

- To highlight the need for open and continuous communication between the bridge and mooring stations, this should be fully discussed during the pre-mooring toolbox talk and risk assessment meeting.
- For situational awareness, the bridge team should ALWAYS notify the mooring stations of any intended actions. Similarly, both mooring stations should also provide a continuous status report for the bridge team’s awareness.

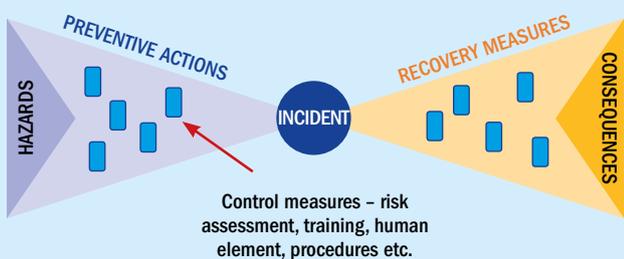
The report highlights a potential cultural issue on board – a vessel’s personnel tend to respond in a certain manner depending on their background. It can be inferred that both culture and communications have led to a suspicion that pilotage was not being effectively monitored and that bridge team management was poor. **(Human Element – culture, competence, complacency, alerting, situational awareness and teamwork).**

The self-criticism by the reporter is a very good point – not everything may have been attributable to the ship. Perhaps in hindsight, the inner anchorage may not have been the best place to anchor if weather conditions were subject to sudden change. A suggested learning point is to consider how pilots, port authorities and VTS manage these situations and how they could have controlled things better. The bow tie diagram illustrates the issue.

Bow tie diagram highlighting prevention of threats on the left-hand side to avoid recovery measures and consequences on the right

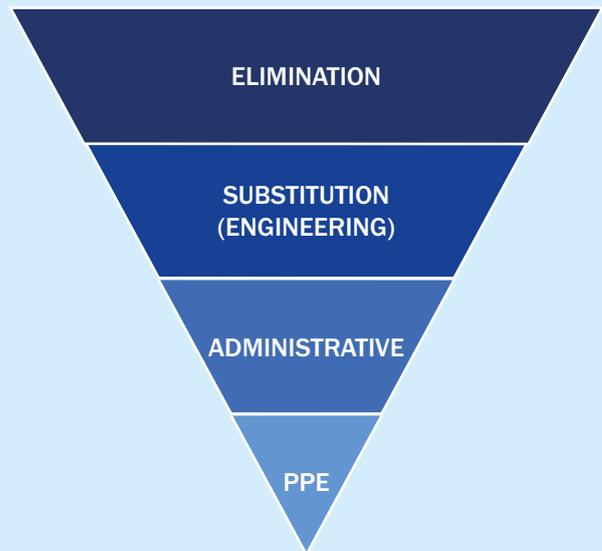
The observation that the responsible officer apparently failed to understand the potential for a serious incident is of concern.

Hierarchy of controls to mitigate hazards

Eliminate the hazard – New builds need the assistance of shipyards, naval architects and regulators to achieve this.

Design out the issues so that all potential discharges or the pilot boarding area are moved elsewhere
