Collision between US Navy Destroyer *John S McCain* and Tanker *Alnic MC*
Singapore Strait, 5 Miles Northeast of Horsburgh Lighthouse
August 21, 2017

Marine Accident Report

NTSB/MAR-19/01
PB2019-100970

**National
Transportation
Safety Board**

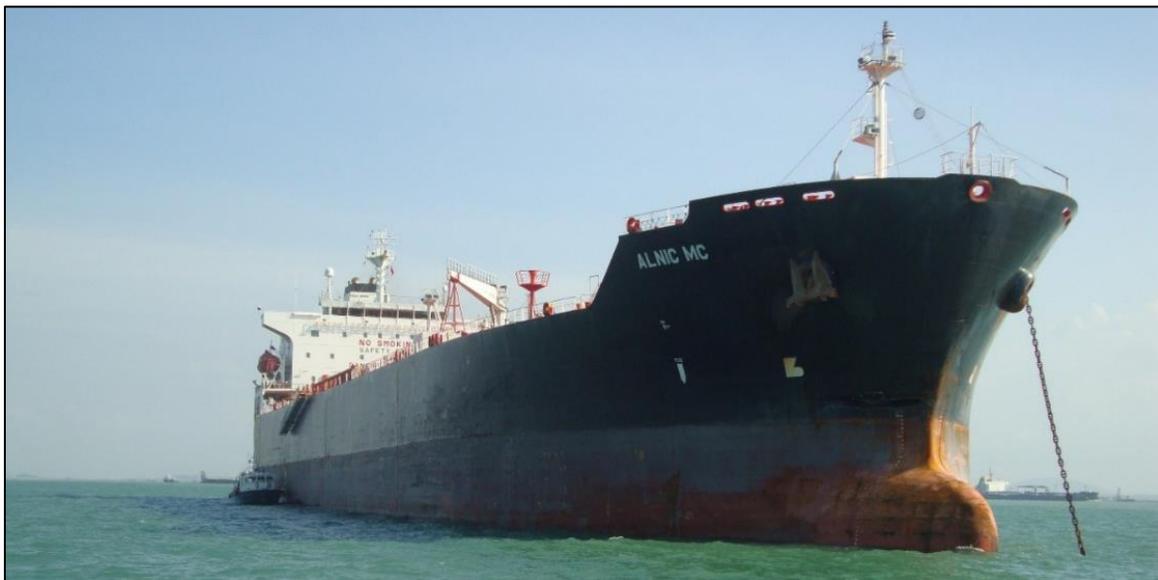
Figure 8. *Alnic MC* after the accident. (Photo by US Coast Guard)

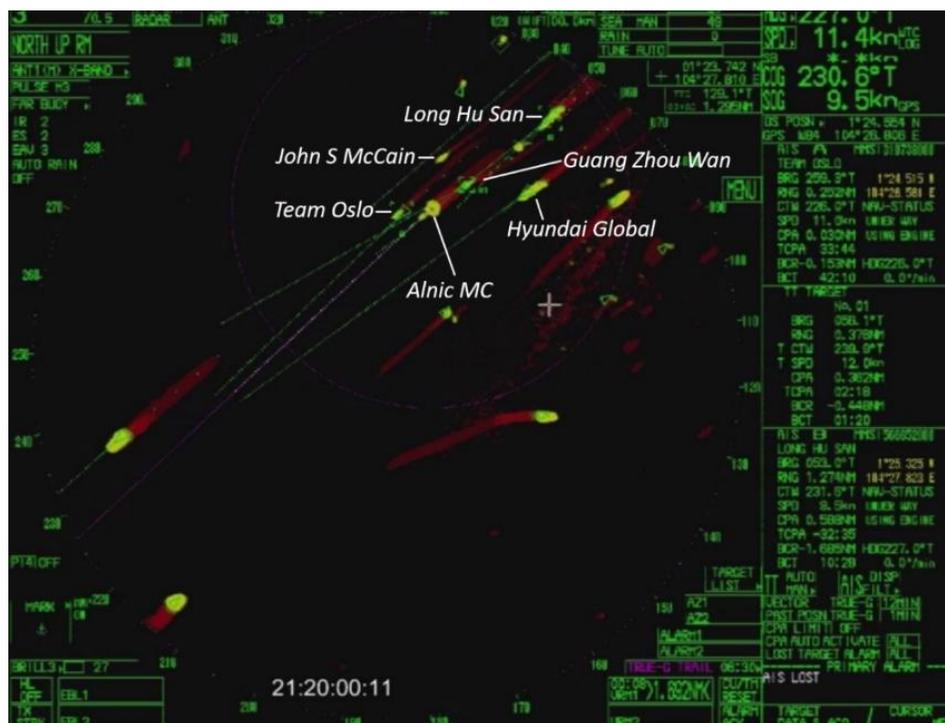
About 4 minutes later, the *John S McCain* entered the TSS and was at the northern extremity of the westbound traffic lane transiting at a speed of 18 knots. At the time, the *Alnic MC* was 45 degrees off the destroyer's port bow at a distance of about 0.6 miles and moving at 9.5 knots at a full ahead engine order. Other vessels in the vicinity, as shown on radar images from the tanker's voyage data recorder (VDR), included the tanker *Team Oslo* moving at 11.0 knots close to and just forward of the *Alnic MC*'s starboard bow, the *Guang Zhou Wan*, also a tanker, traveling at 12.0 knots about 0.5 miles off the port quarter of the *John S McCain* and about 0.4 miles astern of the *Alnic MC*, and the large containership *Hyundai Global*, which was astern and to port of the *Alnic MC* and making speed (16 knots) to overtake the *Alnic MC*.¹⁴

Figure 10. Screen capture from *Alnic MC* automatic radar plotting aid (ARPA) at 0520 on the morning of the accident. (Ship name labels added by NTSB)
