Final report MO-2018-204: *Dolphin Seeker*, grounding, 27 October 2018

Marine inquiry MO-2018-204  
Dolphin Seeker, grounding  
27 October 2018

Approved for publication: July 2019

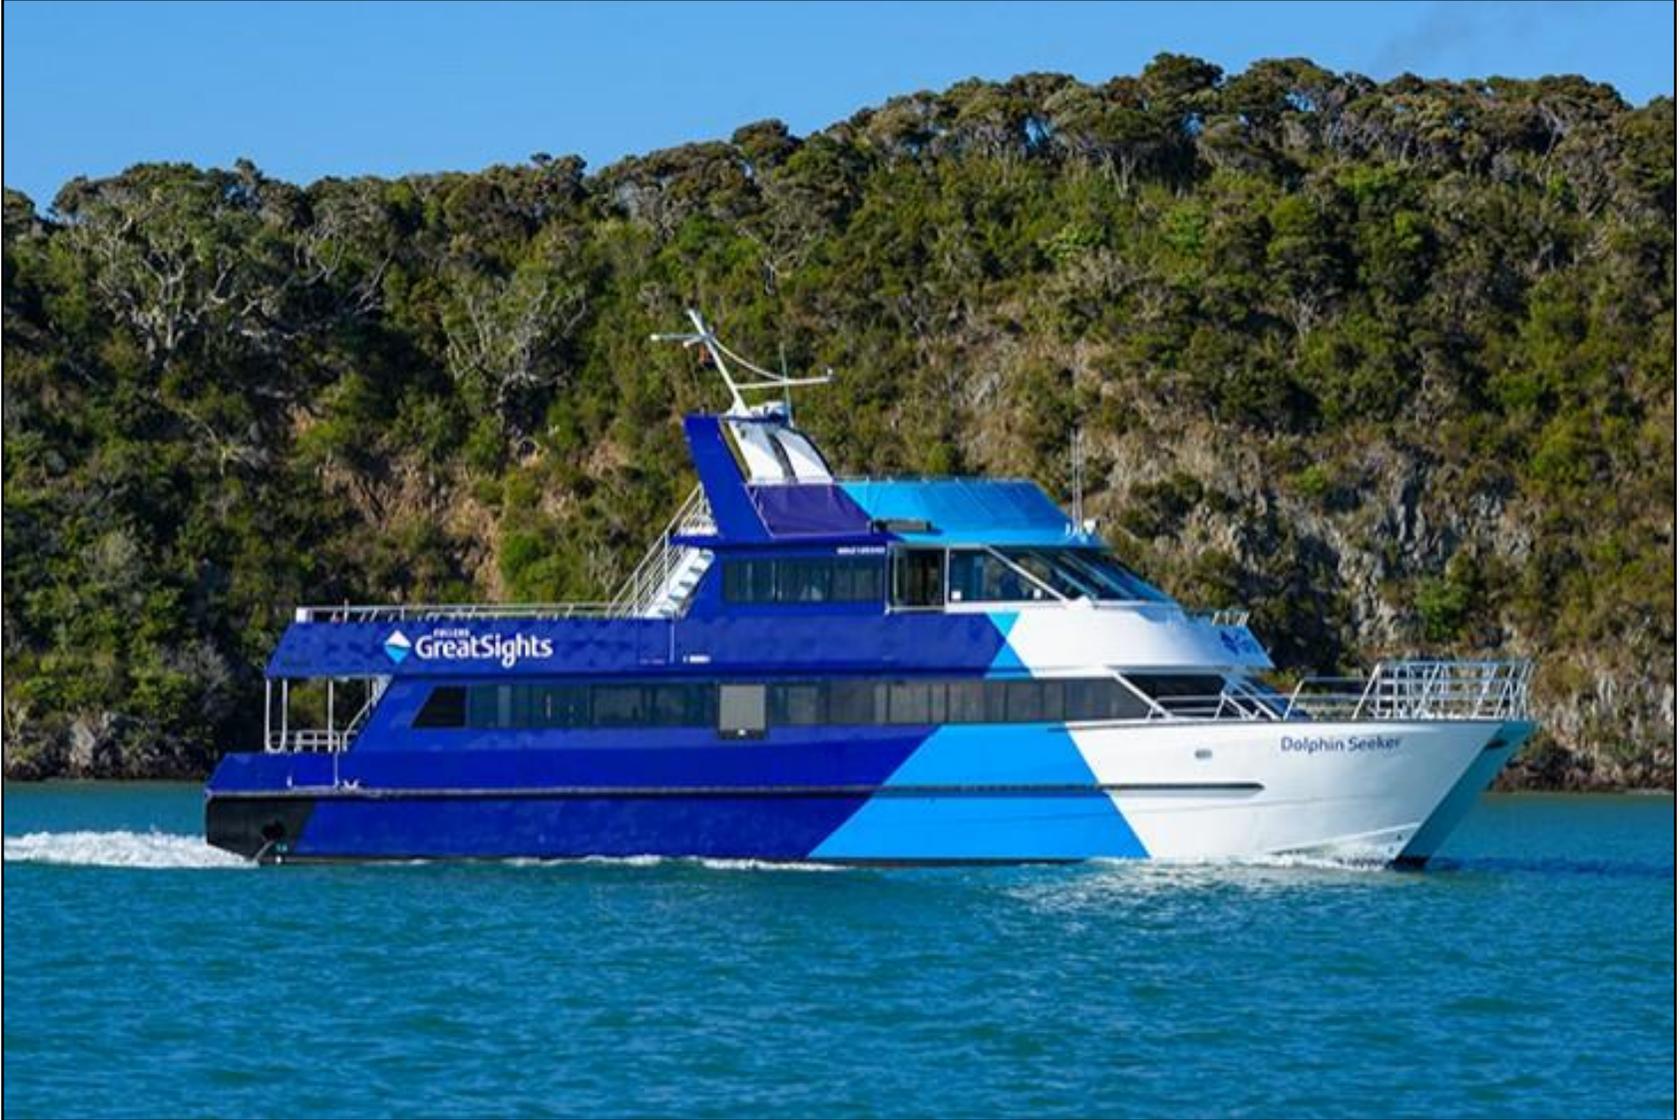
*Dolphin Seeker* (image courtesy of Fullers GreatSights)

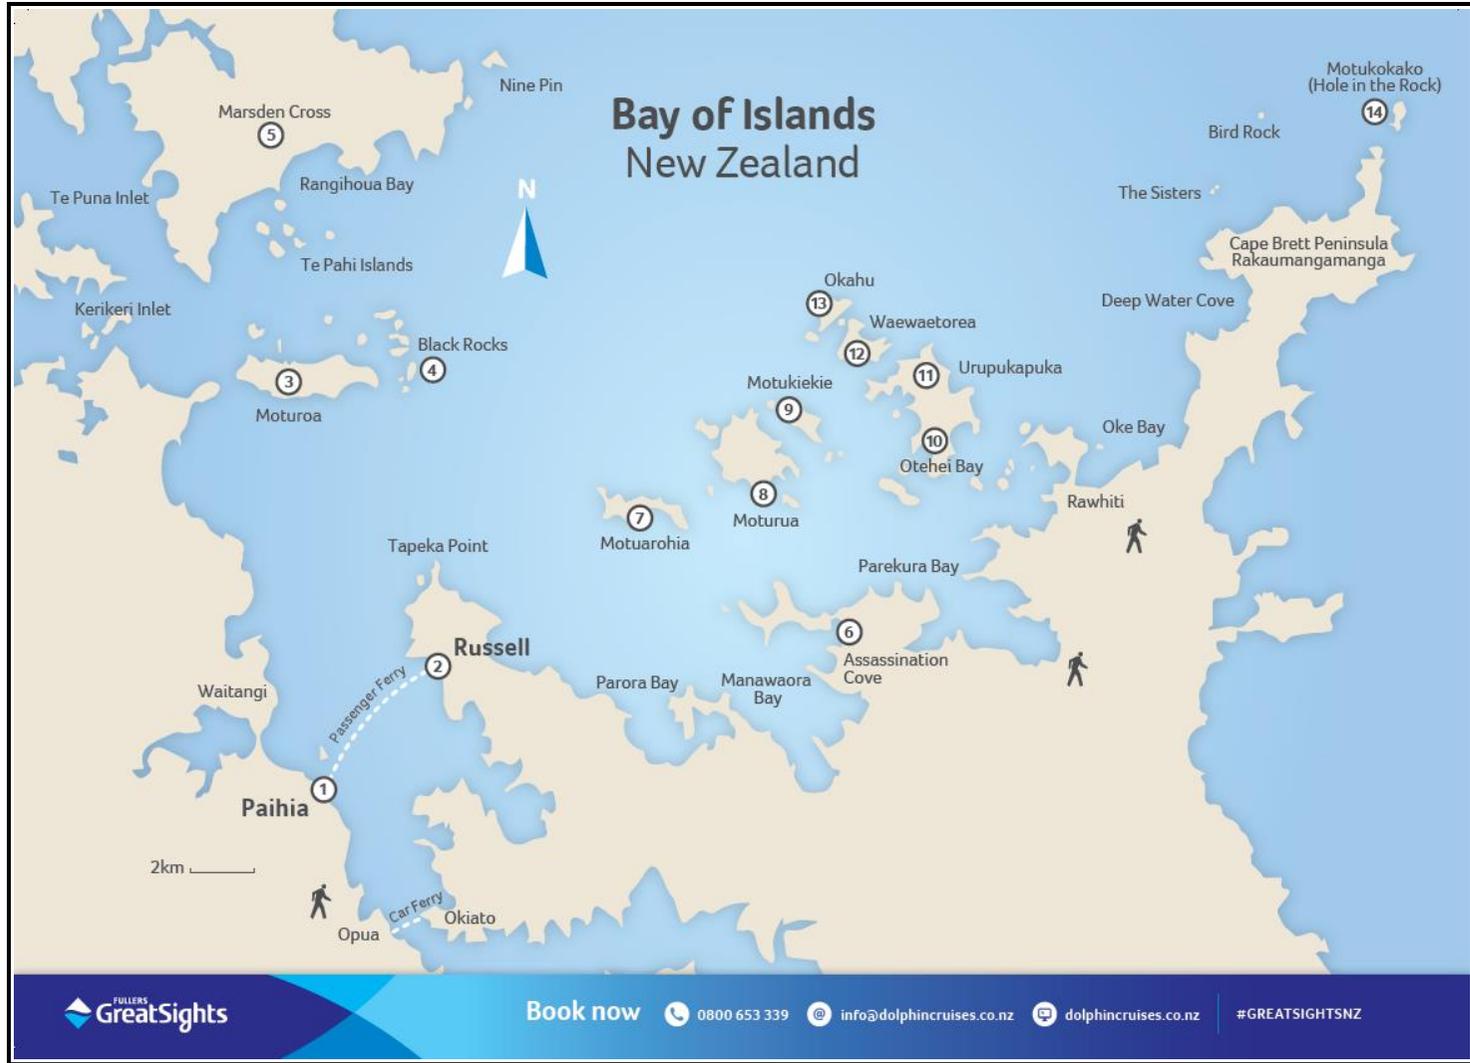
Figure 1  
Fullers GreatSights' tourist map of the Bay of Islands, showing locations of interest

- 3.1.3. Passengers embarked at Paihia, then the vessel made the short trip to Russell to pick up other passengers before beginning the cruise through the Bay of Islands towards the Hole in the Rock.<sup>2</sup> There were several tourist features along the way, where the skipper slowed the vessel and delivered commentary related to the points of interest (see Figure 1).
