Report on the investigation of the  
grounding of the general cargo vessel

***Priscilla***

on Pentland Skerries, Pentland Firth, Scotland

on 18 July 2018

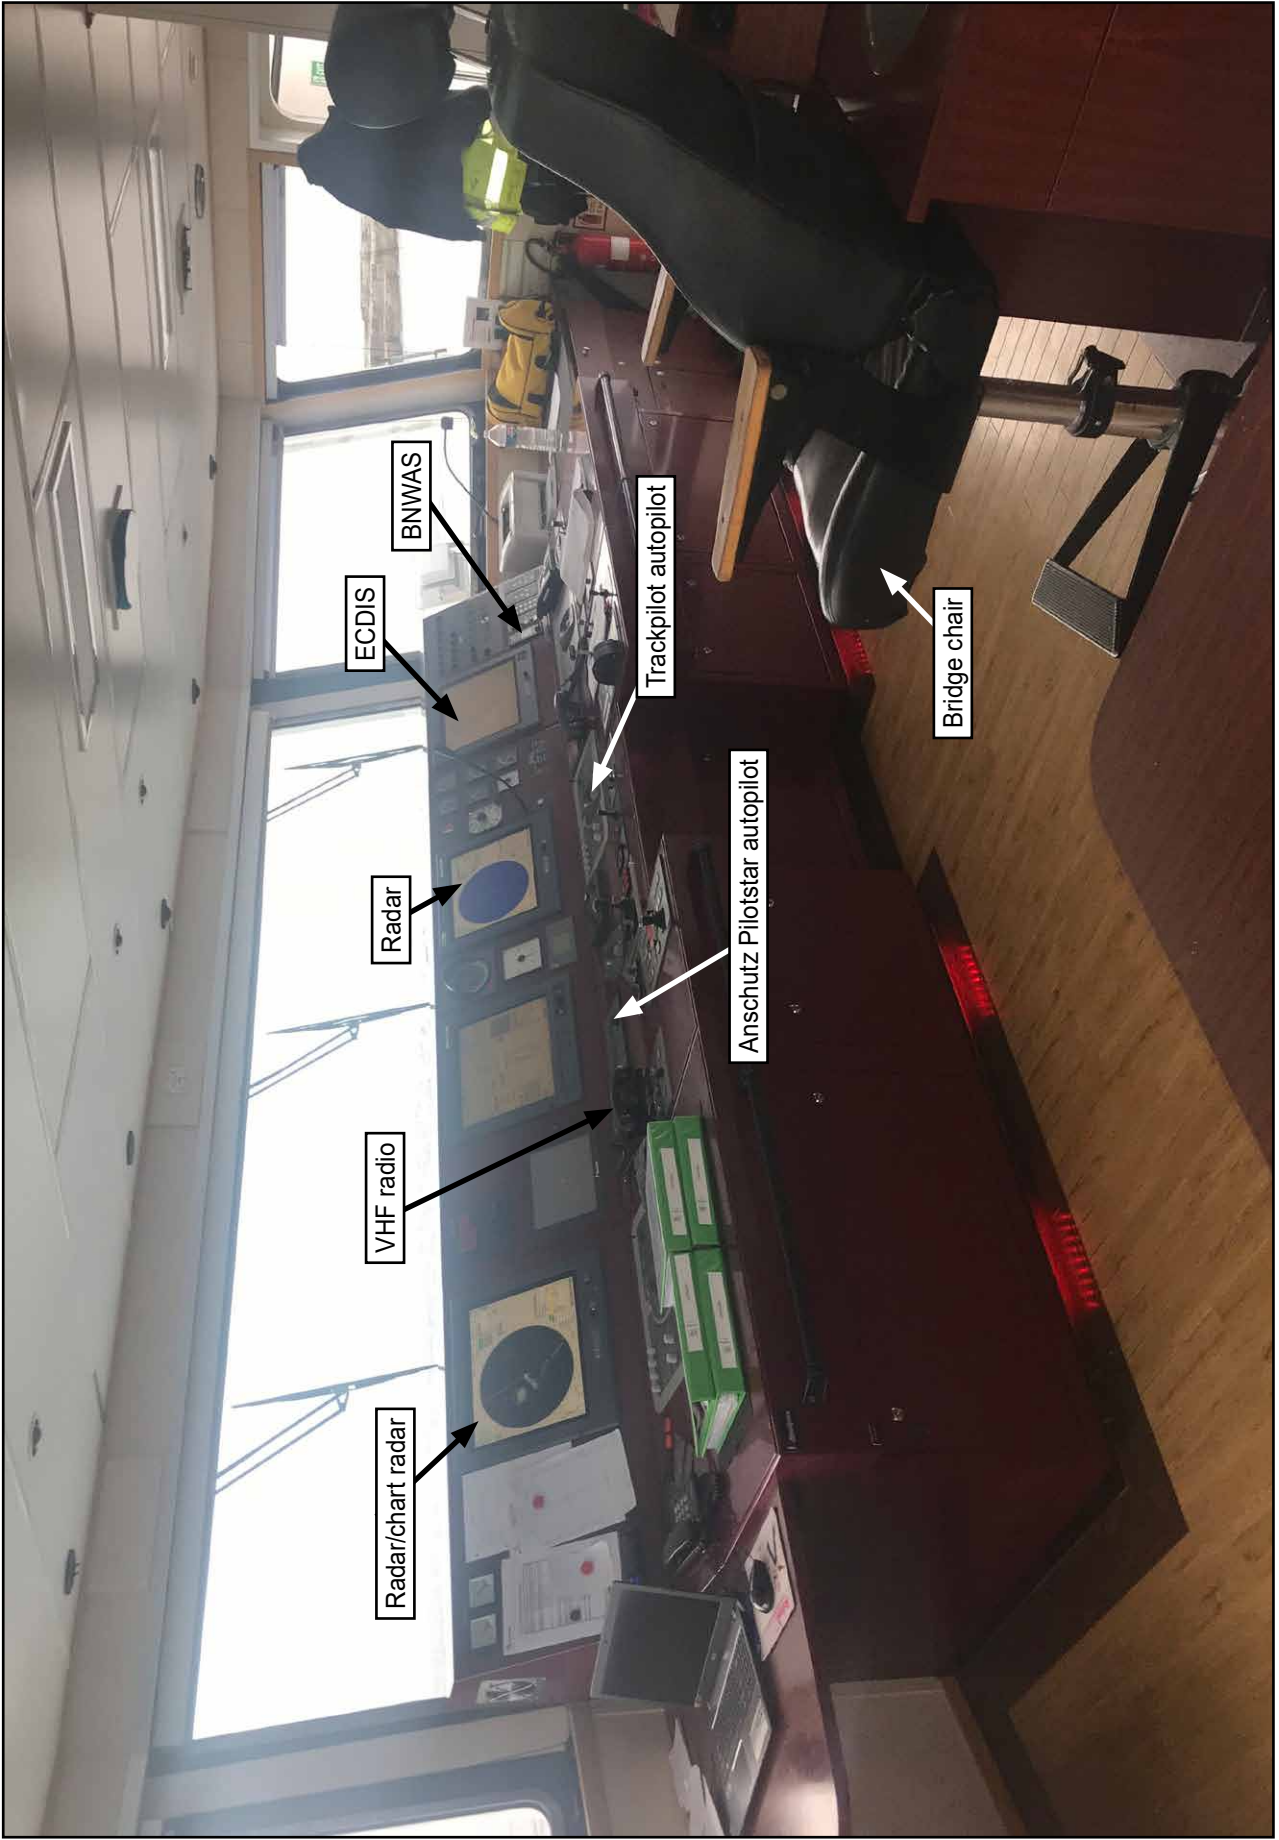
**Figure 2:** Priscilla's bridge showing the radar displays, ECDIS, VHF radio, autopilots and bridge chair

*Priscilla*'s bridge navigational watch alarm system (BNWAS) was located on the starboard side of the main console (**Figure 2**). When activated, the BNWAS would alarm if the OOW did not manually reset it every 12 minutes. BNWAS audible alarms were also fitted in other compartments on board to alert crew in the event of the OOW becoming incapacitated. *Priscilla*'s safety management system (SMS) stated that '*during one-man watch, the bridge watch alarm should be switched on*'. On board *Priscilla*, the master's policy was that use of the BNWAS was at the discretion of the OOW and it was rarely used. At the time of the grounding and during the cadet's watch, the BNWAS was switched off.

The bridge chair was on the port side and its position could be adjusted but it was not routinely moved. When seated in the chair in the position in use on the day of the accident, it was not possible for the OOW to operate the ECDIS, BNWAS, autopilot or either of the radars (**Figure 2**).

When seated in the bridge chair, the OOW was unable to operate or interact with any of the navigational equipment or cancel the BNWAS (**Figure 2**). This meant that, whether awake or asleep, and for about 2 hours, the OOW was unaware of *Priscilla*'s gradual deviation from the planned track.

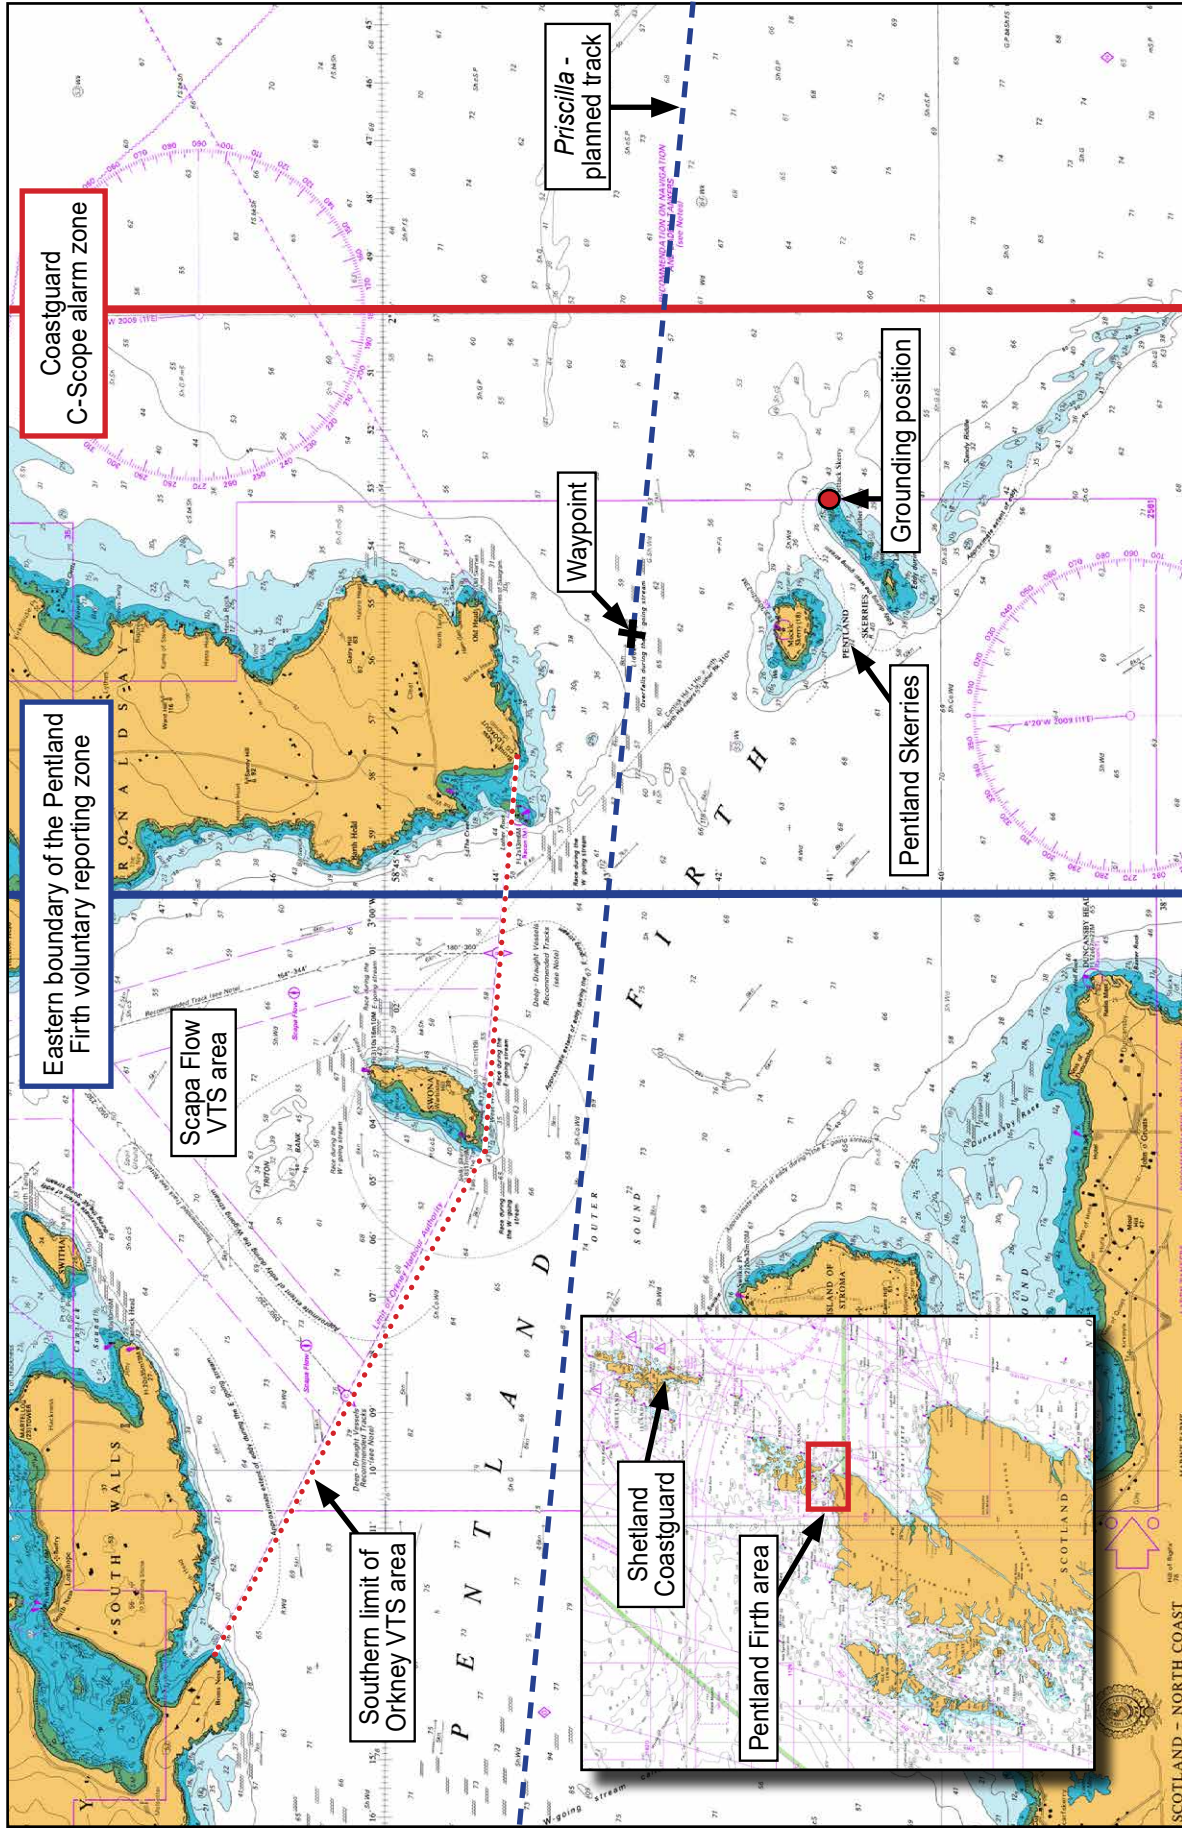
**Figure 7:** Chart showing Pentland Firth, Priscilla's planned track, Orkney VTS limit, the boundary of the Pentland Firth voluntary reporting scheme and the coastguard's C-Scope alarm boundary

Pentland Firth has a voluntary ship reporting scheme. Details of the system were promulgated in the Admiralty List of Radio Signals Volume 6<sup>6</sup> including the area covered (**Figure 7**), and the procedure for vessels to make a maritime report (MAREP) 1 hour before entering, and again on departure. *Priscilla* did not make this report, which would have been due at about 0400, 1 hour prior to entering the zone.

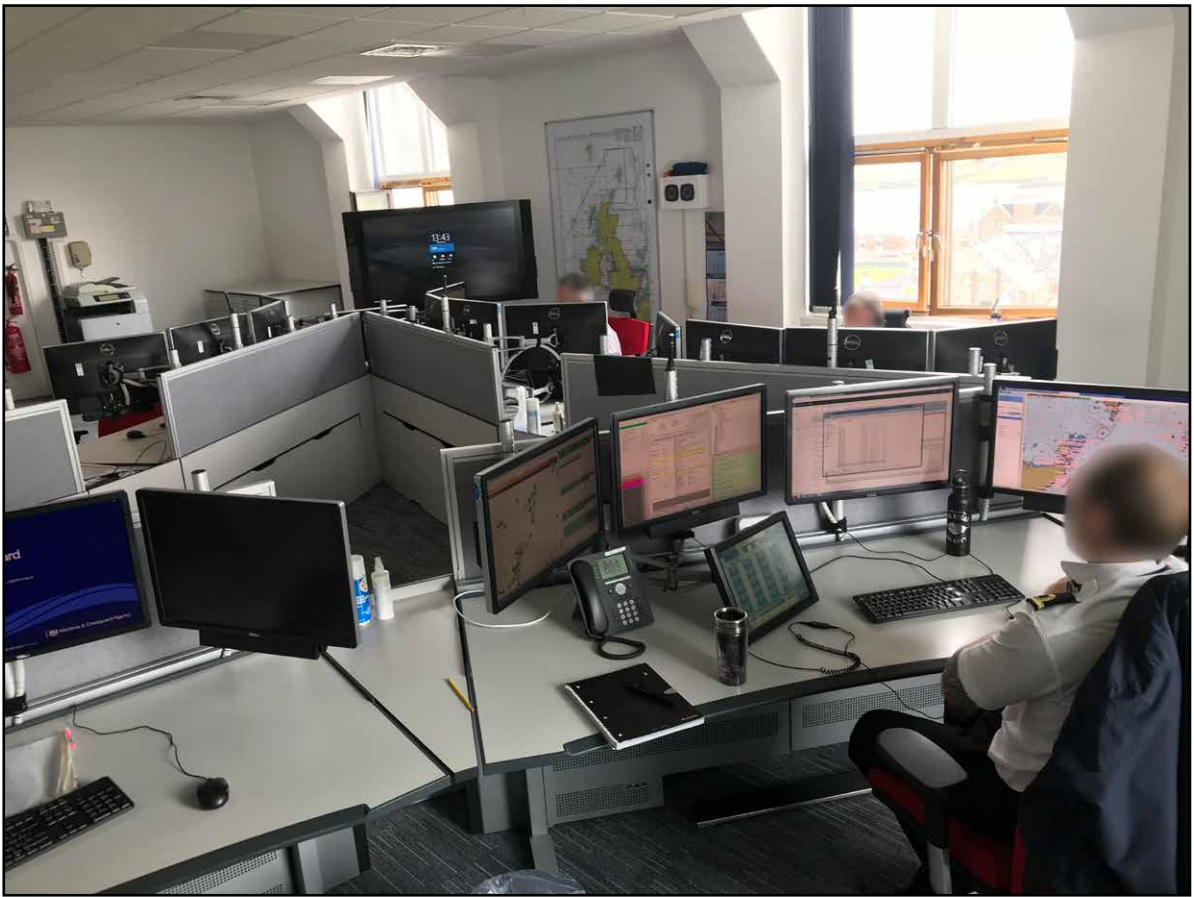
In Shetland CGOC (**Figure 8**) the C-Scope system was installed on three of the six operator terminals. Each of these terminals had been configured to provide an audible and visual alarm to the duty officers when a vessel entered the C-Scope alert zone around the Pentland Firth (**Figure 9**).

**Figure 8:** Shetland Coastguard operations room

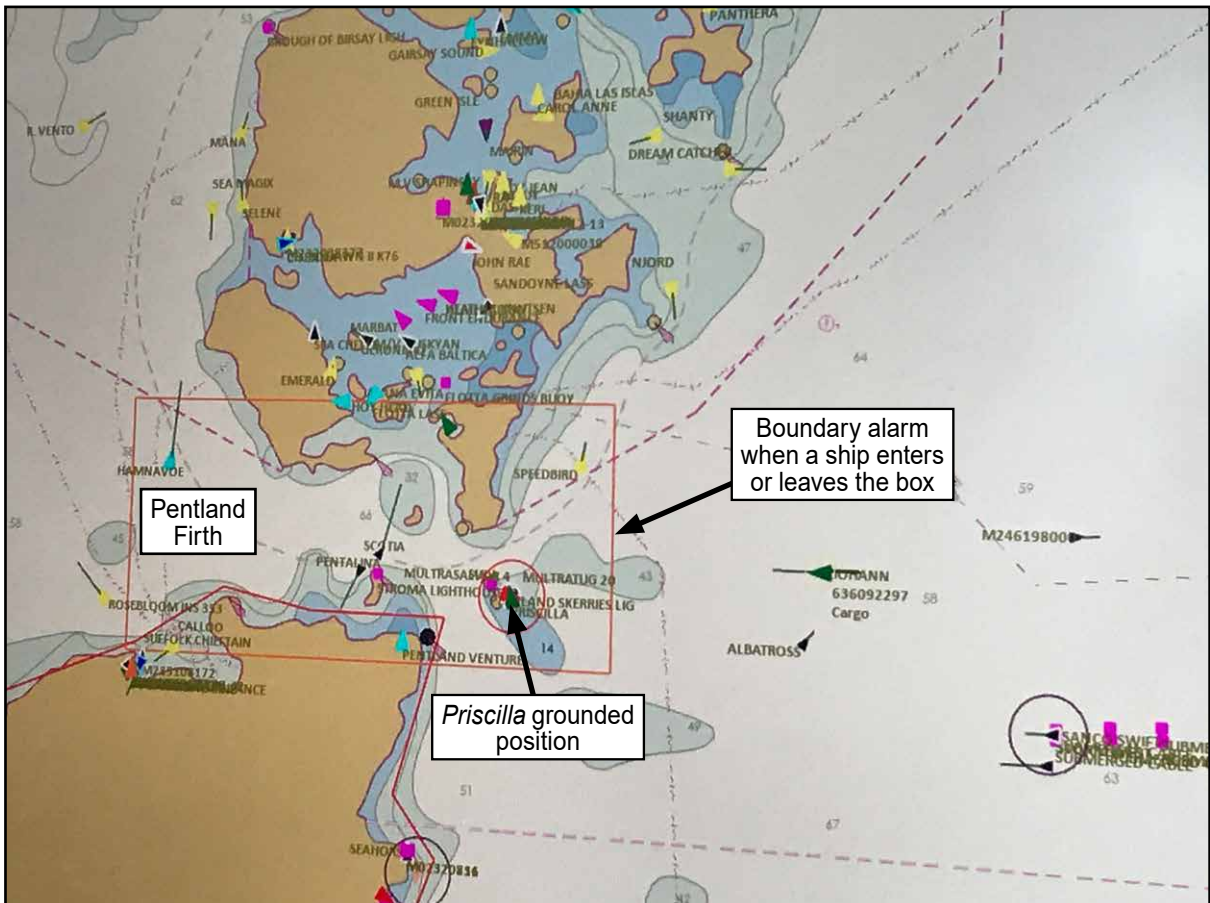
**Figure 9:** Shetland Coastguard's C-Scope display showing the alarm boundary
