Issued November 2019

REPORT

Marine 2019/08

PART ONE REPORT ON THE COLLISION ON 8 NOVEMBER 2018 BETWEEN THE FRIGATE HNOMS HELGE INGSTAD AND THE OIL TANKER SOLA TS OUTSIDE THE STURE TERMINAL IN THE HJELTEFJORD IN HORDALAND COUNTY

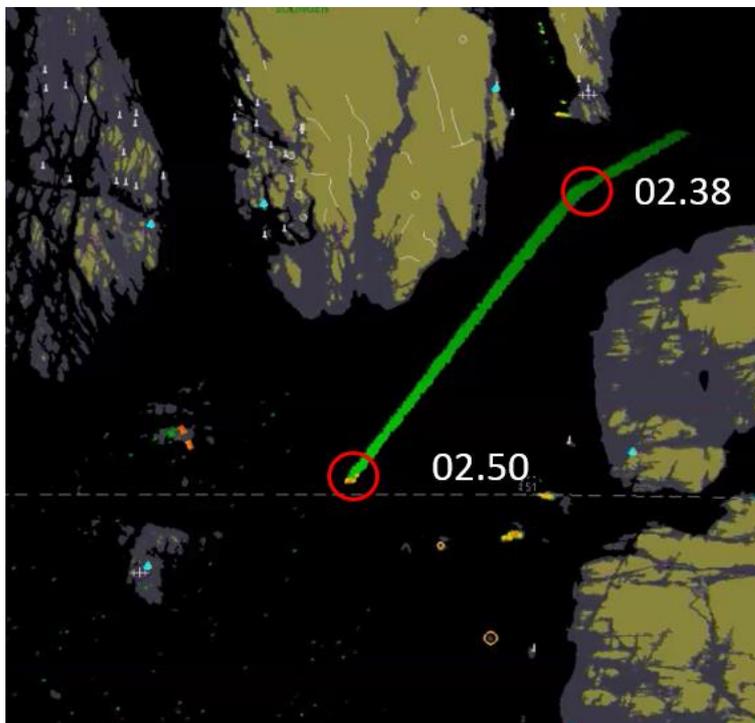
Figure 4: Screenshot of radar replay from Fedje VTS showing the position of HNoMS Helge Ingstad at 02:38 and 02:50, respectively. The broken line represents the boundary of the Fedje VTS area. Note: When preparing the radar replay after the accident, an artificially long afterglow was used to illustrate the frigate's voyage. Source: The NCA/AIBN

At 02:50, HNoMS Helge Ingstad entered the Fedje VTS area from the north (see Figure 4). The VTS operator did not plot the vessel's movements on the radar. The VTS operator would normally, as a matter of routine, plot vessels when they passed into the traffic area, but did not do so this time. Because HNoMS Helge Ingstad was not transmitting AIS signals, information about the vessel's identity, course and speed vectors was also not transmitted automatically.

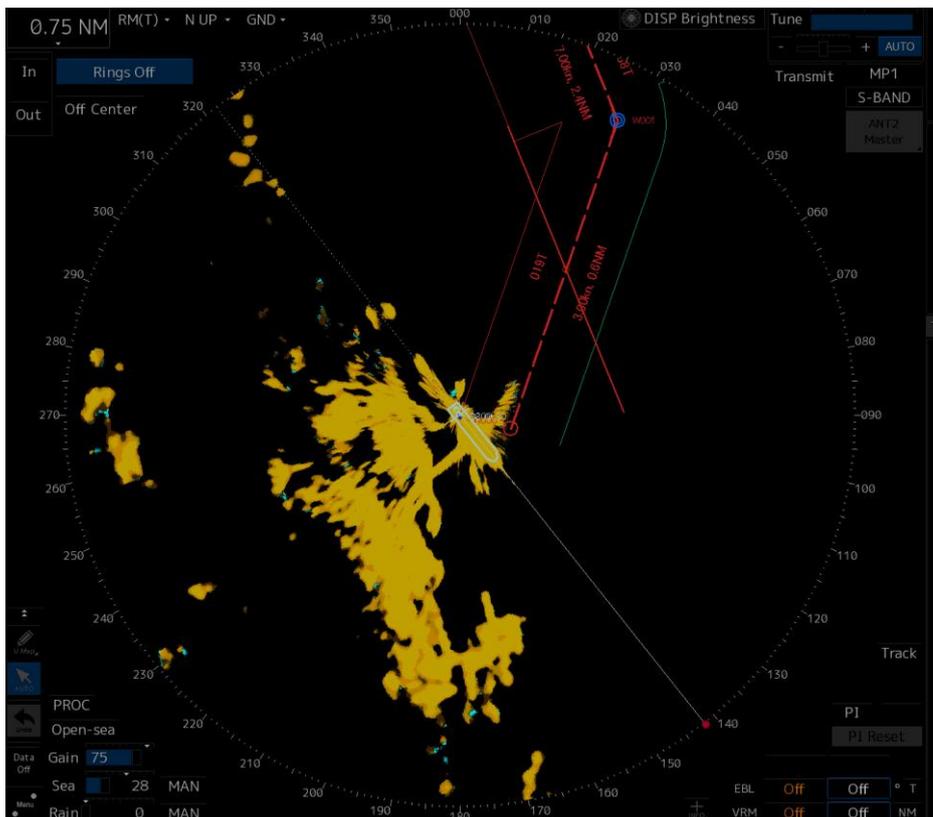
At 03:13, none of the radars or the ECDIS on Sola TS were scaled to display the areas of maritime traffic to the north and south (see Figure 8). At 03:27, approximately 10 minutes before departure, the S-band radar was set to 3 nm and the X-band radar to 1.5 nm. There was still no indication of other vessel traffic on the radar displays, other than one southbound vessel ('Stril Herkules') that was just passing the Sture Terminal. See section 1.10.3.2 for a more detailed description.

Figure 8: The S-band radar on Sola TS, set to a range scale of 0.75 nm, showed no other maritime traffic at 03:13. Source: Tsakos Columbia Shipmanagement S.A.

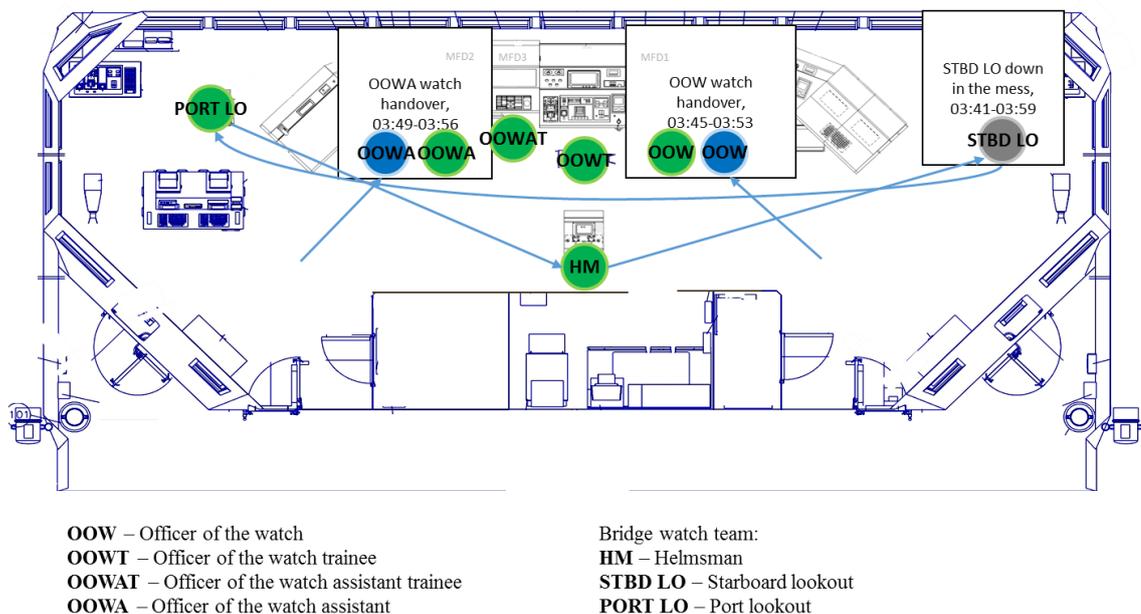
From 03:20, a night meal was being served in the mess, and it was agreed with the OOW being relieved that members of the bridge watch team could go down to get something to eat, one at a time. The STBD LO went down to the mess at 03:41 and was back on the bridge at 03:48. After that, the bridge watch team rotated their positions. The STBD LO took over as PORT LO. The PORT LO took over as HM. The HM, who was to take over as STBD LO, went down to the mess at 03:51 and returned to the bridge at 03:59.

Figure 9: Crew on the bridge of HNoMS Helge Ingstad during the period from 03:40 to 03:59, a period of watch handovers and bridge watch team rotation, when the starboard lookout had gone down to the mess. Illustration: The Royal Norwegian Navy/AIBN

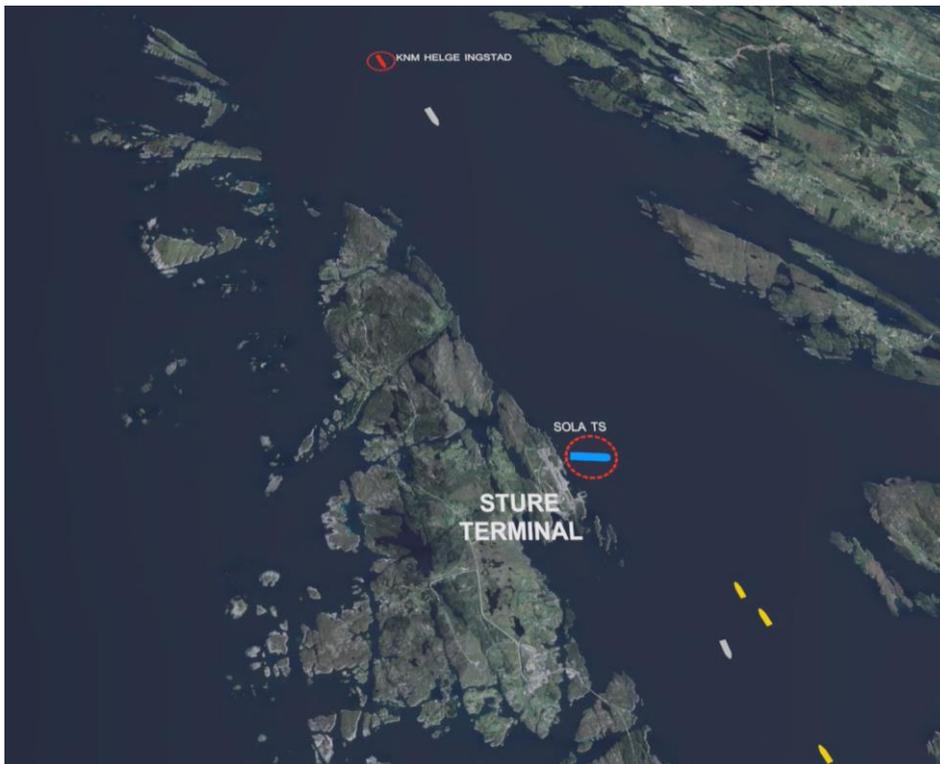
The VTS operator then zoomed in on the Sture Terminal on the main work screen, in such a way that it showed a larger area to the south than to the north of the terminal. The operator observed three northbound vessels that were approaching and concluded that Sola TS had enough time to turn. The northbound vessels (Silver Firda, Vestbris and Seigrunn) were approximately 2 – 3.5 nm south of the Sture Terminal at 03:45. The two southbound vessels, Dr. No and HNoMS Helge Ingstad were directly to the east of Nordøytåna, 5.65 nm to the north of Sola TS, outside the range scale on the VTS operator's main work screen. Figure 11 shows the traffic situation in the Hjeltefjord at 03:45.

Figure 11: The traffic situation in the Hjeltefjord at approximately 0345. The frigate had one southbound vessel just ahead, and three northbound and one southbound vessels south of the Sture terminal. Sola TS and the tugs Ajax and Tenax had now left the quay and started a port turn to set a northbound course towards Fedjeosen. HNoMS Helge Ingstad was directly to the east of Nordøytåna, 5.65 nm to the north of Sola TS. Illustration: AIBN

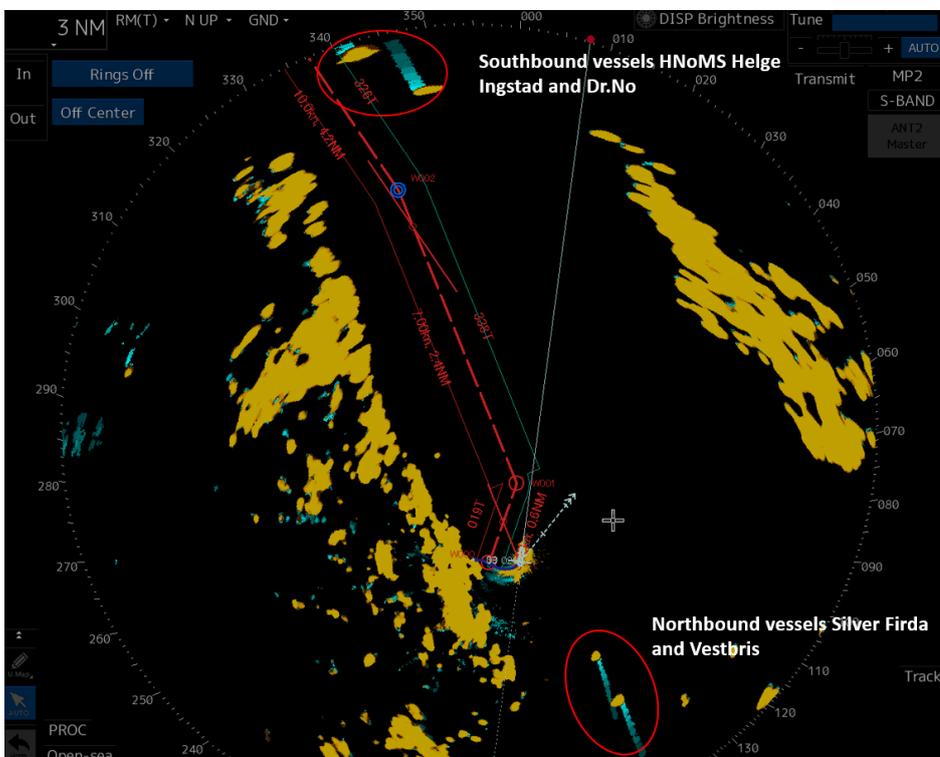
At 03:52, the pilot ordered a course of 350°. Sola TS was then moving at a speed over ground (SOG) of 3.2 knots. The pilot had observed visually, probably slightly before this time, the two southbound vessels to the north of Sola TS. HNoMS Helge Ingstad and Dr. No in the north, and Silver Firda and Vestbris in the south, were now visible on the radar displays on Sola TS (see Figure 12), but they were not plotted on the radar.

Figure 12: The traffic situation as displayed on the S-band radar on Sola TS at 03:51. Source: Tsakos Columbia Shipmanagement S.A.

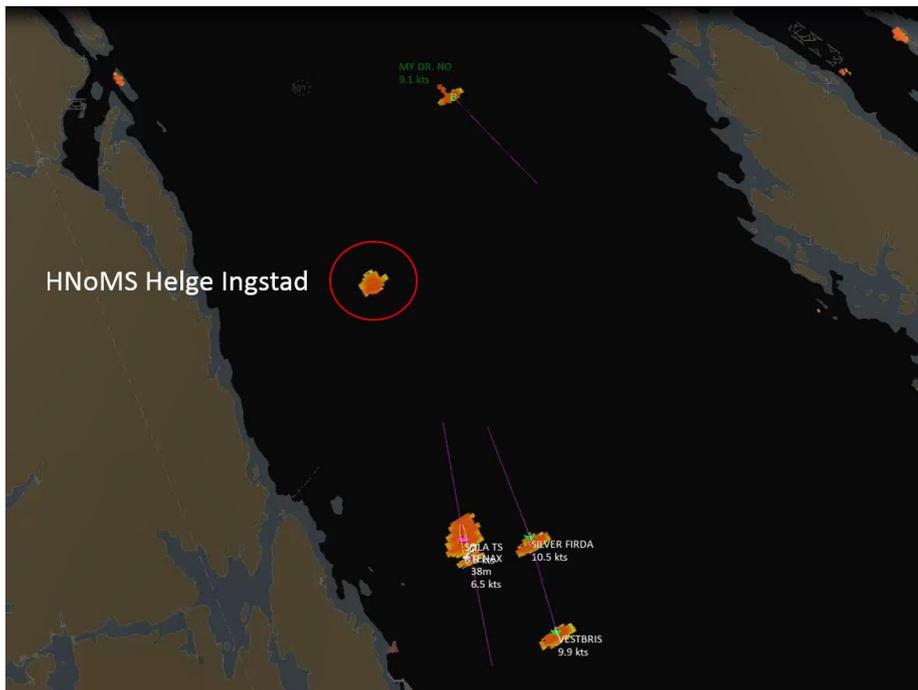
The radar image from Fedje VTS (see Figure 14) shows that the vessels HNoMS Helge Ingstad, Sola TS with the tug Tenax, Silver Firda, Vestbris and Seigrunn were all present in the area around the Sture Terminal at 03:59.

At 03:58:54, after receiving the call from Sola TS, the Area North operator at Fedje VTS plotted the echo on the radar without AIS. He saw that a vector appeared on the screen indicating that Sola TS and the other vessel were on course to collide.

Figure 14: Screenshot of the radar replay from Fedje VTS, showing the traffic situation near the Sture Terminal at 03:59. Source: NCA

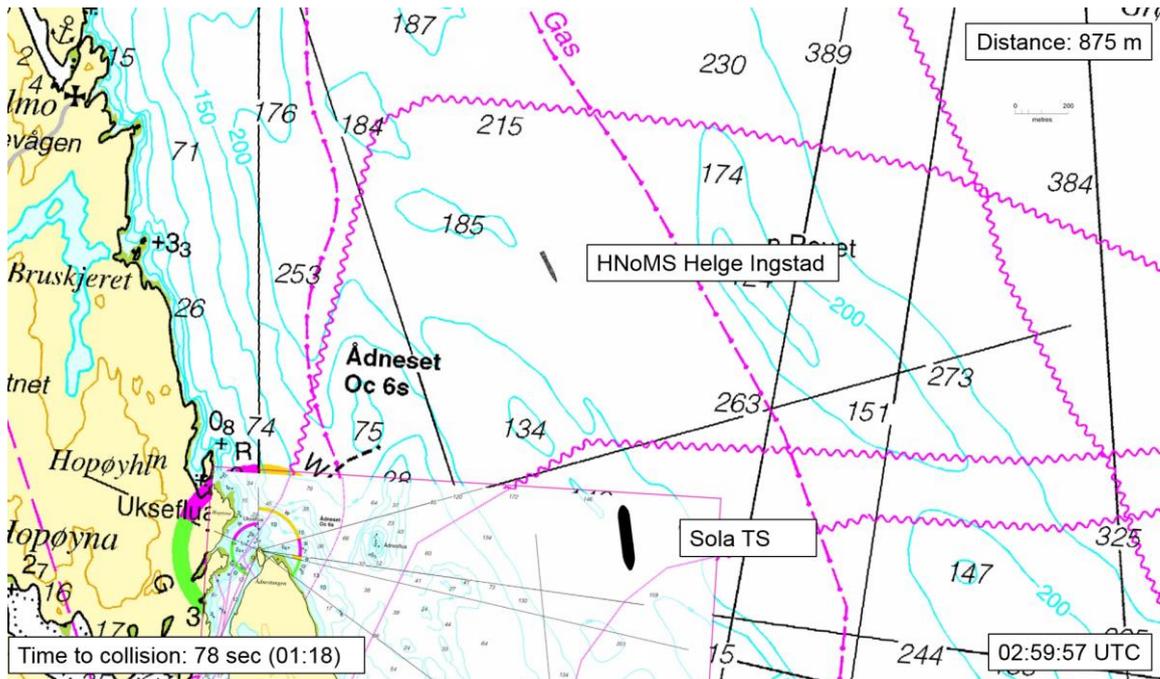
At this point (03:59:57), there was a distance of approximately 875 metres between the two vessels (see Figure 16).

Figure 16: At 03:59:57, there was a distance¹⁴ of approximately 875 metres between 'HNoMS Helge Ingstad' and Sola TS. Illustration: Safetec/AIBN

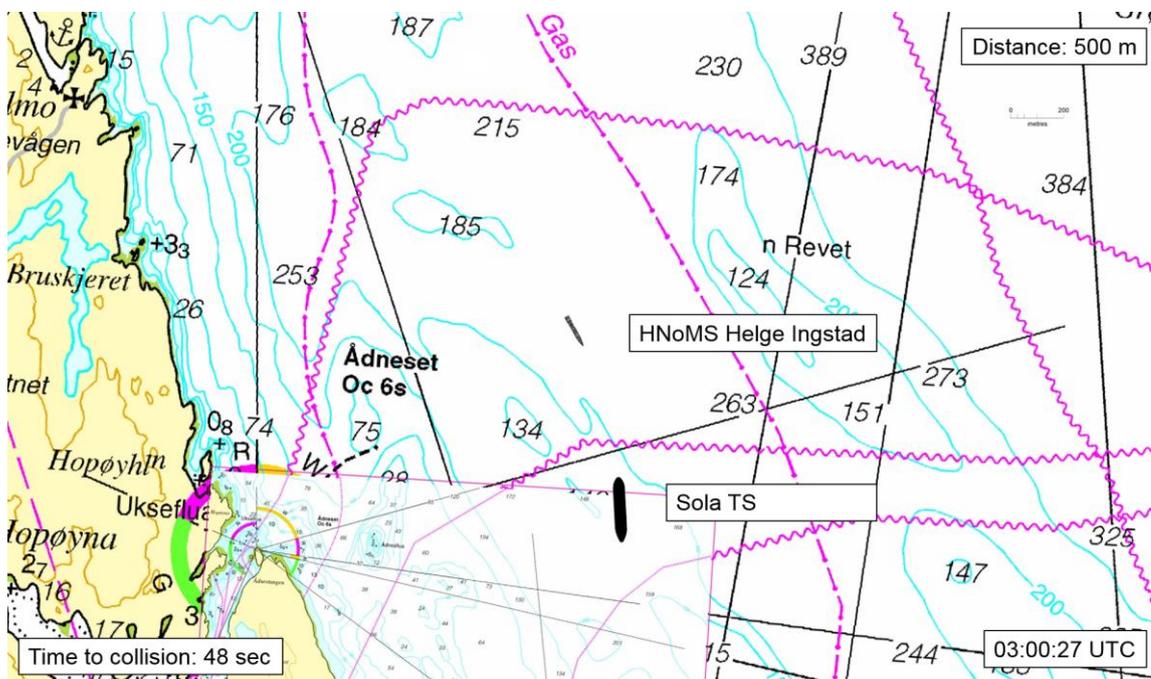
At this point (04:00:27), there was a distance of approximately 500 metres between the two vessels (see Figure 17). At 04:00:20, Sola TS was steering to a course of 355°, still altering course to starboard, while the course over ground (COG) was 345.8°, and it was moving at a speed of 7.2 knots (SOG). At 04:00, HNoMS Helge Ingstad was moving at a speed of 16.9 knots. HNoMS Helge Ingstad had a course of 152.5° at 04:00:26 and of 149.7° at 04:00:36.

Figure 17: At 04:00:27, there was a distance¹⁶ of approximately 500 metres between HNoMS Helge Ingstad and Sola TS. Illustration: Safetec/AIBN

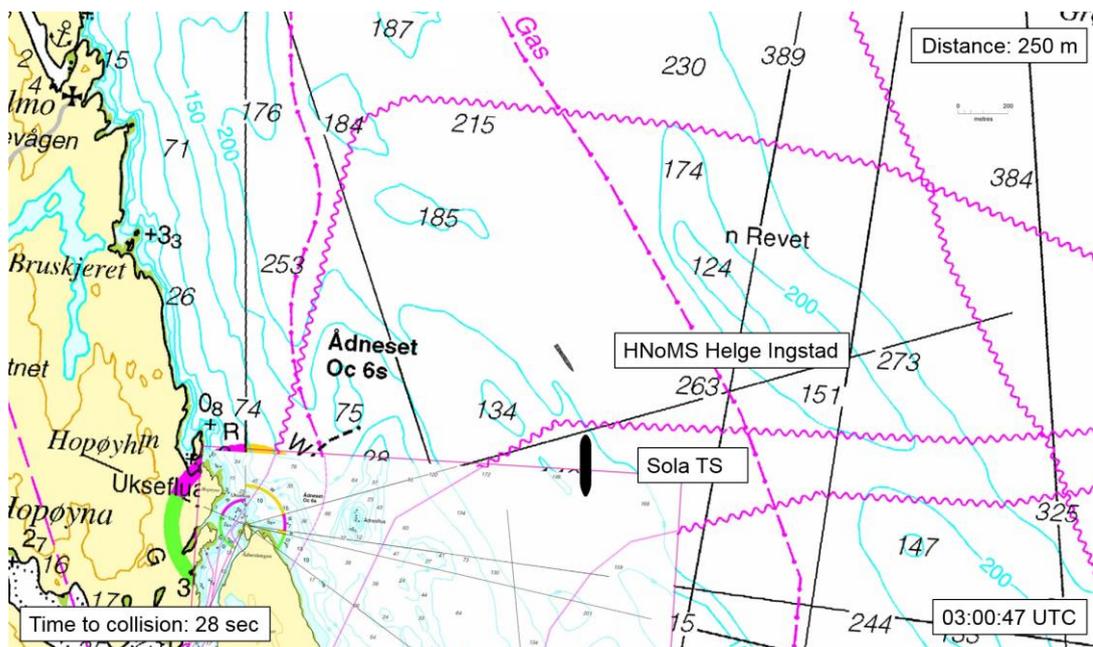
The VTS operator at Fedje VTS had registered that there was radio contact between Sola TS and HNoMS Helge Ingstad and did not want to intervene. The operator has explained that the whole situation was incomprehensible. He did not understand why HNoMS Helge Ingstad replied that they could not go further to starboard. However, in the end, the VTS operator did call HNoMS Helge Ingstad at 04:00:44: 'Helge Ingstad, you must do something. You are getting very close.' At this point (04:00:47), there was a distance of 250 metres between the two vessels (see Figure 18).

Figure 18: At 04:00:47, there was a distance¹⁷ of 250 metres between 'HNoMS Helge Ingstad' and Sola TS. Illustration: Safetec/AIBN

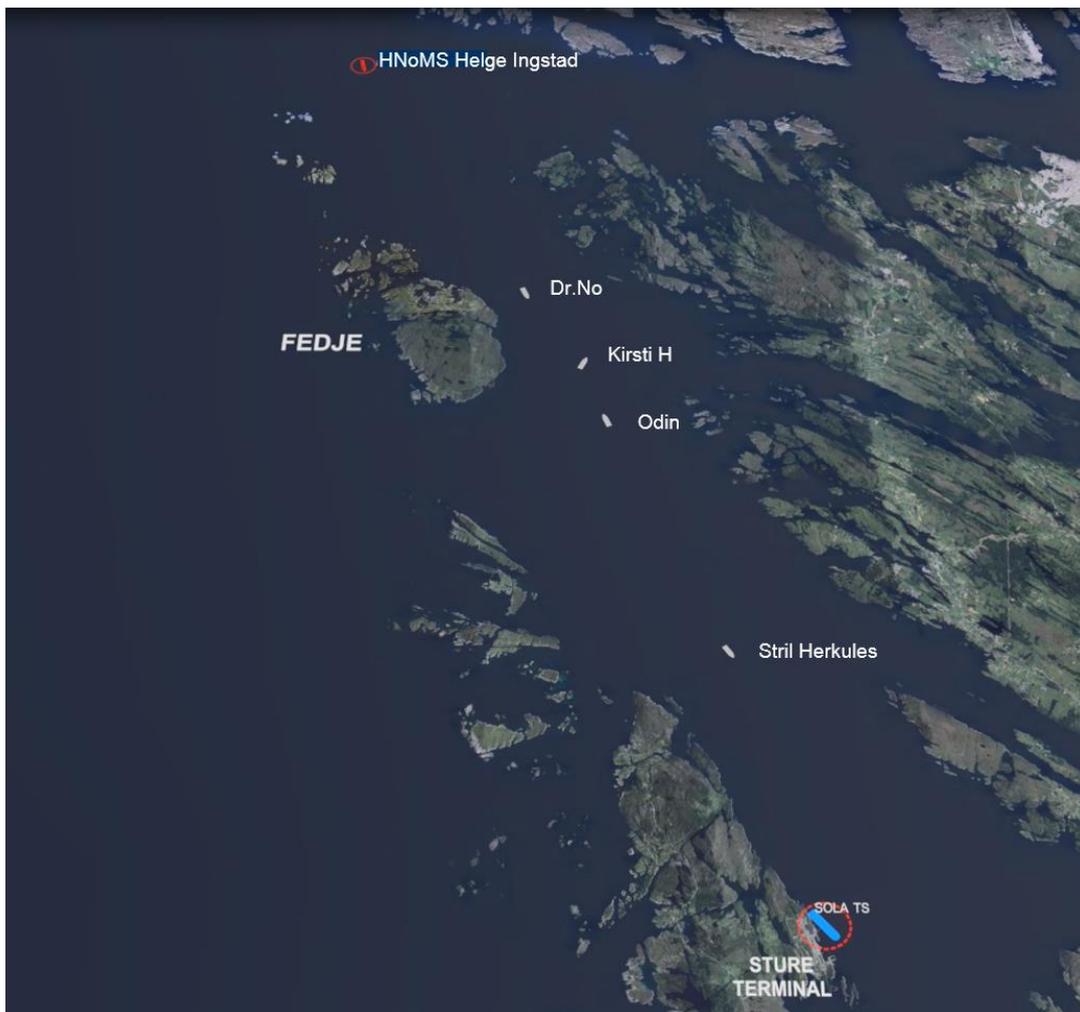
As HNoMS Helge Ingstad approached Holmengrå, the supply vessel Siem Pride was heading out to sea to the west of the frigate. The well boat Ronja Nordic was northbound and about to enter Brosmeosen. There were three vessels further south in the fairway between Fedje and Austrheim and Radøy: the southbound yacht Dr. No, and the northbound Odin and Kirsti H (see Figure 22). All of these vessels transmitted AIS-data, with the exception of HNoMS Helge Ingstad.

Figure 22: The traffic situation at Fedje at approx. 03:09 on 8 November 2018.
Source: AIBN

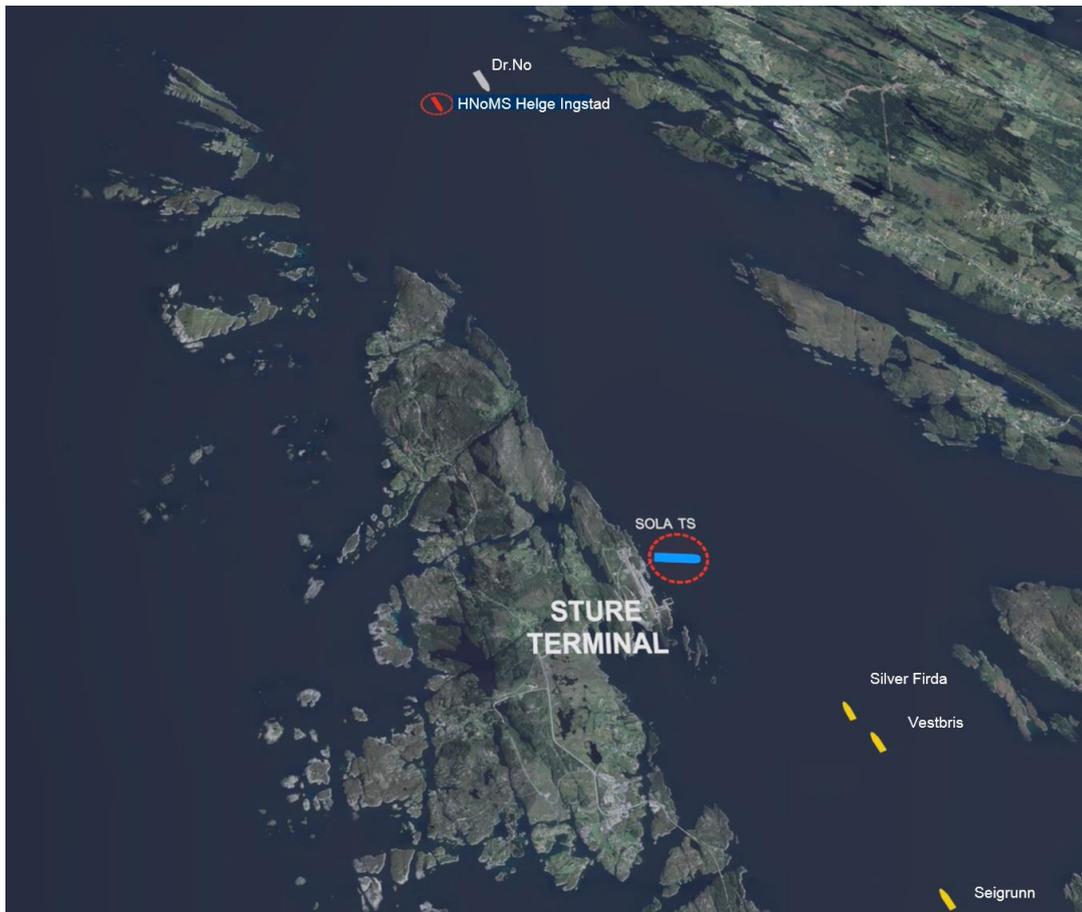
When Sola TS departed from the Sture Terminal at approximately 03:45, HNoMS Helge Ingstad was directly to the east of Nordøytåna. They were about to catch up with and pass the yacht Dr. No. Maritime traffic further south in the Hjeltefjord consisted of three northbound vessels – Silver Firda, Vestbris and Seigrunn, and one southbound vessel – Stril Herkules. Figure 23 shows the traffic situation in the area at approximately 03:53. All these vessels transmitted AIS-data.

Figure 23: The traffic situation at 03:52:55 on 8 November 2018. Source: AIBN

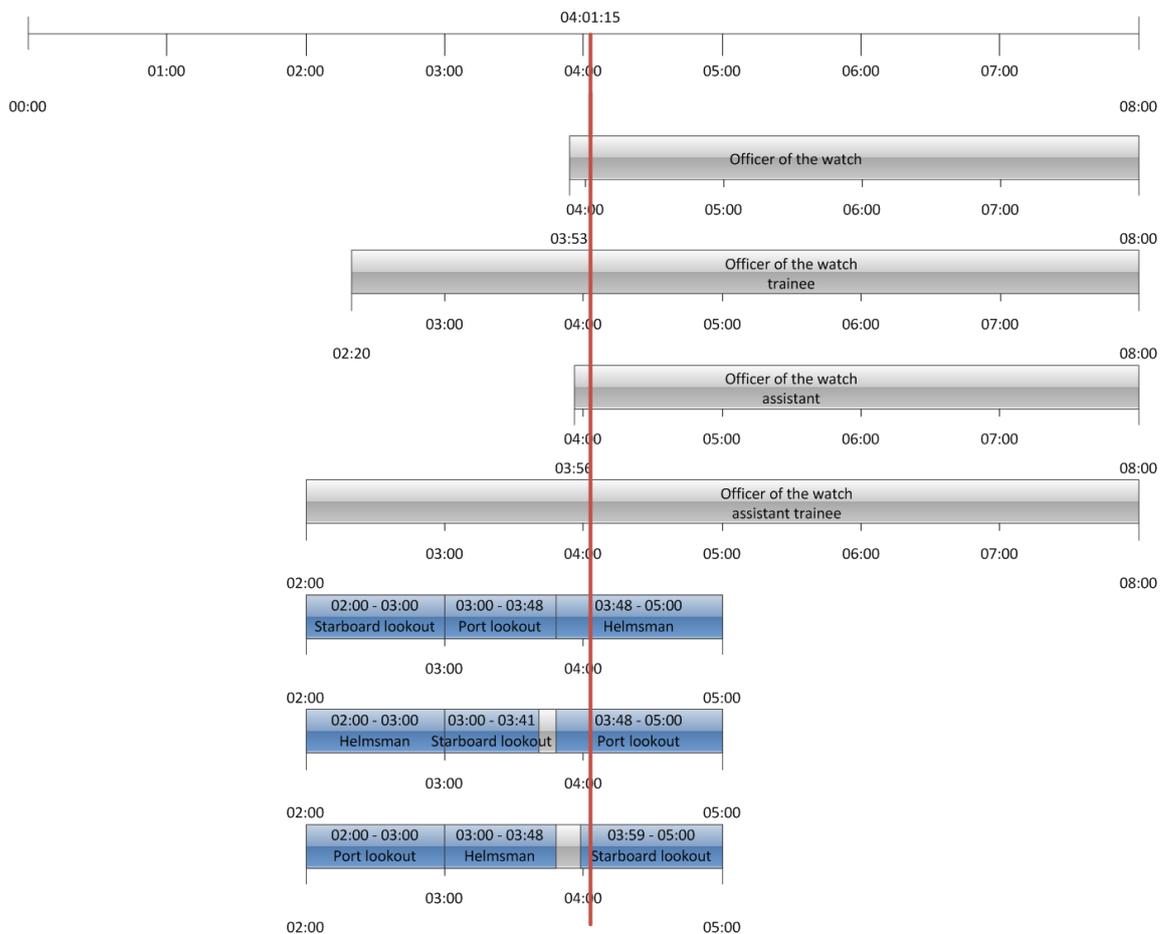
Figure 24 shows the personnel present on the bridge around the time of the accident, including how long each of them had been on watch and the bridge watch team's change of positions. The average age of the members of the bridge team was 22.4 years.

Figure 24: Personnel on the bridge at the time of the accident, at 04:01:15. Illustration: AIBN

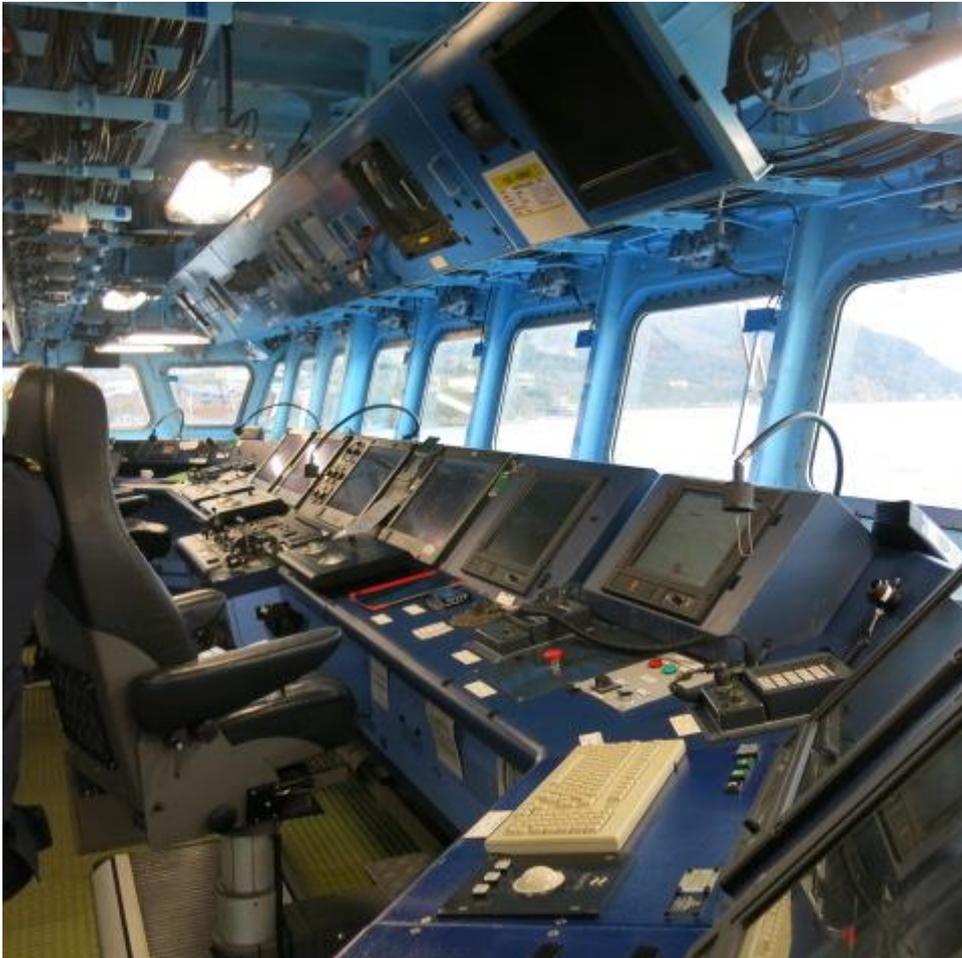
The bridge had 22 windows in total, of which 11 faced forward; all separated by robust dividing bars (see Figure 27). The lookouts had to keep watch from inside the bridge at all times, since the frigate lacked traditional bridge wings, and they were therefore positioned at the far corners.

Bridge ventilation system is so noisy that it is difficult for the bridge team to communicate in a normal manner. Excessive levels of noise interfering with voice communication, causing fatigue and degrading overall system reliability, shall be avoided. (noted during visit on-board)

Figure 27: The bridge on HNoMS Helge Ingstad was near identical to the bridge on HNoMS Thor Heyerdahl shown in the photo. The officer of the watch's chair can be seen in the foreground. Photo: AIBN

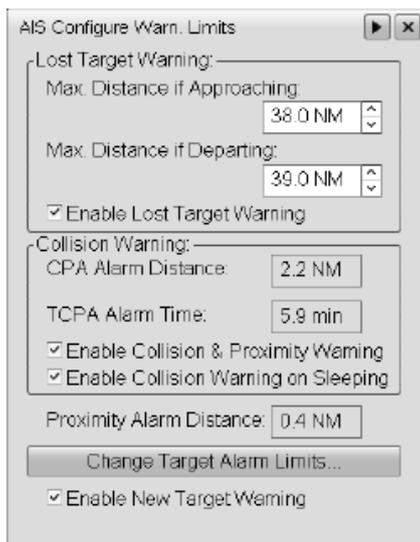
HNoMS Helge Ingstad also had an AIS function that could warn of sleeping AIS targets (see Figure 31), that is AIS contacts not being tracked. The function would issue alerts for sleeping AIS targets at the same CPA and TCPA as tracked AIS contacts. According to the Navy, the function was normally deactivated on inshore voyages since the system would otherwise generate many alarms of vessels alongside quays.

Figure 31: The function for warnings about sleeping AIS targets is activated by ticking the box 'Enable Collision Warning on Sleeping'. The settings for receiving warnings can also be changed. Source: The Norwegian Navy

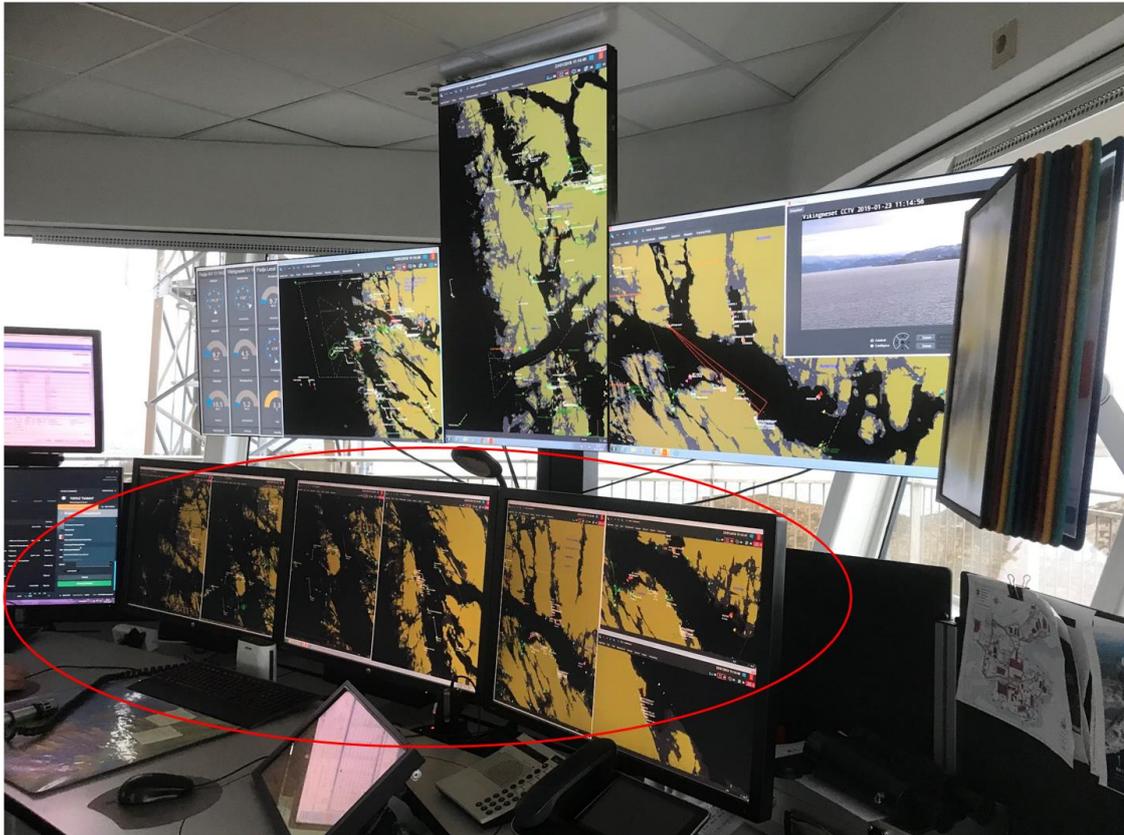
The AIBN understands from interviews with personnel at Fedje VTS that it can be difficult for operators to keep the total picture in view while focusing on a particular location. The VTS centres have routines to monitor the VTS areas to detect vessels sailing into the areas or leaving quay or anchorage.

Figure 40: Workstation for the VTS operator monitoring the northern part of the Fedje VTS area. The three 'main screens' are marked with a red circle. The overview screen is placed above the main screens. Photo: AIBN

According to the NCA the general routine at the VTS centre is that vessels are plotted when they are within the screen layout on the operator's main screens (see Figure 40). This was also normal for the VTS operator who was on duty, but in this case, it was forgotten.

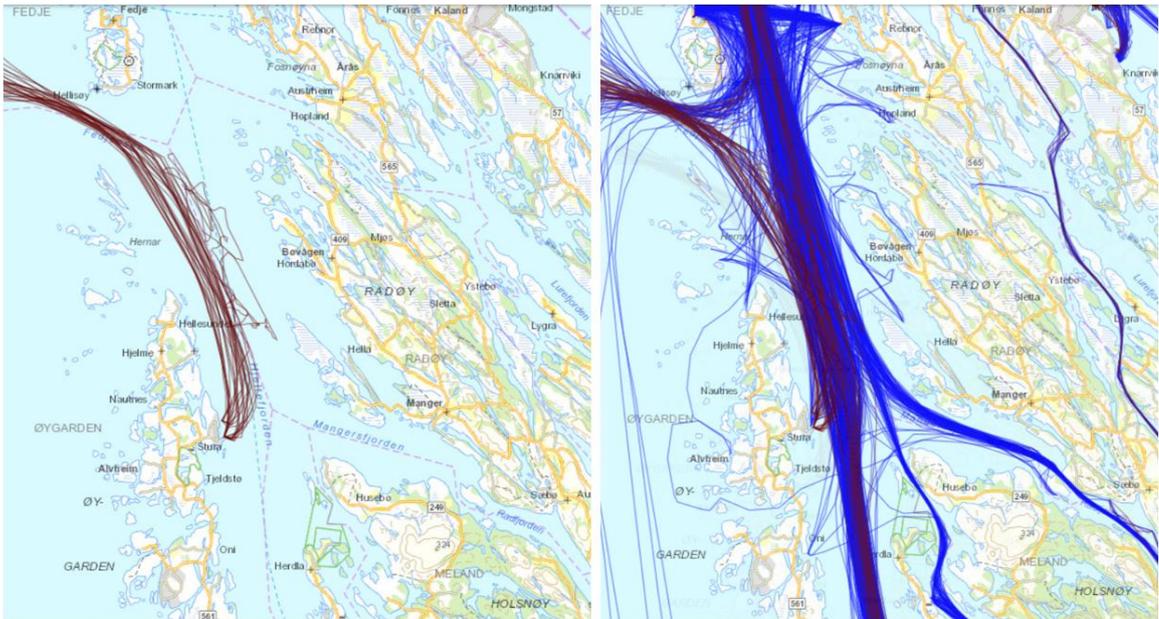
From the AIBN's interviews with personnel at Fedje VTS, it appears that the VTS operators perceived Sola TS as departing in the normal manner from the Sture Terminal and in line with how this is often done. This is largely confirmed by data retrieved from the NCA's Havbase.no (see Figure 41). Tankers and LPG tankers arrive approximately every other day to the Sture Terminal.

The VTS operators have told the AIBN that, after the introduction of AIS and electronic sea charts, vessels generally operate differently from what they did before. They now take the shortest route when heading out through the fjord, as opposed to what was previously the case, when the vessels steered by light sectors and to starboard of the middle of the fairway.

Figure 41: The chart on the left shows the routes taken by tankers of between 50,000 and 100,000 GT in November 2018. The chart on the right shows all traffic of tankers and mixed cargo vessels of all sizes during the same period. The tankers operate along the western side of the Hjeltefjord so as to minimise the length of the approach/departure passage from the Sture Terminal. Other traffic is spread across the width of the fjord, depending on vessel destinations. Map: The NCA, havbase.no

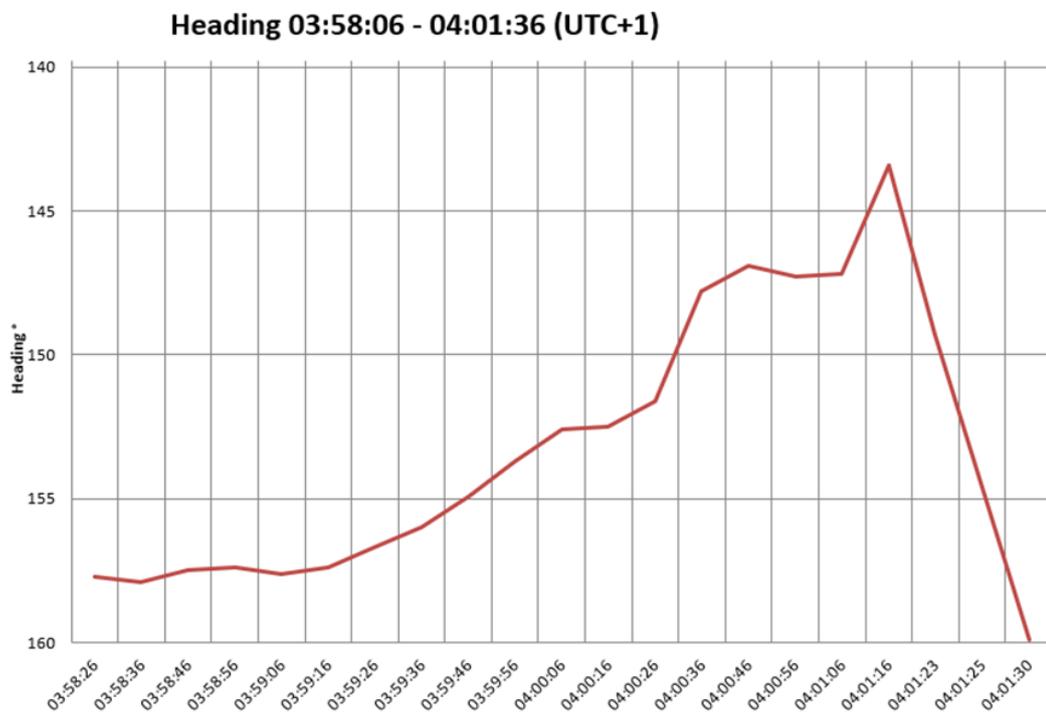
At 03:59:26, HNoMS Helge Ingstad was keeping a course of 157° and moving at a speed of 17 knots. The OOW asked the OOWT to adjust the course by some degrees to port. The OOWT asked whether he should change course to port, which the OOW confirmed. The OOWT conveyed the message to the HM. At 03:59:30, HNoMS Helge Ingstad started to turn to port, ending up at 147° at 04:00:46 (see Figure 42 in section 1.15.1.2).

Based on information from the navigation system, the graph in Figure 42 shows the headings of HNoMS Helge Ingstad in the period from 03:58:06 to 04:01:36.

Figure 42: The headings of HNoMS Helge Ingstad in the period from 03:58:06 to 04:01:36. Illustration: AIBN

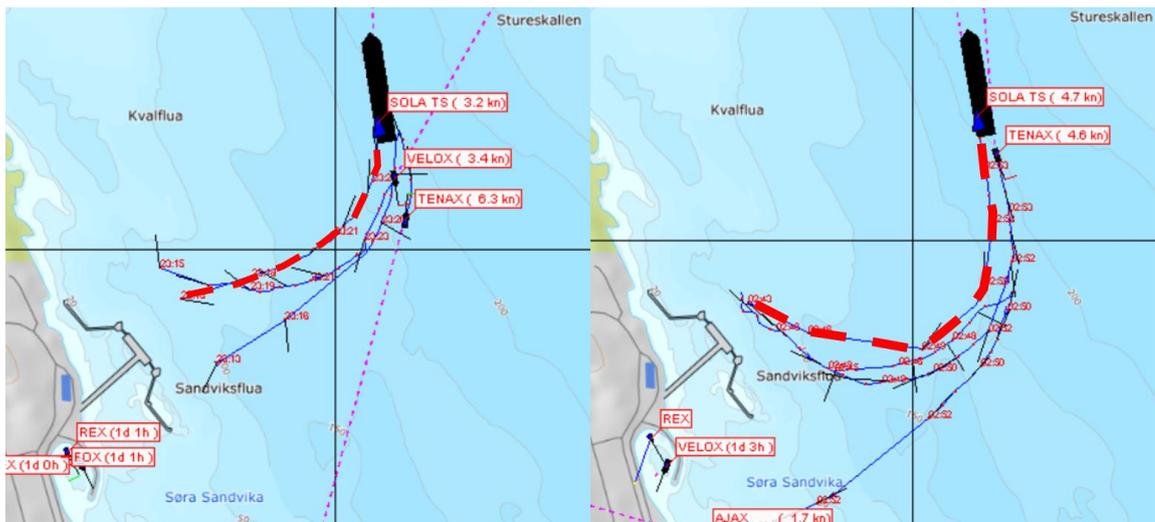
The manoeuvring performed when leaving the quay and the wind conditions caused Sola TS to turn towards a northerly course more quickly than the night of the accident (see Figure 44). This meant that Sola TS was a little closer to HNoMS Roald Amundsen than planned throughout the observation voyage. The time at which the forward-pointing deck lights on Sola TS started to stand out more clearly when viewed from HNoMS Roald Amundsen was probably earlier in the sequence of events than on the accident voyage.

Figure 44: Left: Sola TS manoeuvring out from the quay on the observation voyage. Right: Sola TS manoeuvring out from key the night of the accident. Source: NCA/AIBN

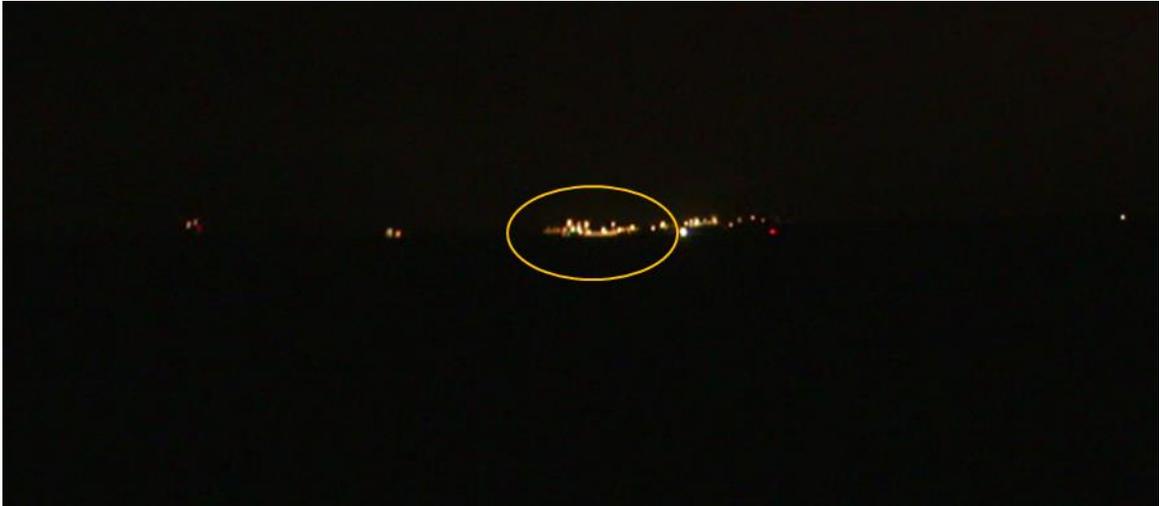
Sola TS started manoeuvring out from the quay at 03:36, exhibiting navigation lights and with some of the deck lights turned on to light up the deck for the crew who were securing equipment etc. for the passage (see section 1.10.4 and 1.10.5). Figure 45 shows what the situation looked like on the observation voyage when Sola TS started to manoeuvre out from the quay.

Figure 45: Screenshot of video recording on the bridge of 'HNoMS Roald Amundsen' on the observation voyage in the early hours of 2 April 2019, when Sola TS started to manoeuvre out from the quay. This corresponds approximately to the situation at 03:36 on the night of the accident. Sola TS marked with yellow circle. Photo: The police

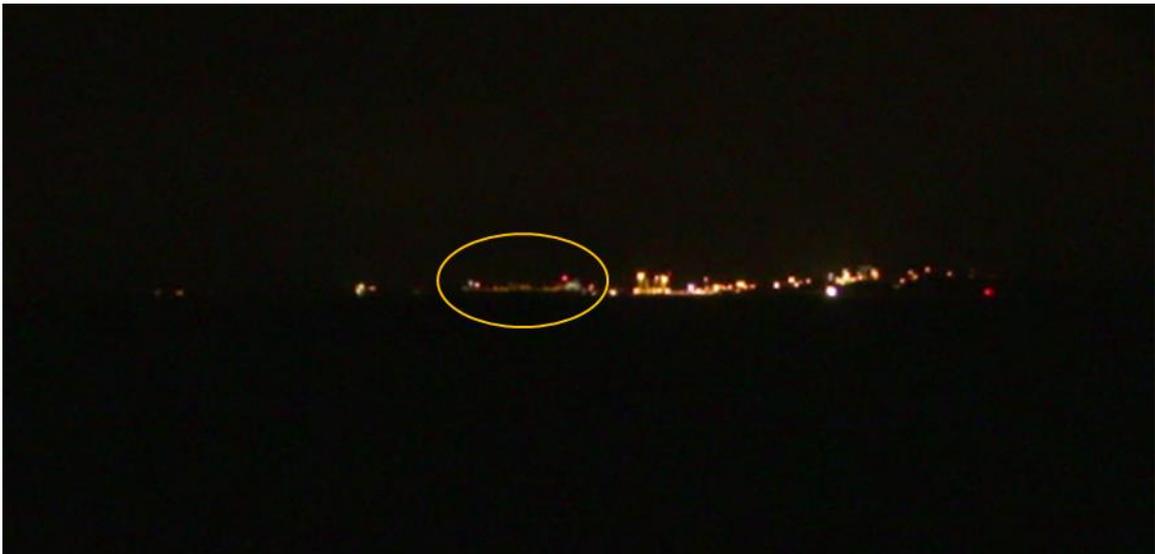
On the observation voyage, the initial manoeuvring out from the quay took place so slowly that no movement could be observed. It was very difficult to observe the vessel against the background lights from the terminal, unless binoculars were used and you knew what you were looking for. The lights from the vessel appeared to be an extension of the lights from the terminal. Figure 46 shows what the situation looked like on the observation voyage as Sola TS was moving away from the quay.

Figure 46: Screenshot of video recording on the bridge of HNoMS Roald Amundsen on the observation voyage in the early hours of 2 April 2019, seven minutes after Sola TS started to manoeuvre out from the quay. This corresponds approximately to the situation at 03:43 on the night of the accident, at which time Sola TS had a more southerly course, however. Sola TS marked with yellow circle. Photo: The police.

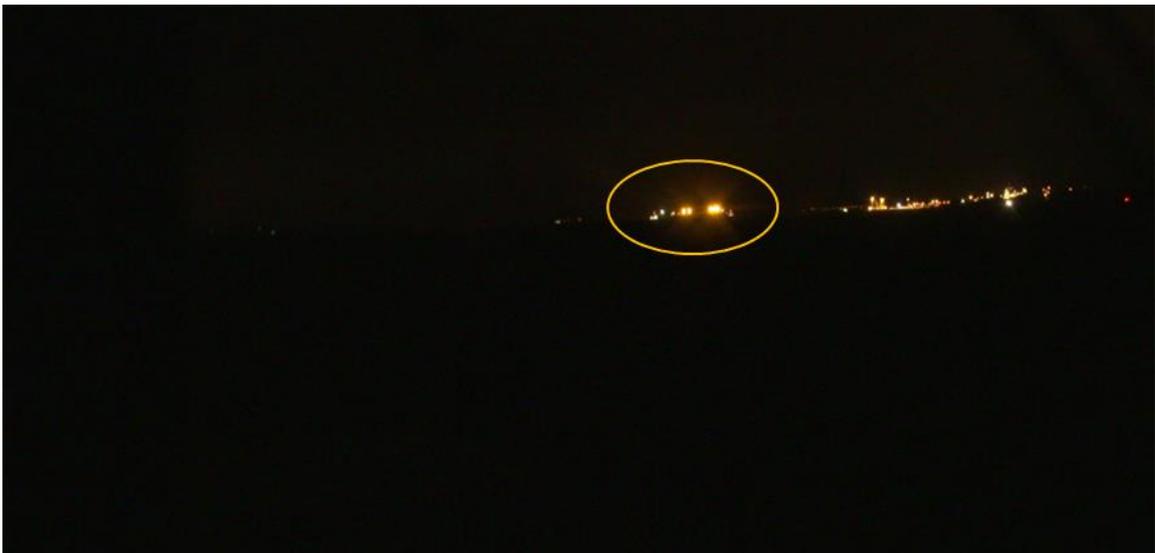
On the observation voyage, Sola TS only stood out clearly as she turned her bow northwards towards Fedjeosen, so that the forward-pointing yellow deck lights became visible (see Figure 47). It was difficult, even through binoculars, to discern the vessel's navigation lights due to the deck lighting. It was probably during this period that the relieving OOW and the OOW being relieved on HNoMS Helge Ingstad were discussing traffic in the fairway. This was when they observed an object giving off masses of light to starboard of the frigate's course line, located alongside or near the Sture Terminal. The 'object' was observed both visually and on the radar display in the form of a radar echo and AIS symbol.

Figure 47: Screenshot of video recording on the bridge of HNoMS Roald Amundsen on the observation voyage in the early hours of 2 April 2019, when Sola TS had turned to a north-northeasterly course (035°). This corresponds approximately to the situation at 03:49 on the night of the accident. Sola TS marked with yellow circle. Photo: The police

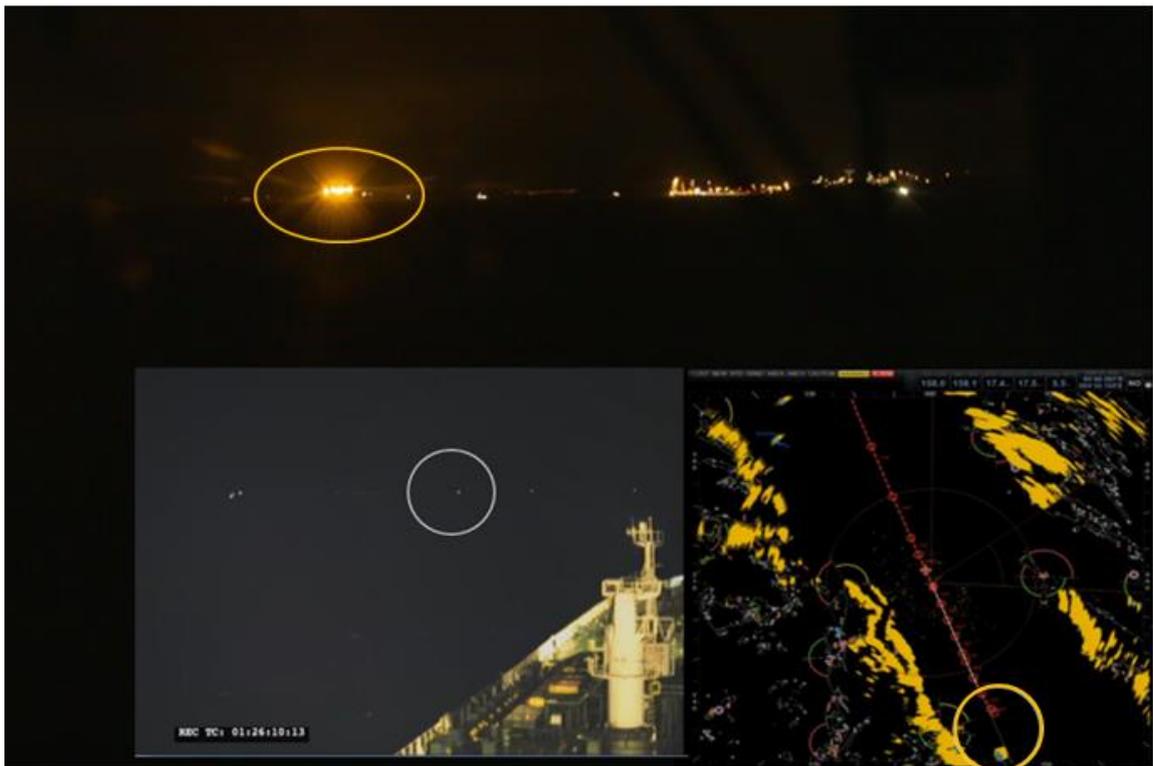
Viewed from HNoMS Helge Ingstad, the deck lights on Sola TS did not give the impression of a moving vessel. On the observation voyage, the lights appeared to increase in intensity as the vessels came closer to each other, but it was nonetheless difficult to judge the distance. Furthermore, the intensity of the lights was dazzling, and it was unpleasant to look straight at them.

Figure 48: Top: Screenshot of video recording on the bridge of HNoMS Roald Amundsen on the observation voyage in the early hours of 2 April 2019. This corresponds approximately to the situation at 03:53 on the night of the accident. Bottom left: Screenshot of video recording on the bridge of Sola TS on the observation voyage. Bottom right: Screenshot of video recording of the radar display on HNoMS Roald Amundsen on the observation voyage, marked with white circle. Sola TS marked with yellow circle. Illustration: The shipping company/police/AIBN

The photo in Figure 48 shows what Sola TS may have looked like from the bridge of HNoMS Helge Ingstad at around 03:53 on the night of the accident. The figure also shows what HNoMS Helge Ingstad may have looked like from the bridge of Sola TS, marked with a white circle. As evident from the image in the bottom right corner, Sola TS was visible on the radar on board HNoMS Helge Ingstad at this time.

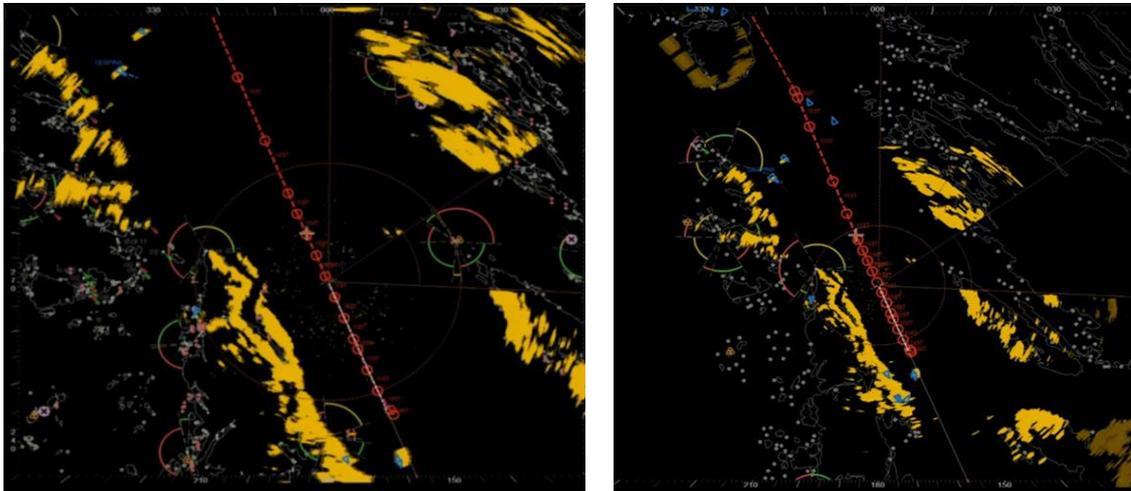
Data from the bridge system show that the settings on the OOW's radar (MFD 1) were changed from 3 nm to 6 nm and back to 3 nm at 03:55 (see section 1.15.2.2). It was probably the OOW whom at this time checked whether there were more vessels further ahead. Figure 49 shows the radar display on HNoMS Roald Amundsen on the observation voyage, at a time approximately corresponding to 03:55 on the night of the accident, with the range scale set to 3 nm on the left and to 6 nm on the right.

Figure 49: Screenshot of video recording of the radar display on HNoMS Roald Amundsen during the observation voyage in the early hours of 2 April 2019, with the range scale set to 3 nm on the left and to 6 nm on the right. This corresponds approximately to the situation at 03:55 during the night of the accident. Photo: The police

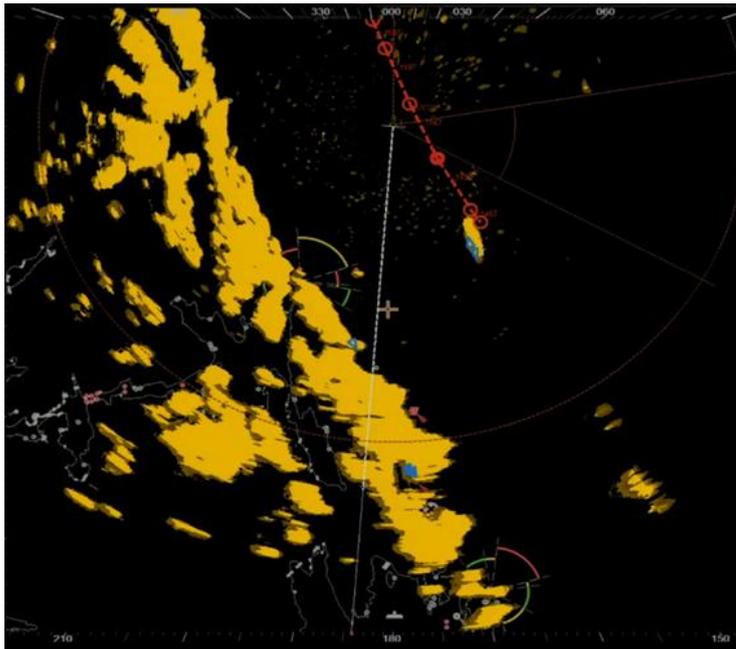
Data from the bridge system show that the settings on the OOW's radar (MFD 1) were changed from 3 nm to 1.5 nm at 03:59 (see section 1.15.2.2). This was probably done by the OOW to check that there was room to adjust the course towards port without conflicting with the three approaching vessels. The OOW instructed the OOWT to adjust the course by some degrees to port. During the period up until the time of the collision, the course of HNoMS Helge Ingstad was adjusted by a total of 10 degrees to port through a series of small course changes (see section 1.15.1.2).⁴⁵

Figure 50: Screenshot of video recording of the radar display on HNoMS Roald Amundsen during the observation voyage in the early hours of 2 April 2019, with the range scale set to 1.5 nm. This corresponds approximately to the situation at 03:59 on the night of the accident, when the distance between Sola TS and shore (Ådnesflua) was approximately 950 meters. Photo: The police

As shown in Figure 50 at this time the distance between land and the 'object' was 950 m. The distance between the 'object' and the first of the three northbound vessels was approximately half of this. The OOW's situational awareness, radar use, experience and competence are discussed further in sections 2.3.2.2 and 2.3.3.2.
