Issued November 2019

REPORT

Marine 2019/08

PART ONE REPORT ON THE COLLISION ON 8 NOVEMBER 2018 BETWEEN THE FRIGATE HNOMS HELGE INGSTAD AND THE OIL TANKER SOLA TS OUTSIDE THE STURE TERMINAL IN THE HJELTEFJORD IN HORDALAND COUNTY

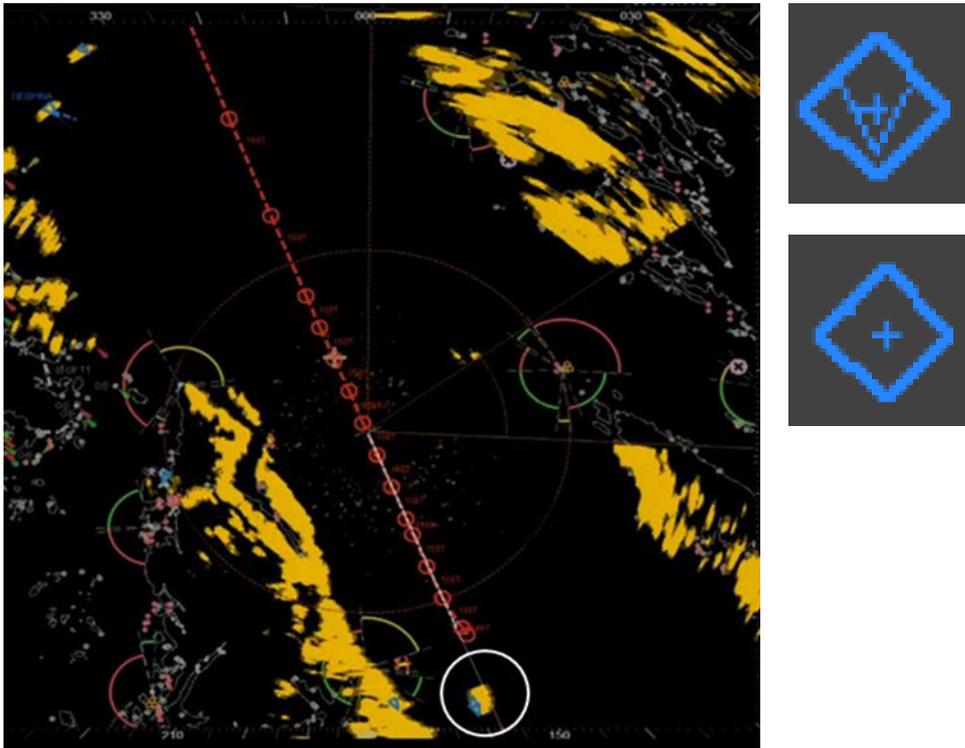
- Presentation of AIS symbols: The relieving OOW has described a blue mark. This was interpreted to be an AIS signal from a fixed installation and not from one or two vessels. Since HNoMS Helge Ingstad had not tracked Sola TS, the tanker will have been represented by the symbol for a sleeping AIS target (see section 1.9.3.8). The tugboats assisting Sola TS will also have been presented as sleeping AIS targets. Since the symbol orientation depends on the bow orientation, Sola TS and the tugboats may have been entangled on the MFD display on HNoMS Helge Ingstad, so that they appeared to represent a navigation object or a virtual navigation object (see Figure 51).

Figure 51: On the left: Screenshot of video recording of radar display on HNoMS Roald Amundsen on the observation voyage. Sola TS with escorting tug marked with a white circle. Virtual navigation object in the top right corner. Navigation object, landmark or buoy with AIS transponder in the lower right corner. Illustration: AIBN

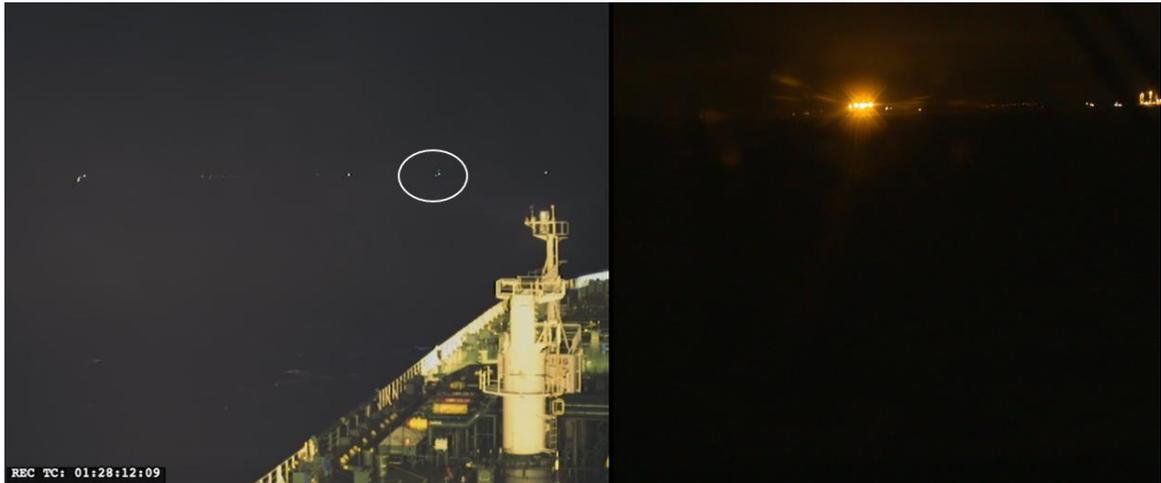
Sola TS left the quay with the forward-pointing deck lights on. The AIBN's experience on the observation voyage showed that it was difficult, even through binoculars, to discern the tanker's navigation lights from the deck lighting (see Figure 52). This implies that it cannot have been easy for the bridge crew on HNoMS Helge Ingstad to observe the

navigation lights on Sola TS. As a consequence of the deck lights it was visually challenging for the bridge crew on the frigate to identify the tanker as a vessel.

Figure 52: Photos from the observation voyage taken at a time corresponding to approximately 03:55 the night of the accident. On the left: the view from the bridge on Sola TS, with HNoMS Roald Amundsen marked with a white circle. The photo on the right shows what Sola TS may have looked like from the bridge on HNoMS Helge Ingstad. The distance between the vessels was approximately 2.3 nm at the time. Photo: The police/the shipping company/AIBN

The pilot considered other options for establishing contact with the vessel. At 03:59:02, the pilot asked the master on Sola TS to use the Aldis lamp to send out signals to the vessel and get her attention. Given the view that the bridge team on Sola TS had of HNoMS Helge Ingstad (see Figure 52), the AIBN can understand the assumption that the flashes from the Aldis lamp would be observed by the approaching vessel.

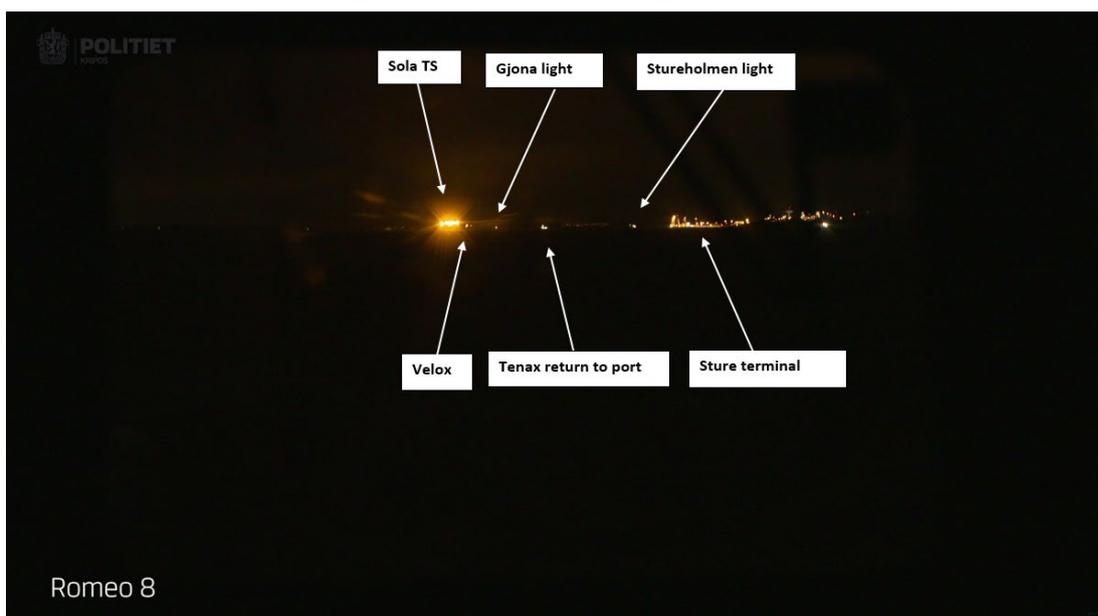
Figur 14. Visible objects that could be observed from the bridge of HNoMS Roald Amundsen during the observation voyage. Source: Police/AIBN
