# Grounding of the bulk carrier *Orient Centaur*

Weipa, Queensland | 6 November 2017

**ATSB Transport Safety Report**  
Marine Occurrence Investigation  
MO-2017-010  
Final – 14 November 2019

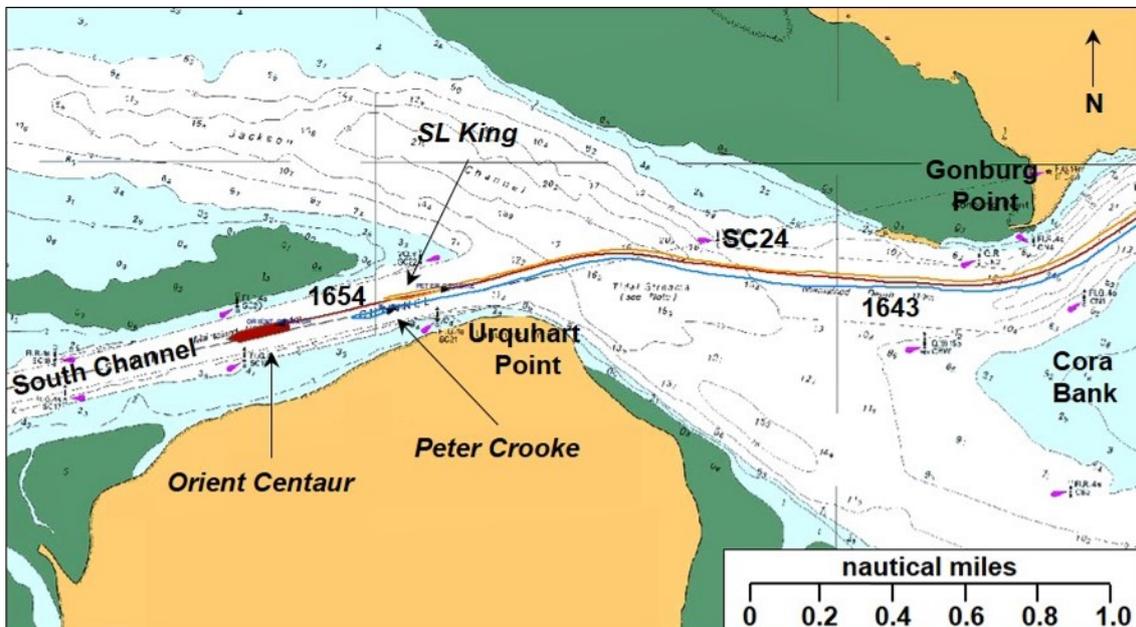
**Figure 2: *Orient Centaur* passing Urquhart Point and entering the South Channel**

At 1643, as the ship passed Gonburg Point, *SL King* was let go and stood by on the quarter, and the conning pilot ordered full ahead. Shortly after, as the ship passed beacon SC24, the conning pilot ordered port helm and started altering course into the South Channel. At about 1654, when the ship was steady in the South Channel, the conning pilot released the tugs as they passed SC22, and they headed back to their berth (Figure 2). The ship then proceeded outbound in the South Channel as planned, at a speed of about 8 knots.

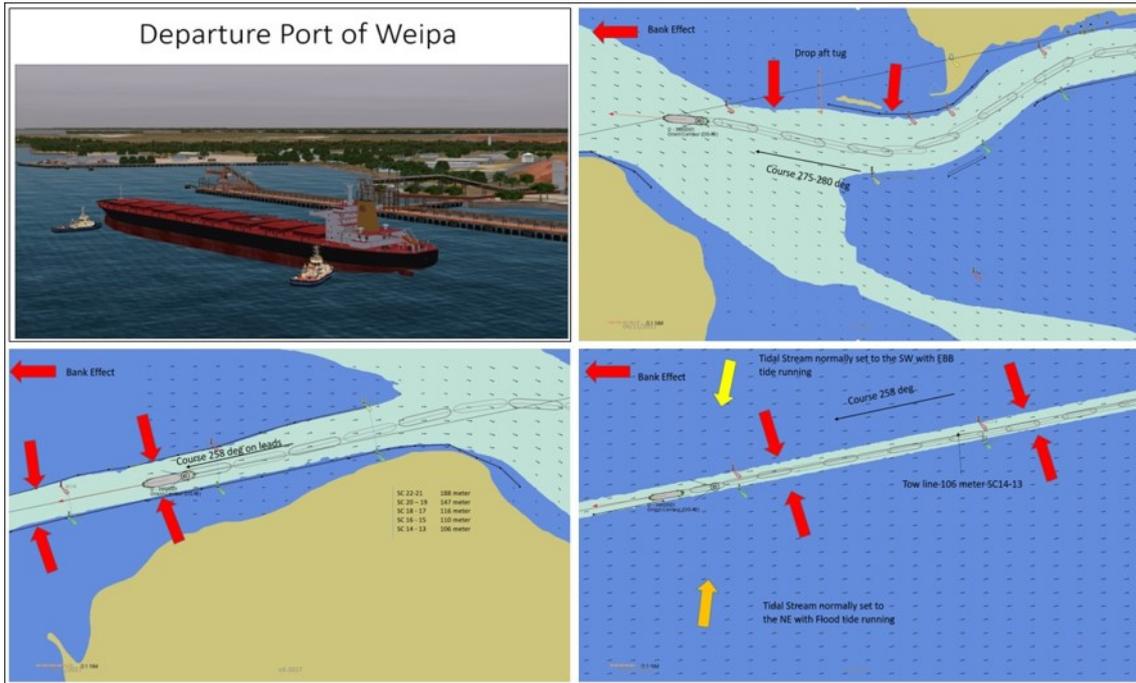
**Figure 8: Port simulation exercise report**

In 2017, Rio Tinto Marine submitted a written application to the RHM for mini cape-size ships that were 255 m in length with a 43 m beam to export bauxite from Weipa. As the ships exceeded the port's size limits, Full Mission Bridge Simulation (FMBS) exercises were required. In May and July 2017, the RHM, pilot manager, several senior pilots and a Rio Tinto shipping specialist, attended the MSQ Smartship simulator in Brisbane, Queensland, to conduct the FMBS exercises. The exercises (Figure 8) used a model of the mini cape-size bulk carrier for arrivals in a ballast condition and departures in a fully laden condition, to a maximum draught of 12.8 m.

Red arrows show areas of bank effect, yellow arrows show flood tide, other annotations show ship's course, past positions and tidal information.

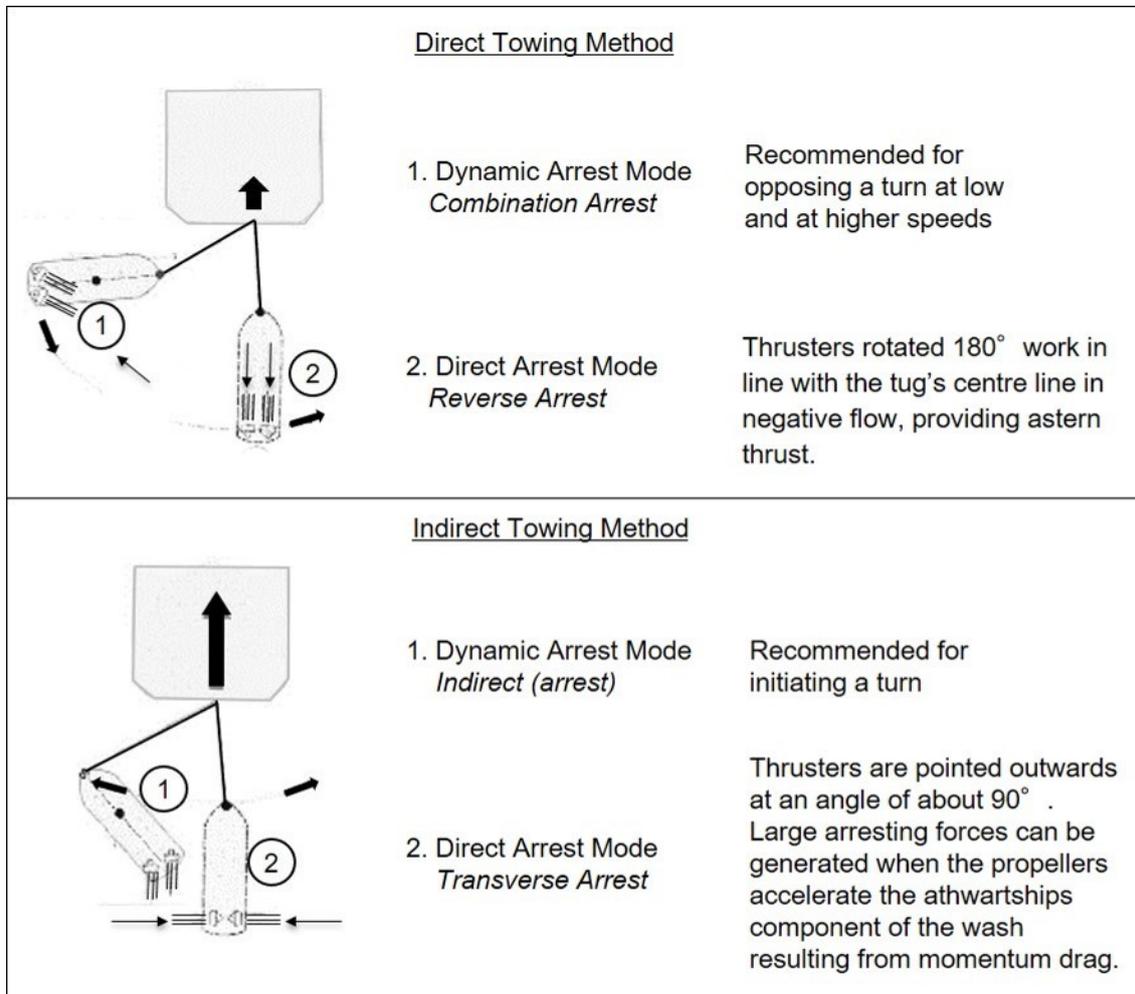
**Figure 9: Azimuth stern drive tugs - direct and indirect towage methods**

ASD tugs can be operated in either direct or indirect towage methods (Figure 9). The method used in the Port of Weipa was direct towage, as the tugs were predominantly used for harbour work and assisting ship berthing and un-berthing manoeuvres. Direct towing is performed at low speeds from about 0- 5 knots. The tug uses its engines and propellers to generate the tow force (directly), which is governed by the conventional bollard pull of the tug.

The effectiveness of the towage methods is also dependent on the availability of safe water to work in. In a narrow channel, the ability to work around the radius of the towline is restricted. Therefore, with the ship at speed (about 8 knots) in the South Channel (106 m) it was prohibitive for a tug to effectively steer it using dynamic arrest mode. However, direct arrest mode remained an effective option when retarding (braking assistance) forces were required.

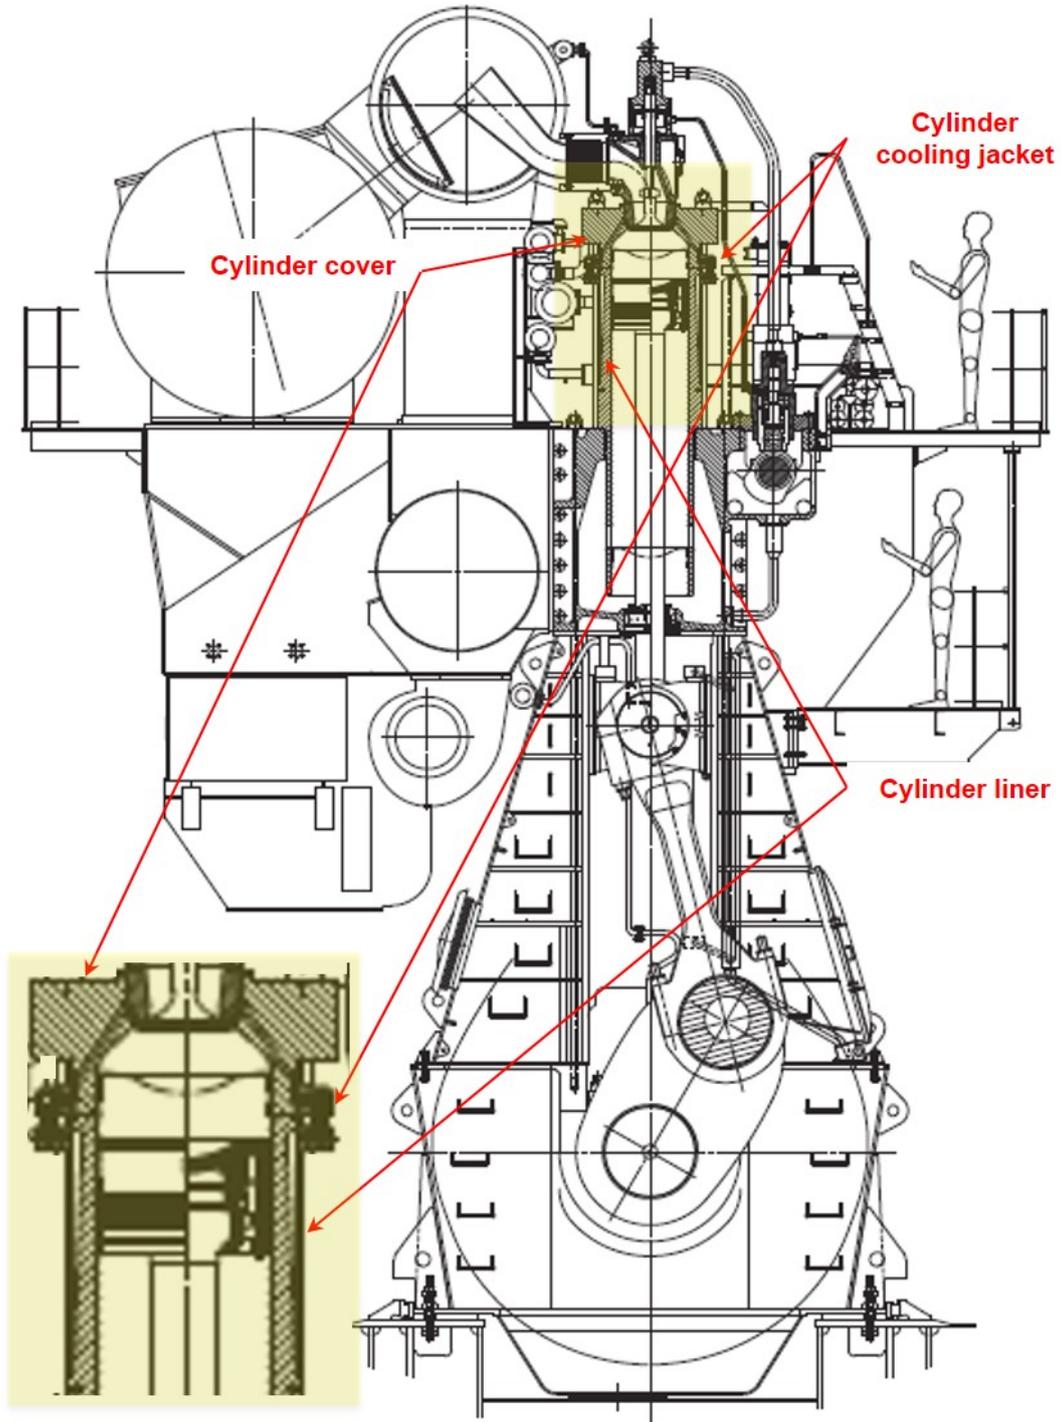
## Appendix A – Engine cross section MAN B&W 6S60MC-C7

At 1800, the ship's engineers identified that the cooling jacket of the cylinder head of number one main engine unit cylinder had cracked, which led to the loss of the jacket water, and the subsequent shutdown of the engine. They then started a cylinder liner jacket overhaul for the failed unit.

*Orient Centaur* remained at anchor throughout 7 November 2017, during which time the ship's engineers completed the cylinder liner jacket replacement. The main engine was tested and made ready for departure.
